**Canterbury Earthquakes 2010/11 Port Hills Slope
Stability: Risk assessment for Clifton Terrace**

**GNS Science Consultancy Report 2014/76
August 2014 FINAL**

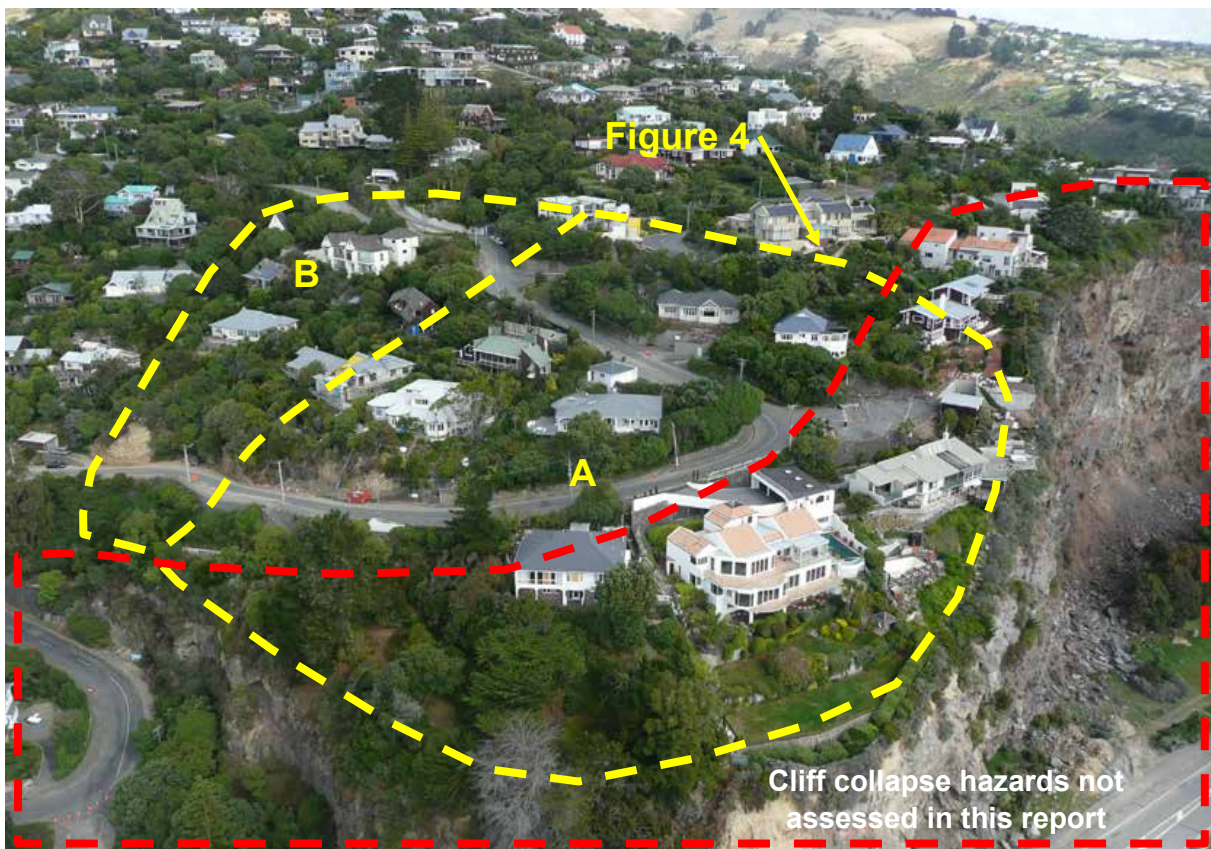
Figure 3 Aerial view of the Clifton Terrace mass movement (approximate extent within the yellow dashed lines). Refer to Figure 2 for the mapped extent of source areas A and B (previously referred to in the Stage 1 report as mass movements 4A and 4B). The cliff-collapse hazards shown within the red dashed lines (approximate extent only), have not been assessed in this report; refer to Massey et al. (2012) for details. Photograph C. Massey (GNS Science, March 2011).

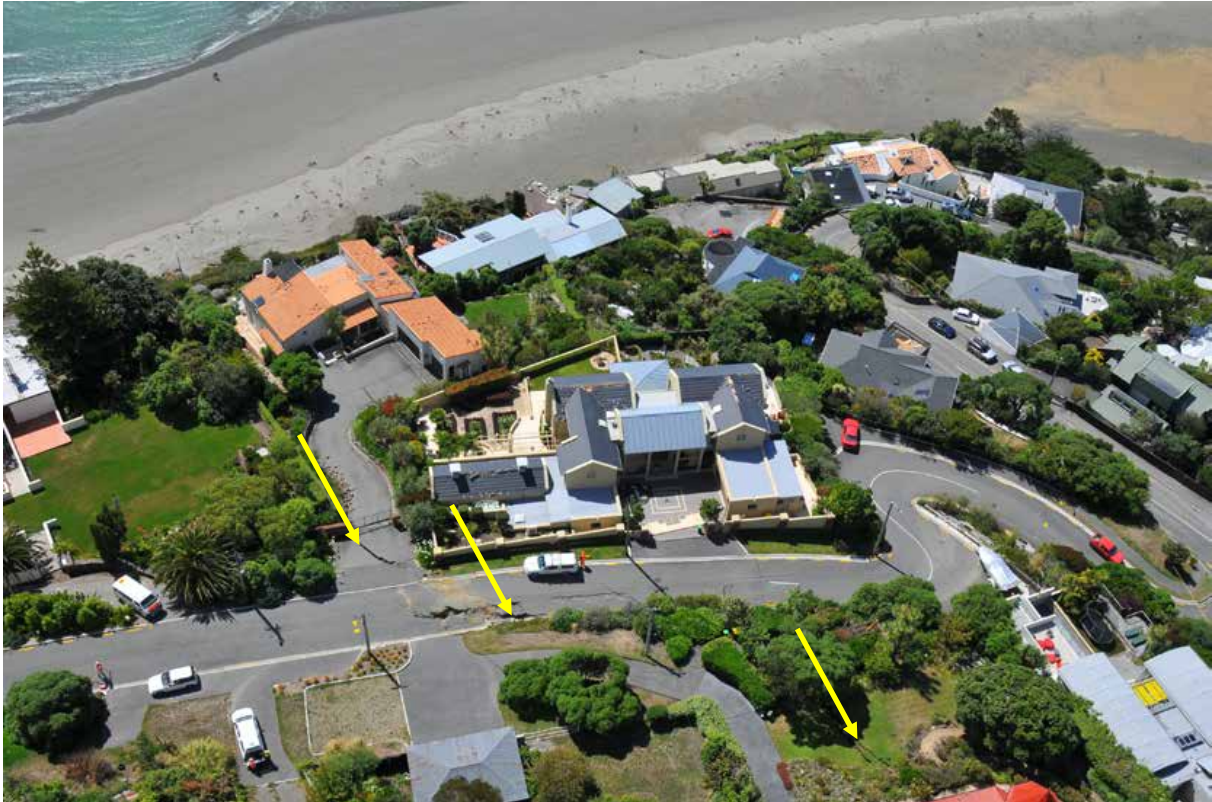
Figure 4 Tension cracks, shears and scarps (yellow arrows) formed by the 22 February 2011 earthquakes at the cliff crest cutting across Kinsey Terrace. Photograph G. Hancox (GNS Science, February 2011).

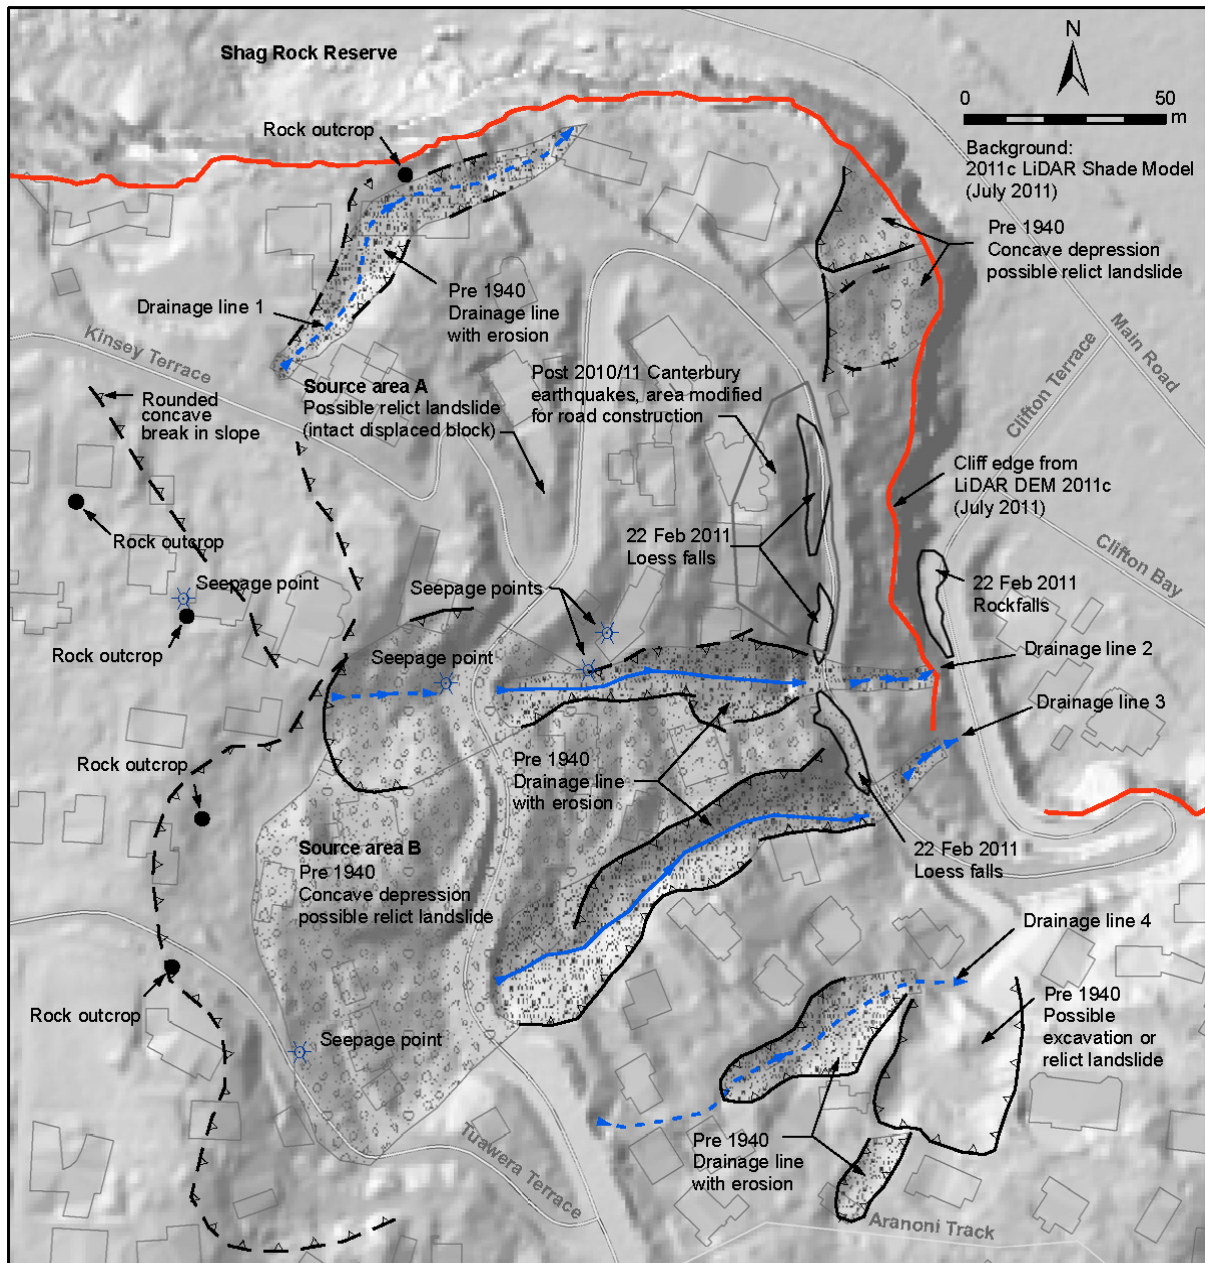
Figure 5 Main features identified at the Clifton Terrace site from field mapping and interpretation of aerial photographs.

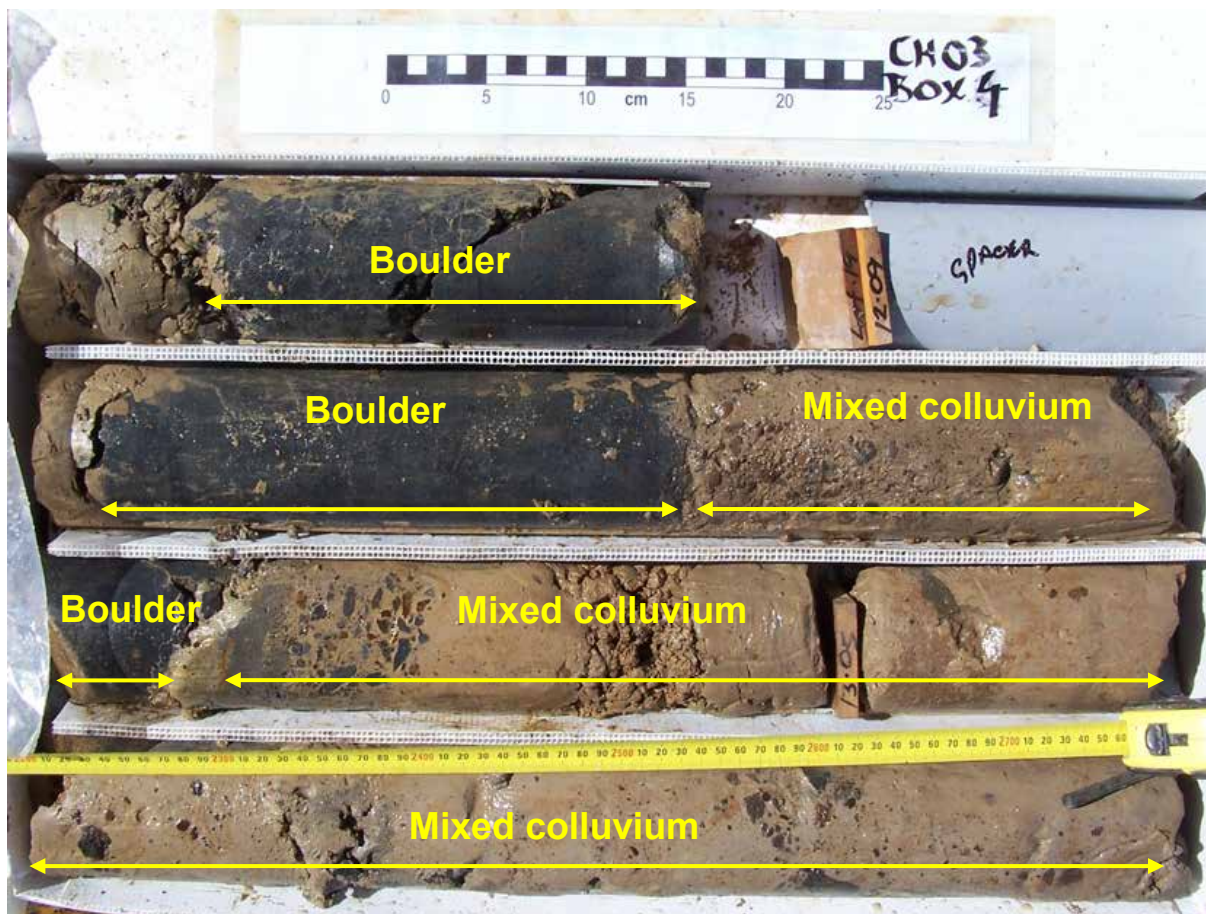
Figure 11 Drillhole core from BH-CH-03. The depth of the core is 11.6 m below ground level (top left of photograph) to 13.8 m below ground level (bottom right of photograph).

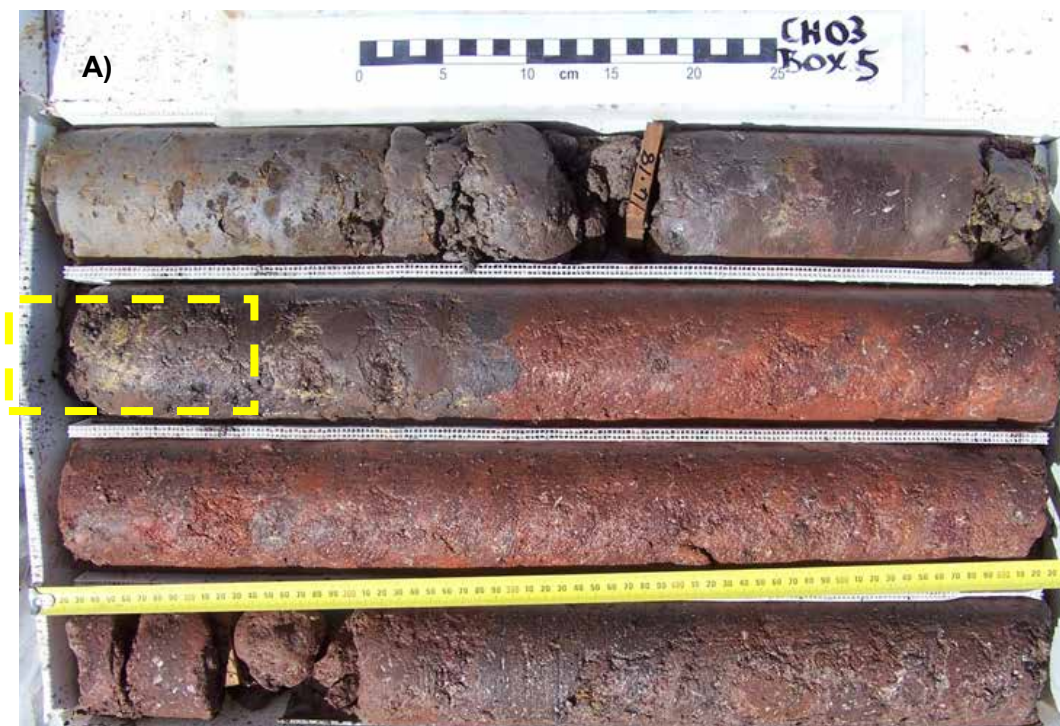
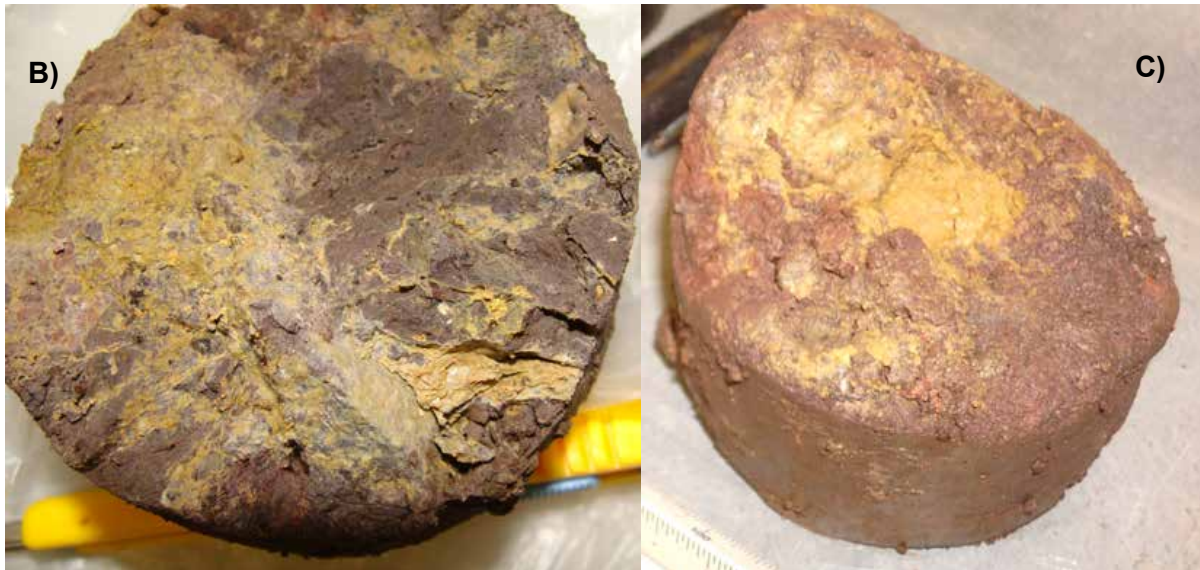
Figure 13 Drillhole core of highly weathered basalt lava breccia from BH-CH-03. A) Core box from depth 13.8 m below ground level (top left) to 16.1 m below ground level (bottom right). B) and C) show the slickensided clay in the weathered breccia, the samples are taken from the drillhole core within the yellow dashed rectangle shown in photograph A).
