Banks Peninsula Fish Passage Assessment and Prioritisation: A Pilot Study

September 2019

Prepared for:
Christchurch City Council

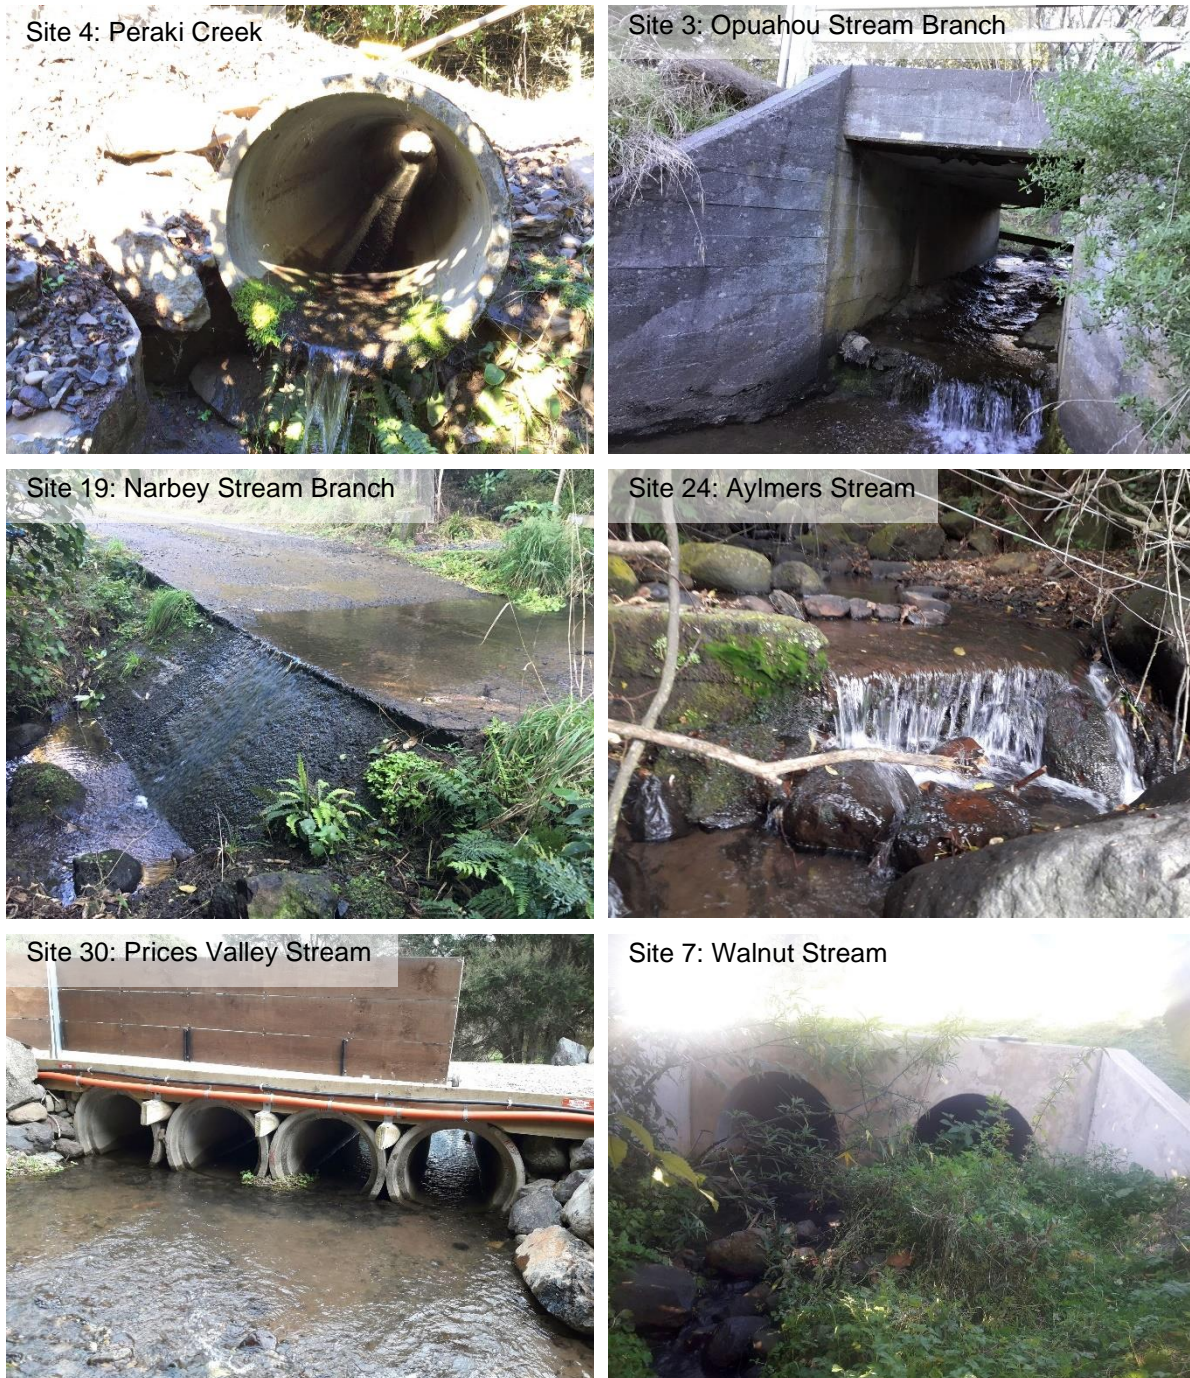
Figure 2: Examples of the range of structures assessed.

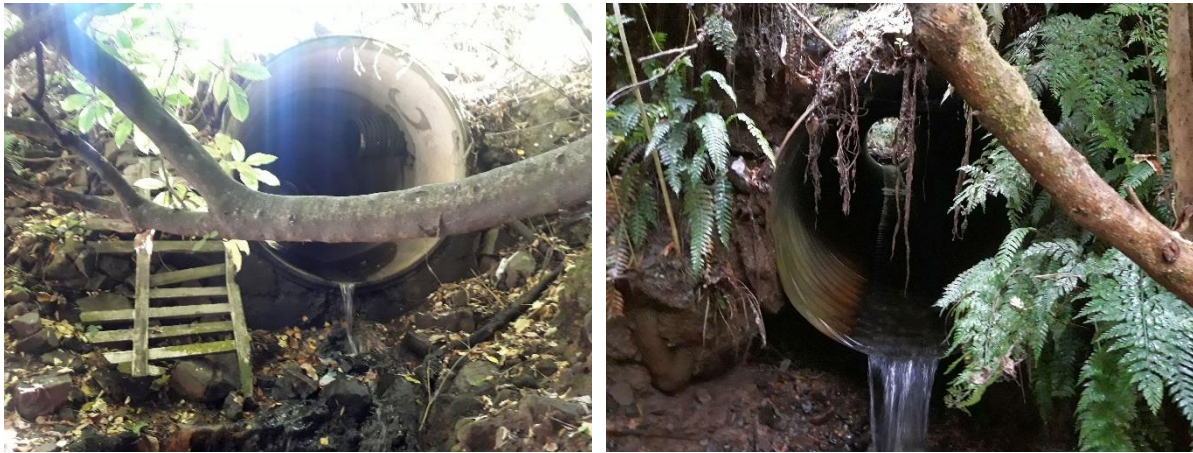
The highest FPAT priority score of 20 (the maximum possible score) was given to a perched culvert on Church Lane Drain (Site 6) in Governors Bay. The lowest FPAT score of 5 (the minimum possible score is 4) was given to two waterfalls (Sites 26 and 28) and a weir (Site 25) on Wainui Valley Stream (Figure 5). Highest priority sites either had no other structures identified elsewhere on the waterway, or a large proportion of the catchment with no other structures. Given the number of additional structures identified during stream walks, it is likely that priority scores would decrease at some sites if stream walks were undertaken upstream

Figure 3: Church Lane Drain (Site 6, left) is a perched culvert assessed as presenting a very high risk to fish passage. The culvert on Wainui Valley Stream Branch (Site 9, right) likely presents a similar risk to fish passage, but the stream location was not mapped in the FPAT app, so a risk score was not calculated for the structure.

in the upper right hand corner of Figure 5. Inspection of the data indicates that Site 7 (Walnut Stream) has the highest combination of FPAT and constructability scores, and so should be a high priority for remediation. In contrast, Site 6 (Church Lane Drain) has the highest FPAT priority score of 20, but a relatively low constructability score of 7, reflecting comparatively difficult site access (Figure 5). Site 1 on Aylmers Stream also had a constructability score of 7, but it had a lower FPAT score of 12. However, the structure was assessed as a bridge, which automatically resulted in a lower risk to fish passage score and a lower FPAT score; if the structure had been assessed as a culvert, the structure risk would likely have been very high and the FPAT priority score would have increased from 12 to 16.
