# Sumner Revetment Assessment

Christchurch City Council

## Operational Review Sumner Revetment

IZ103600-NM-RPT-001 | 4

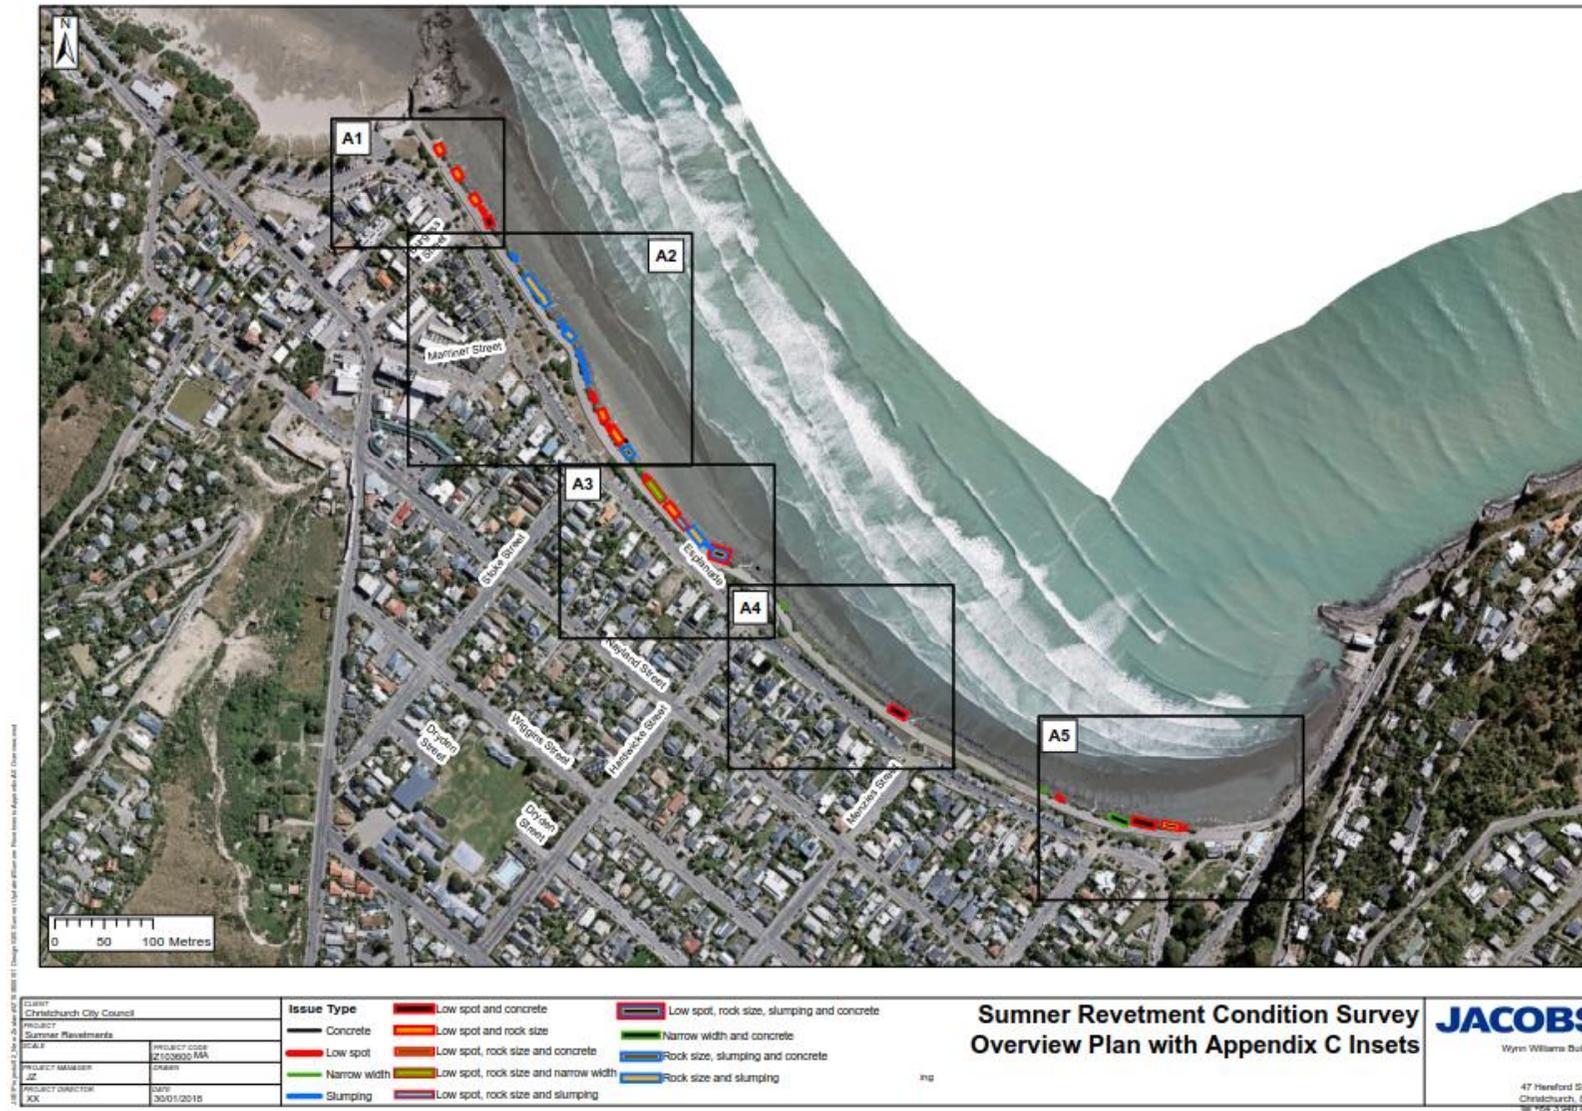
Figure 5.1: Overview of Issue locations identified from initial walk-over condition assessment

From Appendix C, it is notable that the majority of the issue locations are in the northern section of the revetment, particularly from Marriner Street to Hardwicke Street, which contains half of the identified areas within a 320 m length.

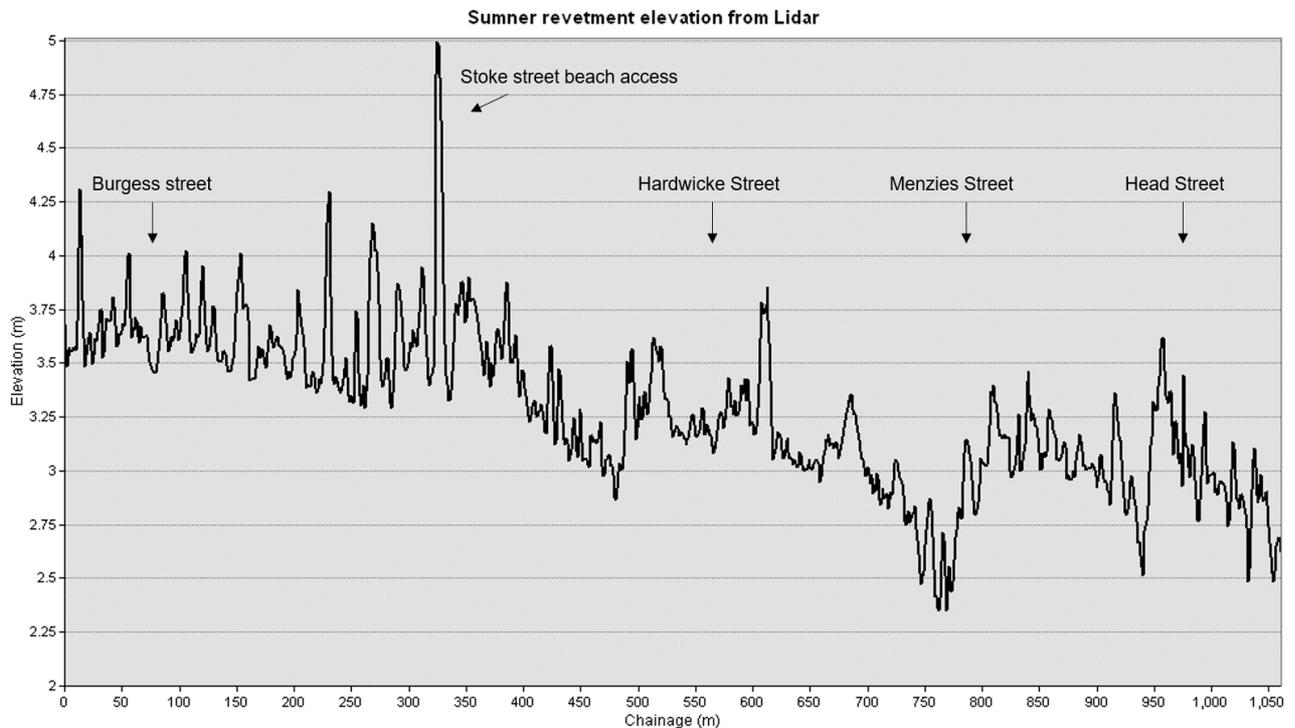
Figure 5.2: Revetment crest elevation long-section from LiDAR (2015) data

The results indicate that the revetment is higher in the northern end, generally being above 3.4m VLD to the north of Stoke St, and in the range 2.8 to 3.2 m at Scarborough to the south of Head Street. The lowest elevation shown on the graph is a beach access way north of Menzies Street, which was identified as a critical location in the walkover assessment. These elevations are assessed against the optimum design elevations in sections 6 and 7.

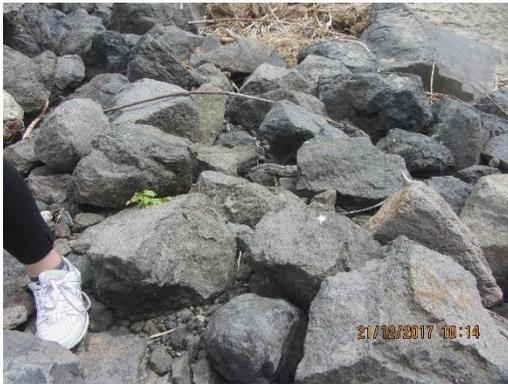
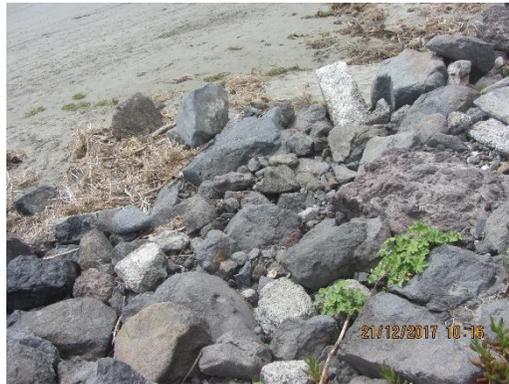
Site 3							
North End Co-ordinates (NZTM)		Length of Area (m)	Crest Elevation from Lidar (m LVD)	Revetment Width from Lidar (m)	Revetment Slope	Est. Armour Rock size if considered issue	Actual Critical Analysis Rank for Priority Assessment
Northings	Eastings						
5176167	1580659	3.2	3.6	7.5	2.94	0.2-0.3m	3a
<b>Other issues identified:</b> Localised low spot.

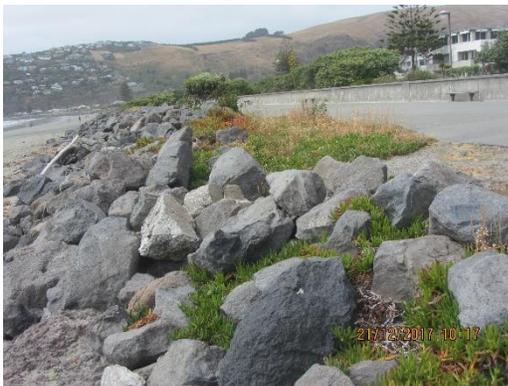
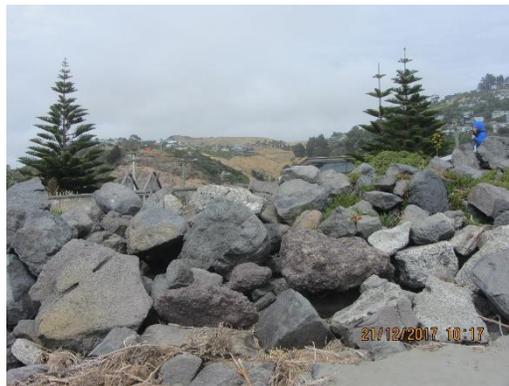
Site 4							
North End Co-ordinates (NZTM)		Length of Area (m)	Crest Elevation from Lidar (m LVD)	Revetment Width from Lidar (m)	Revetment Slope	Est. Armour Rock size if considered issue	Actual Critical Analysis Rank for Priority Assessment
Northings	Eastings						
5176167	1580662	5.8	3.4	7.6	3.04	No issue	1
<b>Other issues identified:</b> Localised low spot at track from promenade to top of revetment.

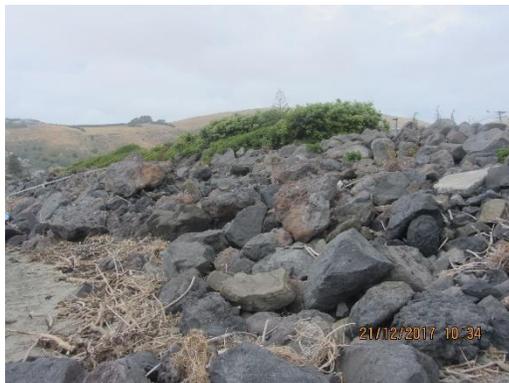
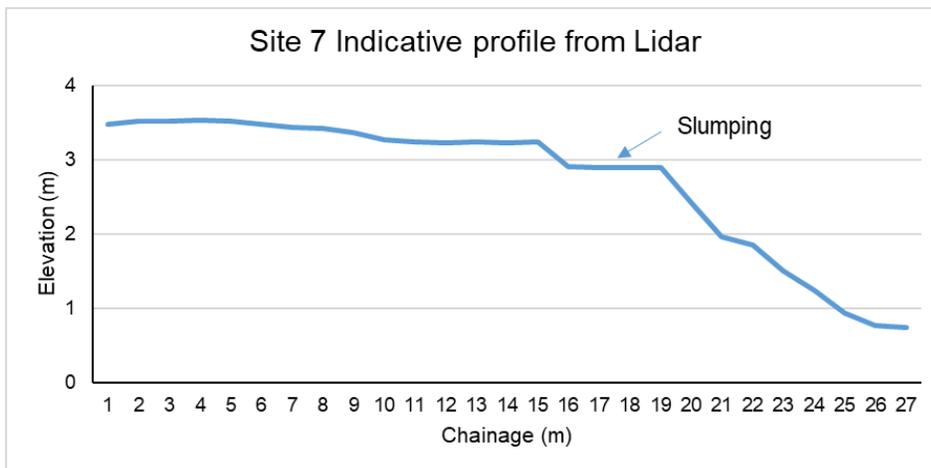
Site 7							
North End Co-ordinates (NZTM)		Length of Area (m)	Crest Elevation from Lidar (m LVD)	Revetment Width from Lidar (m)	Revetment Slope	Est. Armour Rock size if considered issue	Actual Critical Analysis Rank for Priority Assessment
Northings	Eastings						
5176088	1580710	18.4	3.44	11.4	4.16	0.25-0.3m	3b
<b>Other issues identified:</b> Flat slope to front of revetment.

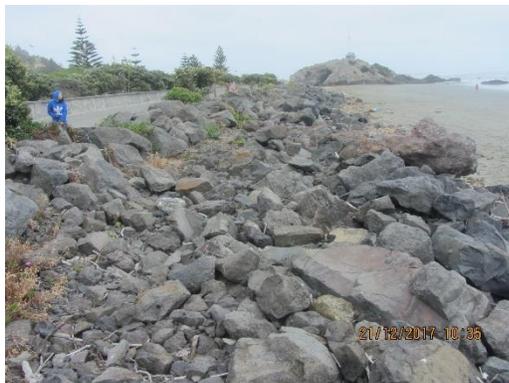
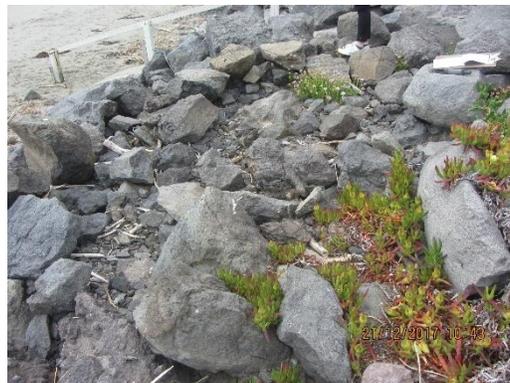
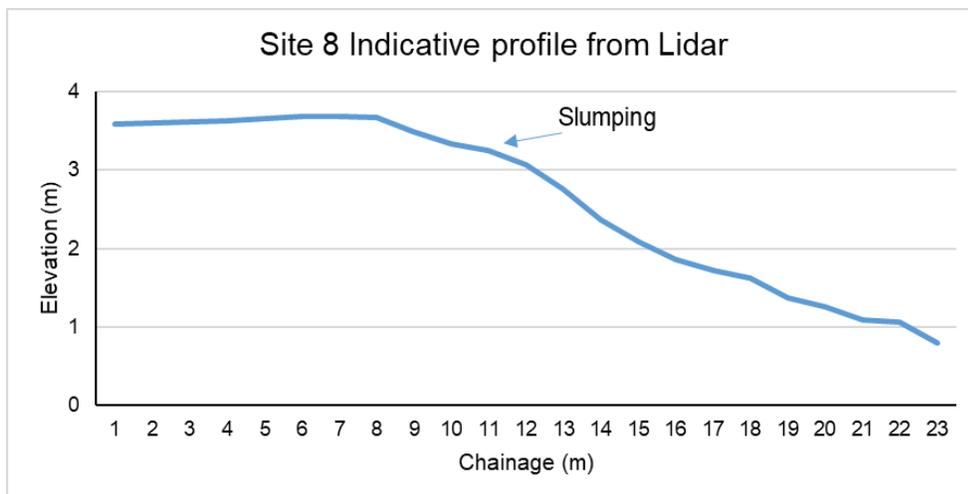
Site 8							
North End Co-ordinates (NZTM)		Length of Area (m)	Crest Elevation from Lidar (m LVD)	Revetment Width from Lidar (m)	Revetment Slope	Est. Armour Rock size if considered issue	Actual Critical Analysis Rank for Priority Assessment
Northings	Eastings						
5176071	1580724	7.0	3.55	9.1	3.14	0.3-0.4m	2
Other issues identified: Slumped profile

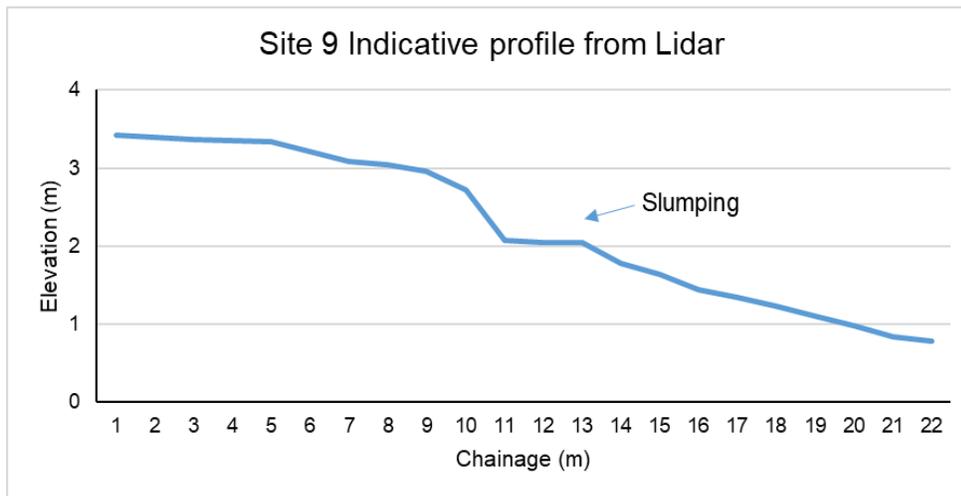
Site 9							
North End Co-ordinates (NZTM)		Length of Area (m)	Crest Elevation from Lidar (m LVD)	Revetment Width from Lidar (m)	Revetment Slope	Est. Armour Rock size if considered issue	Actual Critical Analysis Rank for Priority Assessment
Northings	Eastings						
5176045	1580743	5.8	3.35	9.8	3.66	No issue	1
<b>Other issues identified:</b> Slumped in front of high crest rocks. Large rock in middle of area.

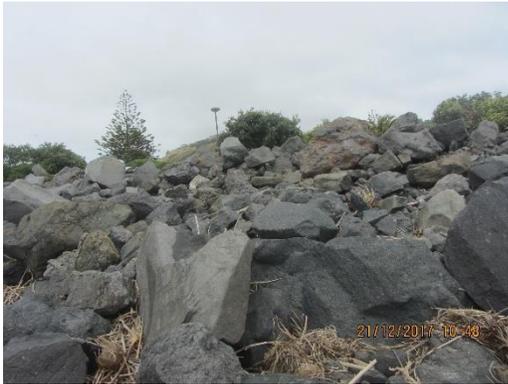
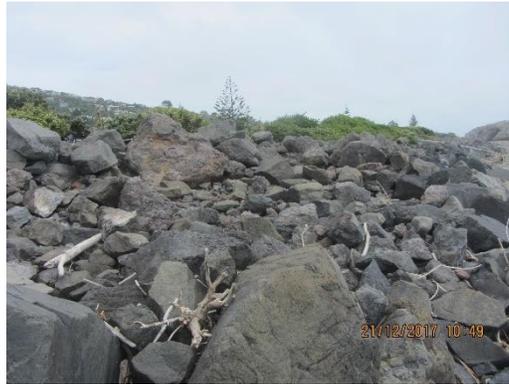
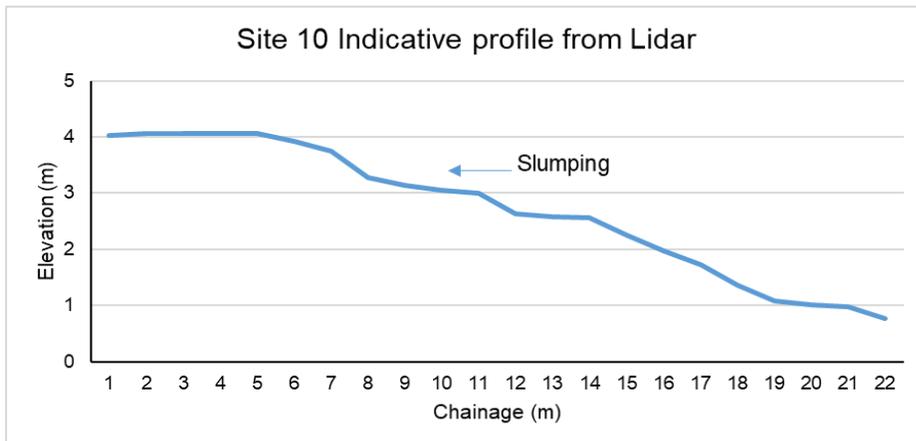
Site 10							
North End Co-ordinates (NZTM)		Length of Area (m)	Crest Elevation from Lidar (m LVD)	Revetment Width from Lidar (m)	Revetment Slope	Est. Armour Rock size if considered issue	Actual Critical Analysis Rank for Priority Assessment
Northings	Eastings						
5176035	1580753	4.2	4.07	9.5	2.91	0.3m	3a
<b>Other issues identified:</b> Slumped in front of high crest rocks.

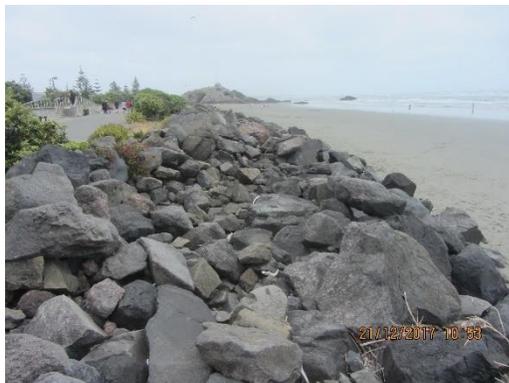
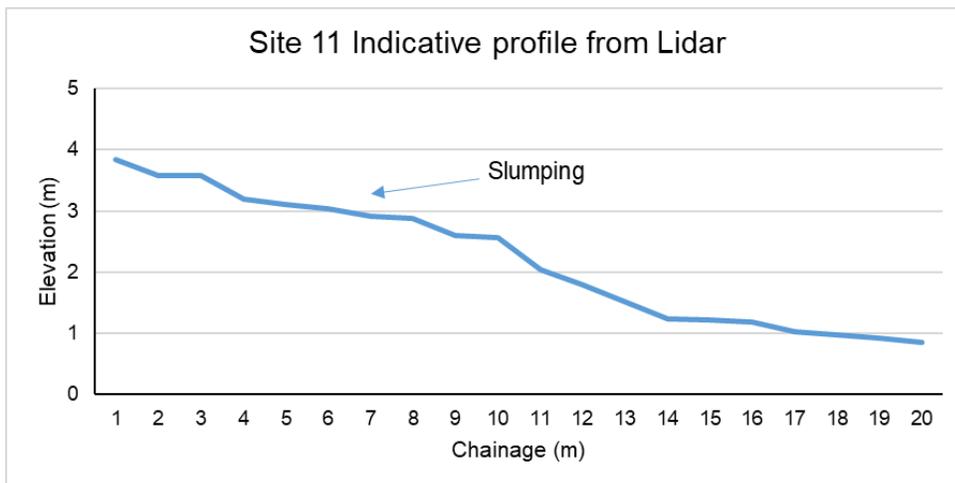
Site 11							
North End Co-ordinates (NZTM)		Length of Area (m)	Crest Elevation from Lidar (m LVD)	Revetment Width from Lidar (m)	Revetment Slope	Est. Armour Rock size if considered issue	Actual Critical Analysis Rank for Priority Assessment
Northings	Eastings						
5176019	1580765	10.8	3.57	8.1	3.12	No issue	1
<b>Other issues identified:</b> Slumped in front of high crest rocks.

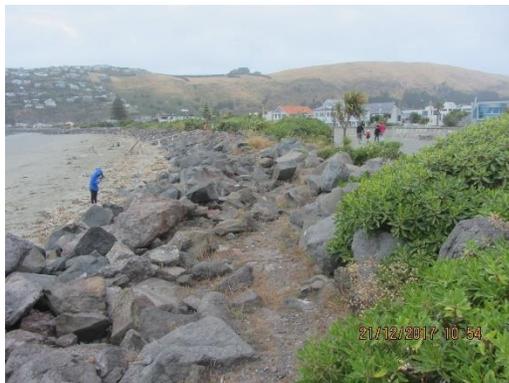
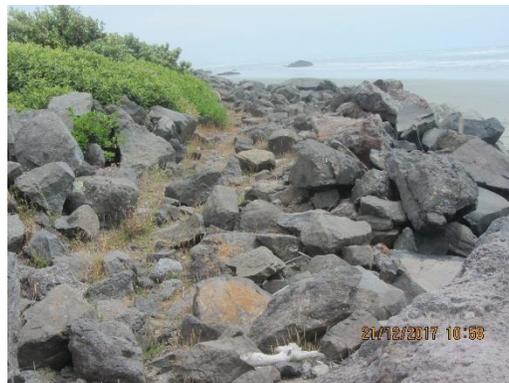
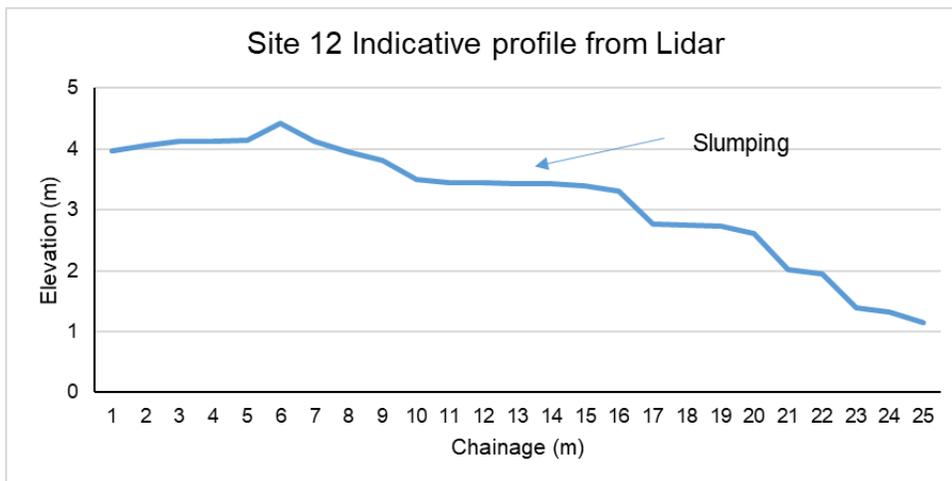
Site 12							
North End Co-ordinates (NZTM)		Length of Area (m)	Crest Elevation from Lidar (m LVD)	Revetment Width from Lidar (m)	Revetment Slope	Est. Armour Rock size if considered issue	Actual Critical Analysis Rank for Priority Assessment
Northings	Eastings						
5176005	1580775	20.0	3.39	7.2	2.75	No issue	2
<b>Other issues identified:</b> Slumped section (potential track) on upper revetment between high front and back rocks.

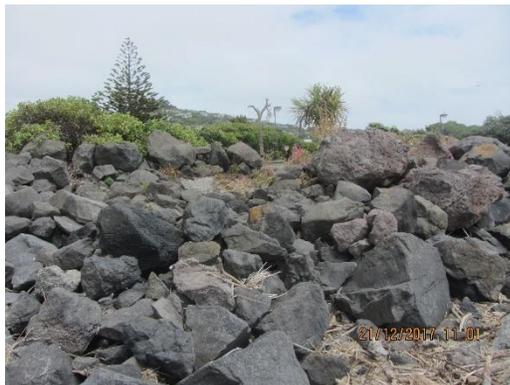
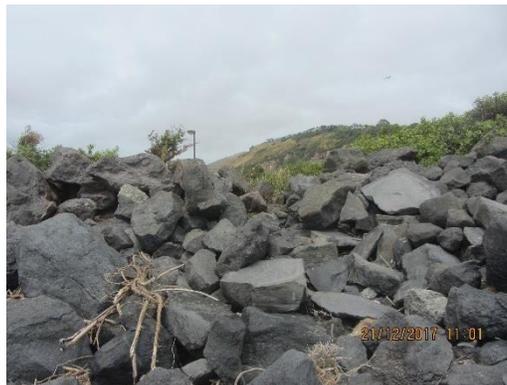
Site 13							
North End Co-ordinates (NZTM)		Length of Area (m)	Crest Elevation from Lidar (m LVD)	Revetment Width from Lidar (m)	Revetment Slope	Est. Armour Rock size if considered issue	Actual Critical Analysis Rank for Priority Assessment
Northings	Eastings						
5175976	1580777	5.4	3.55	7.2	3.51	No issue	1
<b>Other issues identified:</b> Two localized low points. Lacks bulk in front of revetment.

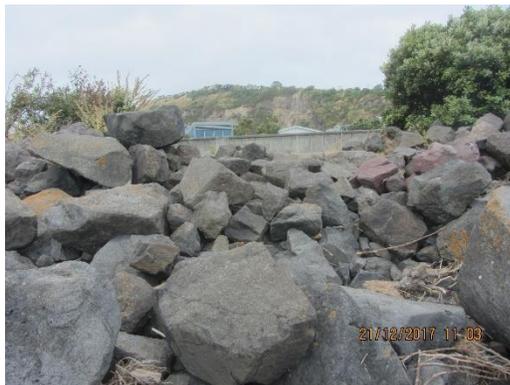
Site 14							
North End Co-ordinates (NZTM)		Length of Area (m)	Crest Elevation from Lidar (m LVD)	Revetment Width from Lidar (m)	Revetment Slope	Est. Armour Rock size if considered issue	Actual Critical Analysis Rank for Priority Assessment
Northings	Eastings						
5175955	1580788	3.2	3.37	6.8	3.64	0.35-0.5m	2
<b>Other issues identified:</b> Localised low point

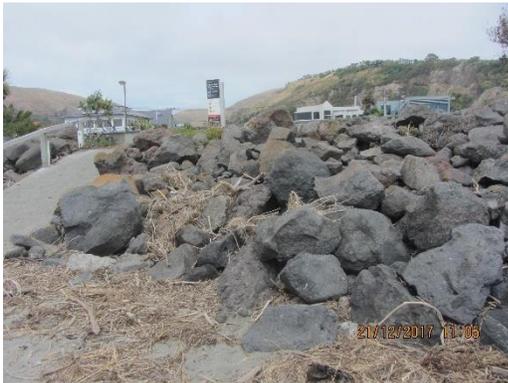
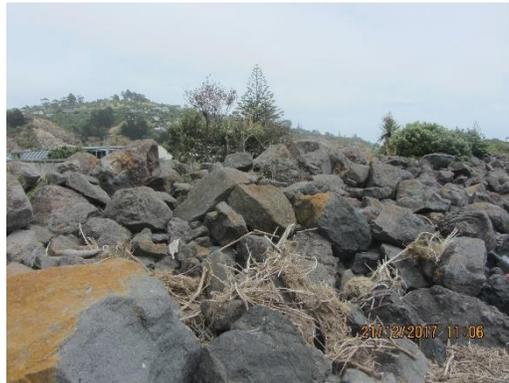
Site 15							
North End Co-ordinates (NZTM)		Length of Area (m)	Crest Elevation from Lidar (m LVD)	Revetment Width from Lidar (m)	Revetment Slope	Est. Armour Rock size if considered issue	Actual Critical Analysis Rank for Priority Assessment
Northings	Eastings						
5175949	1580793	5.1	3.5	7.0	3.5	No issue	1
<b>Other issues identified:</b> Localised low spot.

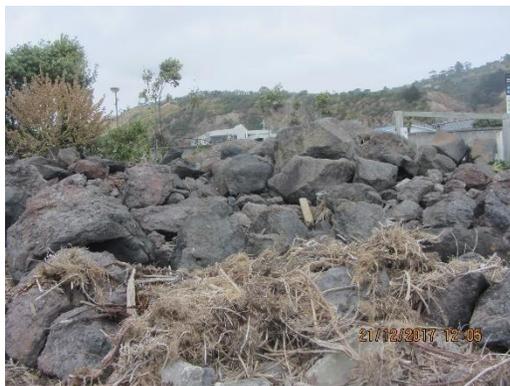
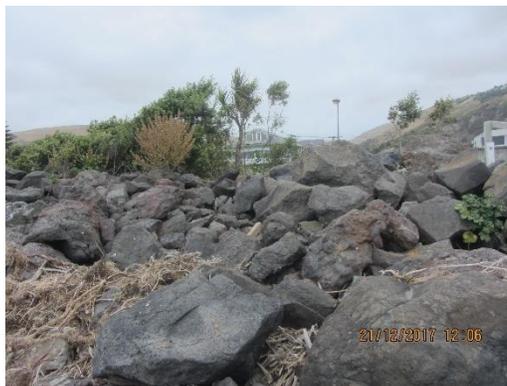
Site 16							
North End Co-ordinates (NZTM)		Length of Area (m)	Crest Elevation from Lidar (m LVD)	Revetment Width from Lidar (m)	Revetment Slope	Est. Armour Rock size if considered issue	Actual Critical Analysis Rank for Priority Assessment
Northings	Eastings						
5175941	1580797	11.7	3.50	6.5	3.42	0.3-0.5m	2
<b>Other issues identified:</b> Localised low spot

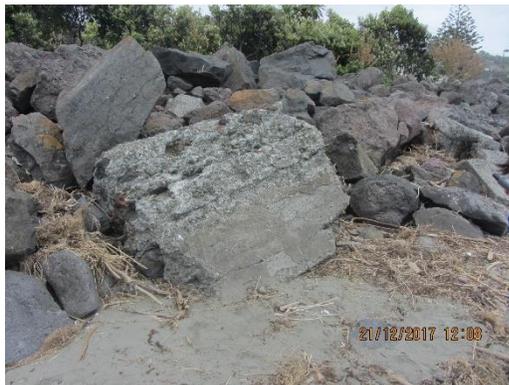
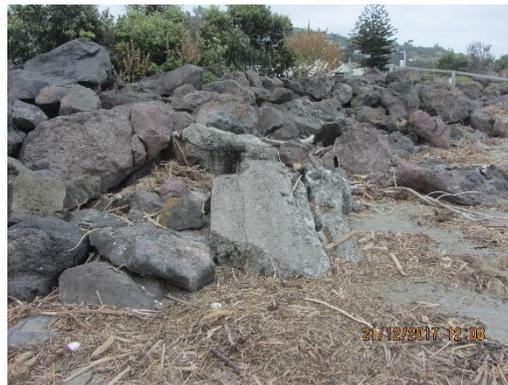
Site 17							
North End Co-ordinates (NZTM)		Length of Area (m)	Crest Elevation from Lidar (m LVD)	Revetment Width from Lidar (m)	Revetment Slope	Est. Armour Rock size if considered issue	Actual Critical Analysis Rank for Priority Assessment
Northings	Eastings						
5175924	1580858	2.8	3.75	7.4	3.29	No issue	1
<b>Other issues identified:</b> Concrete units

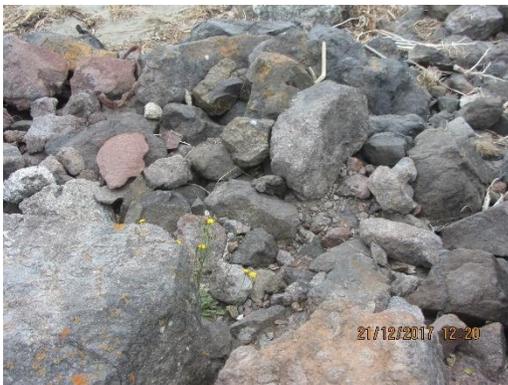
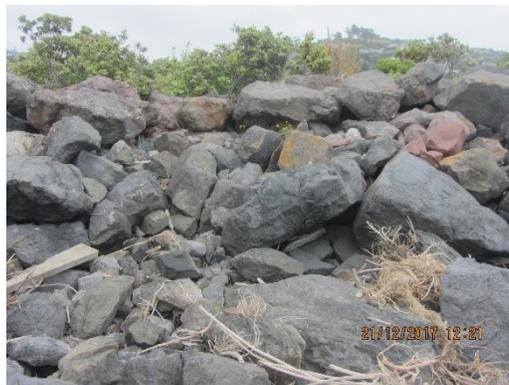
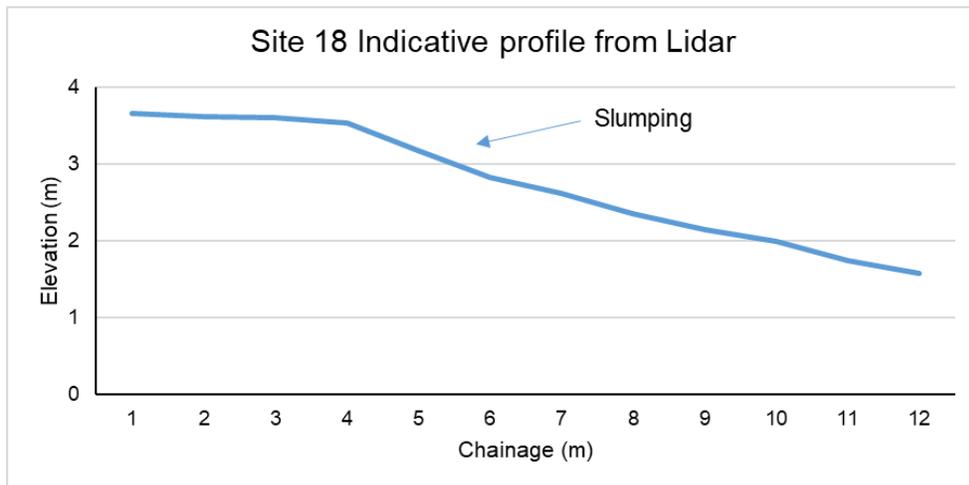
Site 18							
North End Co-ordinates (NZTM)		Length of Area (m)	Crest Elevation from Lidar (m LVD)	Revetment Width from Lidar (m)	Revetment Slope	Est. Armour Rock size if considered issue	Actual Critical Analysis Rank for Priority Assessment
Northings	Eastings						
5175917	1580813	3.6	3.66	6.5	3.12	0.2-0.3m	2
<b>Other issues identified:</b> Slumped in front of high crest rocks. Narrow width. Concrete units.

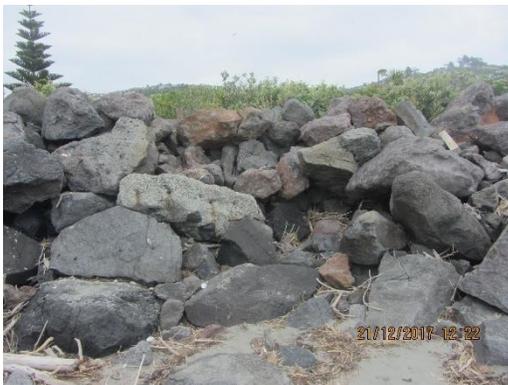
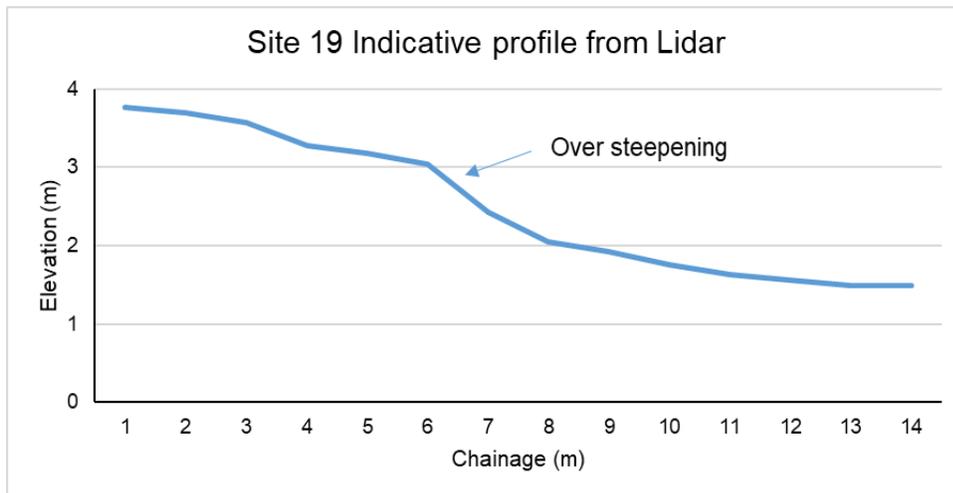
Site 19							
North End Co-ordinates (NZTM)		Length of Area (m)	Crest Elevation from Lidar (m LVD)	Revetment Width from Lidar (m)	Revetment Slope	Est. Armour Rock size if considered issue	Actual Critical Analysis Rank for Priority Assessment
Northings	Eastings						
5175901	1580824	3.6	3.59	6.7	2.94	No issue	2
<b>Other issues identified:</b> Oversteepened toe due to loss of rock at bottom of revetment.

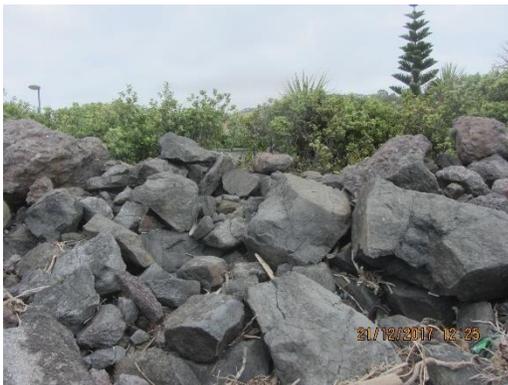
Site 20							
North End Co-ordinates (NZTM)		Length of Area (m)	Crest Elevation from Lidar (m LVD)	Revetment Width from Lidar (m)	Revetment Slope	Est. Armour Rock size if considered issue	Actual Critical Analysis Rank for Priority Assessment
Northings	Eastings						
5175890	1580832	2.4	3.25	6.1	3.43	No issue	1
<b>Other issues identified:</b> Localised low spot, narrow width.

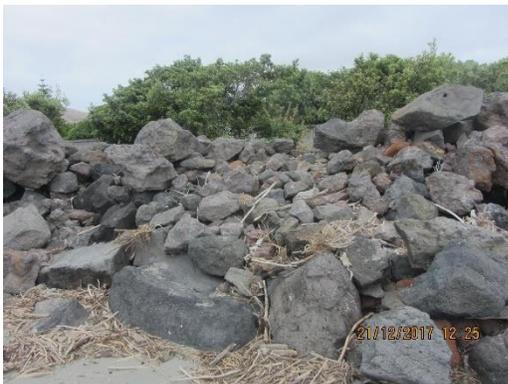
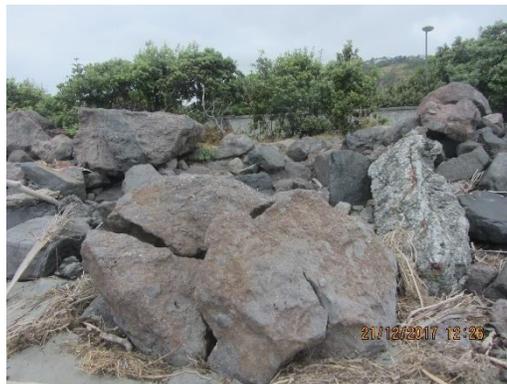
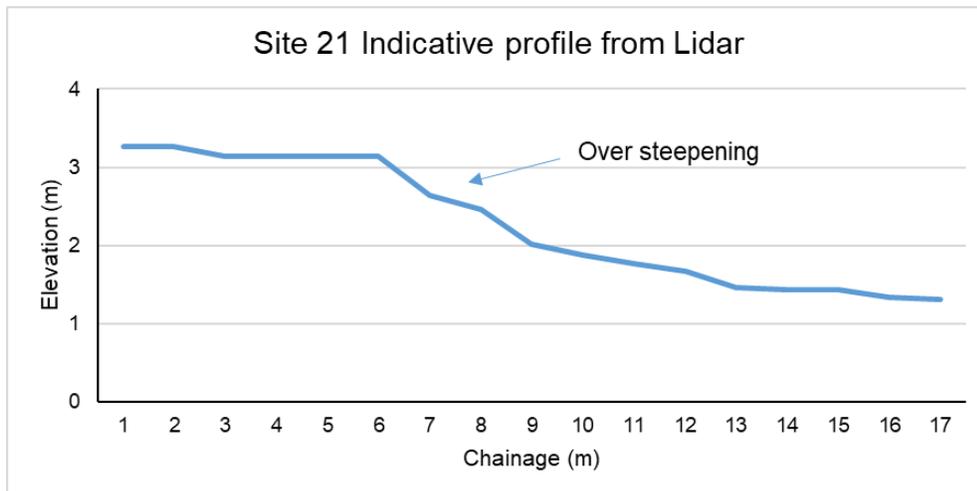
Site 21							
North End Co-ordinates (NZTM)		Length of Area (m)	Crest Elevation from Lidar (m LVD)	Revetment Width from Lidar (m)	Revetment Slope	Est. Armour Rock size if considered issue	Actual Critical Analysis Rank for Priority Assessment
Northings	Eastings						
5175884	1580835	17.8	3.30	7.4	3.79	0.3-0.5m	2
<p><b>Other issues identified:</b> Localised low spot at narrow track from promenade to top of revetment. Oversteepened toe due to loss of rock at bottom of revetment (except one large rock). Concrete units.</p>

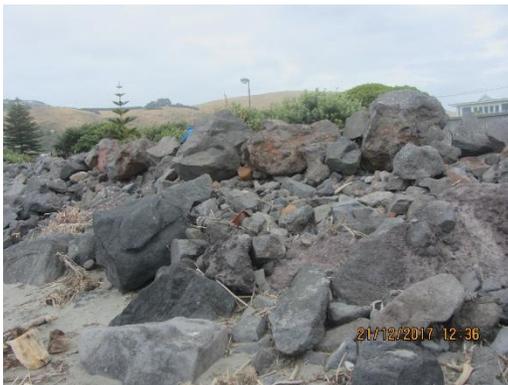
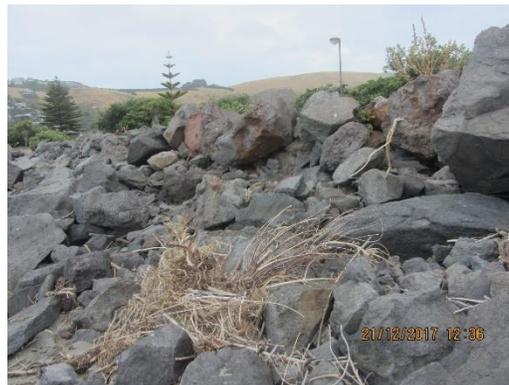
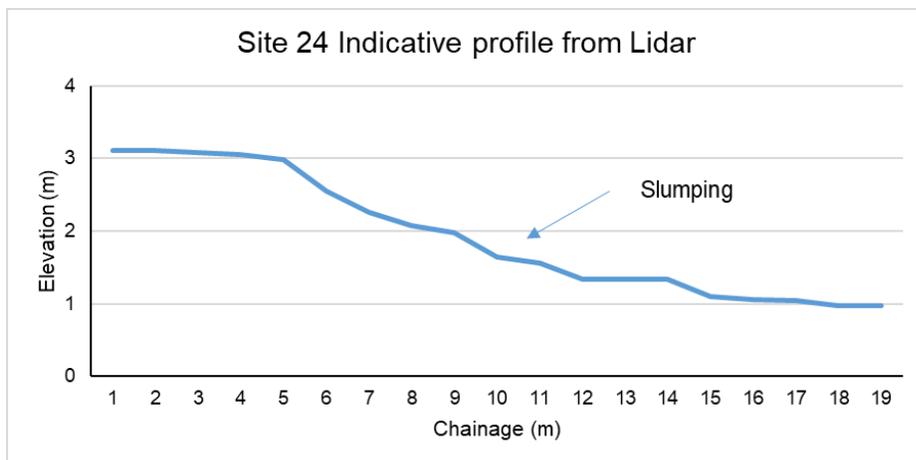
Site 24							
North End Co-ordinates (NZTM)		Length of Area (m)	Crest Elevation from Lidar (m LVD)	Revetment Width from Lidar (m)	Revetment Slope	Est. Armour Rock size if considered issue	Actual Critical Analysis Rank for Priority Assessment
Northings	Eastings						
5175838	1580882	12.8	3.11	9.1	4.28	0.5m	3b
<b>Other issues identified:</b> Slumped in front of crest rocks, which lack volume – only single rock depth.

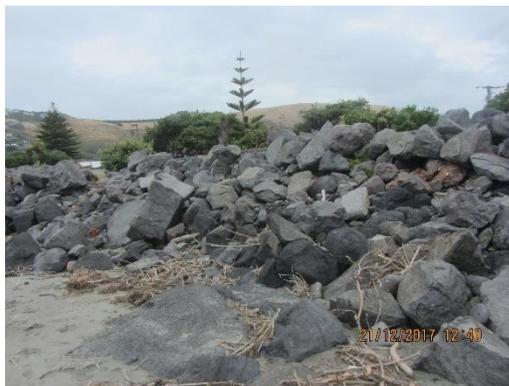
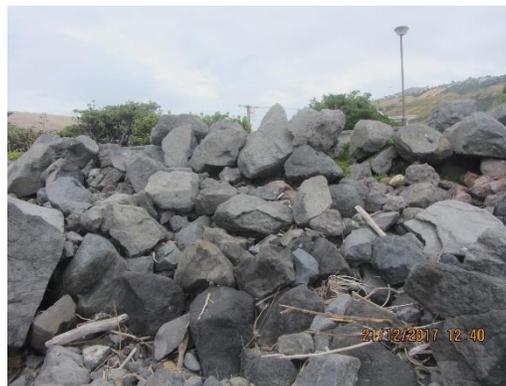
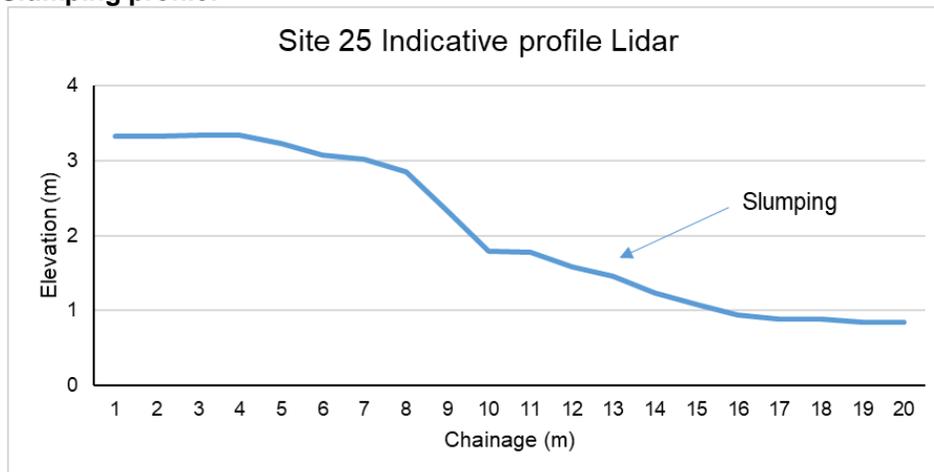
Site 25							
North End Co-ordinates (NZTM)		Length of Area (m)	Crest Elevation from Lidar (m LVD)	Revetment Width from Lidar (m)	Revetment Slope	Est. Armour Rock size if considered issue	Actual Critical Analysis Rank for Priority Assessment
Northings	Eastings						
5175825	1580892	5.8	3.16	8.6	3.53	No issue	1
<b>Other issues identified:</b> Slumped profile lacking rock at the top of revetment.
