# Arboricultural Report

25 March 2017

## Christchurch City Council Avon River Stopbanks Land Drainage Recovery Programme 507 Project (Updated Tree Report)

ARBOR VITAE LTD

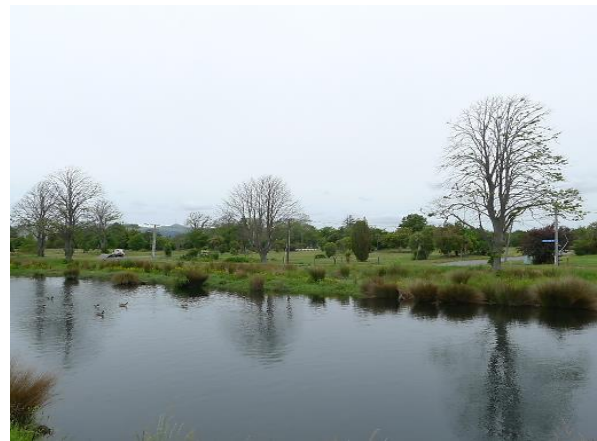
The majority of these trees will be removed due to their current Poor or Very Poor condition, and the potential for the trees to affect the integrity of stopbanks due to deterioration of tree trunks or root systems within the stopbanks. This will allow for the tree stumps and root systems to be removed during the works.

Figure 1: Example of trees in very poor condition, Avonside Drive.

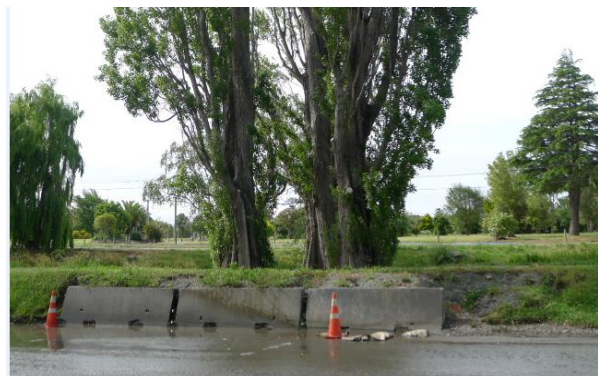
Six (6) Lombardy Poplar (*Populus nigra Italica*) trees that are in Fair condition will require removal on Avonside Drive, opposite Avon Park. This section of Avonside Drive is open to traffic, and there is a requirement that the stopbank does not encroach into the road.

There is inadequate space between the river and the road edge to change the location of the stopbanks, and to achieve the design and construction requirements this section of the stopbank requires extensive works that will result in the removal of the trees.

The tree asset identification numbers for these trees are: 80991, 80992, 80993, 80998, 81000 and 80001. Other trees within this section of the stopbanks that are identified to be removed for the works are in poor condition.

Figure 2: Example of trees within a section of stopbank on Avonside Drive to be removed (opposite Avon Park).

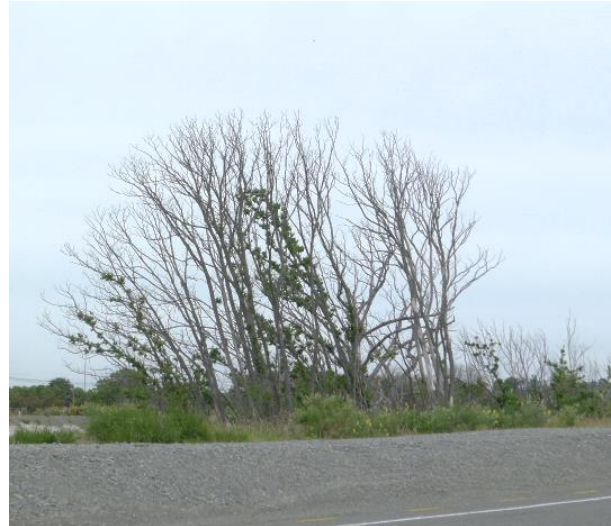
Figure 3: Example of trees in very poor condition, New Brighton Road (near Pratt Street).

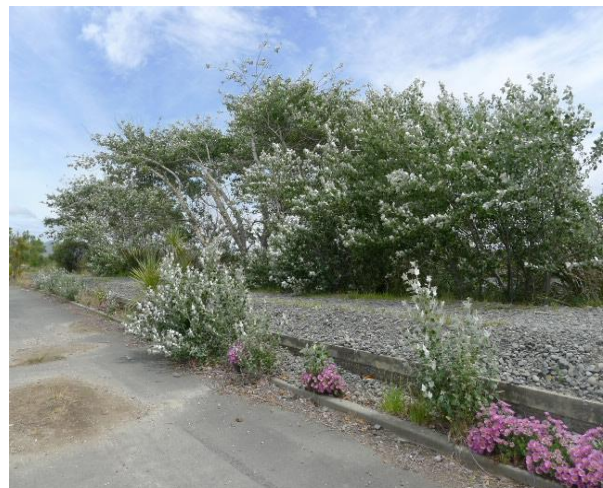
Some tree species have produced sucker growth within the stopbanks, which can damage the stopbanks.

Trees are to be removed as part of the stopbanks works programme where the sucker growth that has been produced is causing damage to the stopbanks.

Figure 4: Example of sucker growth from Grey Poplar trees on opposite side of stopbank, Evans Avenue.

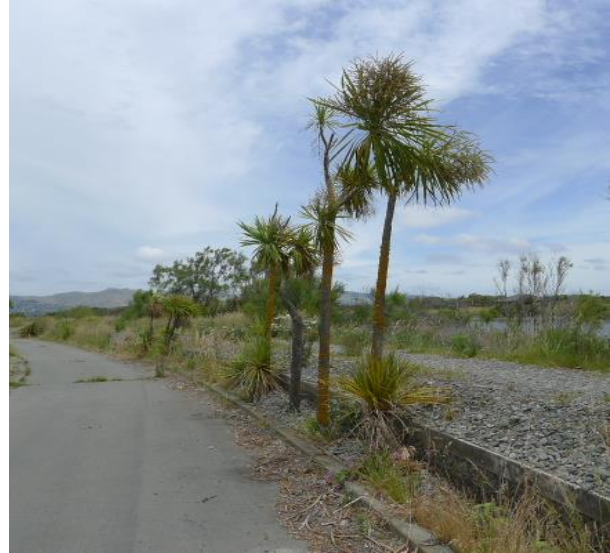
The trees assessed as being in Good condition and Fair condition that require removal also include the following thirty-six (36) small trees:

Figure 5: Example of small trees to be removed for the stopbank works programme, Evans Avenue.

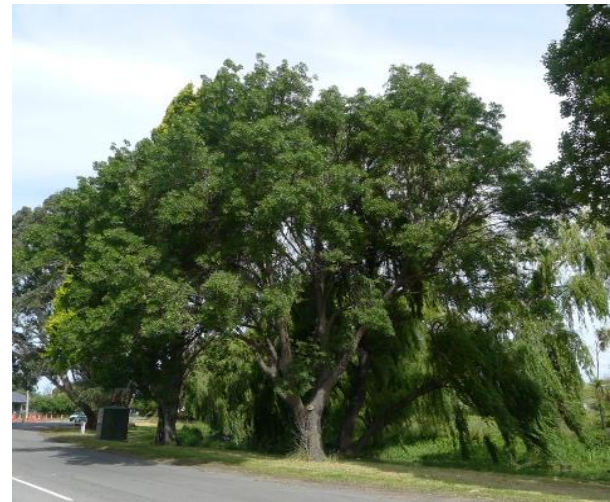
Three (3) trees require removal for the construction of a new section of stopbank between 935 Avonside Drive and the Wainoni Road intersection; 81162 Corkscrew Willow (*Salix matsudana* Tortuosa), 81170 Caucasian Ash (*Fraxinus oxycarpa*) and 81178 Lombardy Poplar (*Populus nigra* Italica).

In this area the alignment of the new section of stopbank is limited by the available space between the river and the road edge, and the presence of other trees. The proposed alignment has been chosen in order to retain as many trees as possible whilst meeting the project design objectives. It is proposed that the subject trees are removed, and a resource consent will be required for the removal of these trees as a new section of stopbank is to be constructed.

Figure 6: Example of tree to be removed for new section of stopbank; Tree 81170 opposite 918 Avonside Drive.

| Street | Number | Tree ID | Species | Height | Canopy Spread | DBH | Tree Health | Tree Form | Overall Condition | Comments |
|---|---|---|---|---|---|---|---|---|---|---|
| Avonside Drive | 918 | 81170 | Fraxinus oxycarpa | 16.0 | 18.0 | 0.75 | 3 | 3 | 3 | Foliage density becoming sparse, previous structural failures |

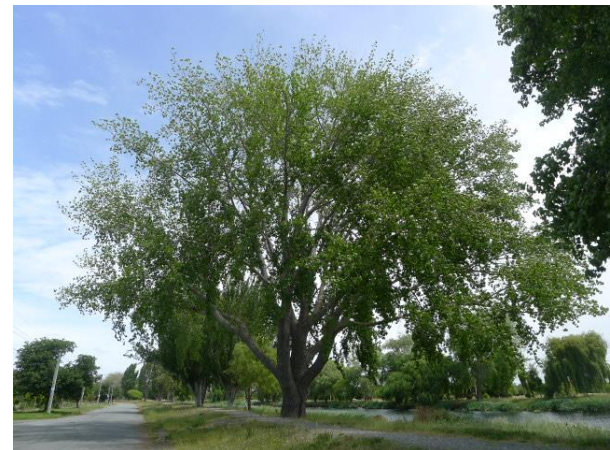
The following six (6) trees in Fair condition are directly within the existing stopbanks, and these trees will require removal for the works.

Figure 7: Example of tree in Fair condition to be removed due to the extent of works that is required; 81625 opposite 1082 Avonside Drive.

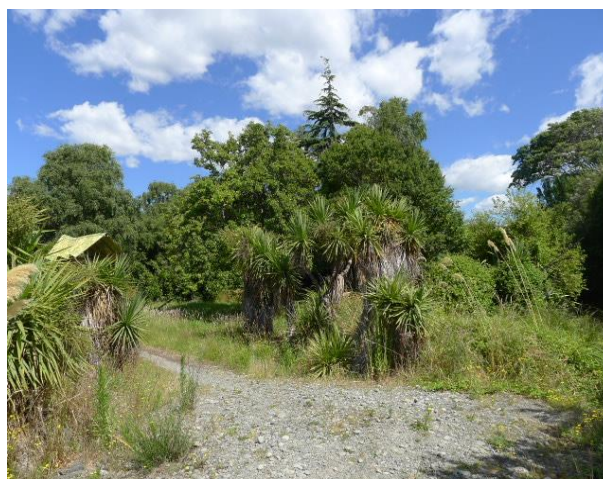
In addition to the works required for the management of the stopbanks, the project will involve a new earth bund to be constructed for flood prevention within the pump station site at 205 New Brighton Road.

It is possible that approximately six (6) mature exotic trees and thirty (30) semi-mature native trees (mostly in mixed native species groups) will require removal of within the pump station site.

Figure 8: Pump Station site, 205 New Brighton Road.

The final design for this part of the project has yet to be finalised, and it is expected that the final design will include replacement tree planting within the site.
