02 October 2020

Naval Point Hazard Assessment

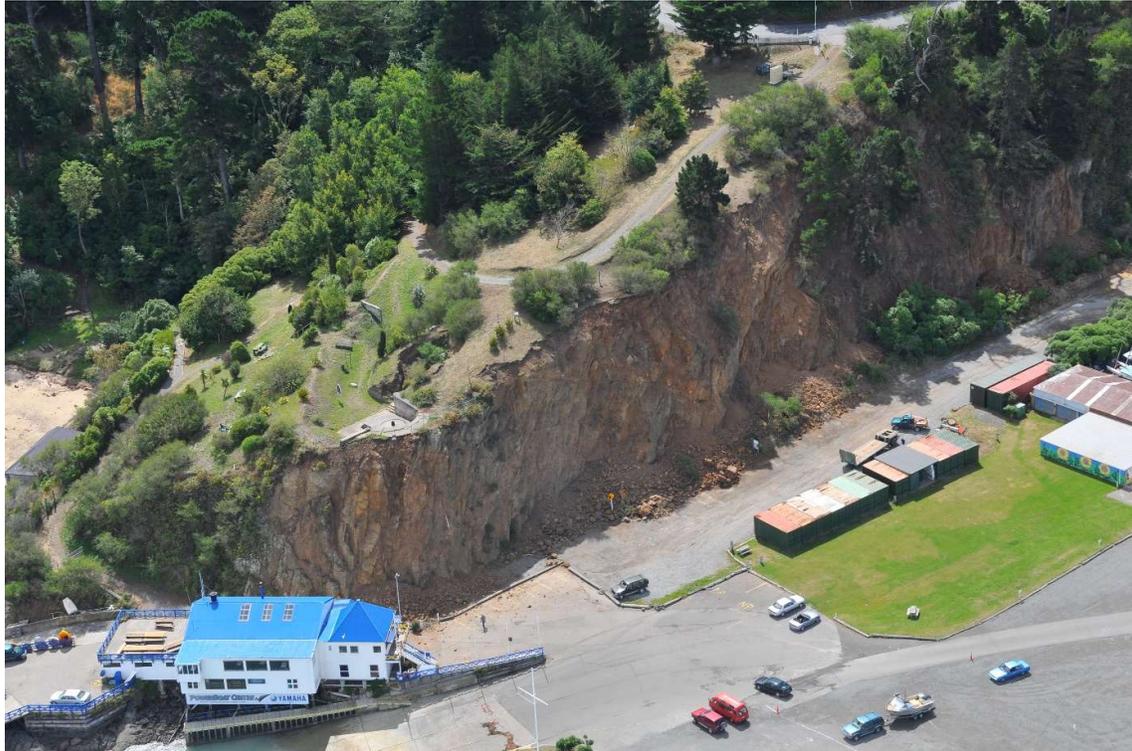
Further damage was sustained at Naval Point as a consequence of the February and June 2011 earthquakes (Figure 2). Rockfall again struck the yacht club. Cliff collapse modelling by GNS Science put the yacht club into the highest risk category (10^{-1} to 10^{-2} AIFR), however it should be noted that this was based solely on suburb-wide assessments of cliff heights and potential debris travel distances. We are not aware of any quantitative risk assessments at this site. Nevertheless, this does reinforce the fact that the yacht club is positioned extremely close to the rockface.

Figure 2 Naval Point on February 24, 2011. Fresh rockfall can be seen in the car park adjacent to the yacht club (blue roofed building). Much of the rockfall visible at the base of the cliffs is fresh, though some is likely to have been present already. Photograph by G Hancox, GNS Science.

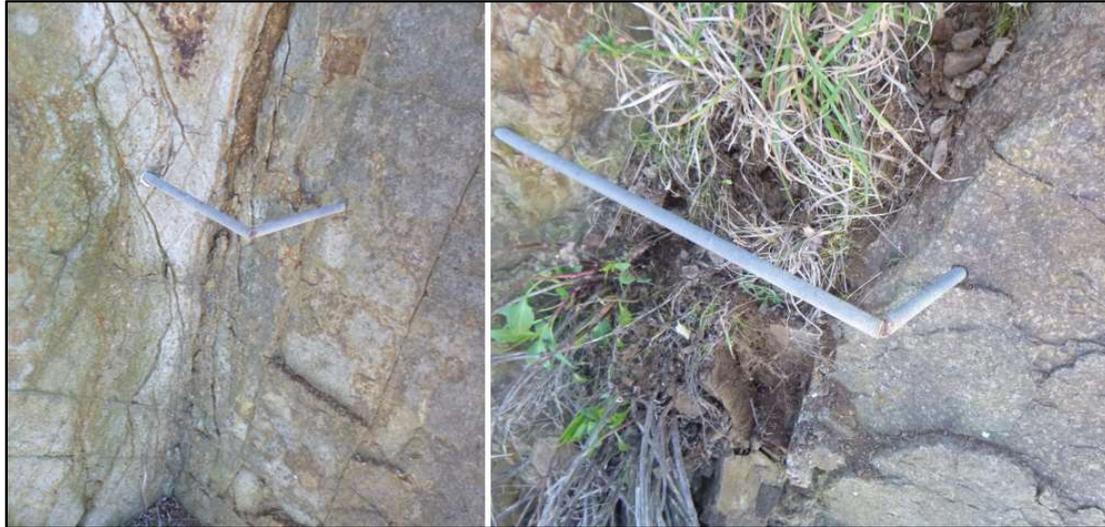
Loose rock on the outcrop surface was observed in several locations along the length of the cliff. These loose blocks were generally quite small (<0.2m on their largest axis). Multiple persistent defects remain visible on the rockface. Overall these do not appear to have dilated or otherwise moved. The monitoring bolts installed on the rockface show no signs of movement (Figure 3). There was no evidence of tension cracks or movement at the top of the cliff.

Figure 3 Current condition of two of the monitoring bolts installed at Naval Point in 2012

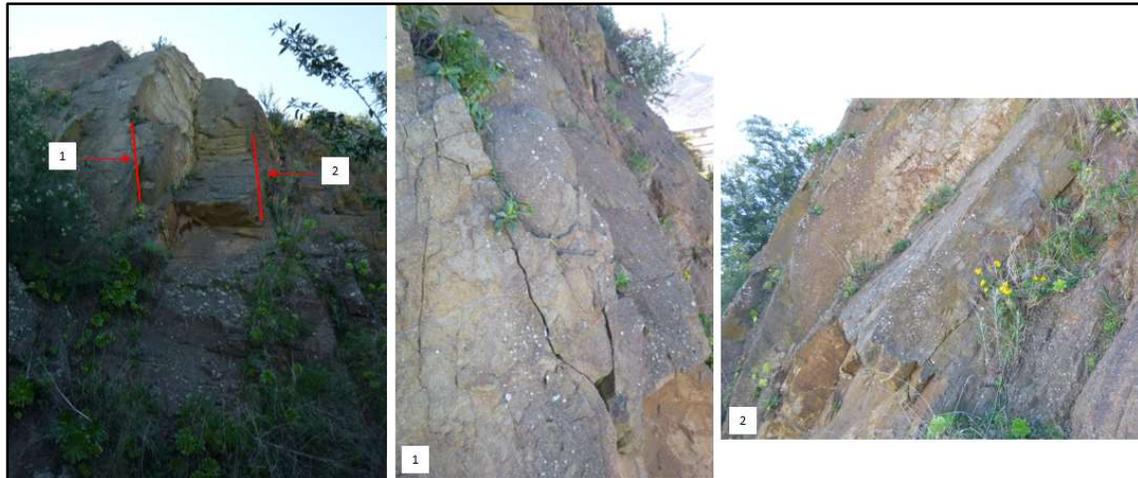
One site of questionable stability was identified and assessed during the roped inspection (Figure 4). This potentially unstable site is located on the previous wedge failure that occurred as a result of the September 2010 earthquake. It consists of 2 blocks that appear to be largely held in place by friction, with persistent defects separating them from the rockmass (Figure 4). The base of the blocks is located approximately 6m up the face. The block on the right (2) is located above the failure that occurred in late 2016 or early 2017. As such it is reasonable to assume that some of its support was removed at that time. The block is of marginal stability as it appears to only be supported by a small piece of rock at the base, and the friction between that block and the outcrop. This block is in the order of 2 x 1 x 0.25 m. Adjacent to and partially supported by this block is another potentially unstable block, in this case measuring 2.5 x 0.6 x 0.5 m and at least partially detached from the surrounding rockmass.

Figure 4 Left image - unstable site (previous wedge failure), red lines indicate location of persistent defects on each block, arrows indicate the direction that the close up photo has been taken. Right images – images to illustrate the defects outlined in the left image.

In addition to the options presented below, we recommend removal of the two unstable blocks identified as part of the previous wedge failure illustrated in Figure 4. Removal of these blocks will likely be able to be completed with hand tools via ropes access.

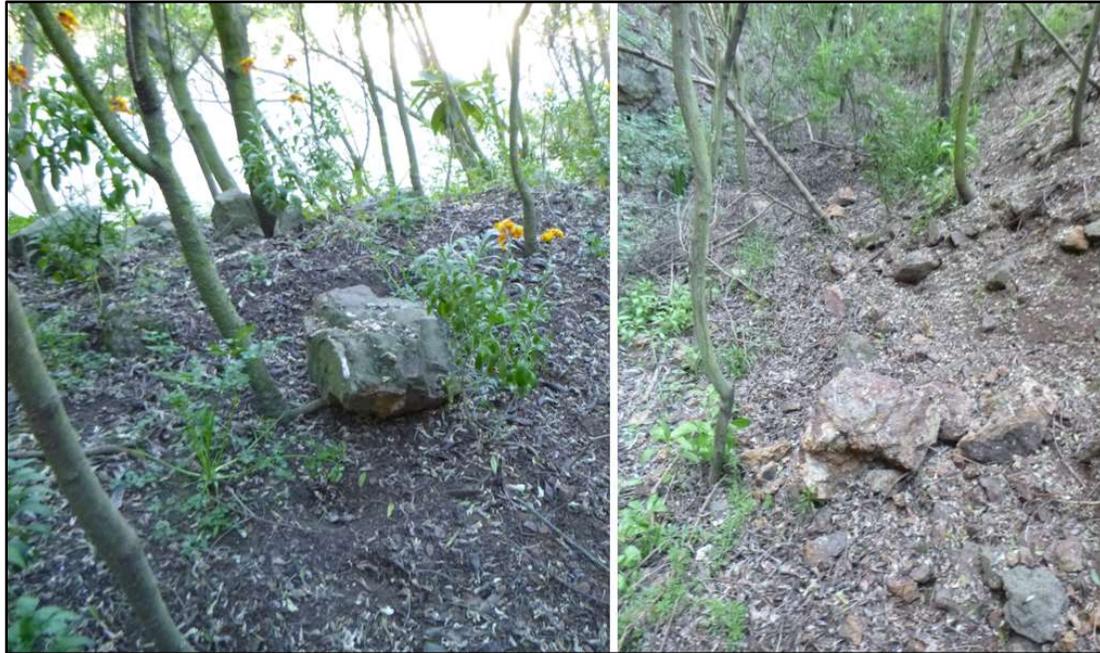
The site inspection revealed evidence to suggest there is ongoing rockfall on the south east side of the site. Figure 5 illustrates some of the rockfall that was observed; the majority was seen to be behind the bund, with one rock observed on top of the bund. Due to the dense vegetation between the cliff and the bund/on the bund restricting access, this area was not inspected extensively. Although there was no evidence to suggest that rocks have travelled over the bund, we cannot be certain this is the case. As there is a vehicle access way situated directly to the east of the bund, any rocks that may have travelled over the bund would likely have been cleared away.

We note that the area behind the bund is slowly decreasing, as this area accumulates debris. This is not just rocks, but organic matter from dead and fallen vegetation, and not least illegally dumped rubbish. Car tyres have been dumped in large quantities behind the bund. While these weren't counted, there were at least 3 large piles of tyres, the largest of which may have had up to 100 tyres in it. The accumulation of debris behind the bund will gradually lessen its effectiveness, as its height relative to the height of the catch area behind it decreases.

Figure 5 Left image - rockfall observed on the top of the bund. Right image – rockfall observed on the upslope side of the bund.

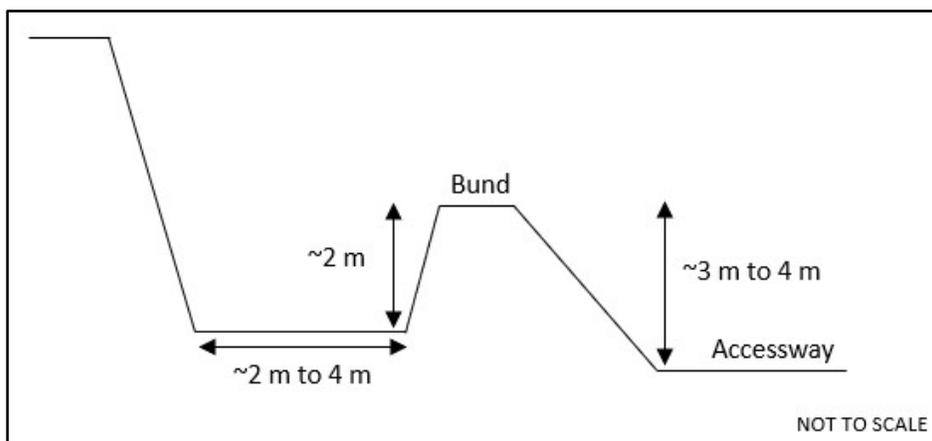
At the base of the cliff a non-engineered earth fill bund, approximately 3 m to 4 m in height (on the downslope side) is present along the south eastern extent of the cliff. Due to debris and vegetation the upslope side of the bund, it is typically approximately 2 m in height. The offset of the bund from the base of the cliff varies along its length, but is generally 2 m to 4 m. A typical section to illustrate the bund is presented in Figure 6. The bund stops approximately 20 m to the south of the stone masons' yard. At the back of the stone masons' yard a separate non-engineered earth bund was observed at the base of the cliff approximately 1.5 m high.

Figure 6 Schematic cross section of the non-engineered earth fill bund

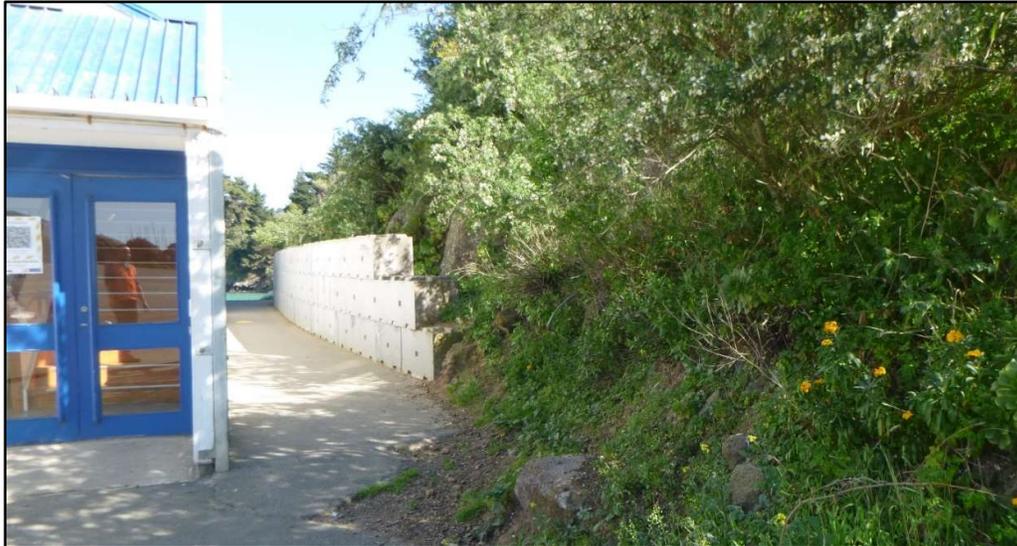
At the southern end of the earth fill bund a concrete block wall, typically 3 blocks high (approx. 1.8 m), extends behind the Naval Point Yacht Club (Figure 7). At the location where the bund and concrete block wall meet, both of these structures taper down to a reduced height creating a low point. Aside from this low point, observations during the site inspection suggest the bund and concrete wall have been an effective mitigation measure due to the fallen rocks observed on the upslope slide of the protection structures.

Figure 7 Concrete block wall behind the Yacht Club and the earth bund adjoining it on the right of the photo.
