19 Aberfoyle Place
Quantitative Engineering
Evaluation

Reference: 232536
Prepared for:
Christchurch City Council

Address: 19 Aberfoyle Place, Parklands

Revision: 2
Date: 16 October 2013

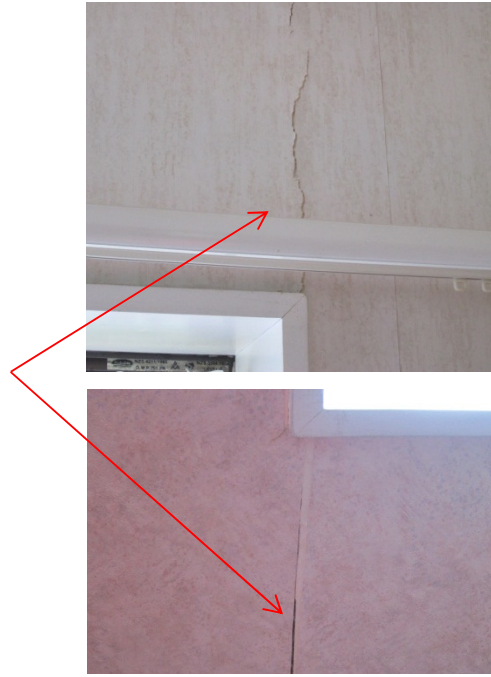
Typical cracks in the corners of the doors and windows.

- Damage to the doors and windows by rehanging
- Repointing cracked brick veneer joints
- Replacement of the cracked brick veneers
- Cracking to internal wall and ceiling fibrous plaster linings should be repaired similar to that used for Gib linings in accordance with GIB 'Guidelines for repairing GIB plasterboard linings in wind and earthquake damaged properties'.

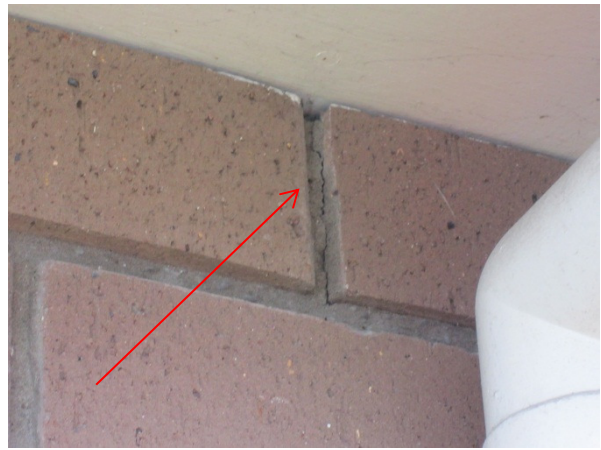
Cracks in the mortar of the brick walls.

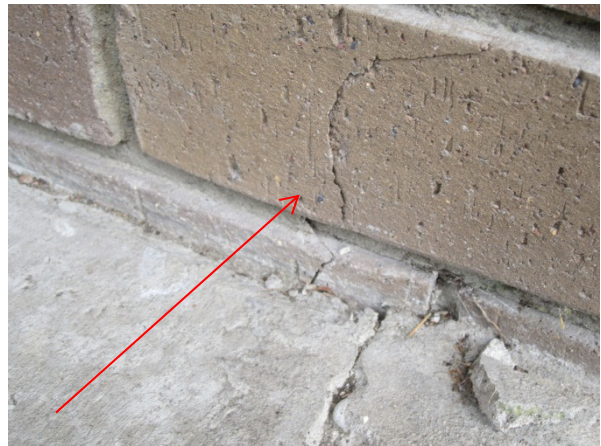
Cracks in brick veneer.

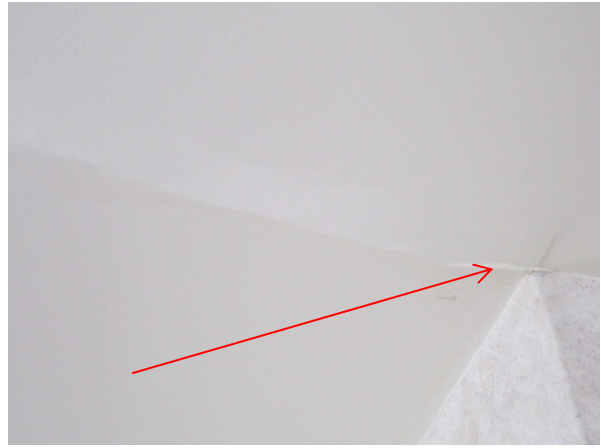
Minor cracks in the ceiling.

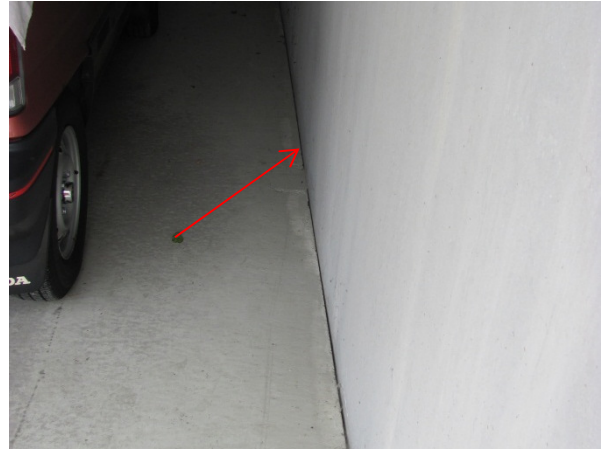
Separation of the concrete wall from the surrounding concrete panel.

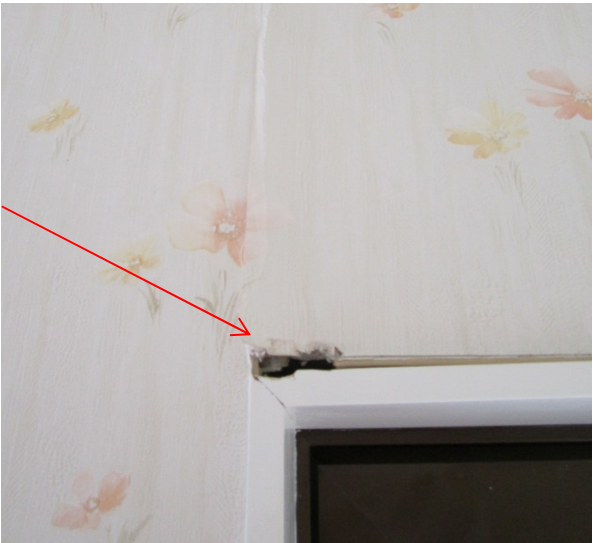
Separation of the door frame from the plasterboard wall.

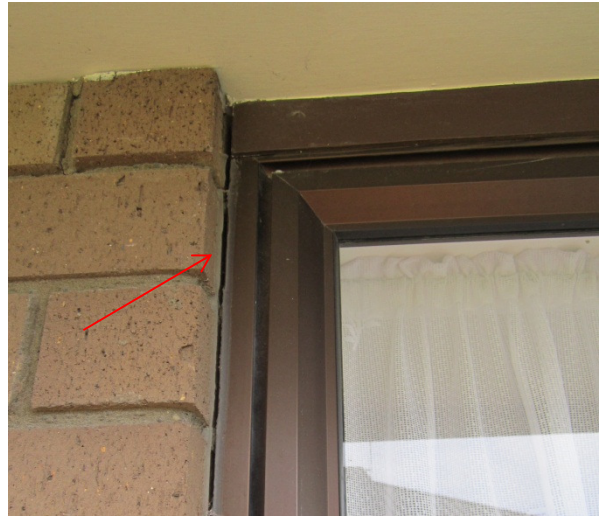
Separation of the window from the wall.

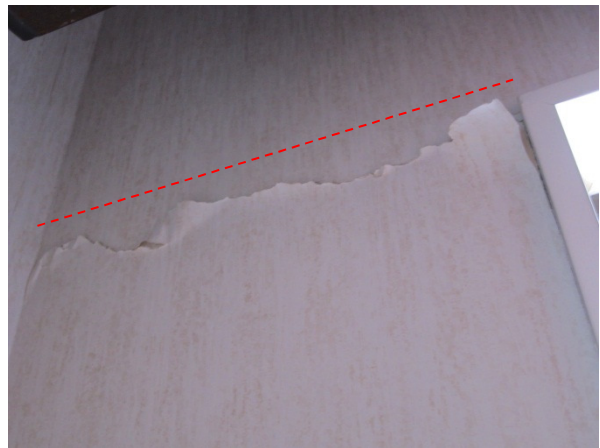
Cracks in the plaster board.

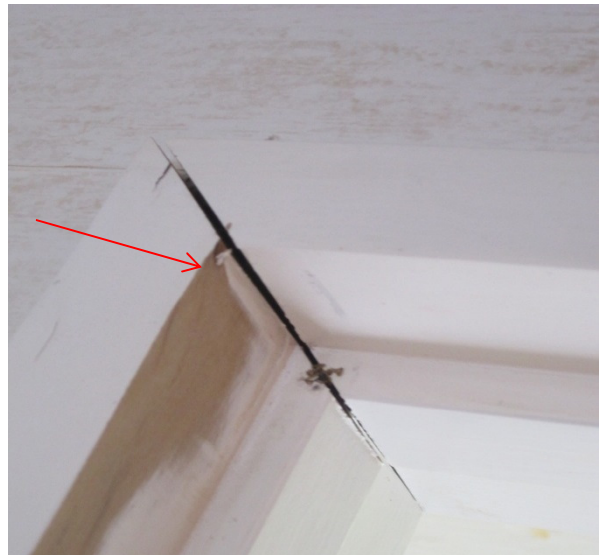
Deformation of the door frame.

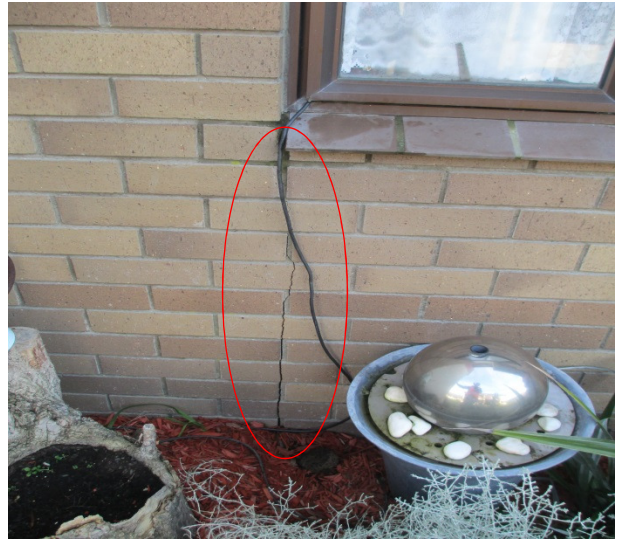
Crack in the brick veneer.

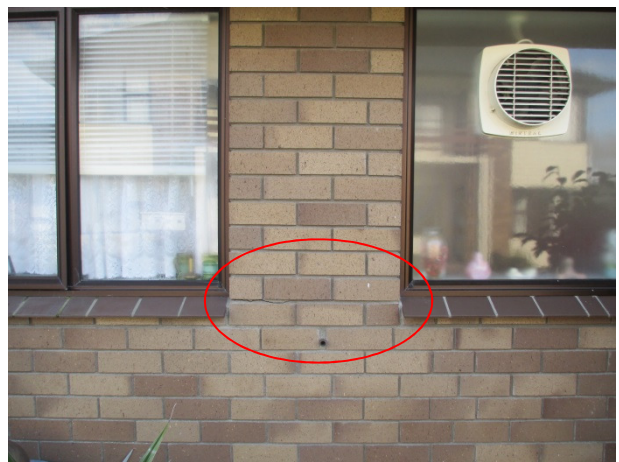
Cracks in the brick veneer.

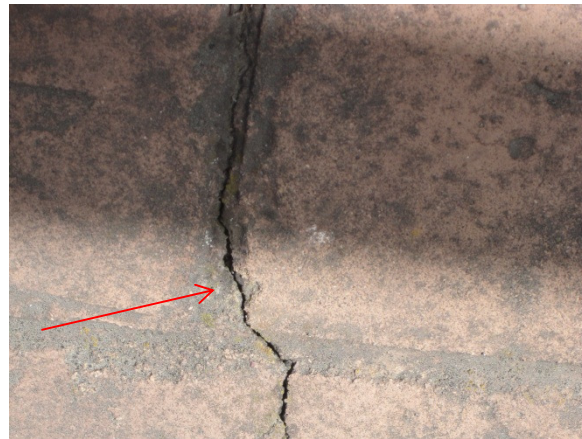
Cracks in the pavements between units.

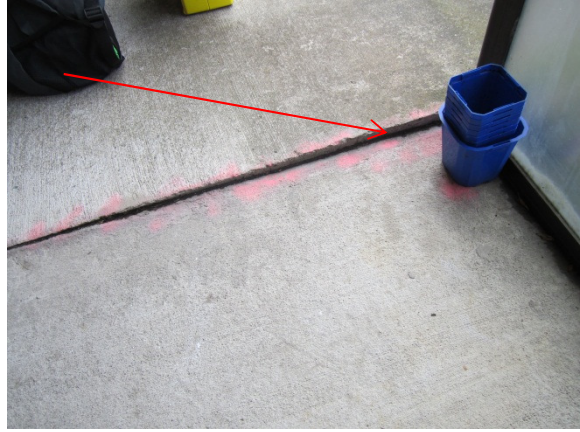
Settlement of the concrete slab around the units.

- Replacement of the damaged concrete slabs around the buildings.

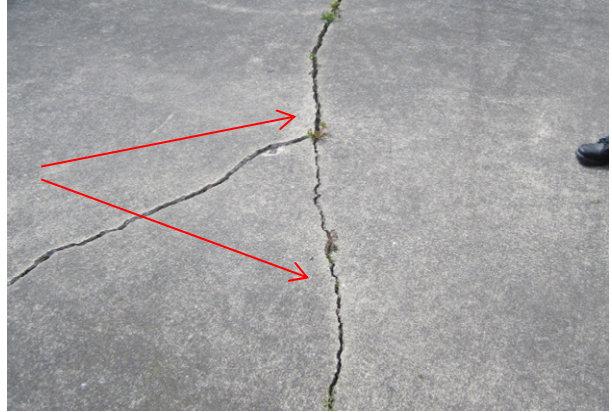
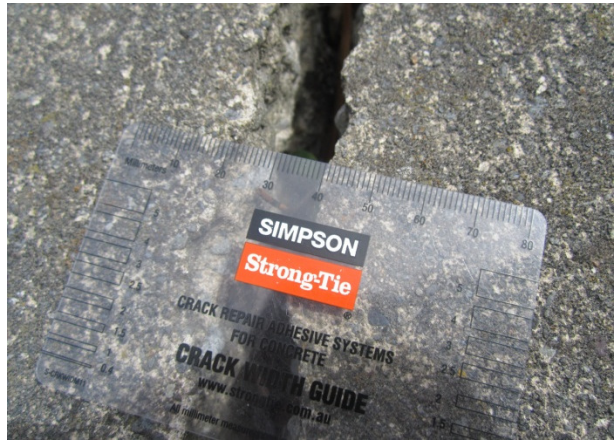
Breaking of concrete on the east side of the site.

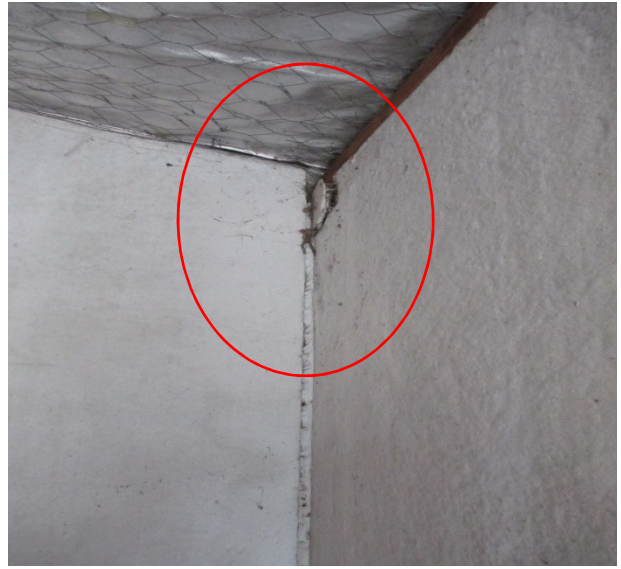
Damage in the connection between two walls

The garages do not have appropriate diaphragm to transfer earthquake induced forces in the along direction. **Strengthening is recommended for the garages**. The strengthening will most likely involve installation of a cross-bracing in the roof and providing additional connections between the concrete panels.

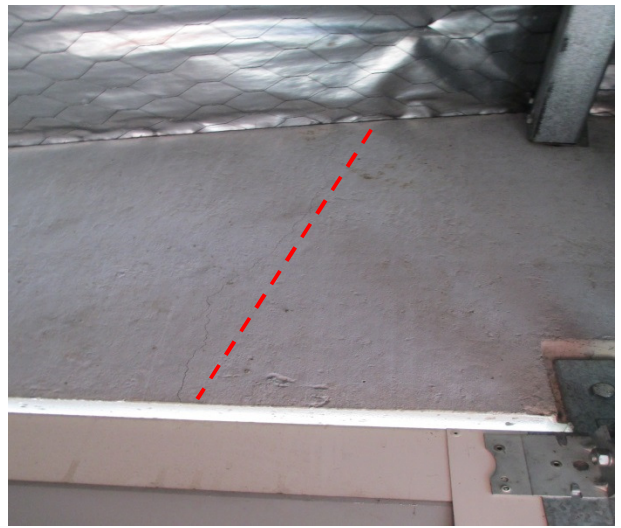
Cracks in the gable wall.

- Repair cracks in the entrance gable wall by epoxy injection.

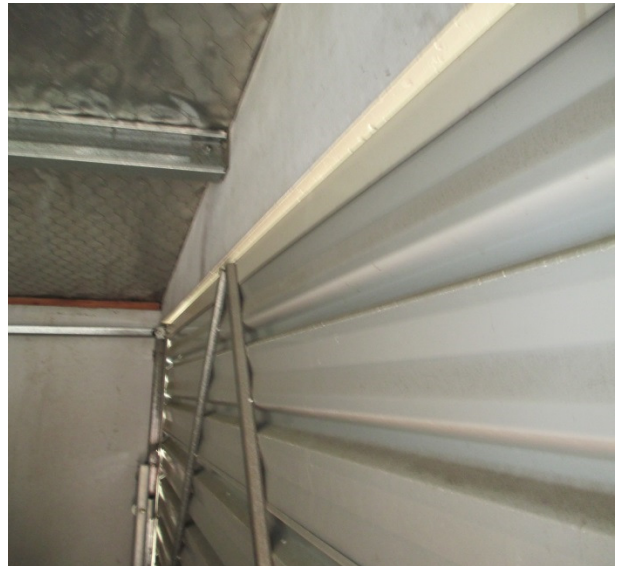
Twist and movement of the gable wall.

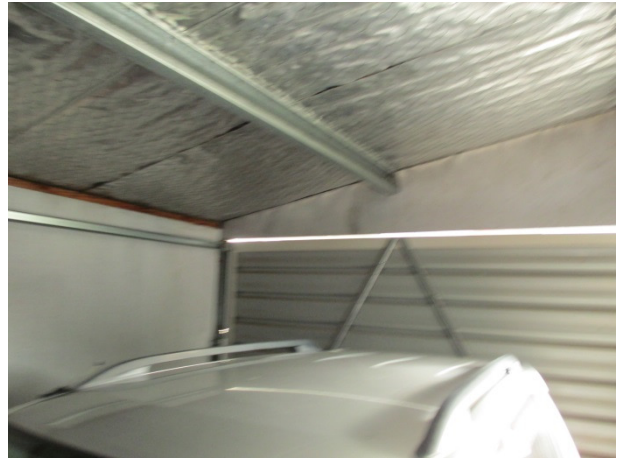
Twist of the DHS purlin.

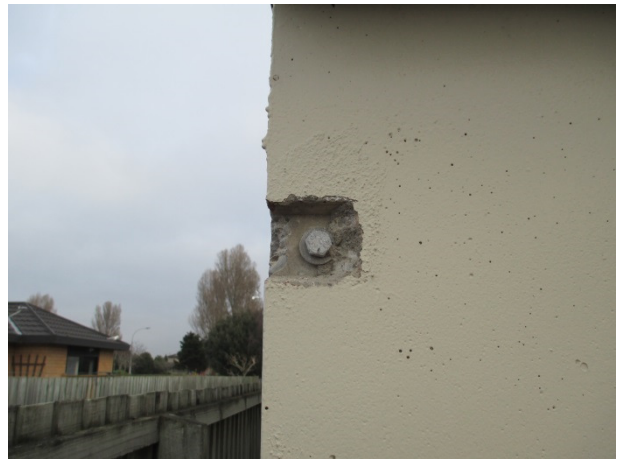
Intrusive investigation on the garage wall showing the M12 connection between the two walls.

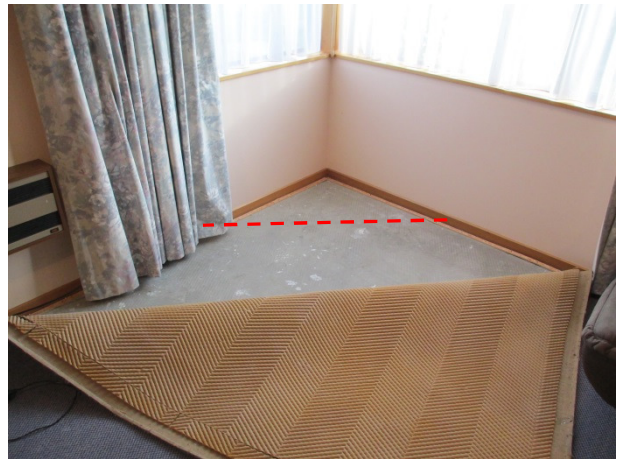
Intrusive investigation in the Lounge Room showing a minor crack in the concrete floor.

- Cracks in the perimeter concrete foundation should be filled by epoxy injection
- Cracks in the concrete floor should be filled by epoxy injection.

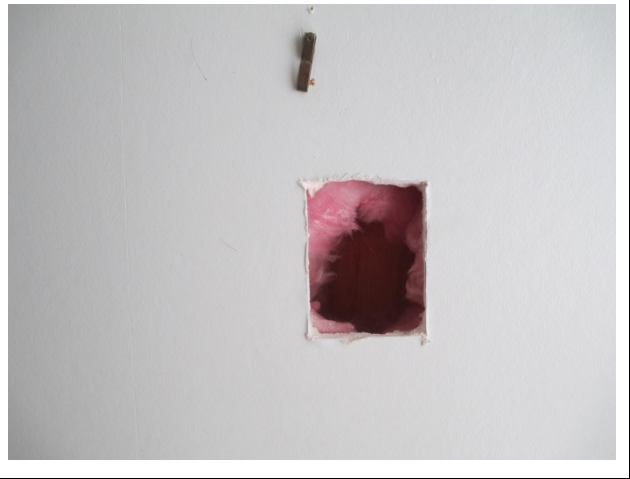
Intrusive investigation on the wall of unit 7 to check the wall behind. The investigation shows plywood behind the plasterboard wall.

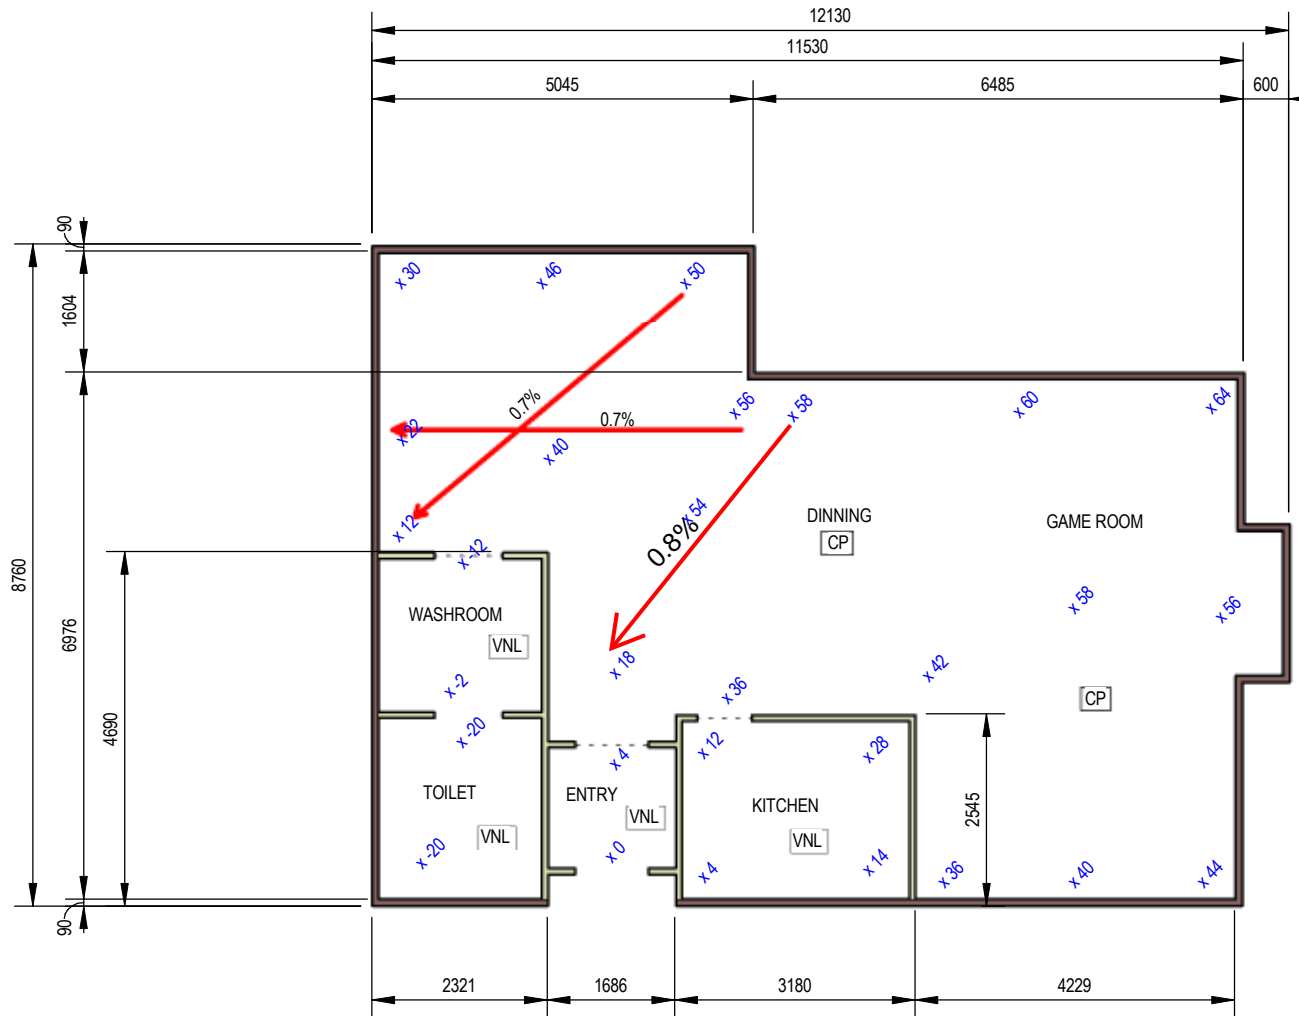
RESIDENTS LOUNGE

For the Lounge room, since the total variation in floor level is more than 50 mm and the floor has a slopes 0.8%, re-levelling is recommended. Re-levelling would likely involve low mobility grout injection below foundation.
