**Akaroa Museum**  
**BU 3635-002 EQ2**

**Detailed Engineering Evaluation**  
**Quantitative Assessment Report**

**71 Rue Lavaud, Akaroa**

Date: October 2012  
Reference: 6-QUCCC.94  
Status: Final

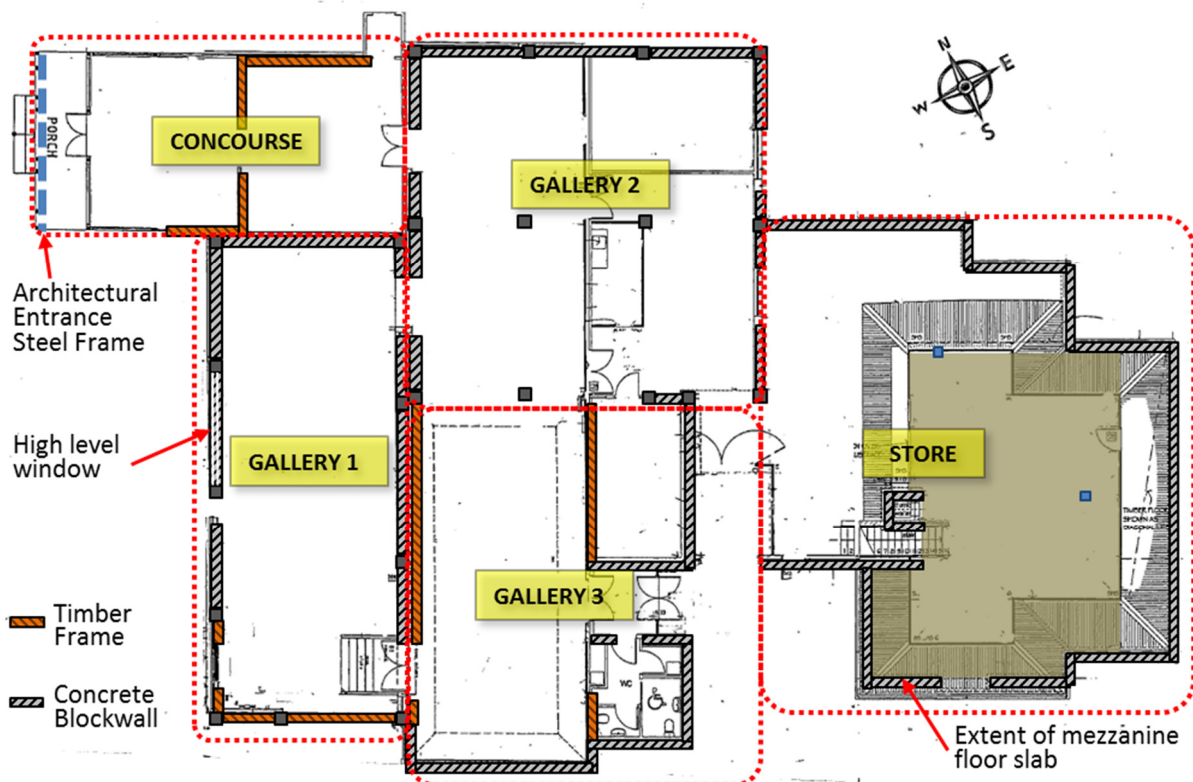
Figure 3 - Building Layout Showing Key Lateral Load Resisting System

An overview of the key lateral resisting elements for the main museum complex is shown in Figure 3 below.

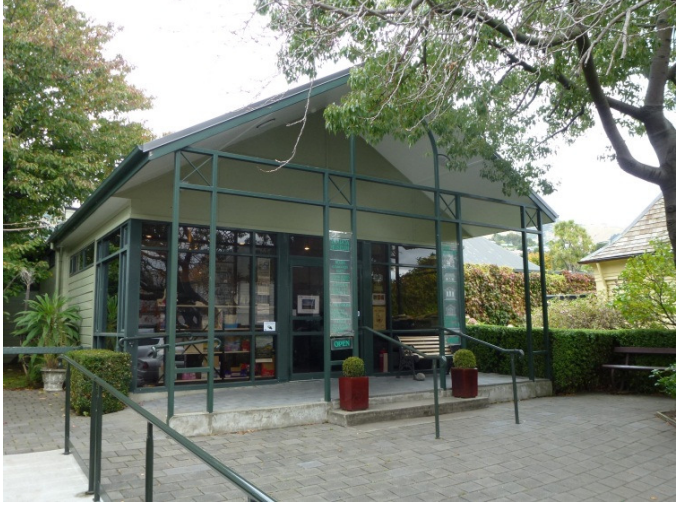
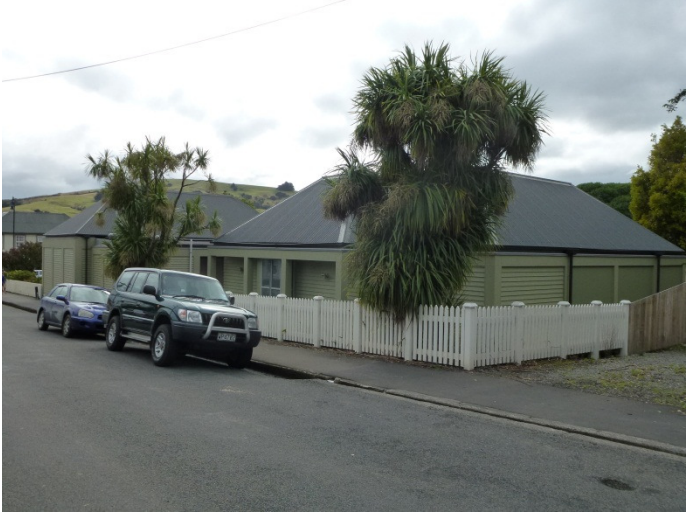
No.	Item description	Photo
1.	<p data-bbox="387 342 592 405">General building elevations</p> <p data-bbox="517 555 691 618">Entrance view west elevation</p> <p data-bbox="451 1061 691 1124">Rear view south east elevation</p>

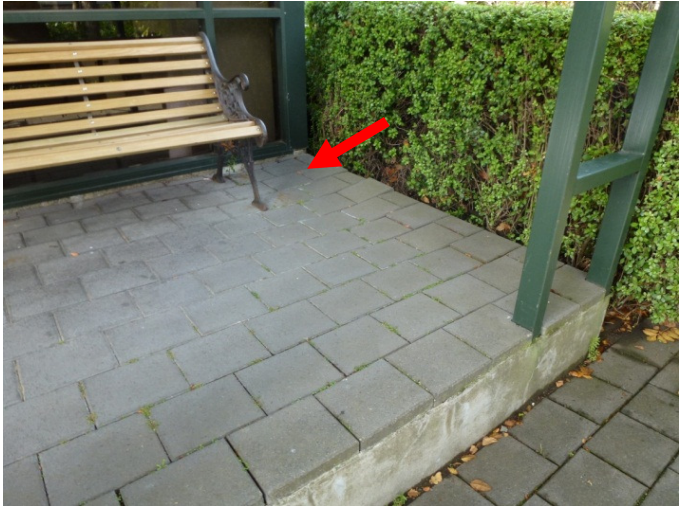
The existing foundations of the Akaroa Museum complex appear to have performed satisfactorily in the recent seismic events. No liquefaction has been observed on site. The settlement of the pavers at the west entrance does not appear to have been caused by the recent seismic events. The minor cracking and subsidence of the footpath on the south side is not considered to be seismically induced damage. Due to the likely presence of silty gravels at shallow depths, the risk of lateral spreading and liquefaction induced is considered low. No further geotechnical testing is recommended at this location as part of this assessment. However, further testing may be required for the design of any strengthening works.

2.	<p data-bbox="387 1491 655 1585">Minor localised settlement at the front entrance porch</p>

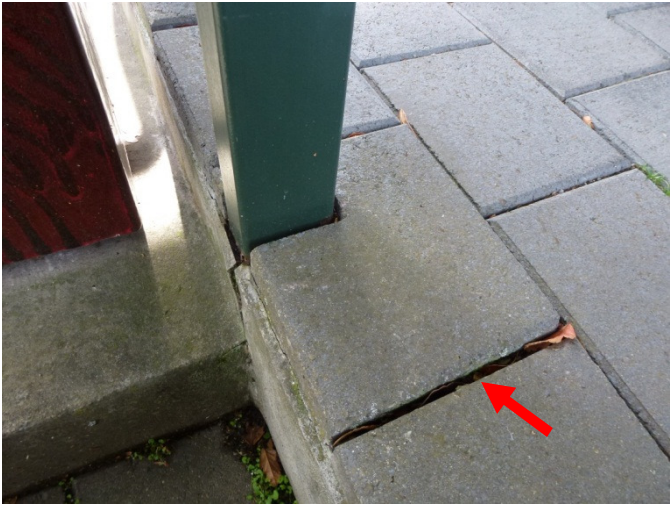
3.	Minor movement in the paving on the west elevation (front entrance porch)

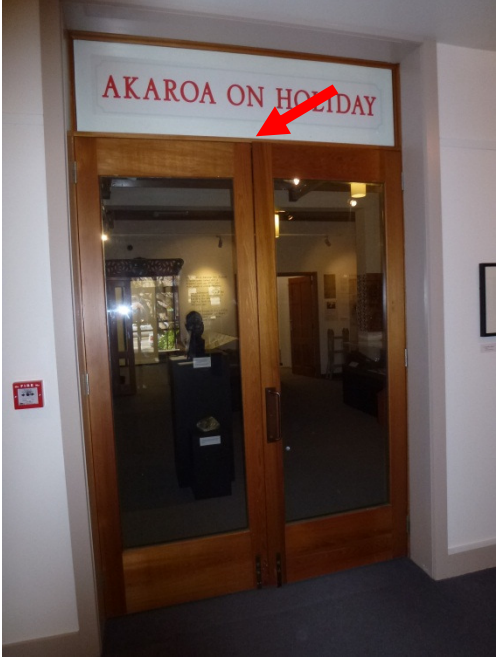
4.	Out of plumb door frame

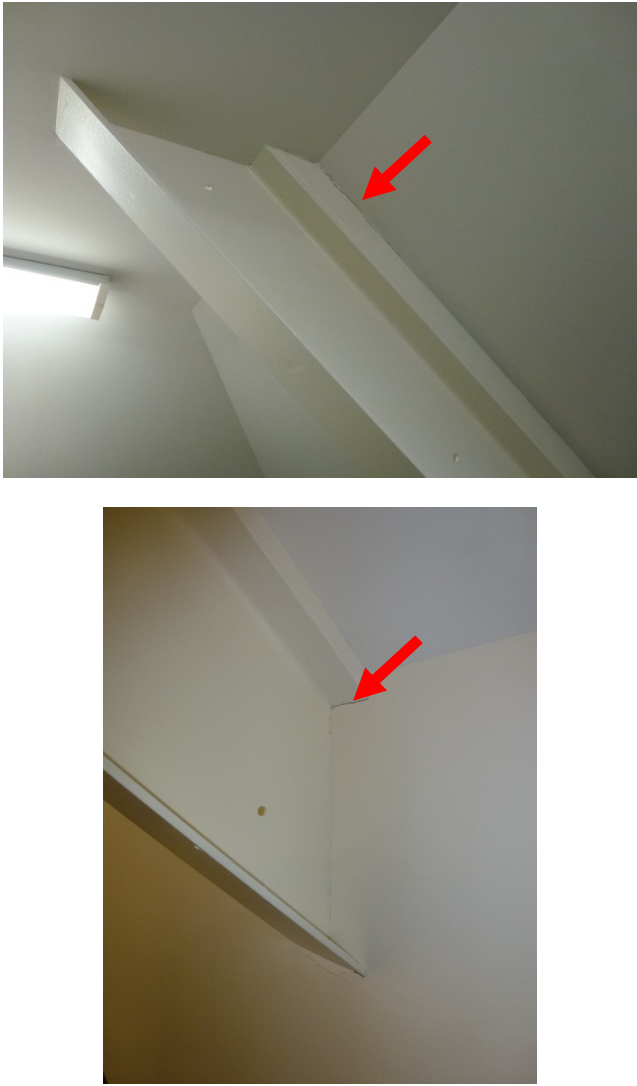
6.	Minor cracking to internal plaster lined ceilings at Concourse

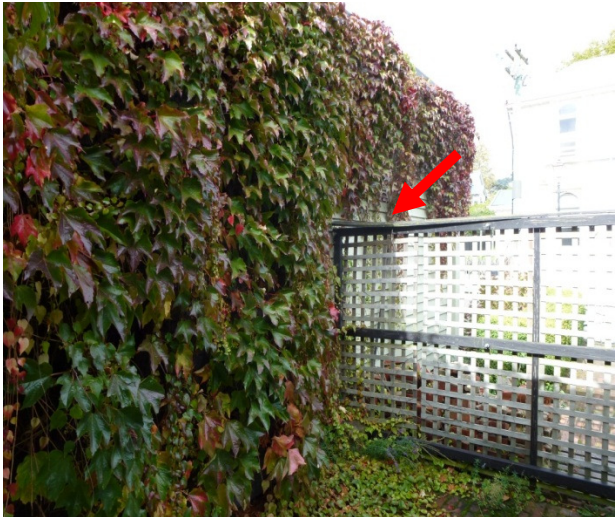
7.	Possible settlement of the fencing
