# **Akaroa Weighbridge PRK 3650 BLDG 002**

**Detailed Engineering Evaluation  
Quantitative Assessment Report**

**Beach Road, Akaroa**

Date: September 2013  
Reference: 6-QUCCC.79  
Status: Final

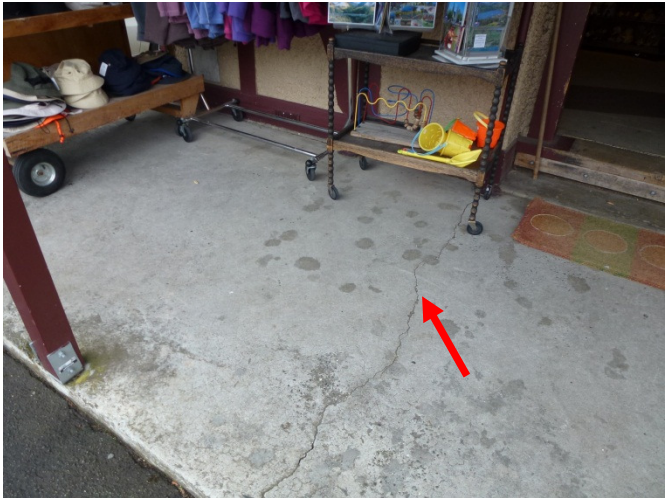
- a) A transverse cracking of up to 3mm wide is observed to the front porch on ground slab. See Photo 1.
- b) Minor separation of approximately 5mm at the west corner of the slab at the porch. See Photo 2.

No.	Item description	Photo
1.	Cracking to ground bearing slab at several locations

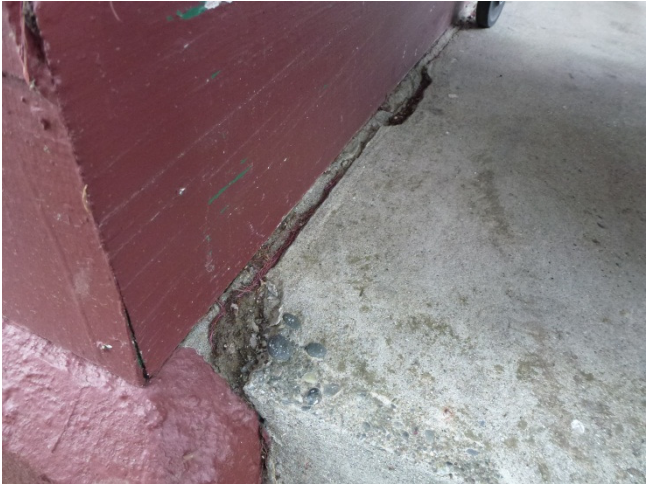
2.	Minor separation at the west corner of slab at porch.

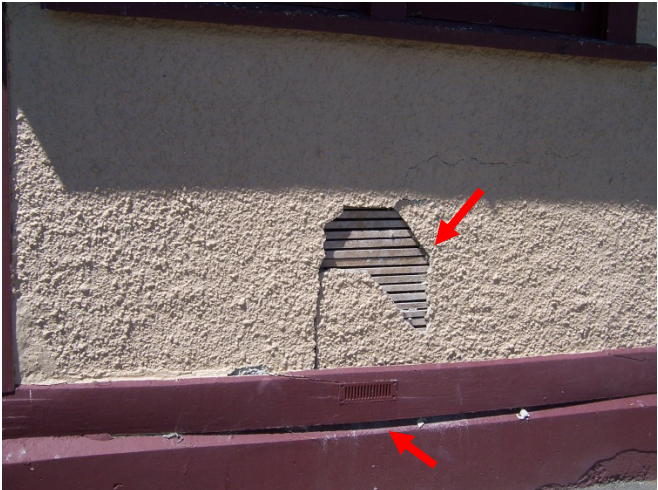
- a) Moderate cracking and peeling to the north elevation pebbledash finish. However, it is not certain how much of the finish peeling is due to earthquake shaking and how much is due to subsequent vandalism. See Photo 3, 4 and 5.
- b) Minor buckling and cracking to the fascia board at the base of the wall. See Photo 3.
- c) Minor rotation to the west elevation vertical fascia board adjoining the canopy. This is likely to be caused by the different responses of the roof and the canopy during earthquake shaking, and hence, leaving a permanent residual gap of 20mm at the top of the fascia board. See Photo 6.

3.	Moderate peeling to north elevation pebbledash finish (prior to temporary repair) and minor buckling to base fascia board

- a) The overall %NBS for this building is 68%, and therefore no strengthening work is required.
- b) It is recommended that:
  - The cracking to the external pebbledash finish be repaired as soon as possible and weather-proofed to prevent long term seepage of moisture which could lead to degrading of timber members.
  - The external wall base connection is checked by an engineer when the temporary cladding is removed for permanent repair, to confirm that the bottom timber plate is connected to the foundation. If the building is found to not be well connected to the foundation, we would recommend that this connection be added.

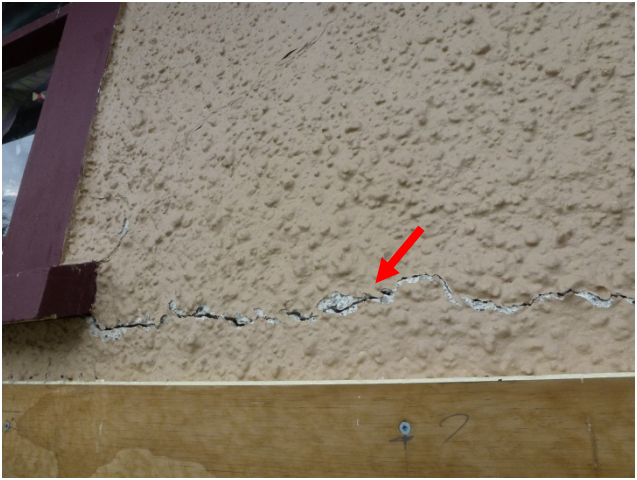
<p>4.</p>	<p>Cracking to north elevation pebbledash finish</p>

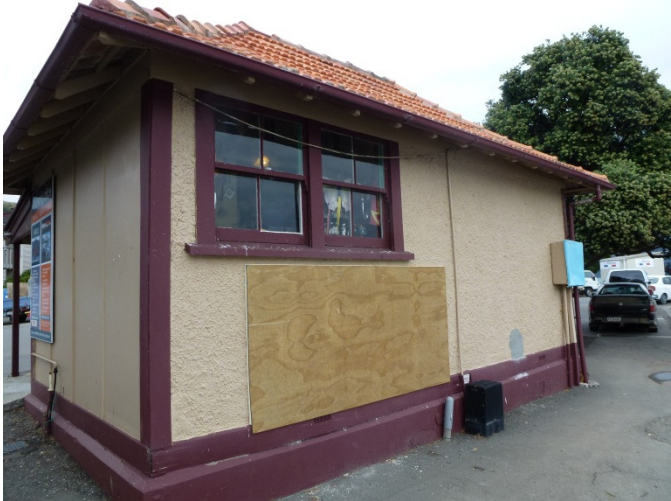
<p>5.</p>	<p>Existing temporary repair to the north elevation wall</p>

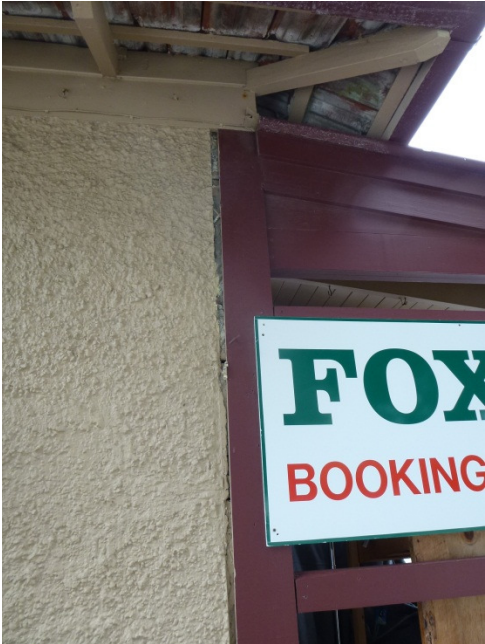
<p>6.</p>	<p>Rotation to the top of the front canopy at the west corner. Gap at top measured approximately 20 mm.</p>
