# **Arran Courts Housing Complex PRO 0823**

**Detailed Engineering Evaluation  
Quantitative Assessment Report**

**27 Arran Crescent, Linwood,  
Christchurch**

Date: September 2013  
Reference: 6-QC309.00  
Status: Final

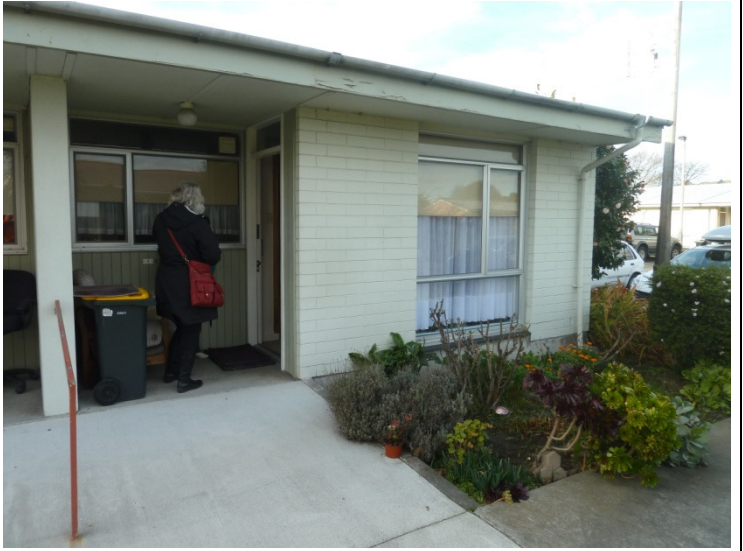
Arran Courts Housing Complex		
Residential Units		
1	Typical unit exterior, front.

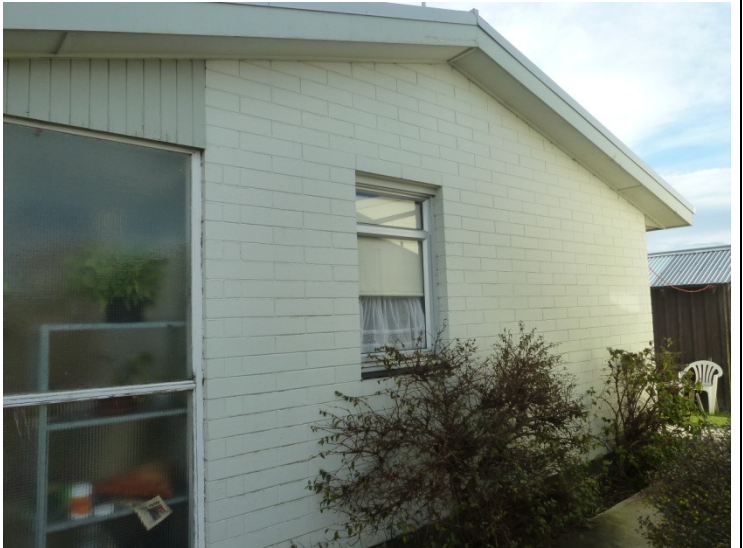
2	Typical unit exterior, side.

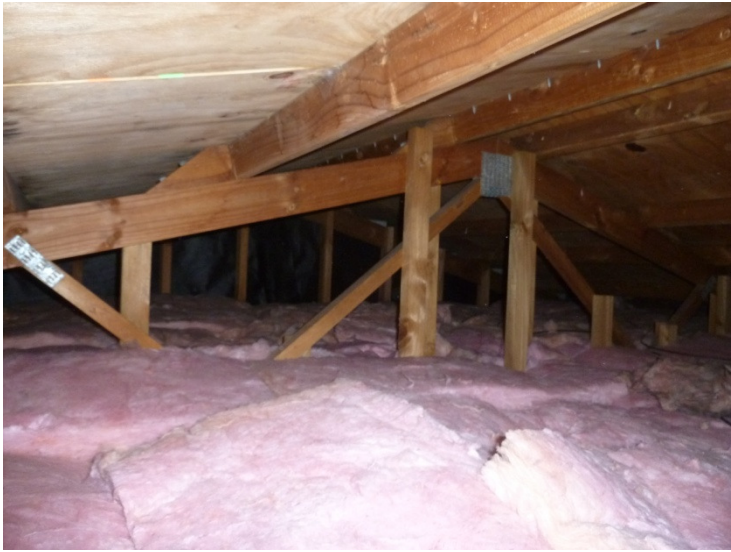
13	Typical ceiling space showing truss system.
