CHRISTCHURCH CITY COUNCIL
BU 0680-008 EQ2
Avebury Park Pool Plant Shed
9 Eveleyn Couzins Ave, Richmond

**QUALITATIVE ASSESSMENT REPORT
FINAL**

- Rev B
- 25 March 2013

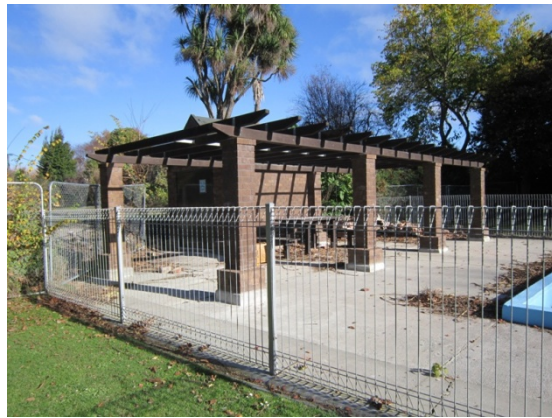
Photo 1: Northeast elevation

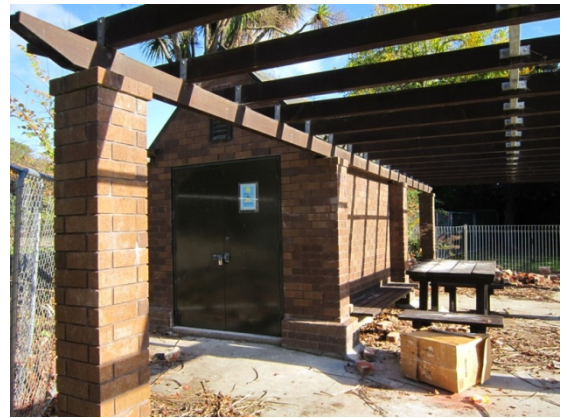
Photo 2: East elevation

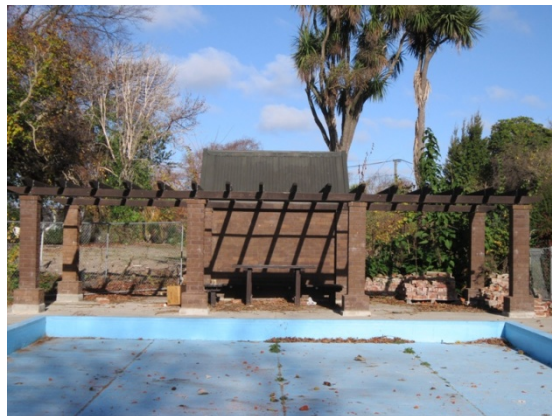
Photo 3: North elevation

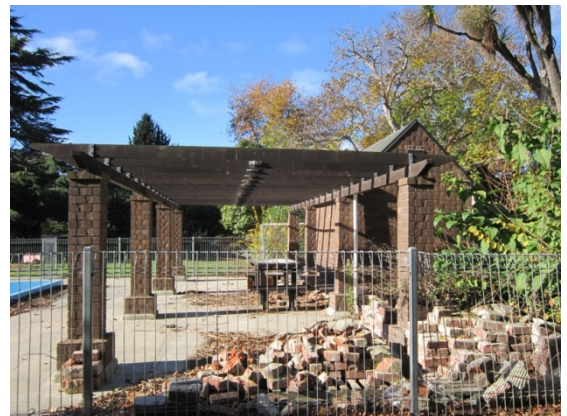
Photo 4: West elevation

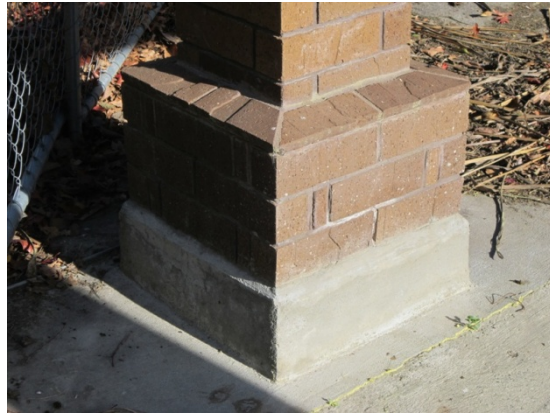
Photo 5: Base of brick column northeast of building.

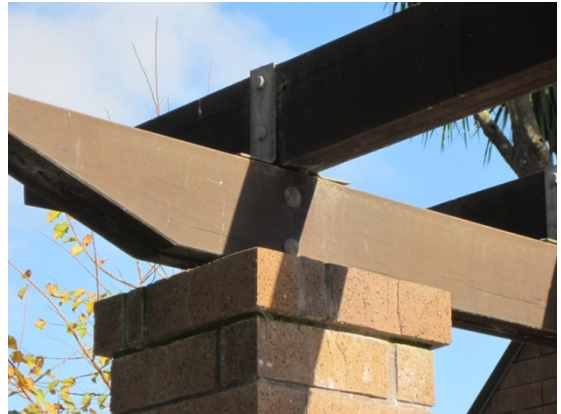
Photo 6: Top of brick column northeast of building. Connection shown between timber beams in the shelter.

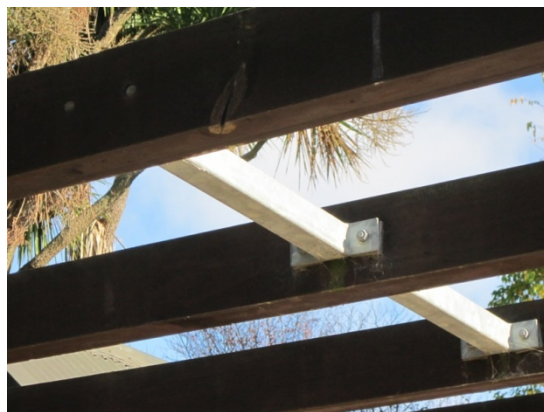
Photo 7: Steel hollow sections used as lateral supports between the timber beams of the shelter.

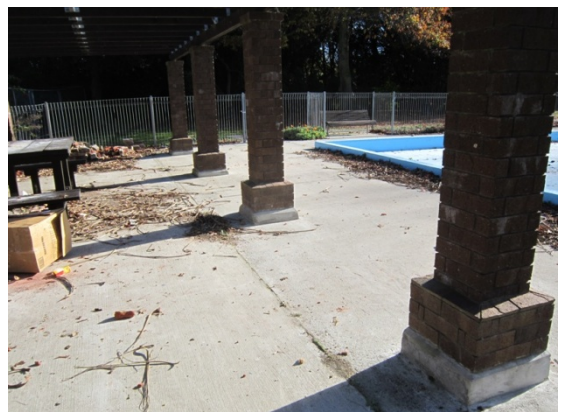
Photo 8: Four shelter support columns north of the building, spaced at 3.6m centres.

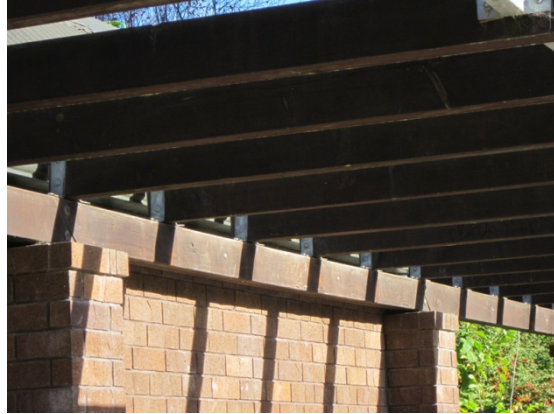
Photo 9: Timber beams in shelter.

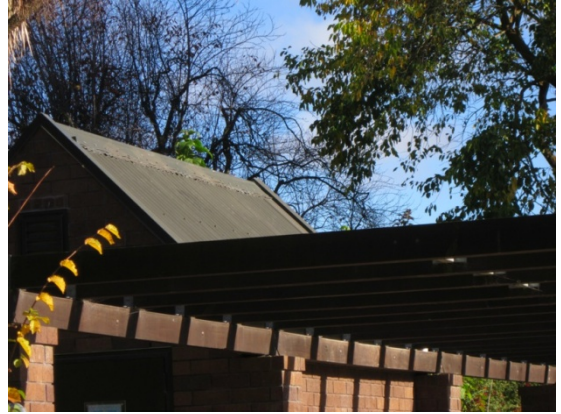
Photo 10: Timber beams in shelter.

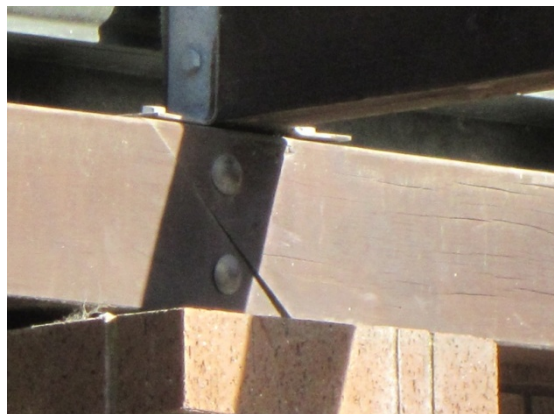
Photo 11: Connection in timber rafter on top of brick column.

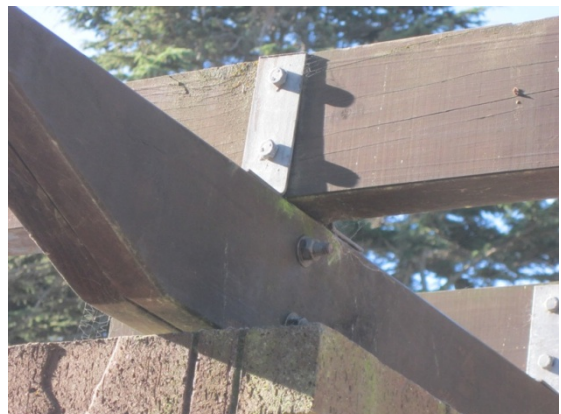
Photo 12: Timber elements and connection on top of brick column.

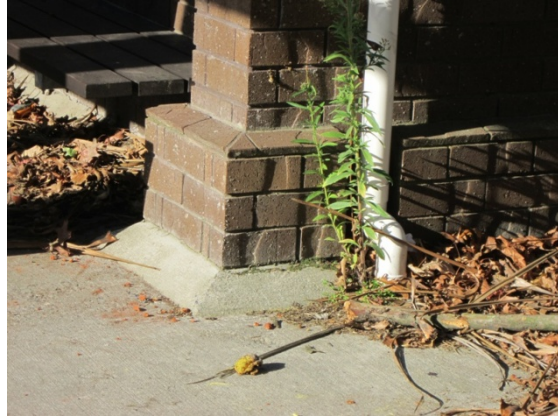
Photo 13: Base of brick column.

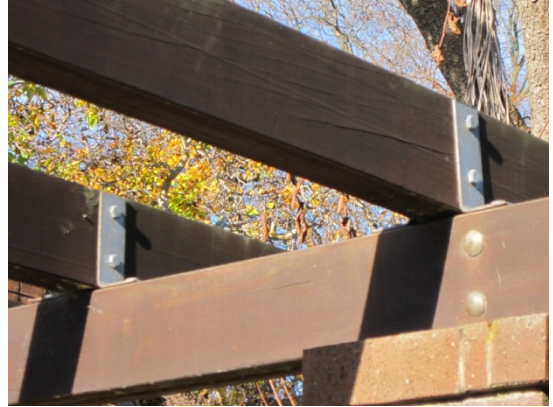
Photo 14: Timber elements and connection on top of brick column

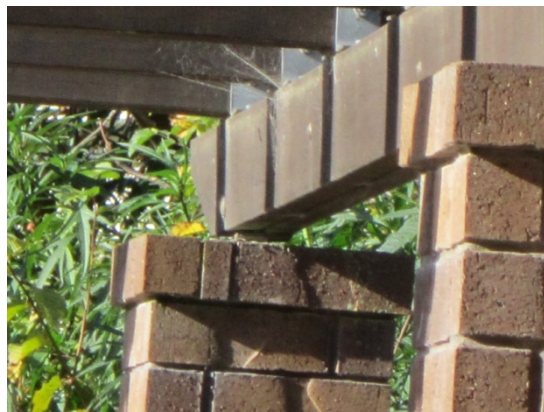
Photo 15: Timber elements on top of brick column.

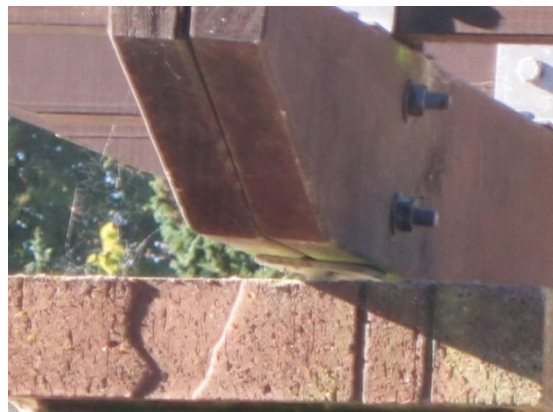
Photo 16: Timber rafter on top of brick column.

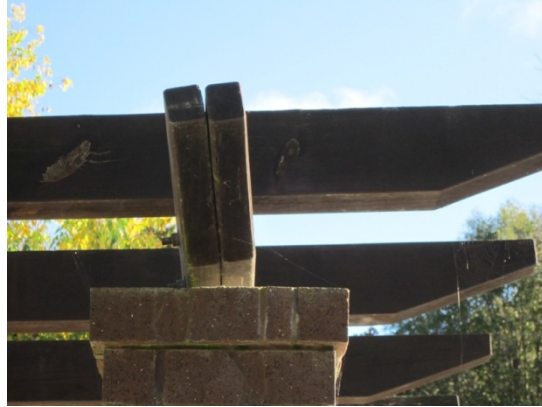
- 1) Warping of the timber beam in the pergola was noted, but it is believed to be caused by weathering, instead of earthquake damage.
- 2) Rotation of the gutter on the southeast corner was noted, but is not believed to be a result of earthquake-related damage.

Photo 17: Warped timber element on top of brick column. Not believed to be earthquake damage.

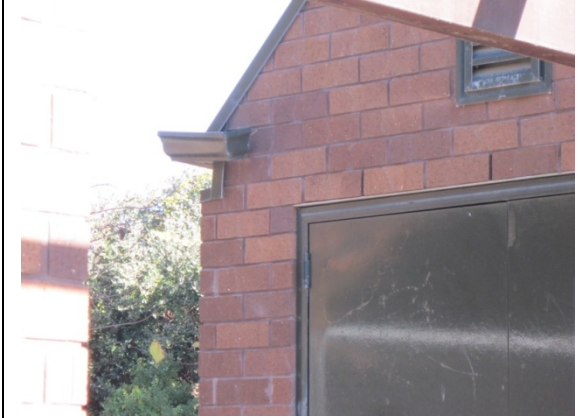
Photo 18: Dislodged gutter. Not believed to be earthquake damage.

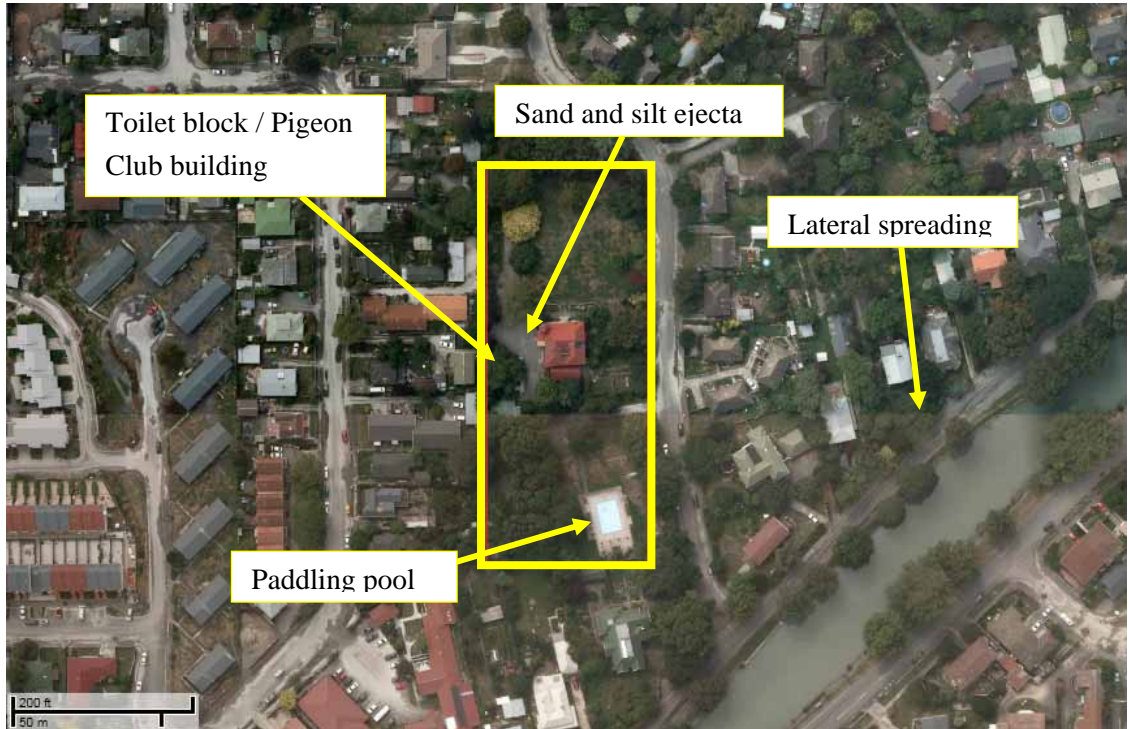
- **Figure 5 – Aerial photography from 24 Feb 2011 (<http://viewers.geospatial.govt.nz/>)**

Aerial photography shows significant liquefaction after the 22 Feb 2011 event, particularly on the site at the location of the toilets and Pigeon Club building, as well as on the streets to the east and south of the site. Large lateral spreading cracks can be seen within the road and properties near the river.

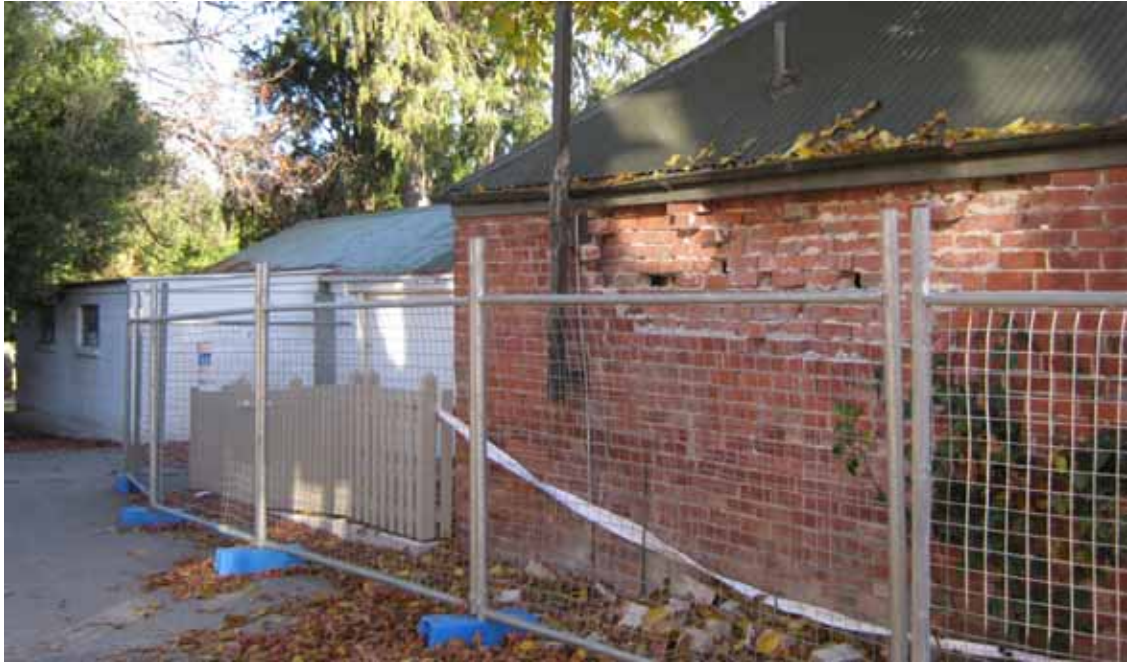
The toilet block had extensive earthquake related damage with most of one side's cladding collapsed as well as multiple cracks in other areas of cladding. The Pigeon Club building had moderate cladding damage with step cracks in the masonry cladding common. Recent mortar repairs to the cladding cracks were observed. There did not appear to be any damage to the paddling pool filter shed.

■ **Figure 7 Overview of the toilet block and Pigeon Club structures**

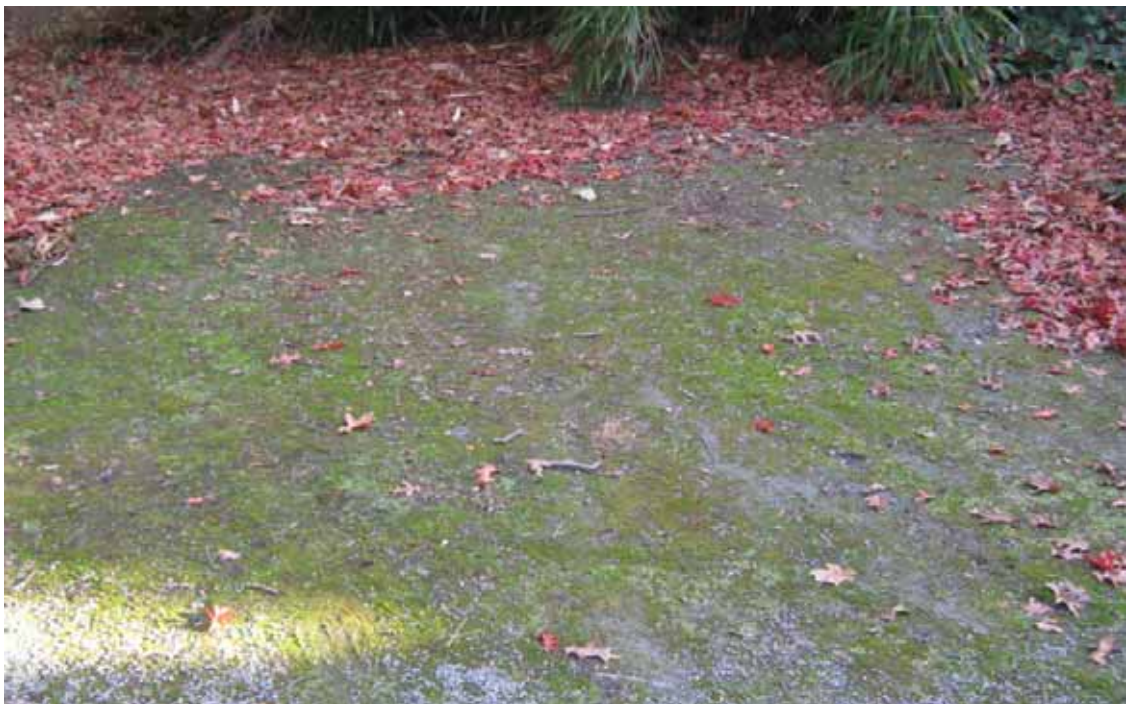
■ **Figure 8 Evidence of sand and silt ejecta close by the toilet block and Pigeon Club buildings.**

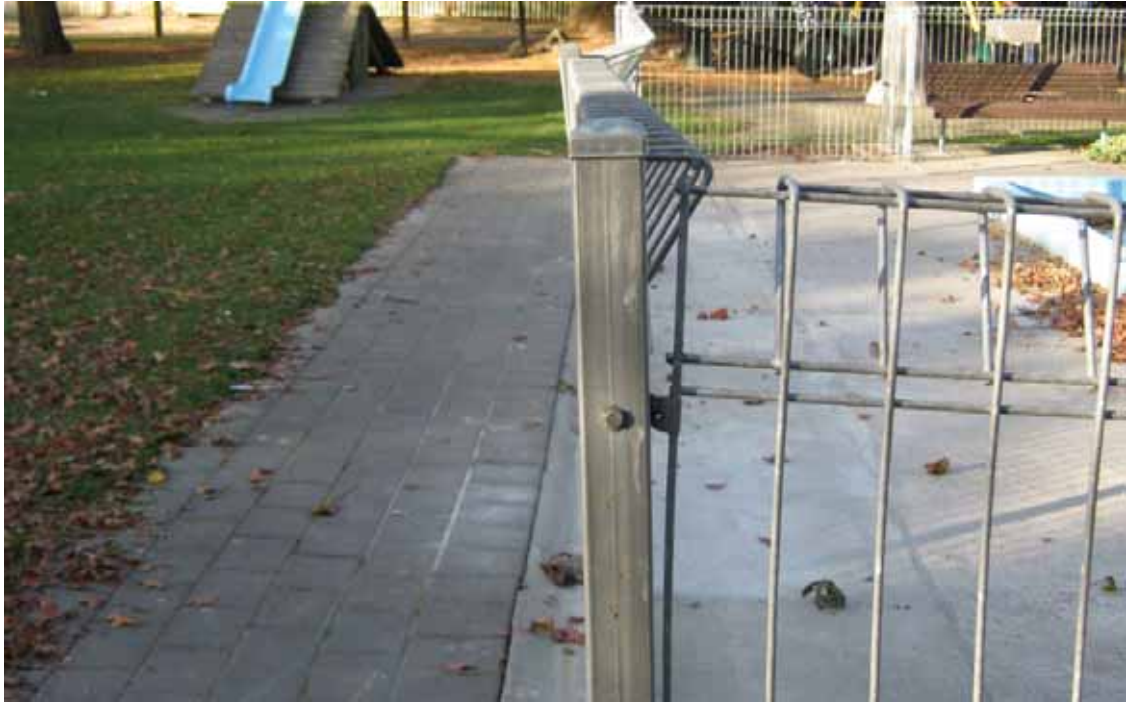
In the paddling pool area there were ground undulations on the grassed area, playing area and paving surrounding the pool. The concrete slabs around the pool were tilted and undulating.

- **Figure 9 Undulating paving next to the paddling pool, and damage to the fence and concrete slabs, relating to earthquake ground damage.**

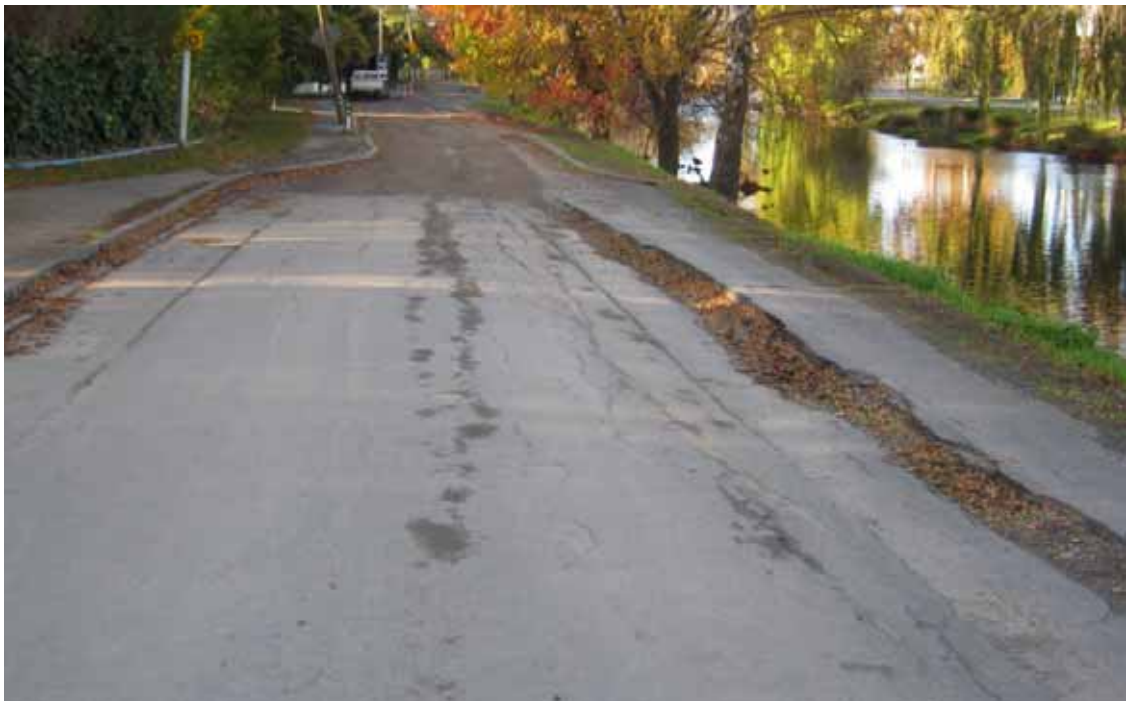
The site is located 50 m north west of the Avon River and lateral spreading was evident on the road along the river.

- **Figure 10 Lateral spreading ground damage along the Avon River.**
