Project: Avice Hill Arts & Crafts Centre Hall

Qualitative Engineering Evaluation

Prepared for: Christchurch City Council

Date: 3 July 2013

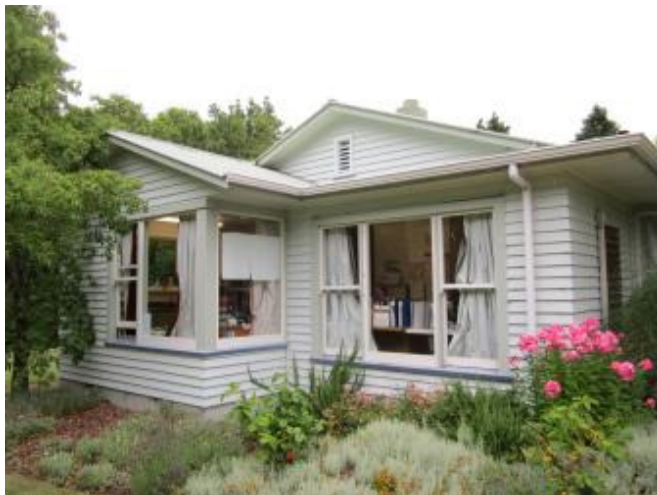
Front Elevation

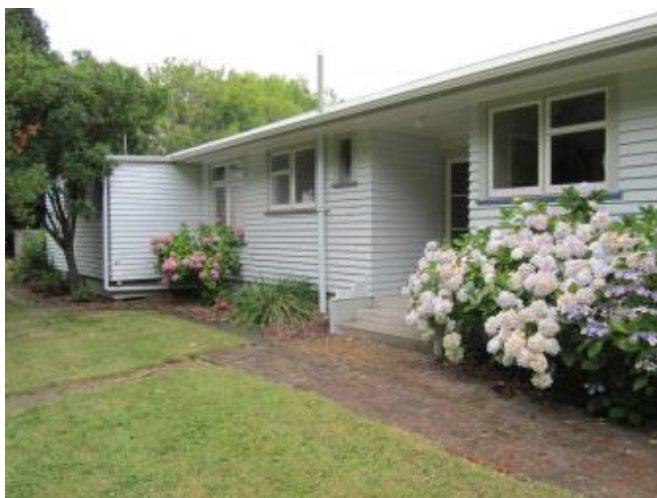
Side Elevation

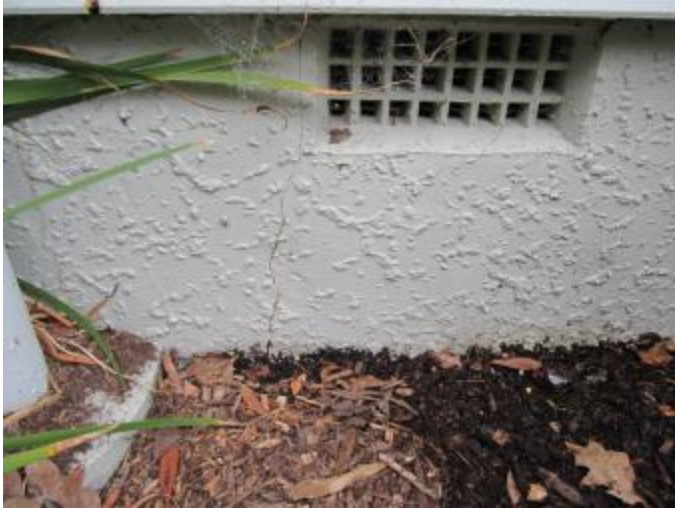
Very minor cracking to the gypsum board wall linings is not considered significant and will not greatly reduce the buildings capacity to resist lateral loads. Cracking is due to the movement of the timber frames during the earthquakes. The cracking in the concrete perimeter foundation is also not considered significant and in our opinion will not affect the buildings ability to carry loads.

Minor cracking on perimeter concrete foundation

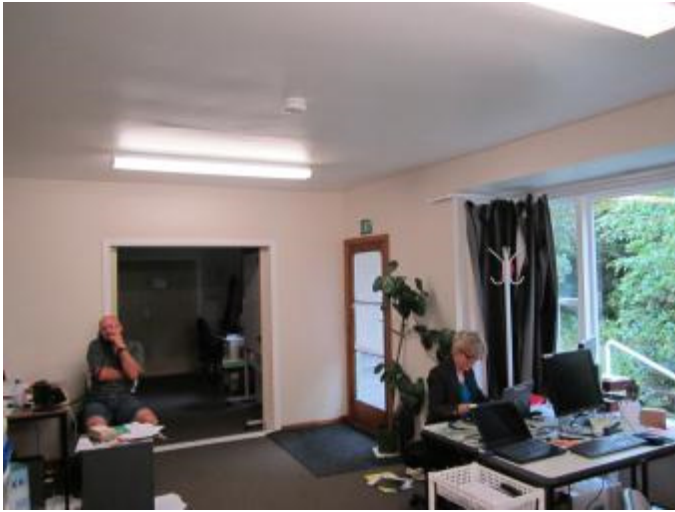
Gypsum lined walls
