Awa-iti Domain
Toilets
PRK 3746 BLDG 004 EQ2
Detailed Engineering Evaluation
Quantitative Assessment Report

Awa-iti Domain Toilets Quantitative Assessment Report

40 Western Valley Road, Little River

Date: March 2013
Reference: 6-QUCC1.26
Status: Final

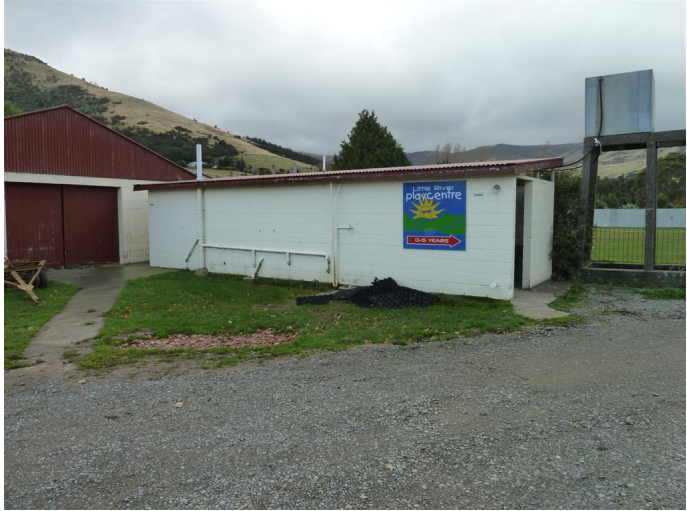
Awa-iti Domain Toilets		
No.	Item description	Photo
1.	South east side

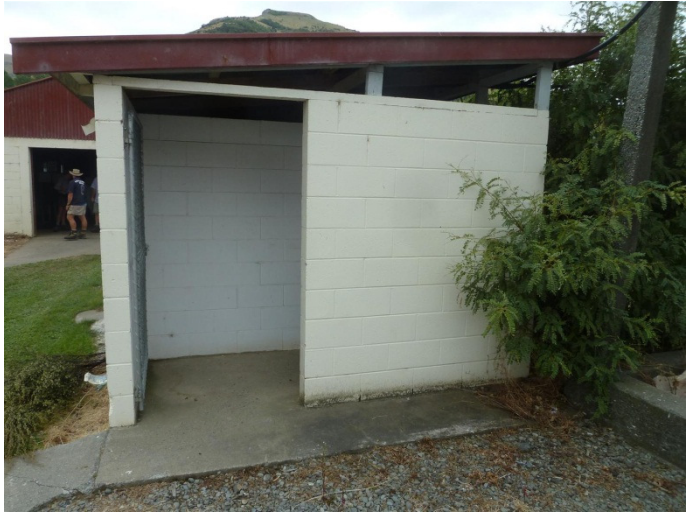
2.	East end

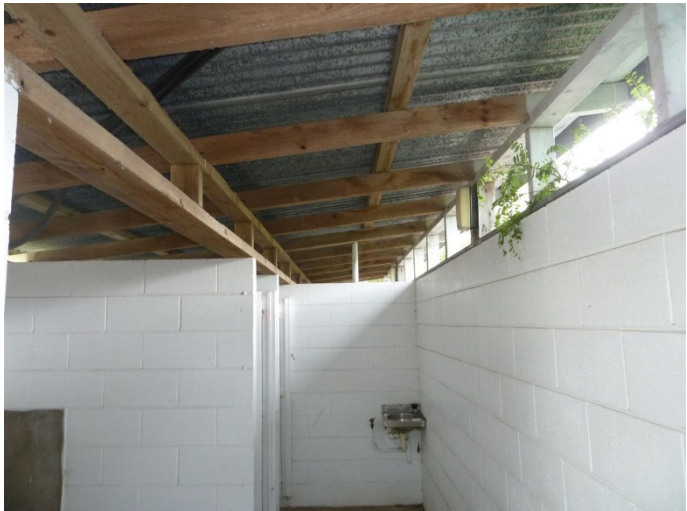
3.	Interior - Mens

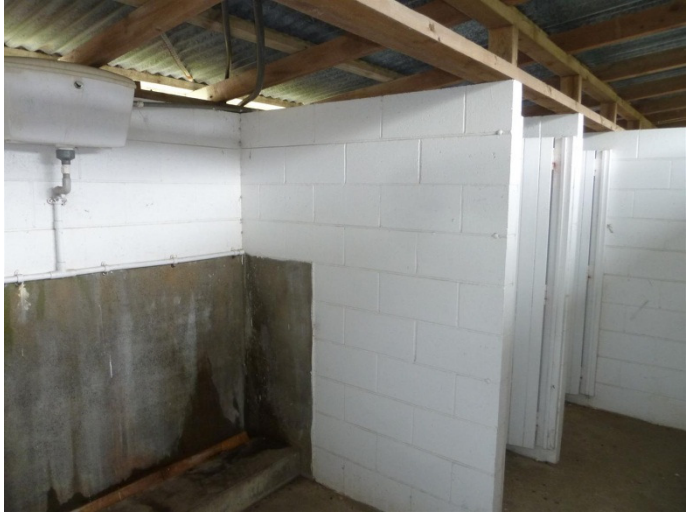
4.	Interior - Men's (south wall)

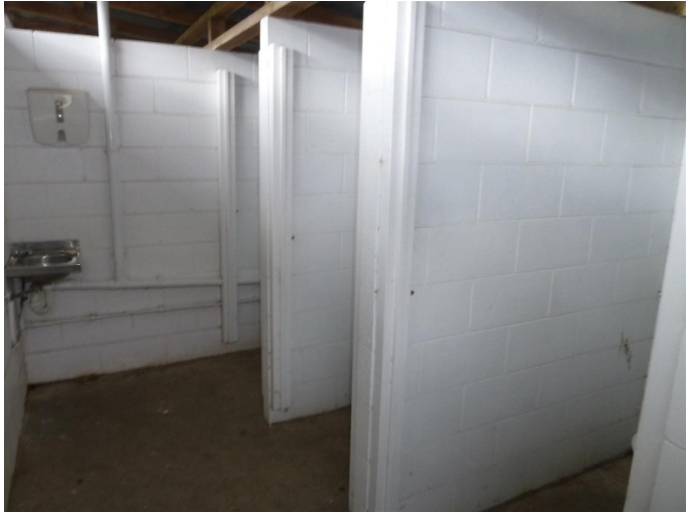
5.	Interior - Women's

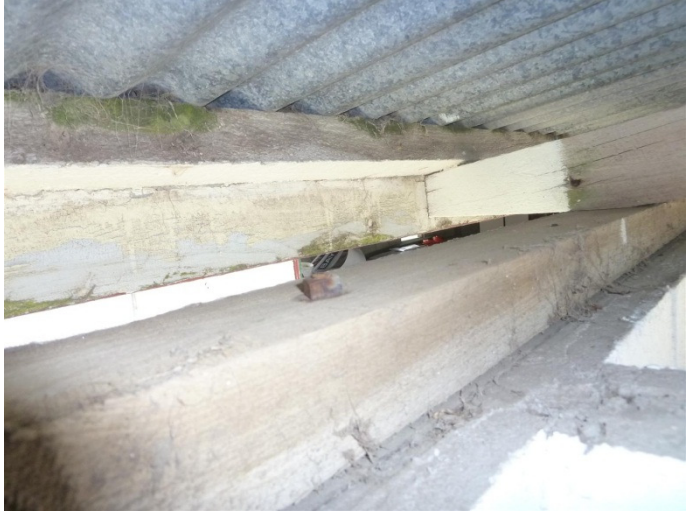
6.	Roof connection low roof side (south wall)

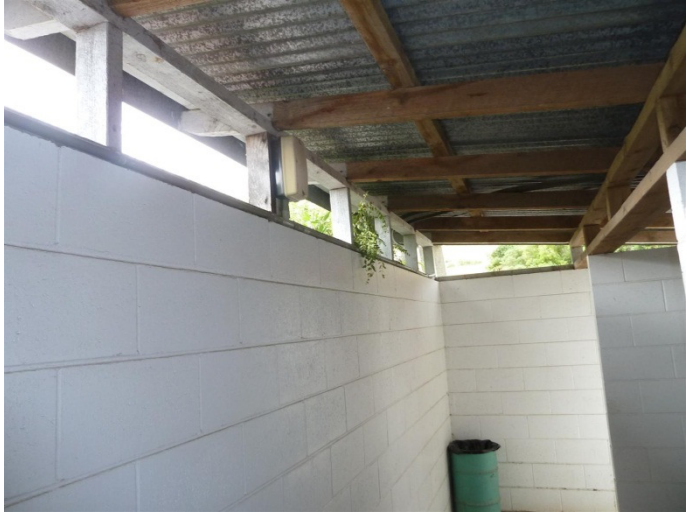
7.	High roof side (north wall)

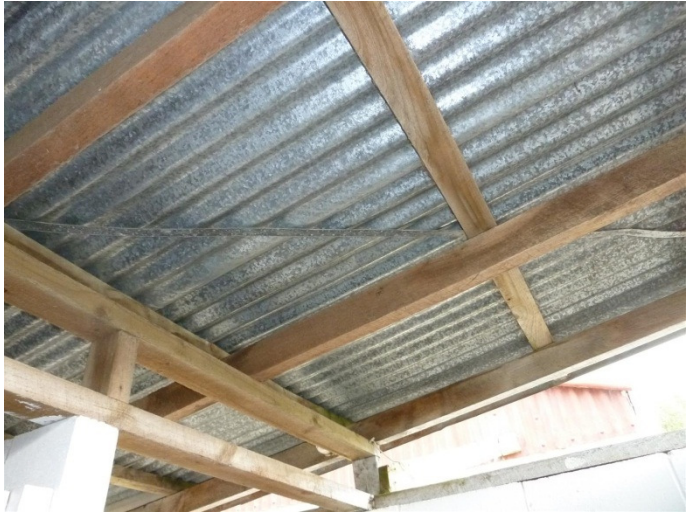
8.	Roof strap bracing

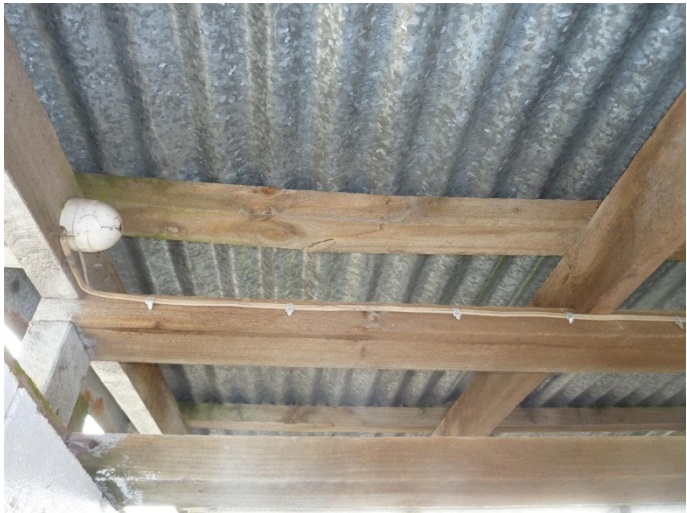
A purlin at the north-western end has a significant crack, but it is unlikely that this was due to seismic activity (refer Appendix 1, photo 9).

9.	Cracked purlin
