**Dwelling**  
**PRK 1201 BLDG 001 EQ2**  
Detailed Engineering Evaluation  
Qualitative Report  
Version FINAL

Barbadoes Cemetery, 357 Cambridge  
Terrace, Christchurch

Christchurch City Council

**Date**  
6<sup>th</sup> March 2013

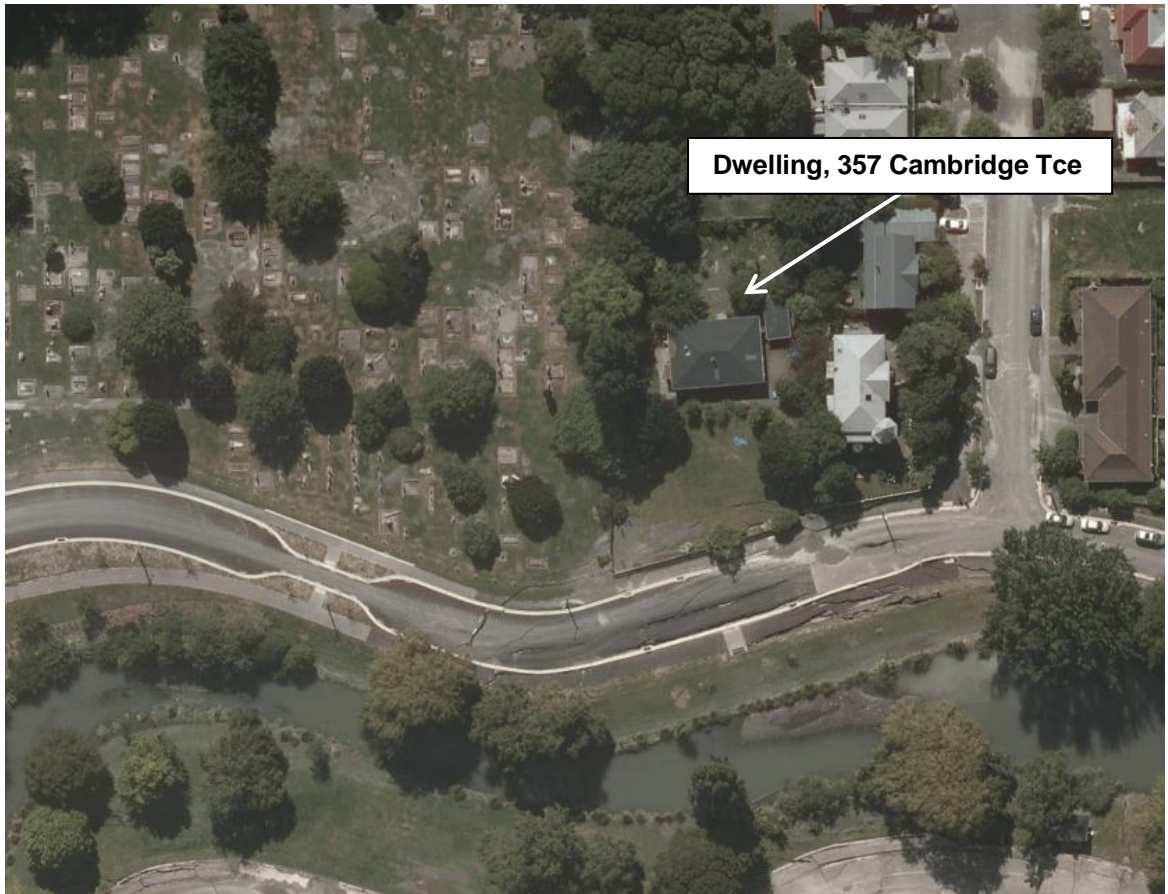
**Figure 3 Post February 2011 Earthquake Aerial Photography**<sup>2</sup>

Aerial photography taken following the 22 February 2011 earthquake (Figure 3) shows significant evidence of liquefaction in the cemetery, adjacent properties and along the river reserve. There is also evidence of lateral spreading along both sides of the Avon River adjacent to the site. Extensive lateral spreading along the riverbank, through the road, and into a portion of the cemetery was observed (during a walkover) following the earthquake on 22 February 2011.

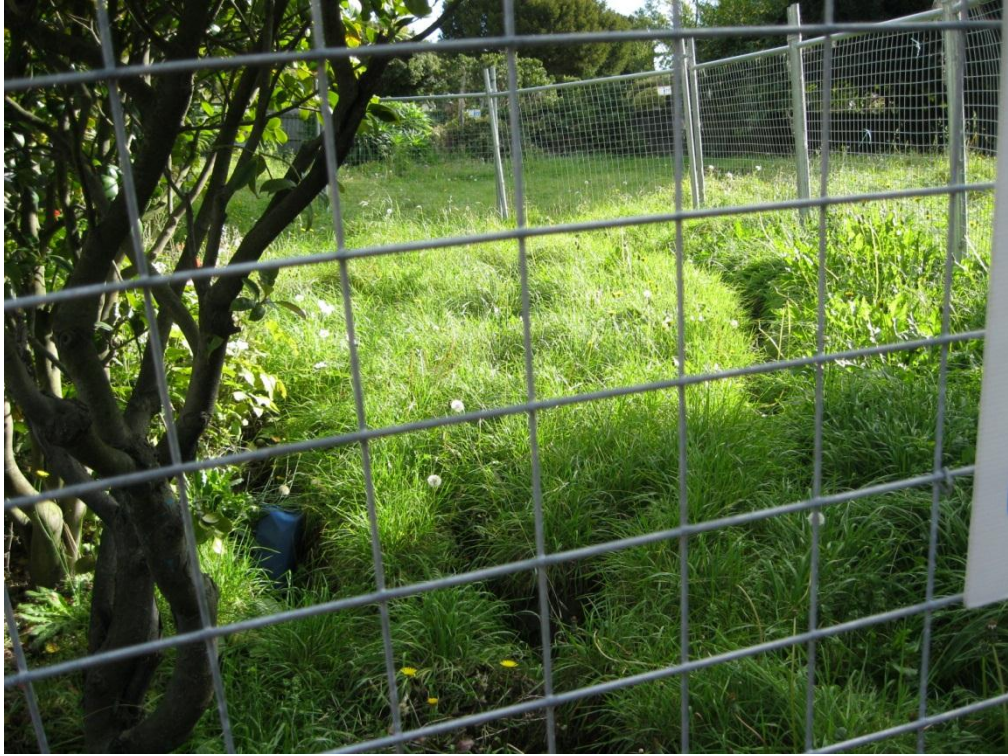
**Photograph 5 View of the site lateral spreading.**

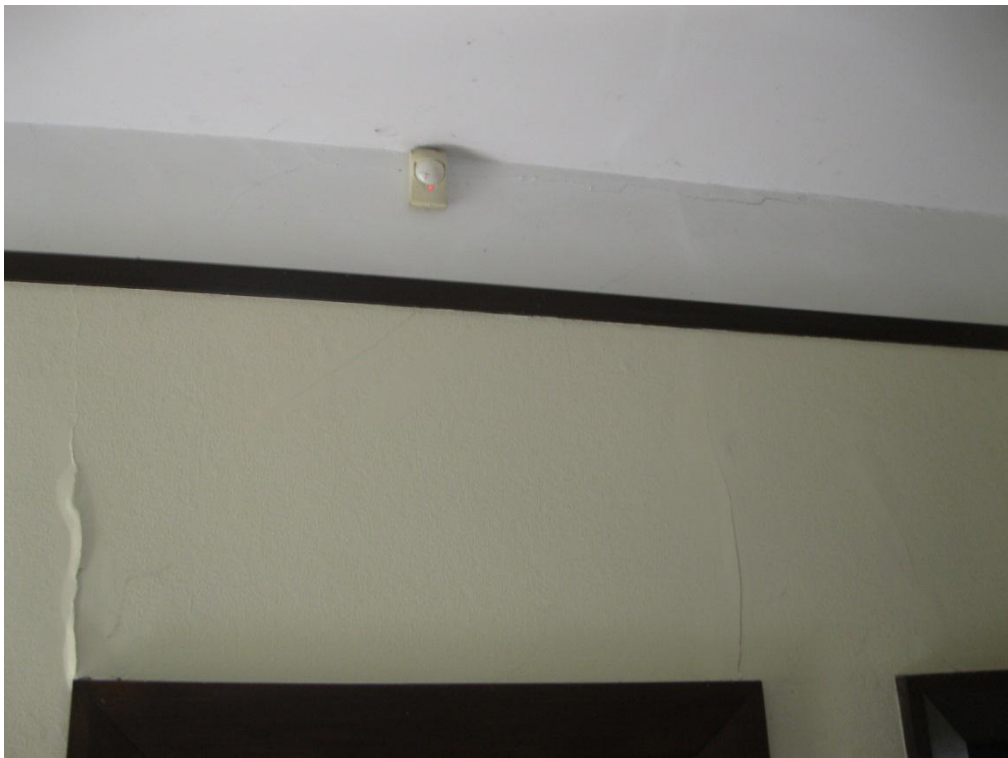
Cracking as a result of earthquake forces was noted to the internal plasterboard wall and ceiling linings (see photograph 6-8) and on the perimeter strip footing (see photographs 9-11).

**Photograph 6 Vertical cracking in what is likely to be plasterboard wall lining.**

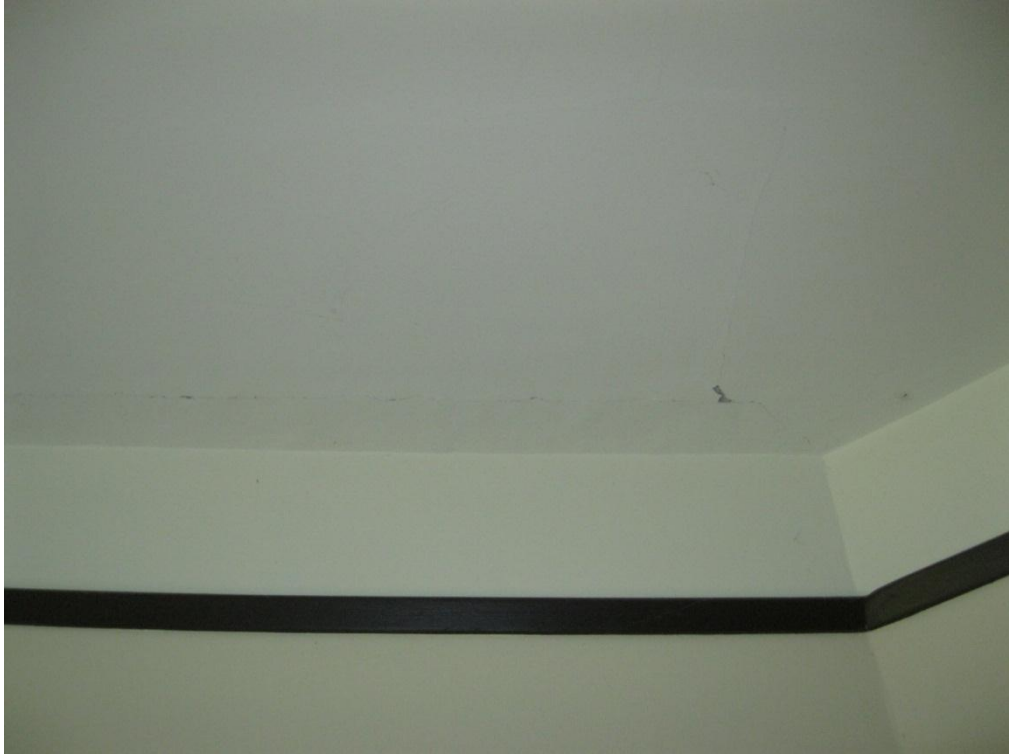
**Photograph 7 Cracking to plasterboard ceiling lining.**

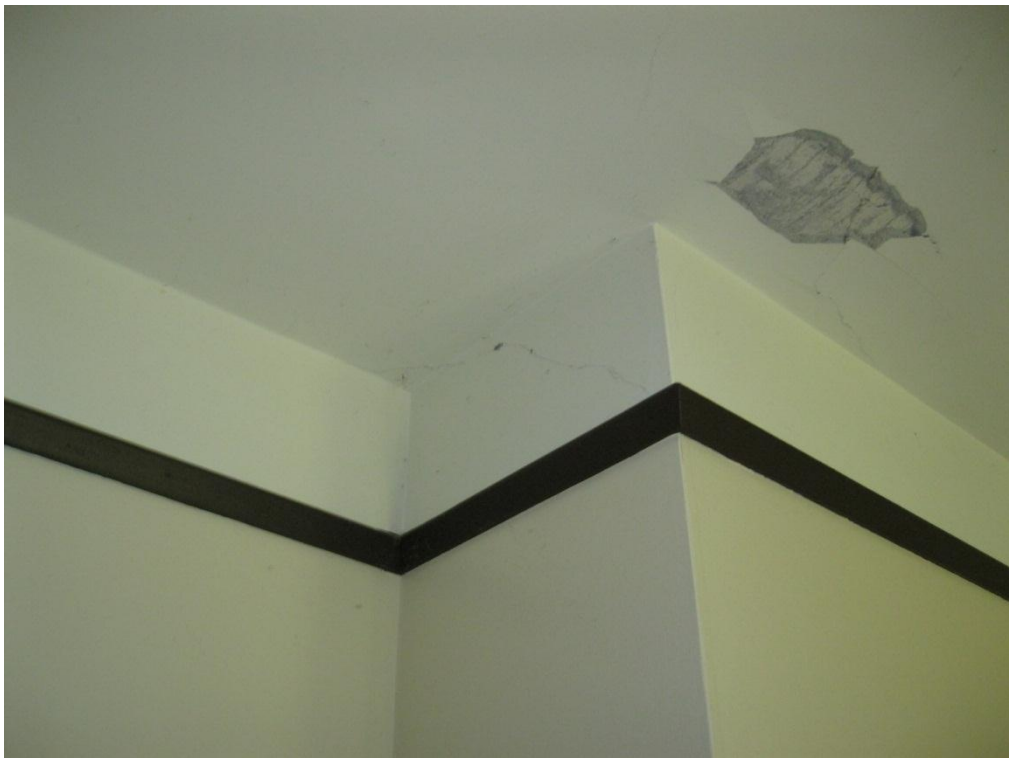
**Photograph 8 Cracking to lath and plaster ceiling lining.**

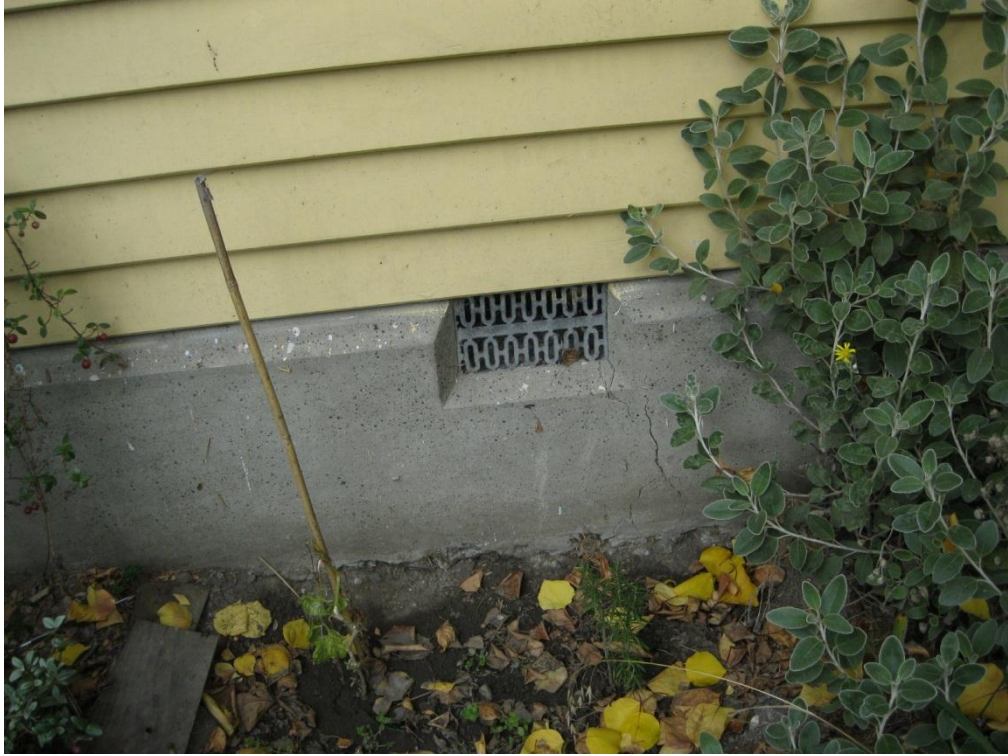
**Photograph 9 Cracking to concrete perimeter strip foundation.**

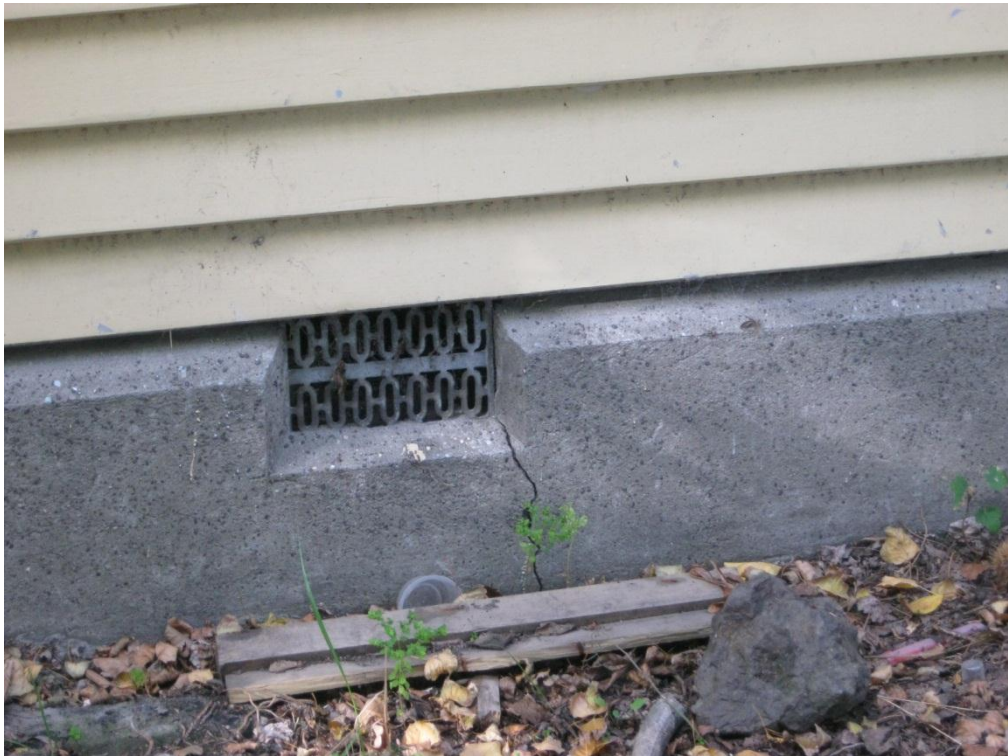
**Photograph 10 Cracking to concrete perimeter strip foundation.**

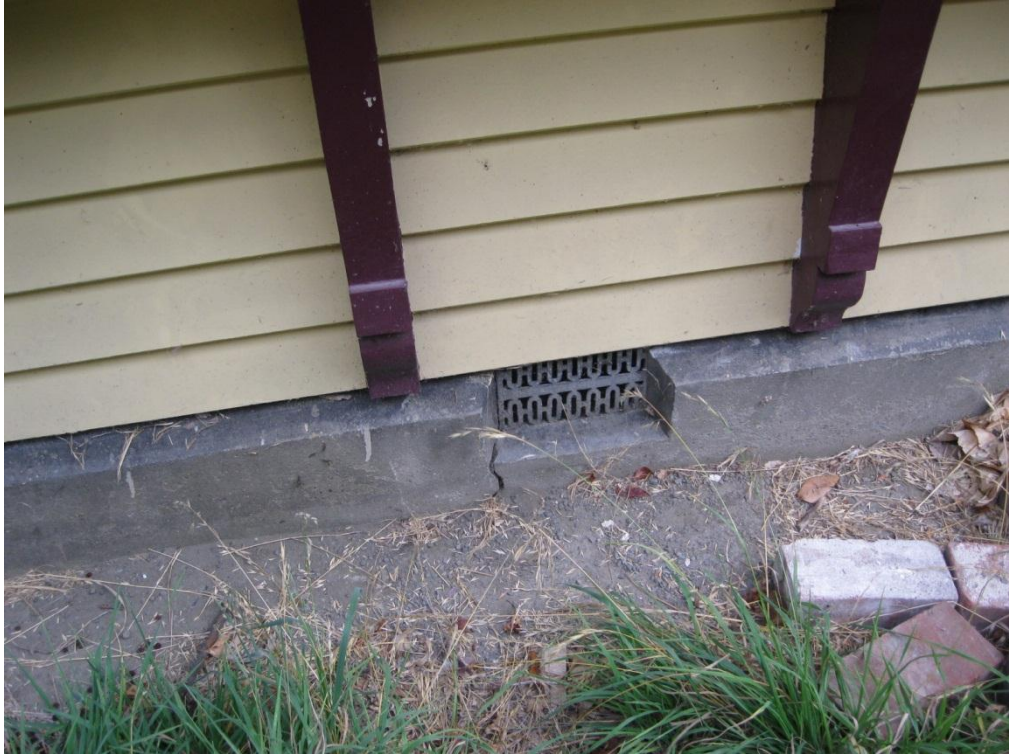
**Photograph 11 Cracking to concrete perimeter strip foundation.**
