**Barnett Avenue
Housing Complex
PRO 1140**

**Detailed Engineering Evaluation
Quantitative Assessment Report**

Barnett Avenue Housing Complex Quantitative Assessment Report

Date: January 2014
Reference: 6-QC312.00
Status: Final

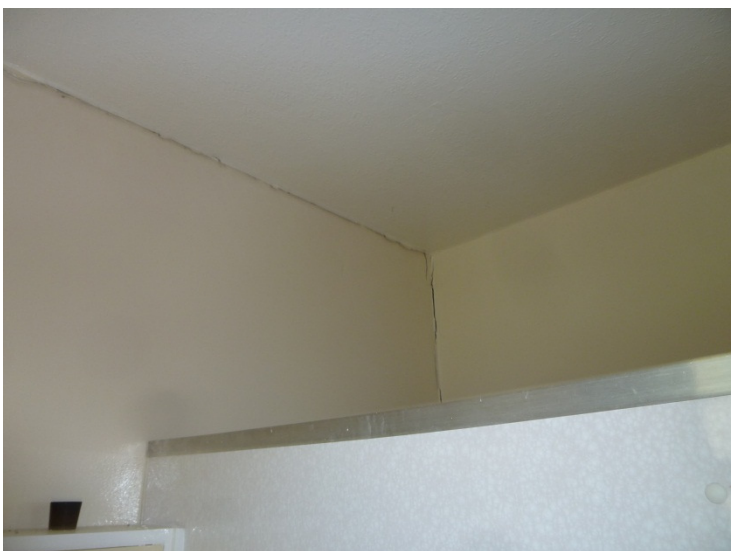
Some separation was observed as the concrete fire has separated from the timber supporting walls in bathroom of Unit 40 (photo 8). No similar damage was observed in any other units.

<p>8.</p>	<p>Separation of concrete fire wall from timber walls in Unit 40</p>

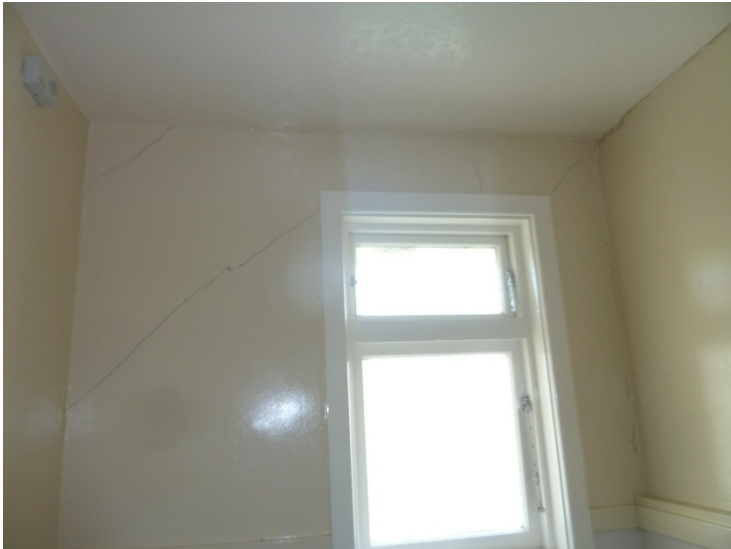
Cracking of ceilings and wall linings was observed in all units. This form of damage is common throughout the unit, particularly surrounding window and door openings.

9.	Severe cracking of wall lining in Unit 40

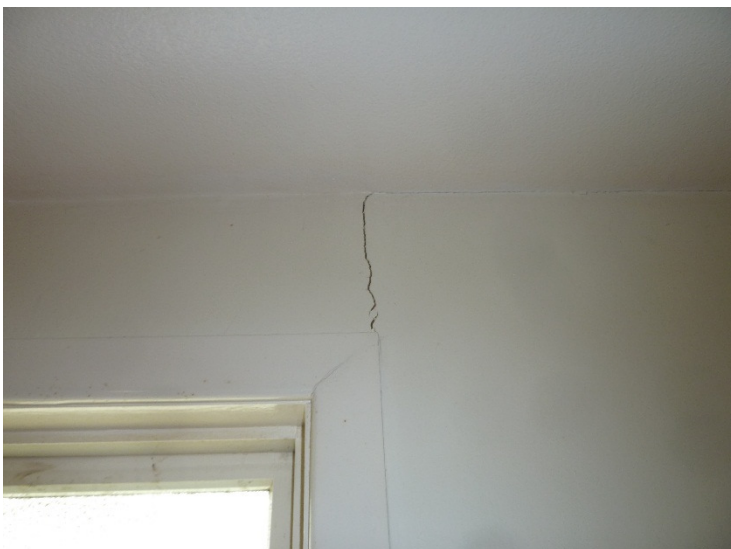
10.	Typical cracking of wall lining

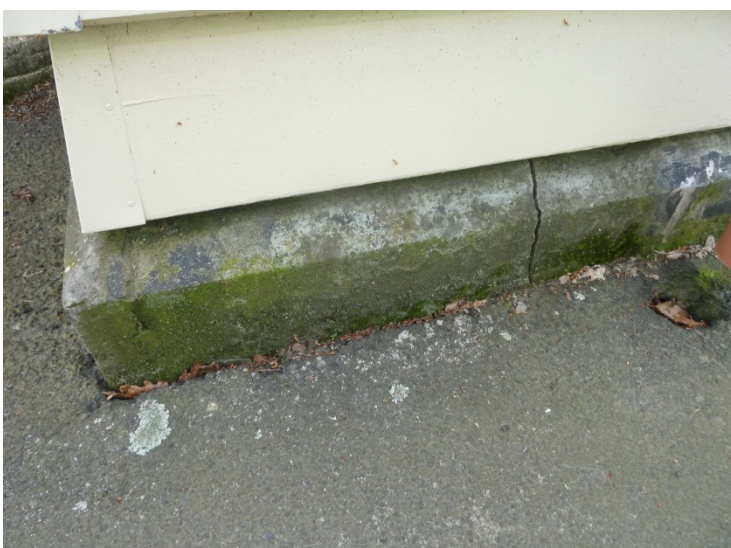
Minor cracking to the concrete perimeter footing was observed on the some units.

11.	Cracking of concrete perimeter footing

- The concrete perimeter footings be repaired on blocks where severe cracking occurs.
- Cosmetic repairs be undertaken as required.
- All buildings be strengthened to at least 67% NBS.

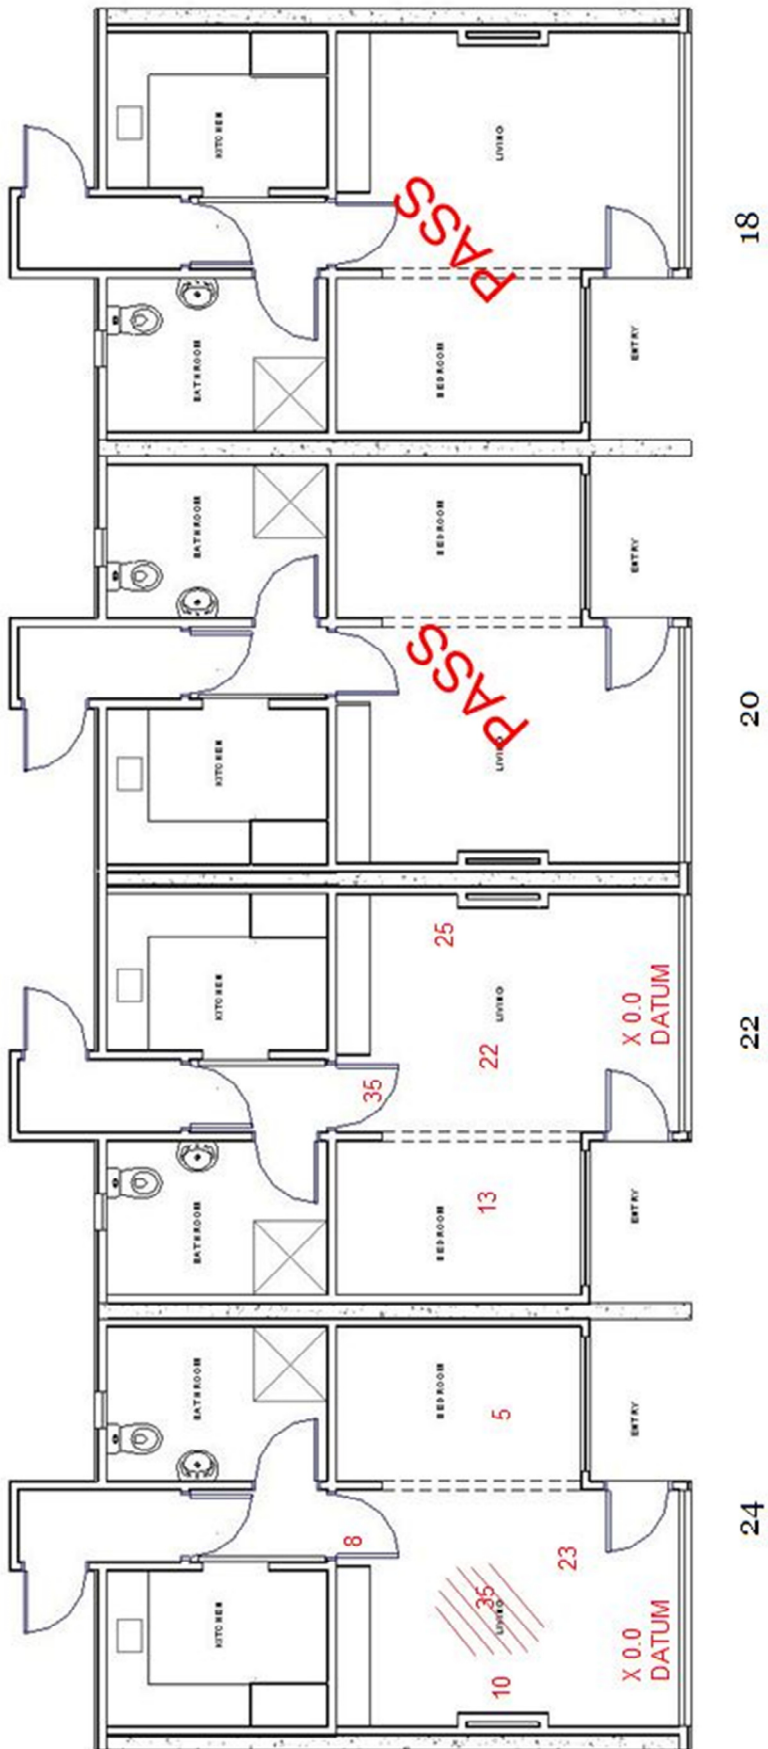
Appendix B – Level Survey

Block	Unit No.	Comment	Maximum Fall
A	2	Pass	
	4	Pass	
	6	Pass	
	8	Pass	
B	10	Pass	
	12	Pass	
	14	Pass	
	16	Pass	
C	18	Pass	
	20	Pass	
	22	Fail	8.3mm/m
	24	Fail	8.3mm/m
D	26	Pass	
	28	Pass	
	30	Pass	
	32	Pass	
E	34	Pass	
	36	Pass	
	38	Pass	
	40	Pass	
F	42	Pass	
	44	Pass	
	46	Pass	
	48	Pass	
	50	Pass	
	52	Pass

The results of the level survey indicate the possibility of ground settlement due to the earthquakes in only Units 22 and 24. The floor slopes were measured to be beyond the 5mm/m limitation imposed by MBIE guidelines in the kitchen and bathroom areas.
