**Barnett Park Sports Ground Pavilion**  
**PRK 1390 BLDG 001 EQ2**  
Detailed Engineering Evaluation  
Quantitative Report  
Version FINAL (Rev1)  
Redcliffs, Christchurch

Christchurch City Council

**Date**  
14/03/2014

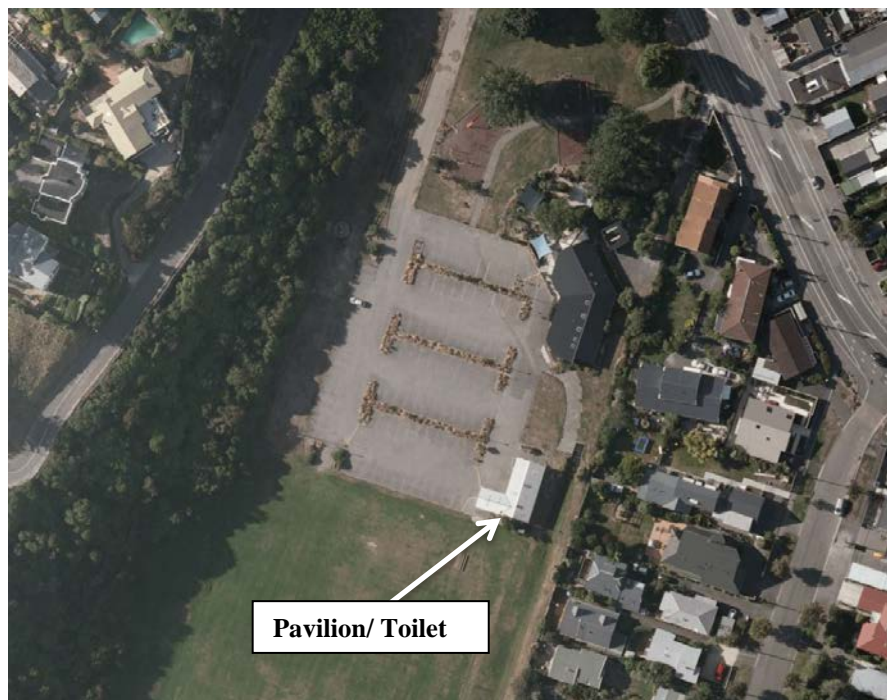
**Figure 3 Post February 2011 Earthquake Aerial Photography<sup>2</sup>**

Aerial photography taken following the 22 February 2011 (Figure 1) shows no signs of liquefaction with sand boils eminent near the site.

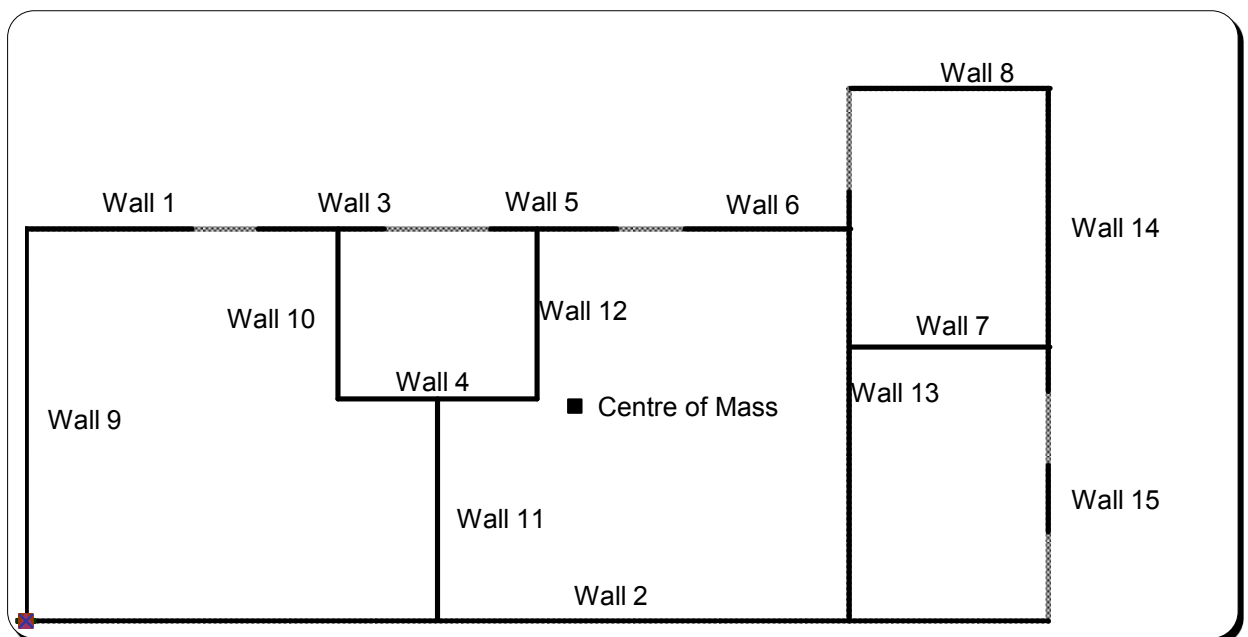
Figure 4 Plan Details and Wall Locations of Block A

As Block A achieves greater than 33% NBS, it is considered a potentially Earthquake Risk structure in accordance with the NZSEE guidelines. As no immediate collapse hazards or critical structural weaknesses have been identified for the building, occupancy of the building is permitted.

It is however recommended that the building is strengthened to 67% NBS in line with the NZSEE guidelines.

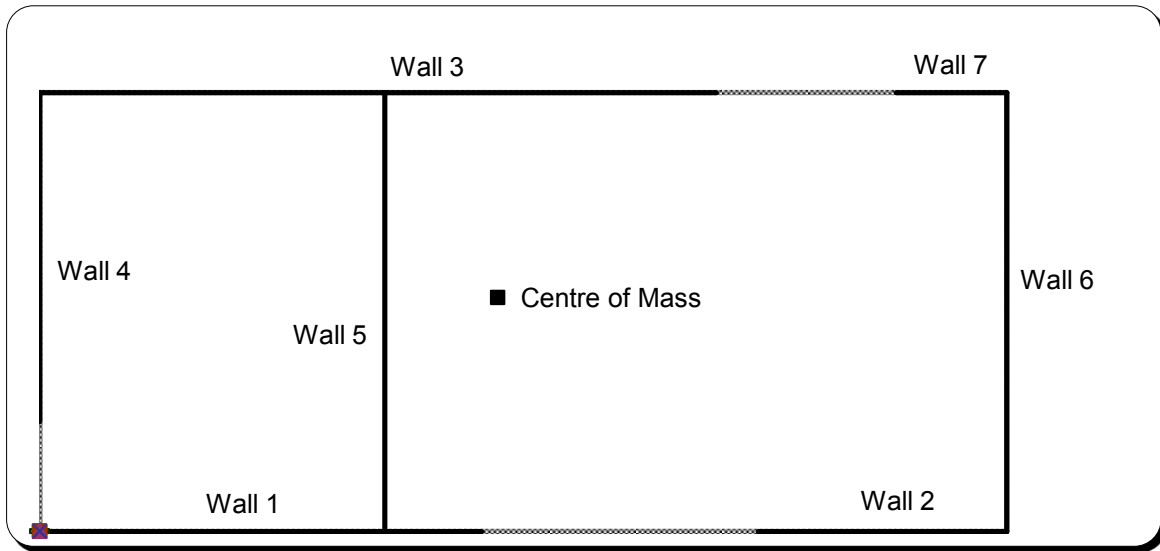
Figure 5 Plan Details and Wall Locations of Block B

As Block B has been assessed to have a %NBS greater than 67% NBS, it is not deemed to be Earthquake Prone nor an Earthquake Risk. As no immediate collapse hazards or critical structural weaknesses have been identified for the building, occupancy can continue.

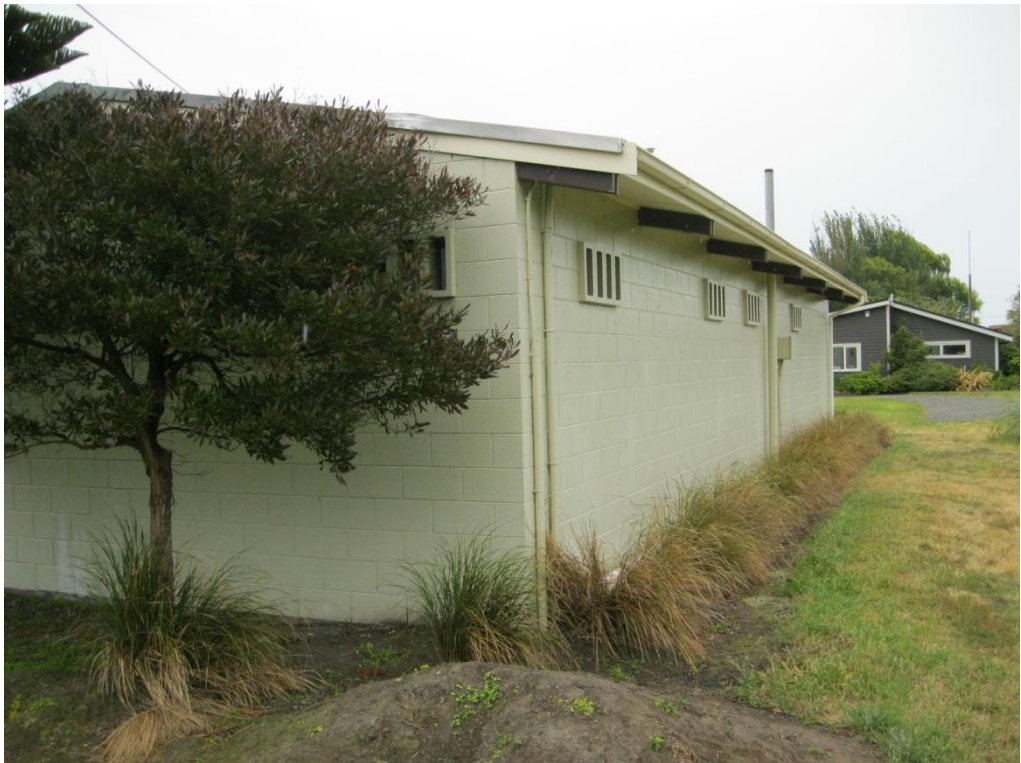
Minor cracking was noted on the east wall of the pavilion. This is not considered significant.

**Photograph 4 East face of pavilion building.**

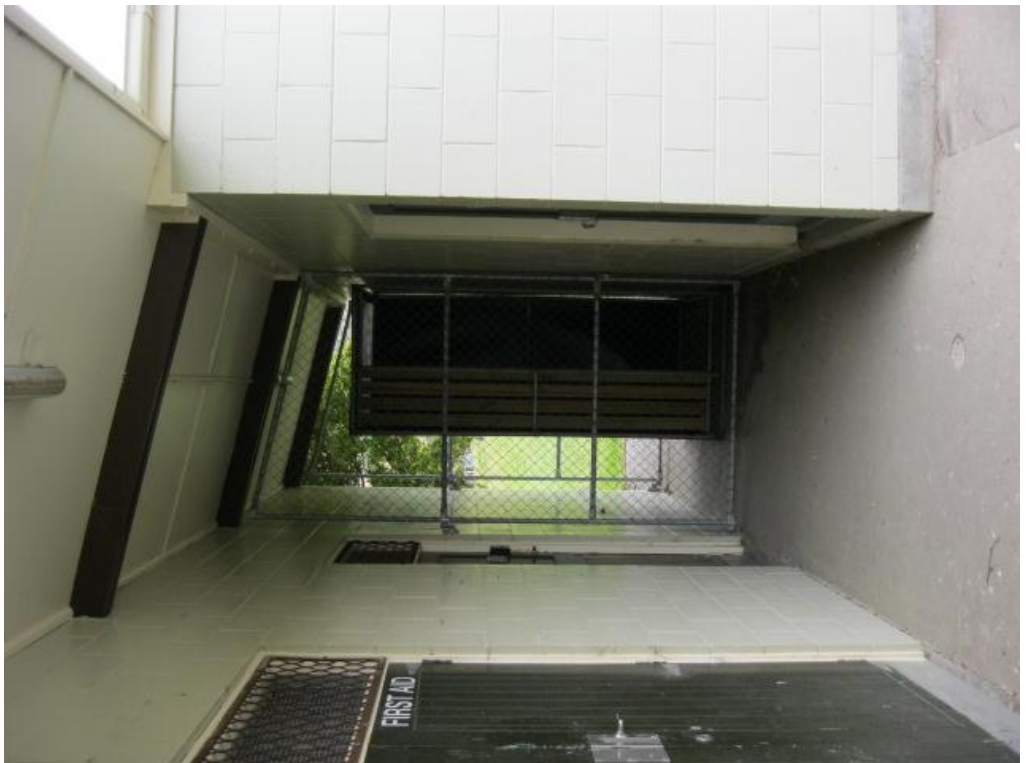
**Photograph 6 Gap between sections of the building.**

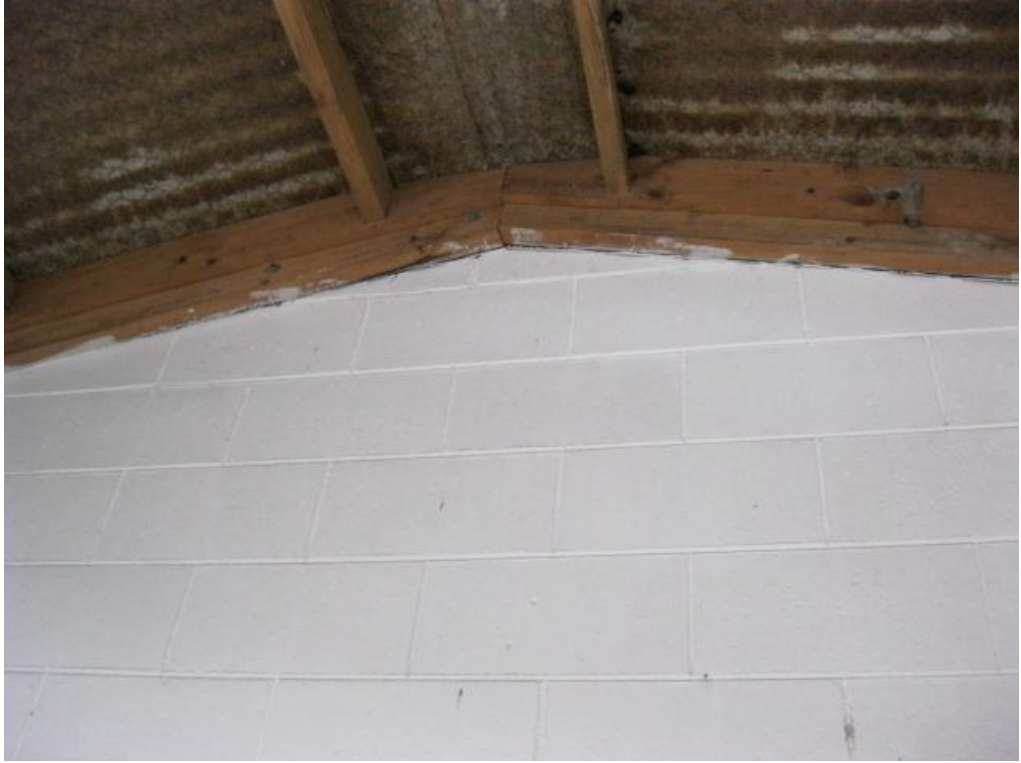
**Photograph 9 Masonry walls extending the full height of the building to roof apex level.**
