# **Barnett Park Toilets**

## **PRK 1390 BLDG 002**

**Detailed Engineering Evaluation**

**Quantitative Assessment Report**

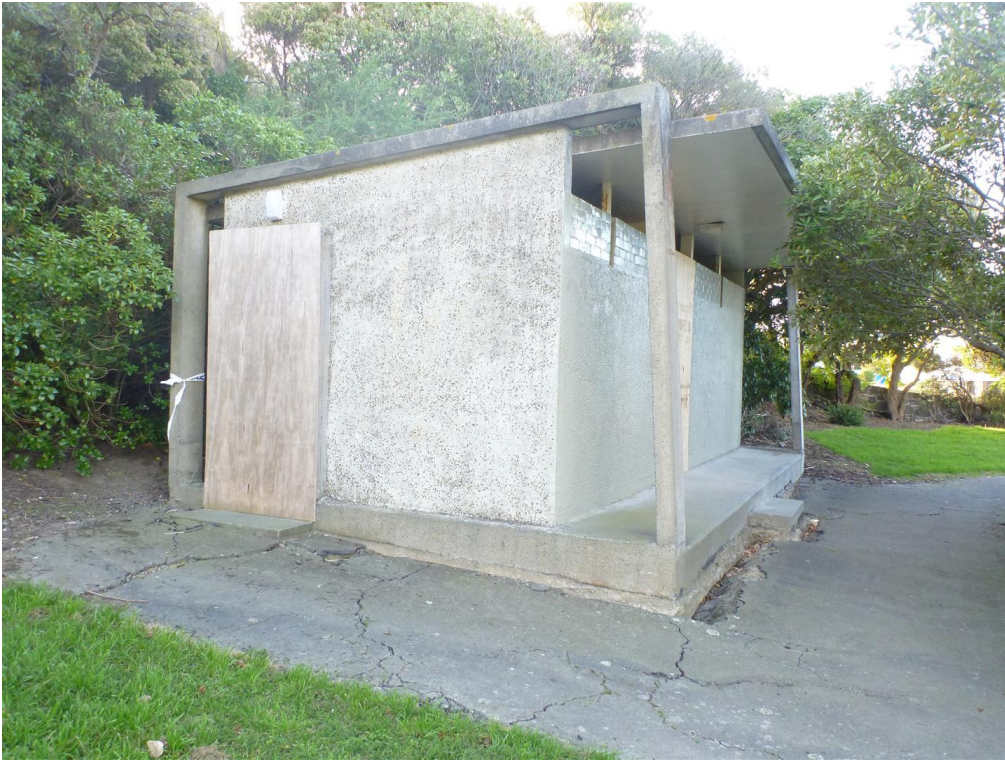
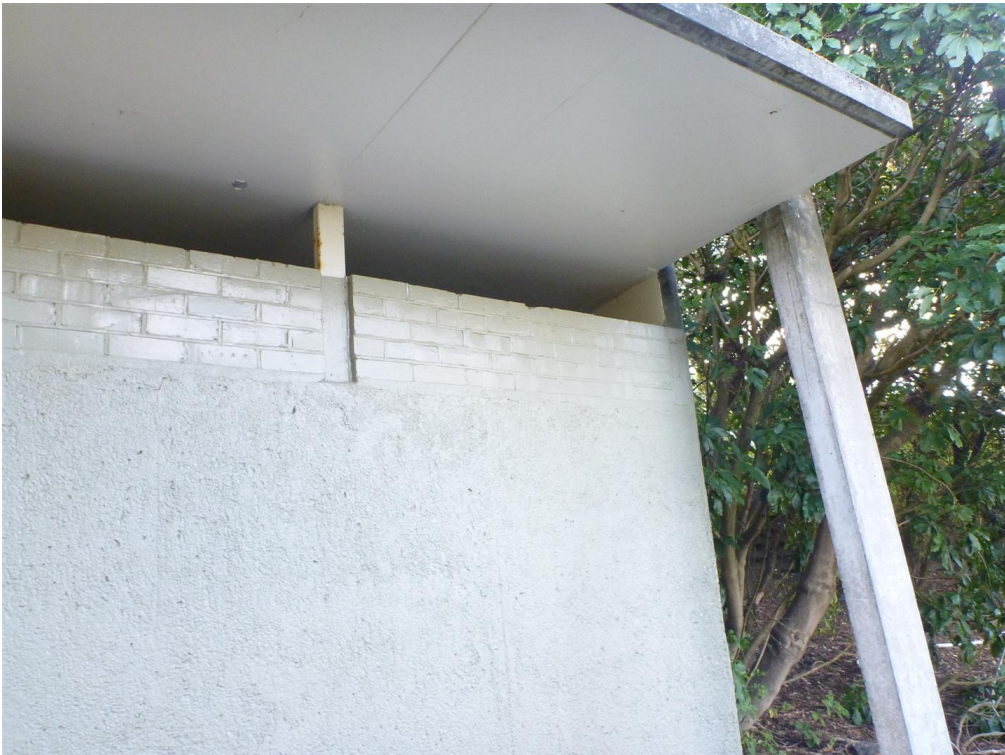
North and west faces of Barnett Park Toilets

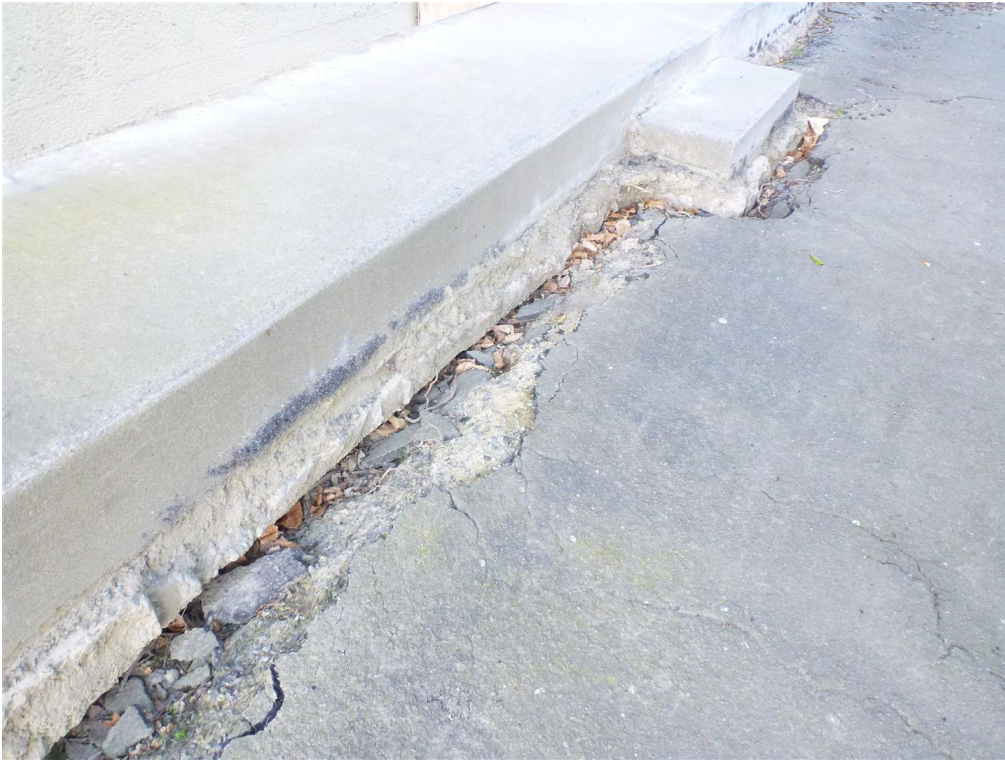
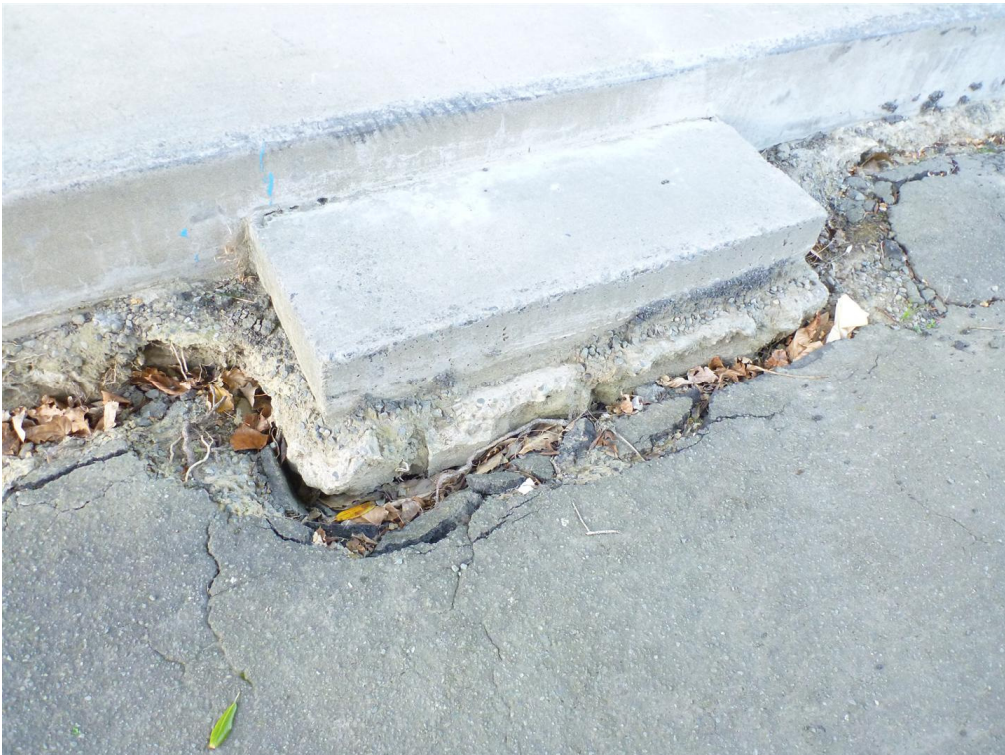
Displacement at front steps

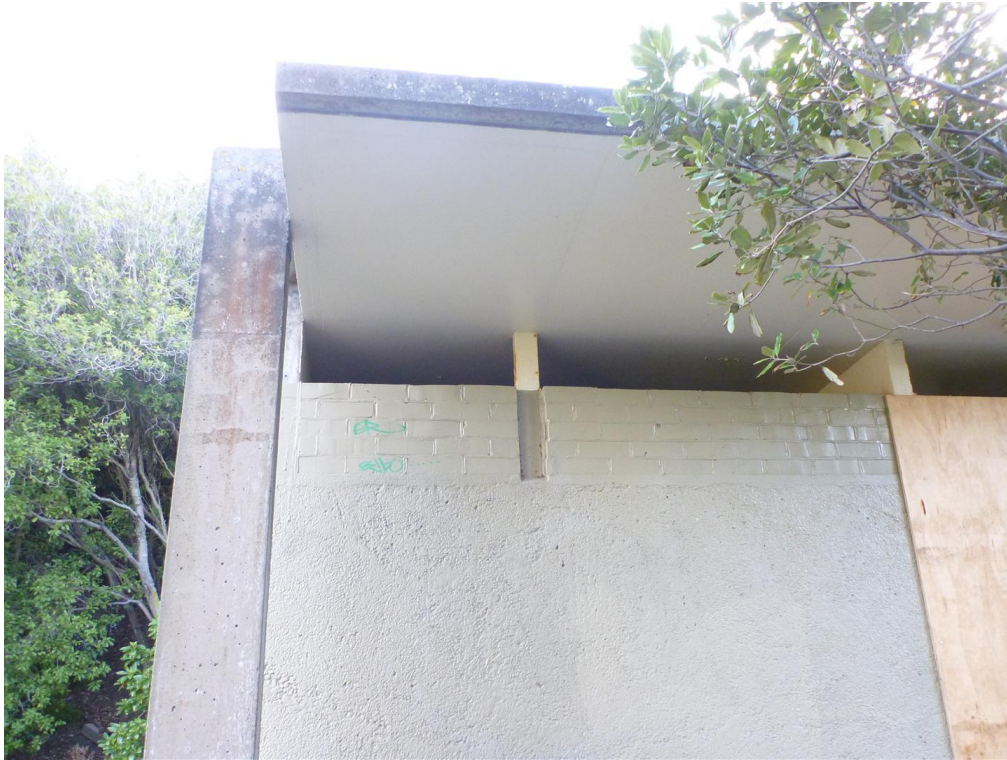
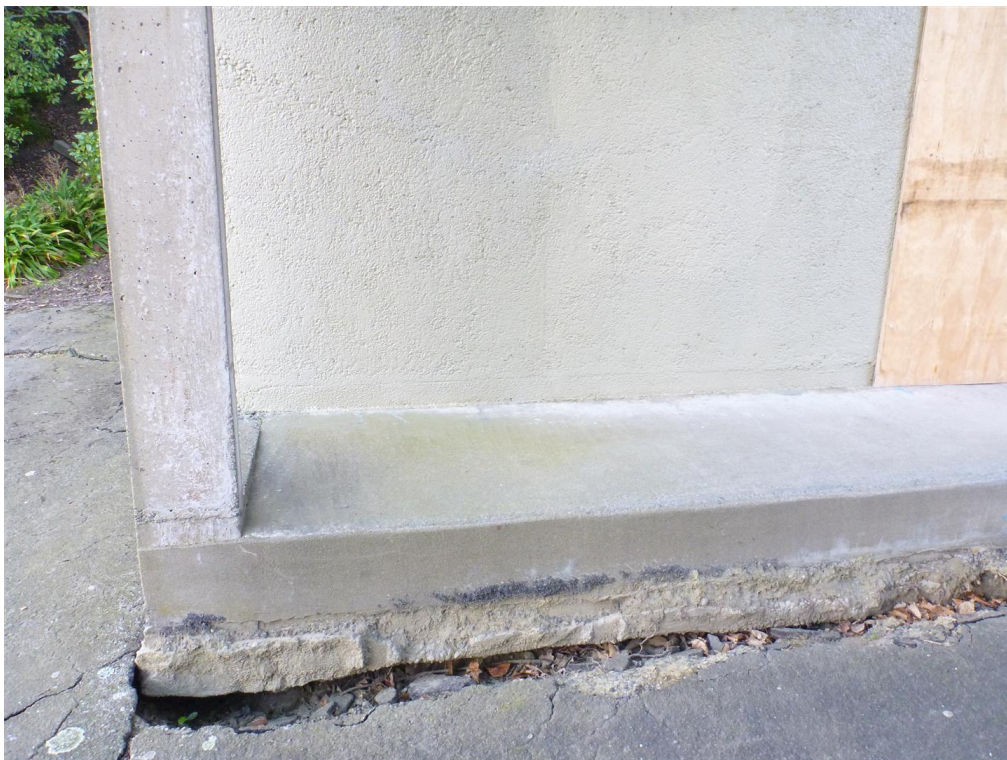
- (c) The signs of settlement of the adjoining pavement, movement of the building and cracking of the surrounding pavement is primarily due to displacement of the structure as it moved horizontally (and vertically) during extreme levels of ground shaking on relatively shallow foundations.

Pavement damage indicating movement of toilet facility

- (a) Remove the bricks located on top of the front concrete wall which are a potential fall hazard.
- (b) We recommend that strengthening work is undertaken to increase the overall building capacity to at least 67%NBS.
- (c) Investigate the services to the toilet to confirm the extent of damage to the water and sewer infrastructure.

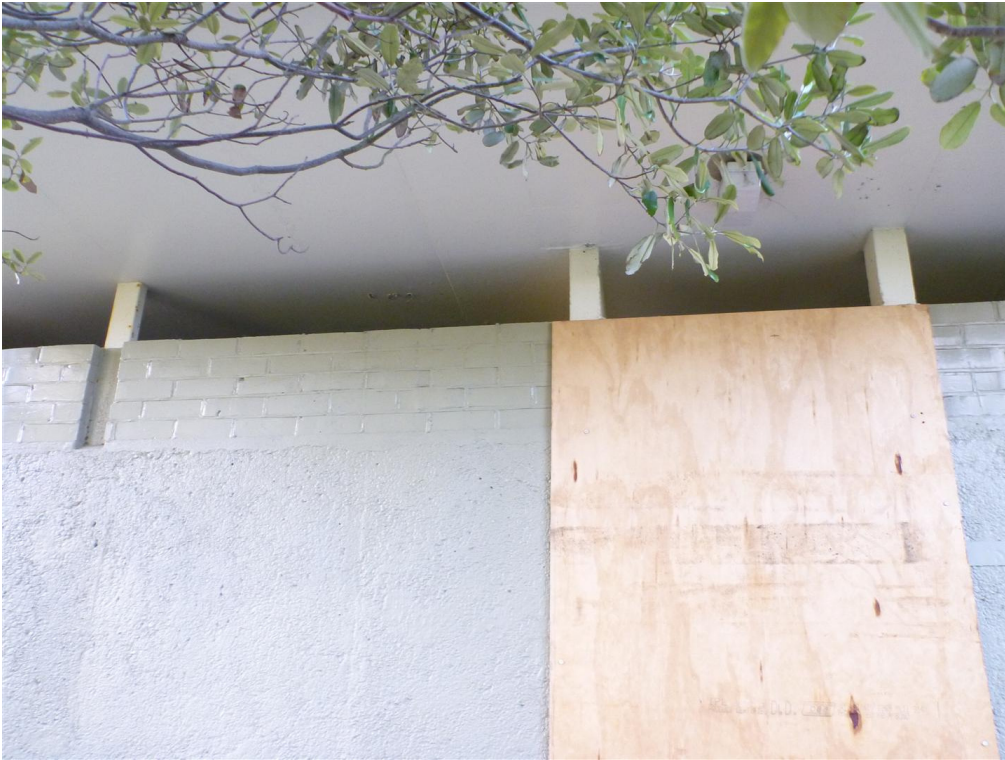
The capacity of the building is limited by the full height wall layout in the north south direction. In this direction only one 915mm long wall extends to the roof and once this wall capacity is reached the end walls will resist the seismic load in out of plane bending. As the concrete walls are assumed to be reinforced with mesh, when the capacity of the building is reached it is likely to be a brittle failure.

West wall. Note: Concrete wall not full height to roof diaphragm

- Strengthening of the concrete walls to provide additional north-south in plane shear capacity of the concrete walls
- Assessment and repair of the plumbing pipes and surrounding pavement
- Replacement of the bricks located on top of the front concrete wall with a suitable alternative to remove the fall hazard

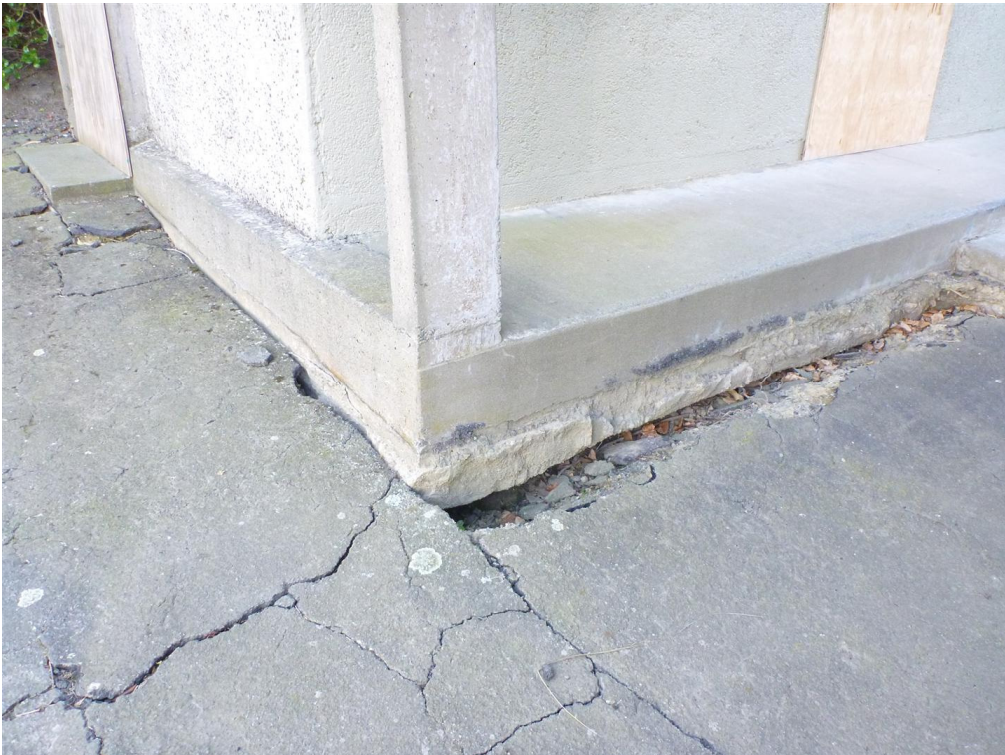
The permanent displacement of the building westward by at least 50mm confirms that there is insufficient friction developed and or insufficient horizontal bearing resistance developed by the site soils. This lack of resistance to horizontal foundation movement occurred because the foundations are too shallow. Underground plumbing pipes may well have been damaged by this displacement.

Rear (east) wall. Note the displacement of the building relative to surrounding slab.

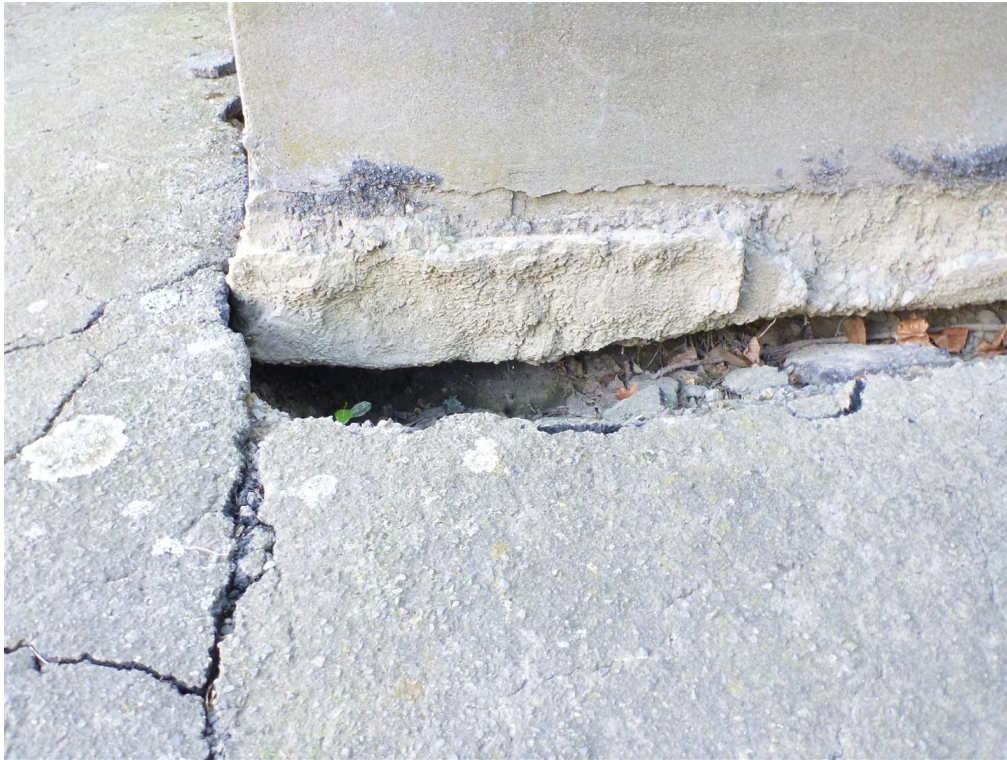
The concrete columns forming part of an ornamental portal frame at the north and south ends suffered minimal damage because the relatively stiff transverse east-west concrete walls protected these columns from experiencing large displacements.

Front side. Note columns on separate foundation than building

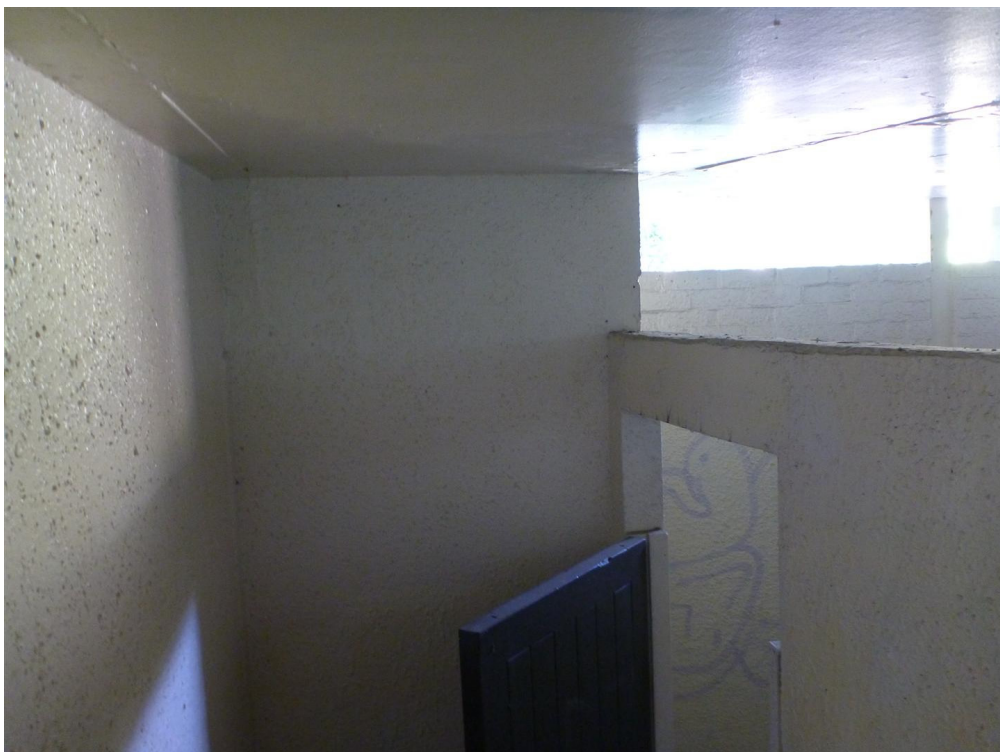
- (b) The capacity of the building is limited by the full height wall layout in the north south direction. In this direction only one 915mm long wall extends to the roof and once this wall capacity is reached the end walls will resist the seismic load in out of plane bending. As the concrete walls are assumed to be reinforced with mesh, when the capacity of the building is reached it is likely to be a brittle failure.

Interior 0.9m full-height north-south wall – the only north-south wall that is full-height

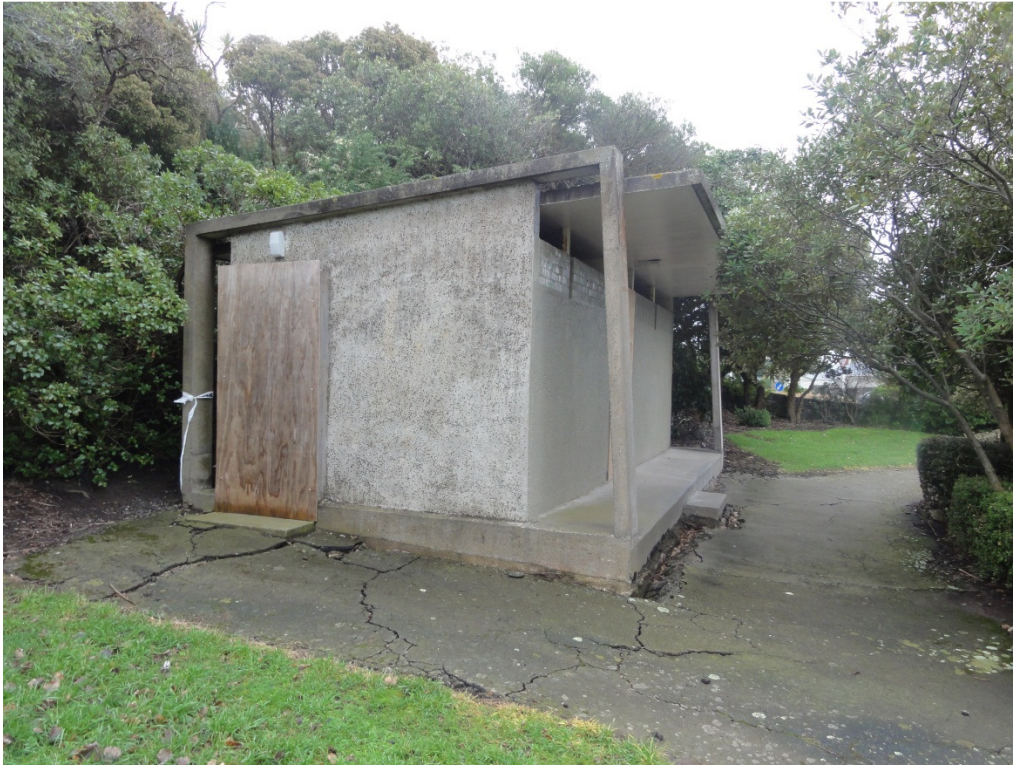
**Figure 1: Southern elevation of the Barnett Park Toilet building.**

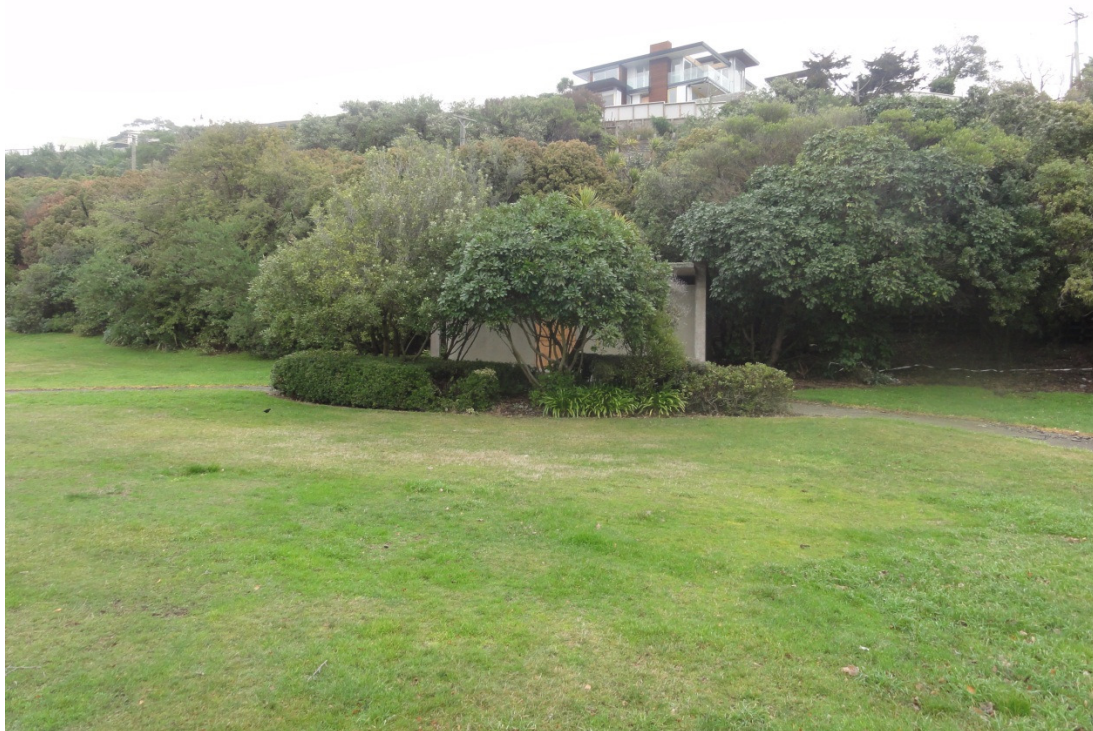
**Figure 2: Eastern elevation of the Barnett Park Toilet Building.**

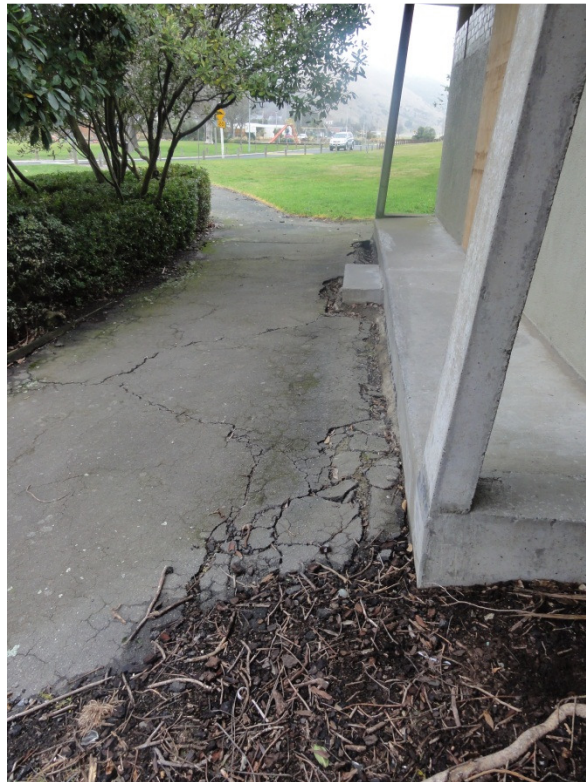
- Main Road, 30m east of the building has undergone significant deformation due to the recent seismic events.
- The surface asphalt of the footpath leading toward the building has been severely cracked (up to 70mm wide) (Figures 1, 3 and 4).
- A lateral offset of up 300mm is evident between the asphalt and the concrete pad on the buildings eastern elevation (Figures 4 and 7).
- The asphalt paving on the eastern elevation appears to have settled up to 150mm relative to the foundations (Figure 4).
- An apparent tension crack (200mm deep and 150mm wide) extends from the south western corner of the building (Figure 6).
- A void underneath the concrete floor slab has been identified on the southern end of the east elevation (approximately 300mm wide, with an unknown length) (Figure 5).

**Figure 3: Asphalt damage along the eastern side of the building.**

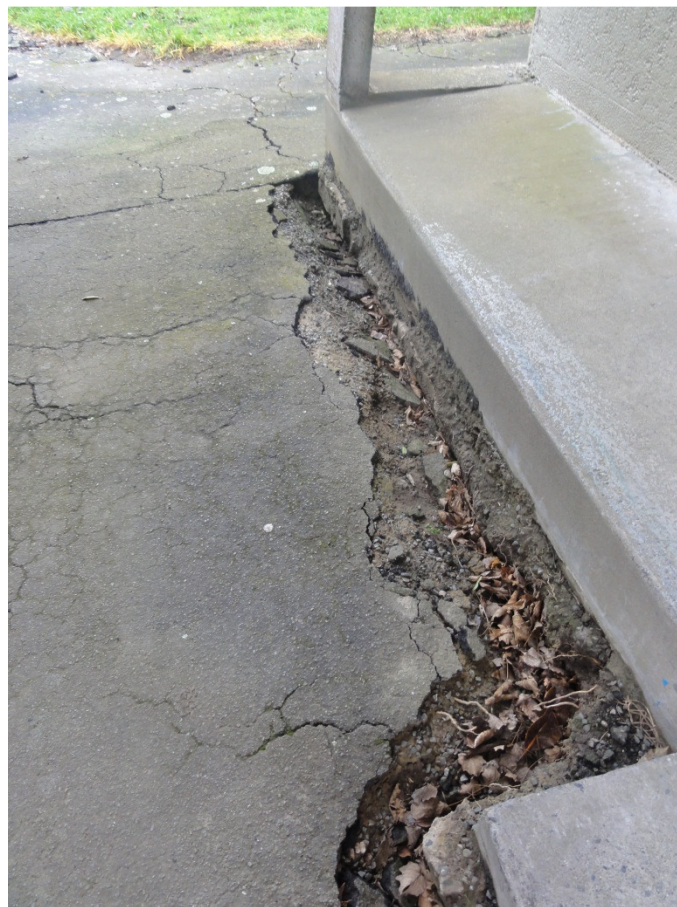
**Figure 4: Ground deformation on the south eastern corner of the building.**

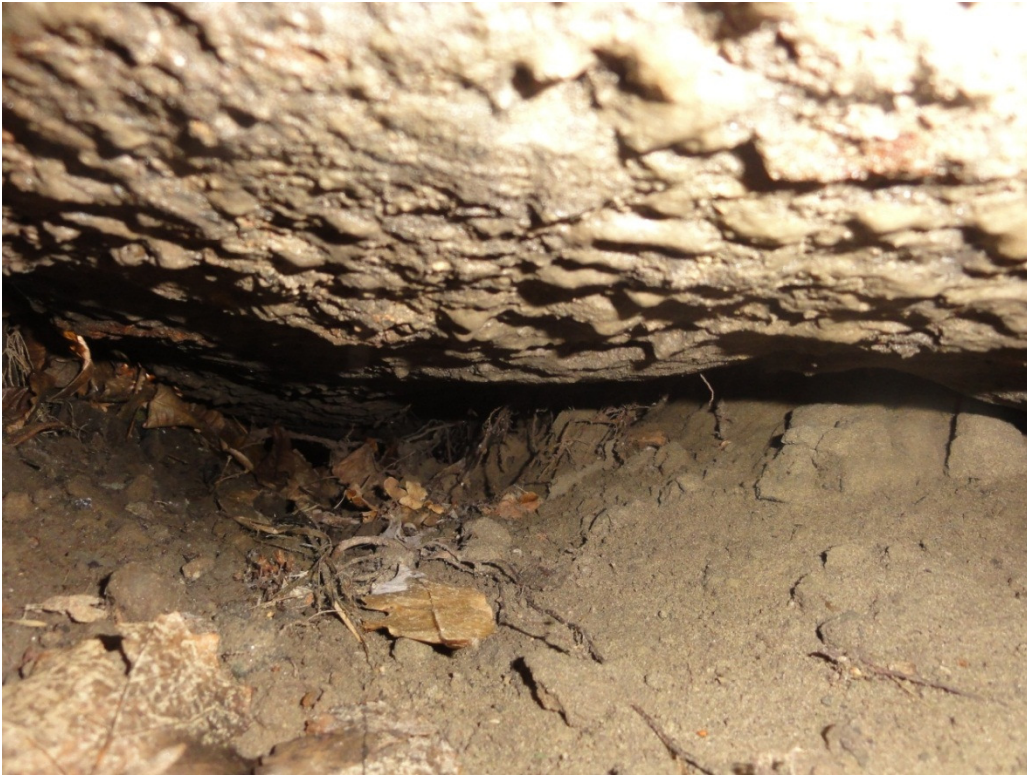
The cause of the void located beneath the concrete floor slab on the south eastern corner may be attributed to a localised area of sand which has settled due to the recent seismic events, which is consistent with the settlement of the surrounding footpath.

**Figure 5: Void underneath the south eastern corner of the concrete floor slab.**

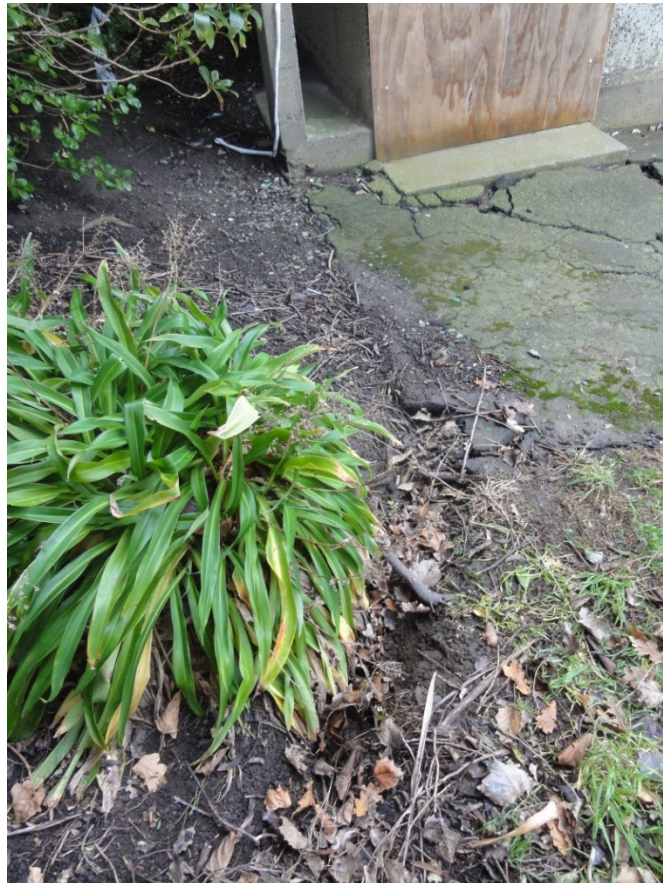
**Figure 6: Tension crack extending from the south western corner of the building.**

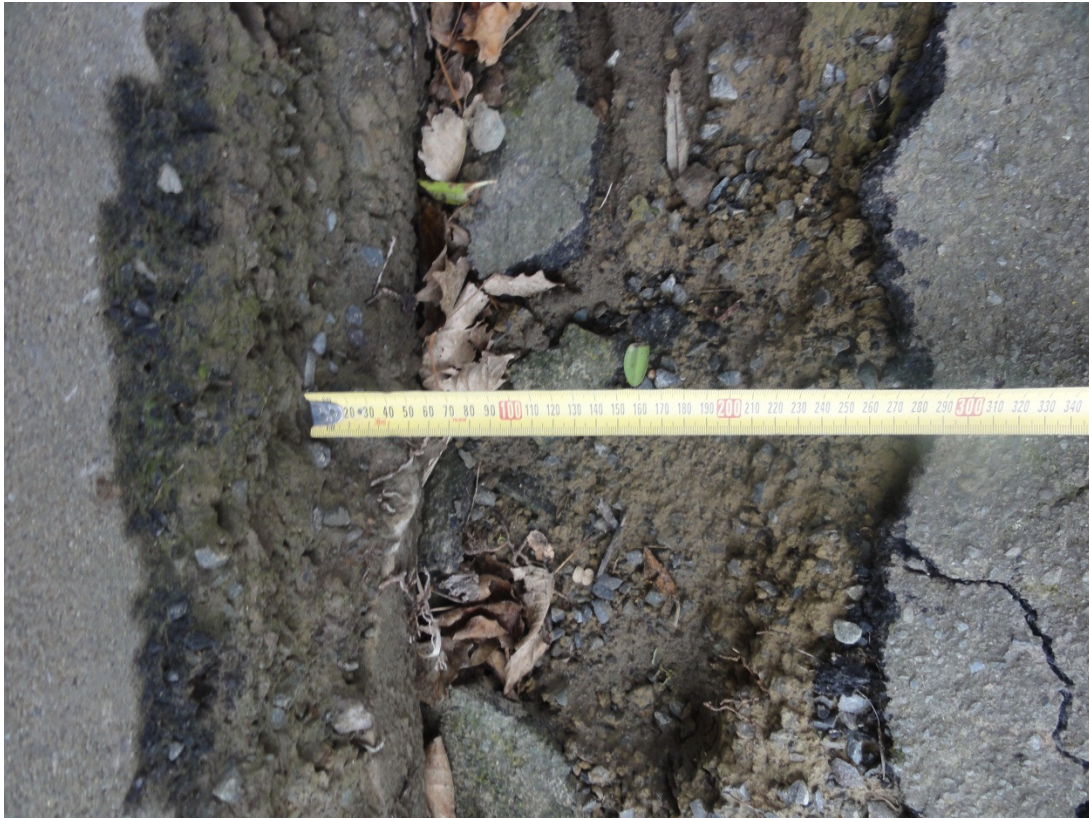
Severe ground shaking at this site has caused extensive cracking on the asphaltic footpaths. The asphalt footpaths leading to the toilet block are severely cracked, due to the induced movement, and have settled vertically by 150mm and displaced horizontally by up to 300mm.

**Figure 7: the asphalt along the eastern side has been offset by approximately 300mm.**

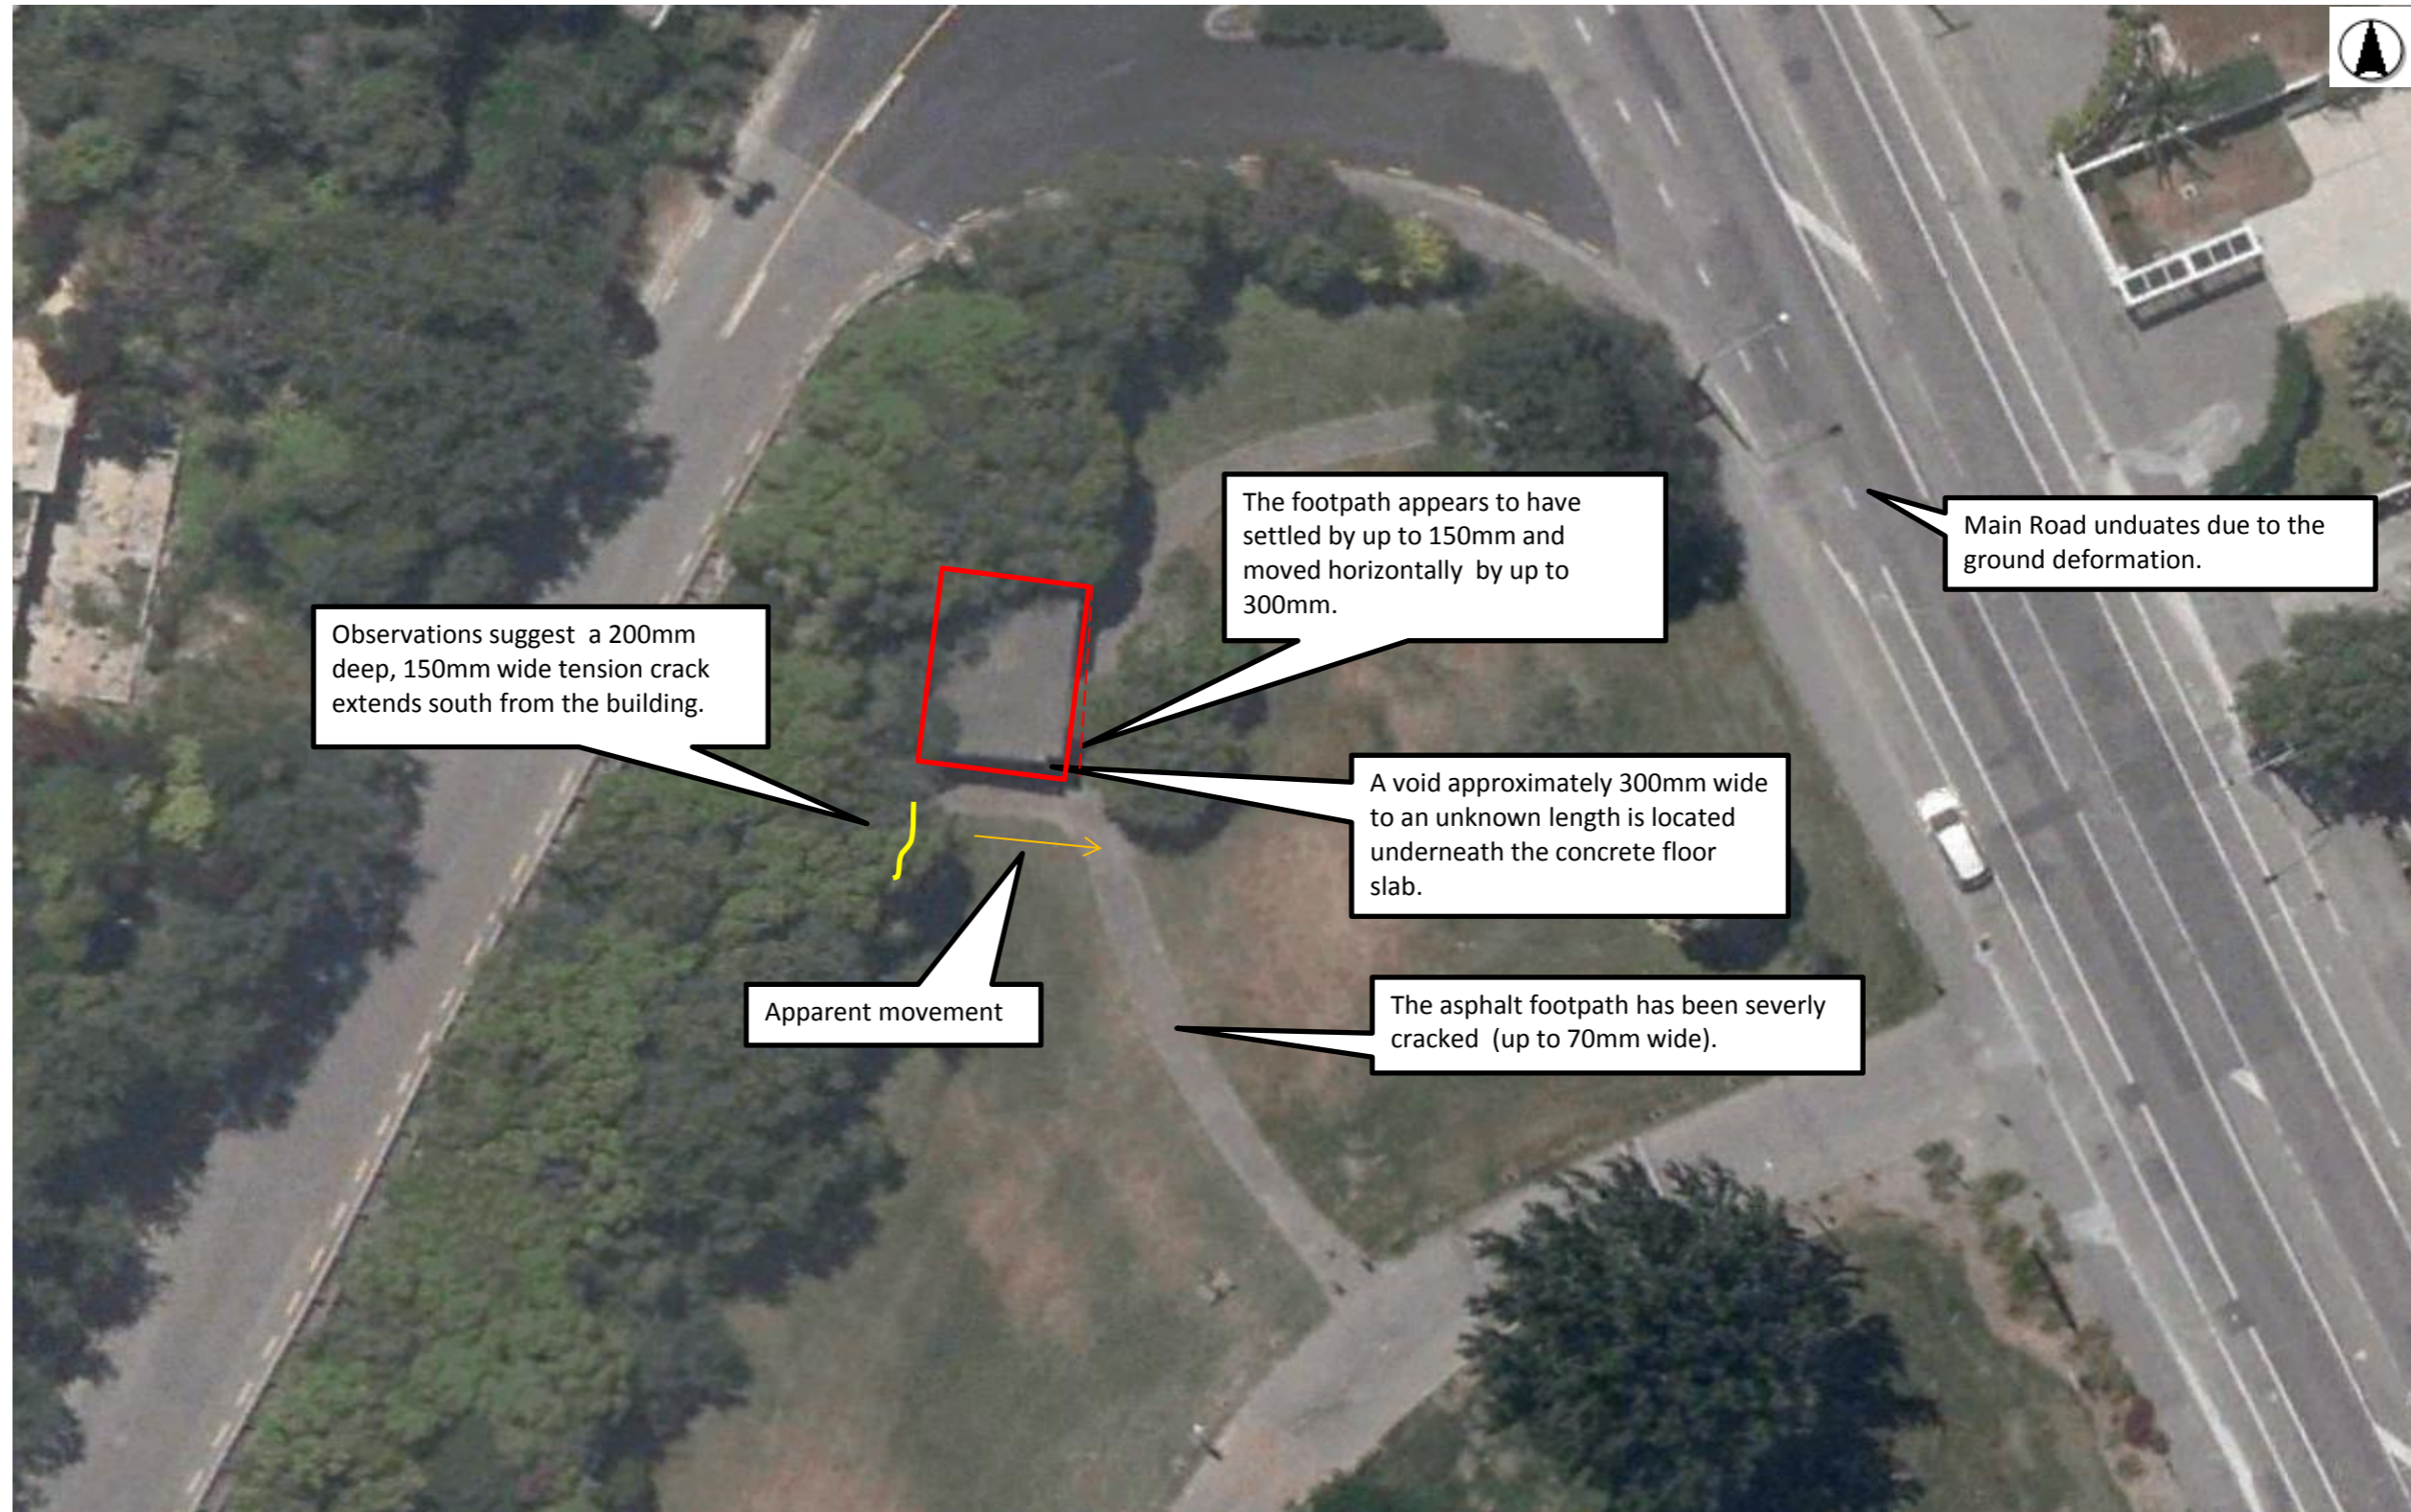
Site Walkover Plan

Observations suggest a 200mm deep, 150mm wide tension crack extends south from the building.

The footpath appears to have settled by up to 150mm and moved horizontally by up to 300mm.

The asphalt footpath has been severely cracked (up to 70mm wide).
