**Belfast Cemetery
Garage
PRK 0384 BLDG 001 EQ2
Detailed Engineering Evaluation
Quantitative Assessment Report**

Belfast Cemetery Garage

Quantitative Assessment

Date: February 2013
Reference: 6-QUCCC.68
Status: Final

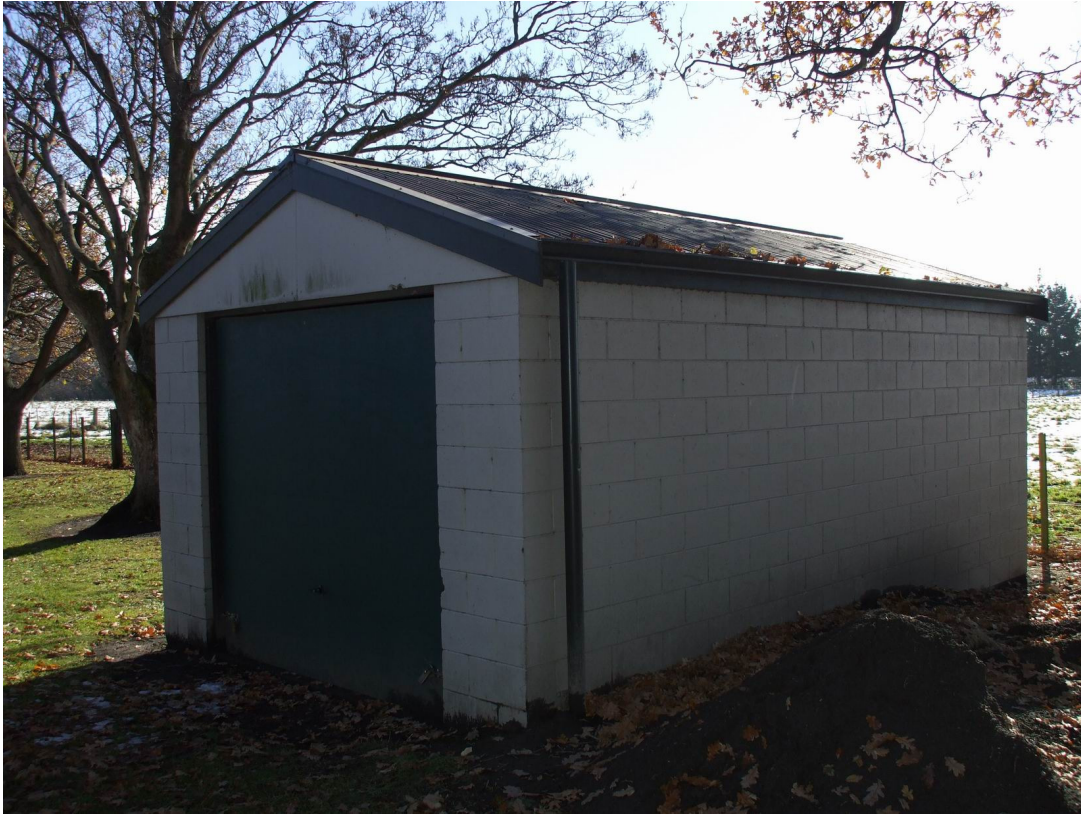
Photo 1: General

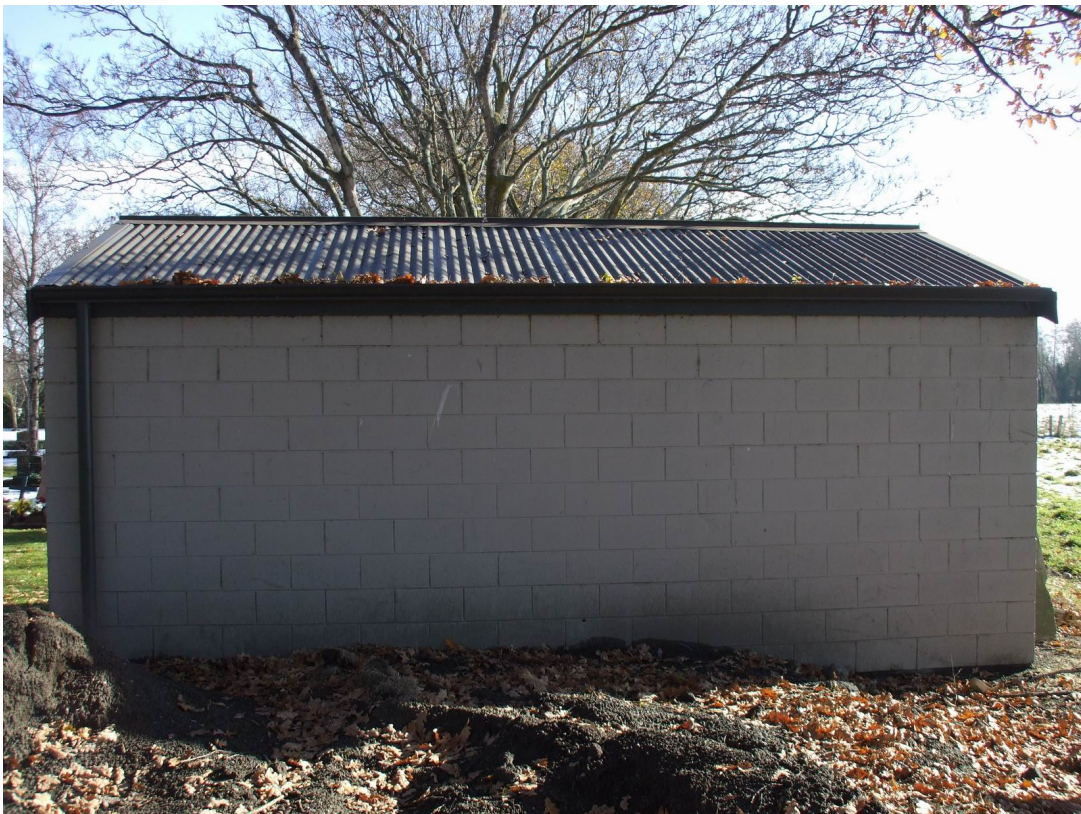
Photo 2: General side

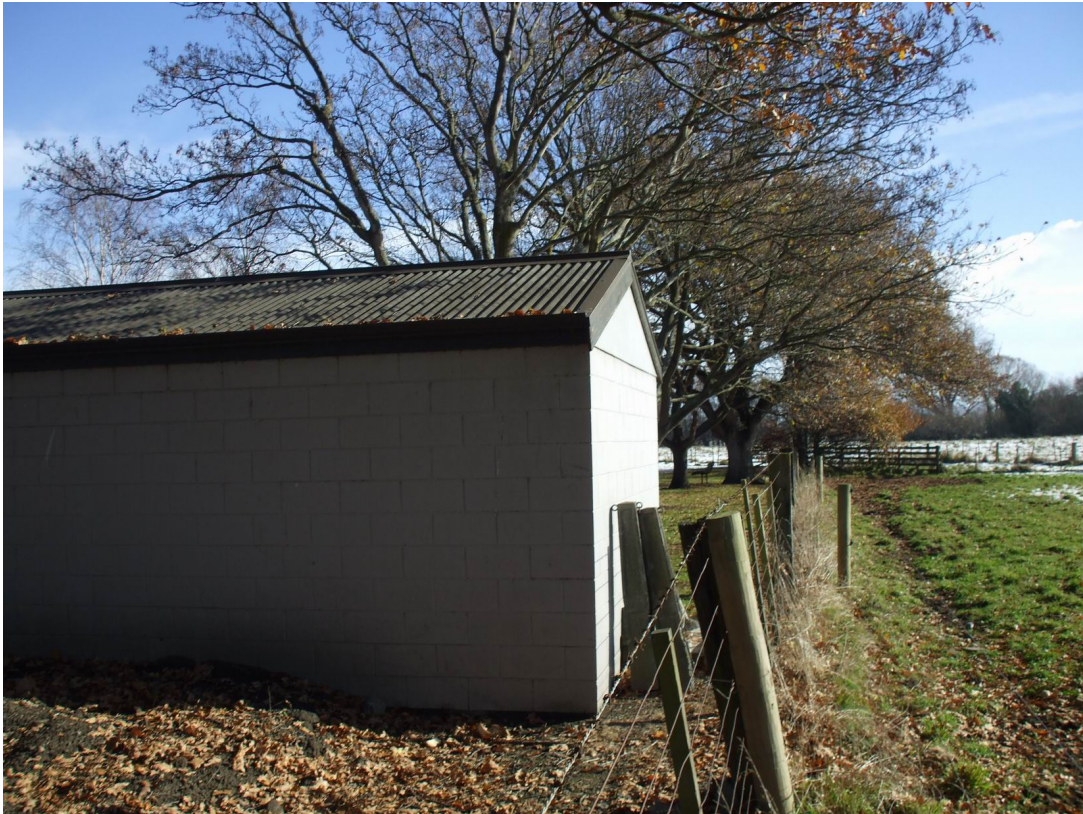
Photo 3: General side

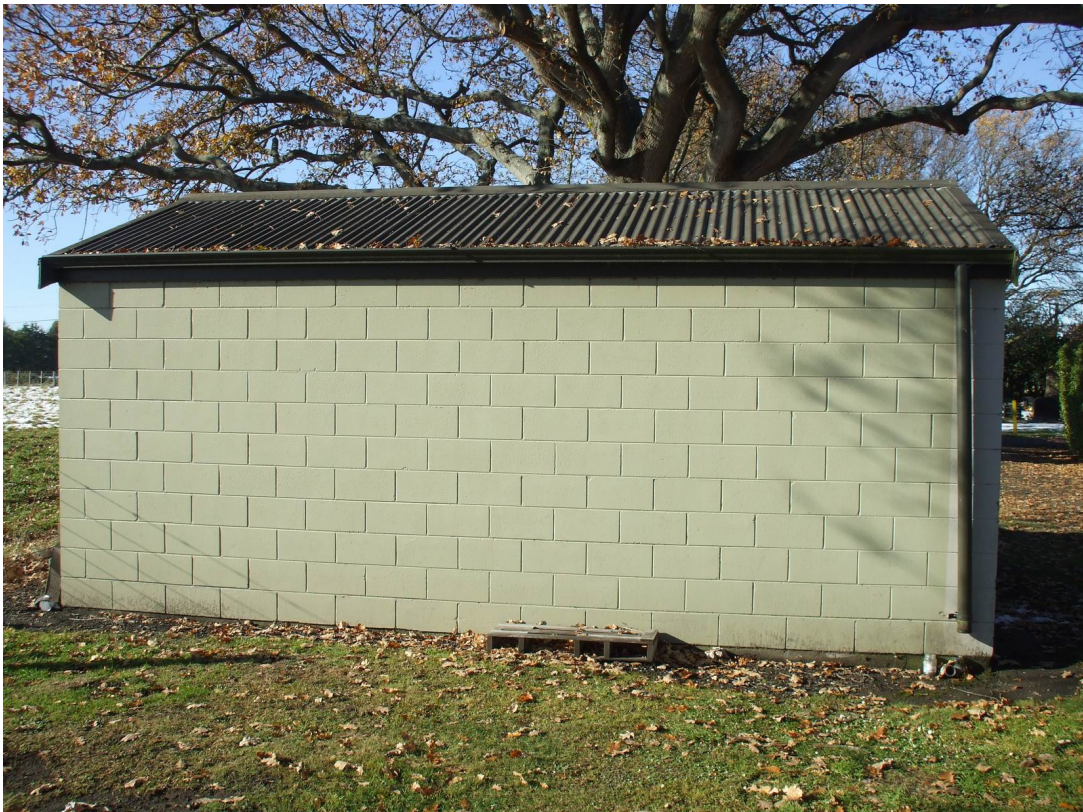
Photo 4: General side

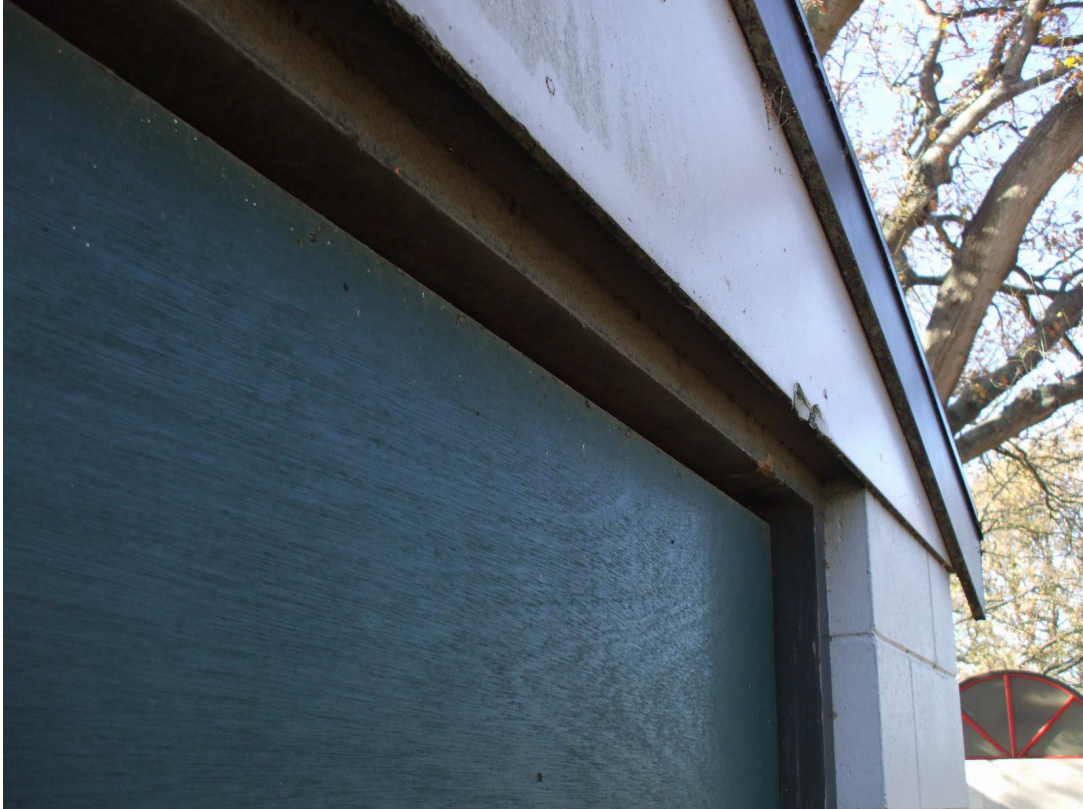
Photo 5: Top of garage door

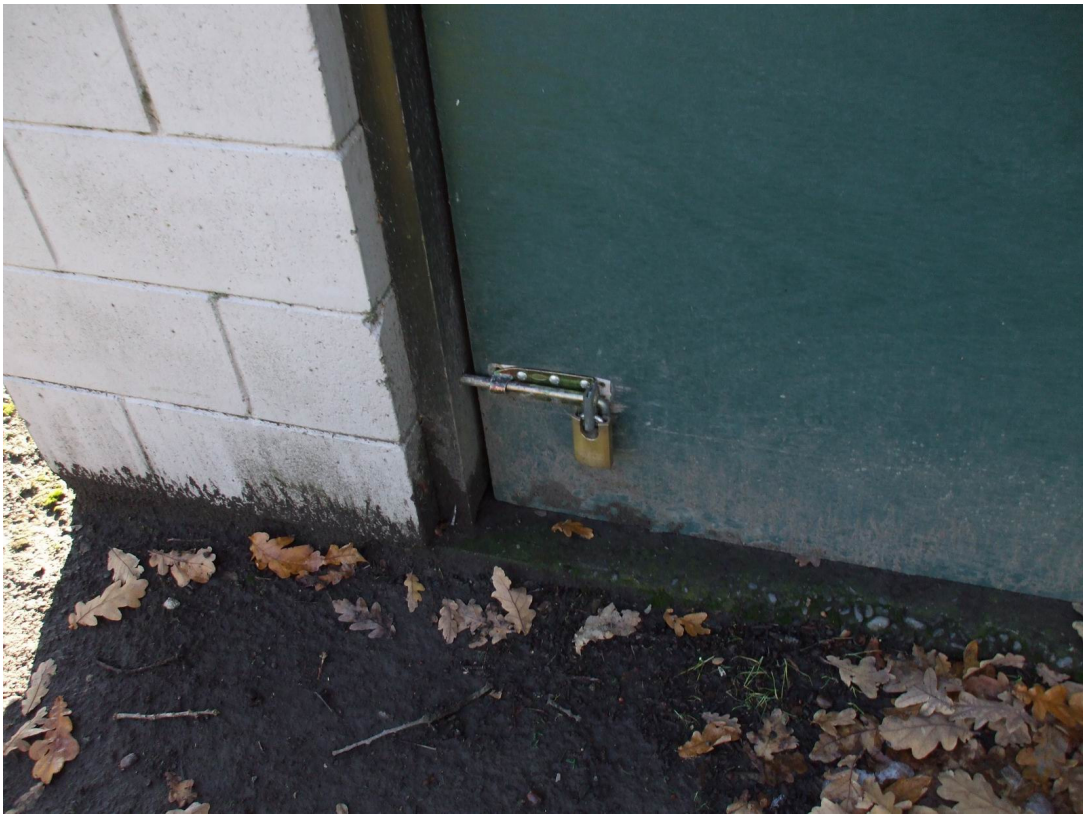
Photo 6: Bottom at garage door
