Belfast Cemetery Toilets  
Qualitative Engineering Evaluation

**Reference:** 229176

**Prepared for:**  
Christchurch City Council

Address: Cnr Belfast & Guthries Road

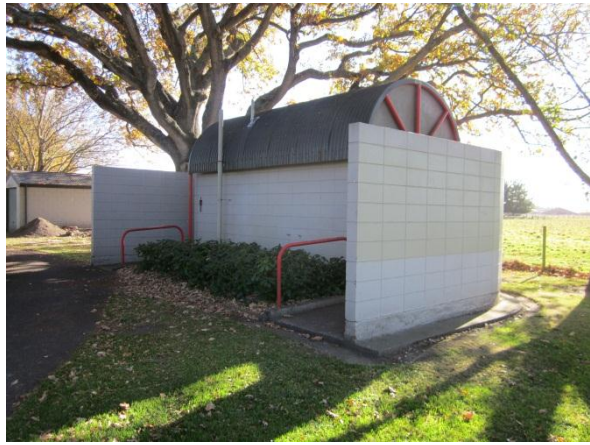
Building south-east elevation.

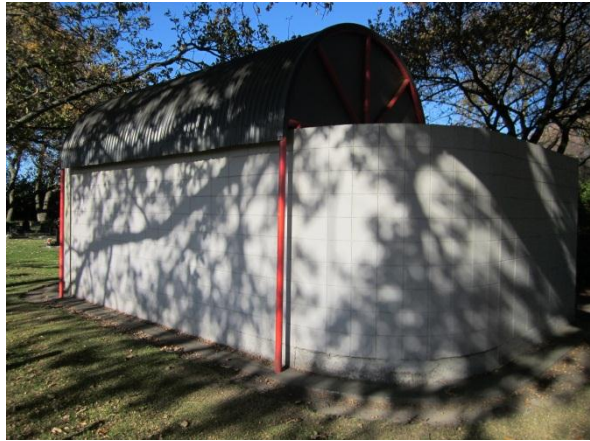
Building north-west elevation.

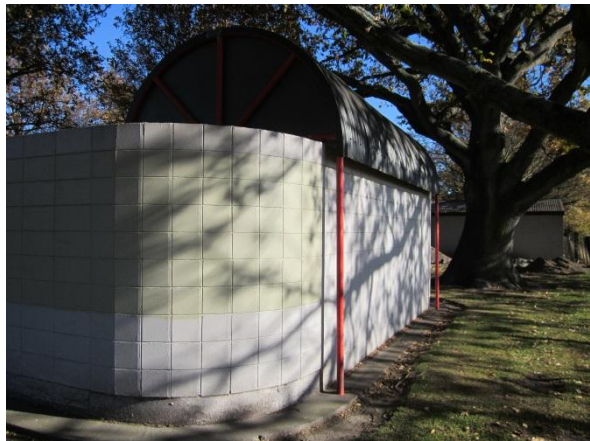
Building north-east elevation.

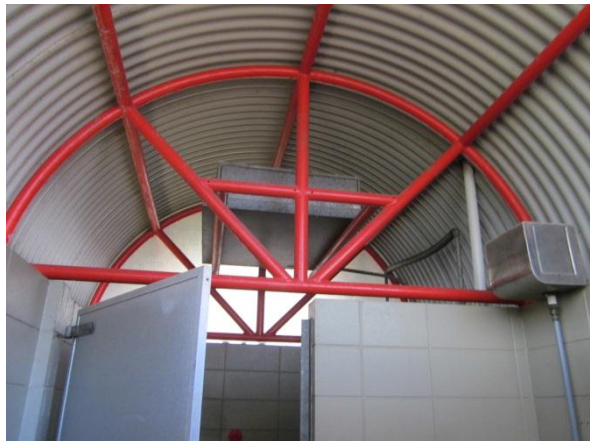
Interior view of steel trusses.

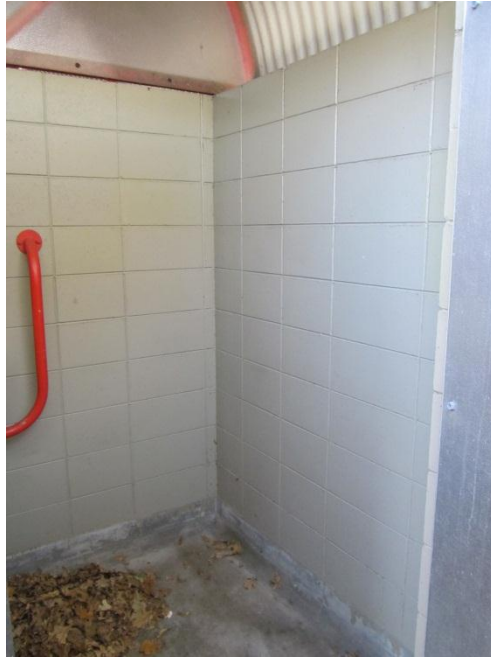
Interior view of reinforced concrete block-walls.

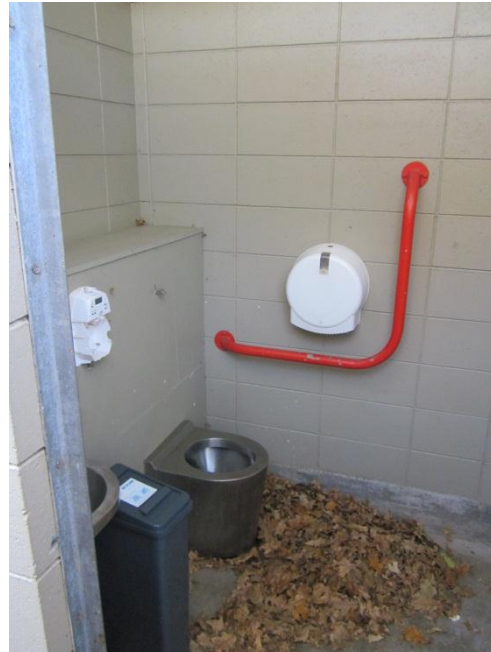
Interior view of reinforced concrete block-walls.

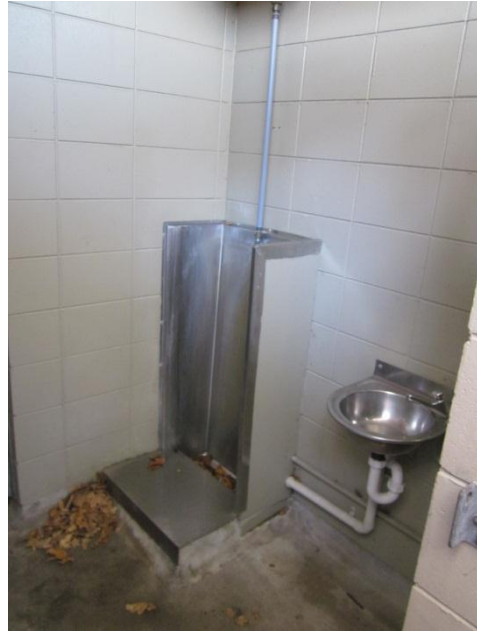
Interior view of reinforced concrete block-walls.

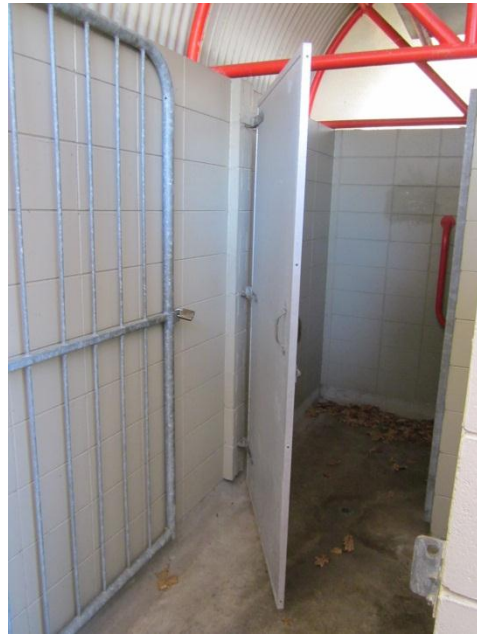
Interior view of reinforced concrete block-walls.
