Project: Belfast Pool – Main Building Complex

Qualitative Engineering Evaluation

Prepared for: Christchurch City Council

Date: 9 October 2013

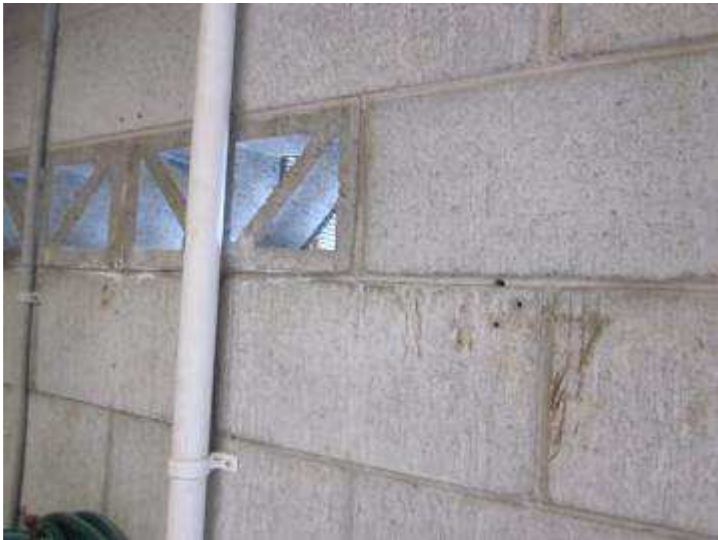
Minor damage to the concrete masonry changing rooms in the form of diagonal cracks across the walls was noted. The walls were investigated by means of acoustic assessment and it was concluded that they were partially filled.

Damage to the walls could be partly due to lack of shrinkage control joints on the long walls. Generally cracks were hairline and not significant in terms of structural damage. Any damage should have minimal effect on the capacity of the building to continue to carry gravity and lateral loads.

Diagonal cracking on internal wall in women's changing room (West End)

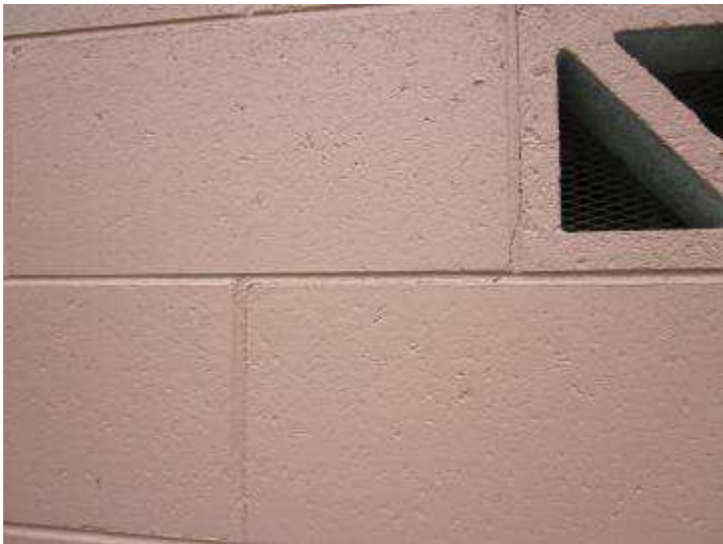
Cracking on external southern wall.

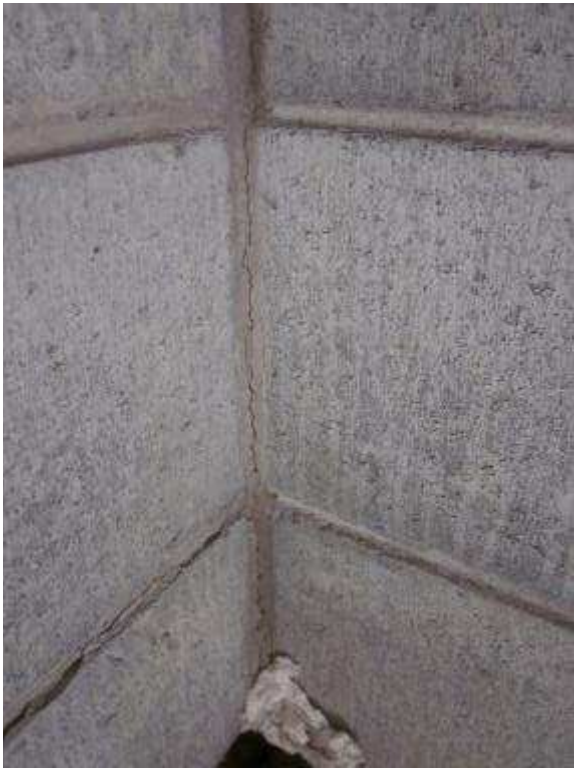
Cracking on interior corners of building in men's changing room (East end)

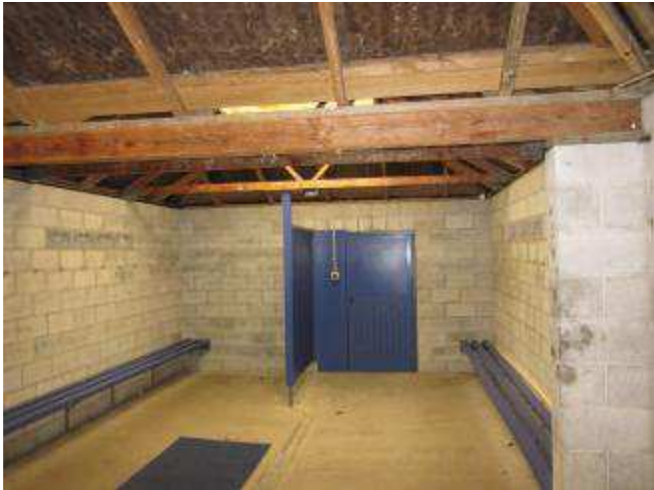
No noticeable damage to light timber roof frames

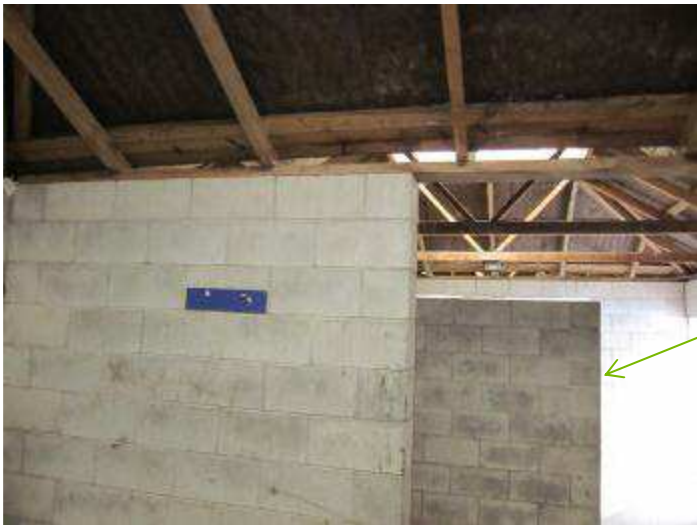
Apart from lack of lateral support to some walls no specific critical structural weaknesses affecting global structural stability were identified as part of the building qualitative assessment.

Low partition wall unsupported laterally

Potential fall hazard of hollow internal walls.

It is recommended that the internal non-structural partition walls in the men's and women's changing rooms, as shown on the plan, are braced by means of a steel channel installed to distribute out of plane loads into adjacent return walls.

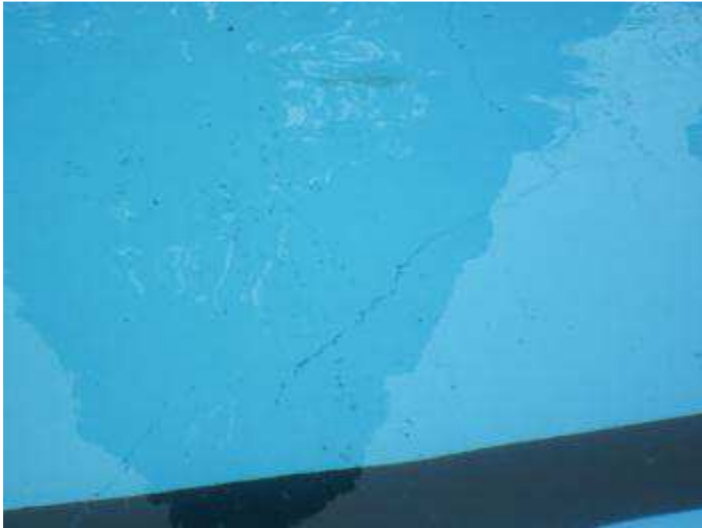
Some displacement damage around the edge of the pool between the side and the surrounding slab was also identified.

Cracking on base of pool

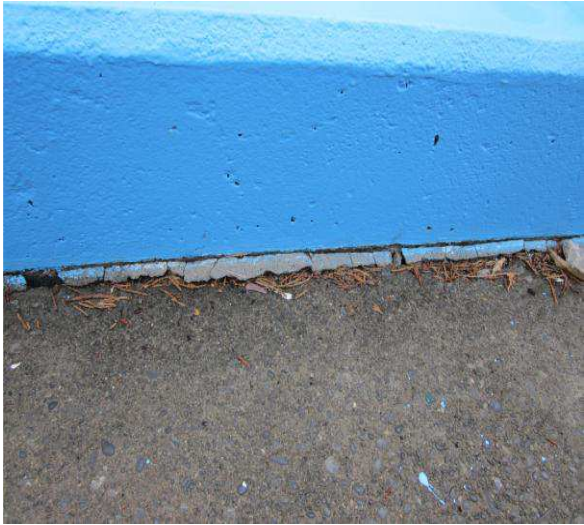
Concrete slab pulling away from edge of pool
