Berwick Courts
BE 0630 EQ2
Detailed Engineering Evaluation
Quantitative Report
Version FINAL

31 Berwick Street, St Albans

Christchurch City Council

Date
25 January 2013

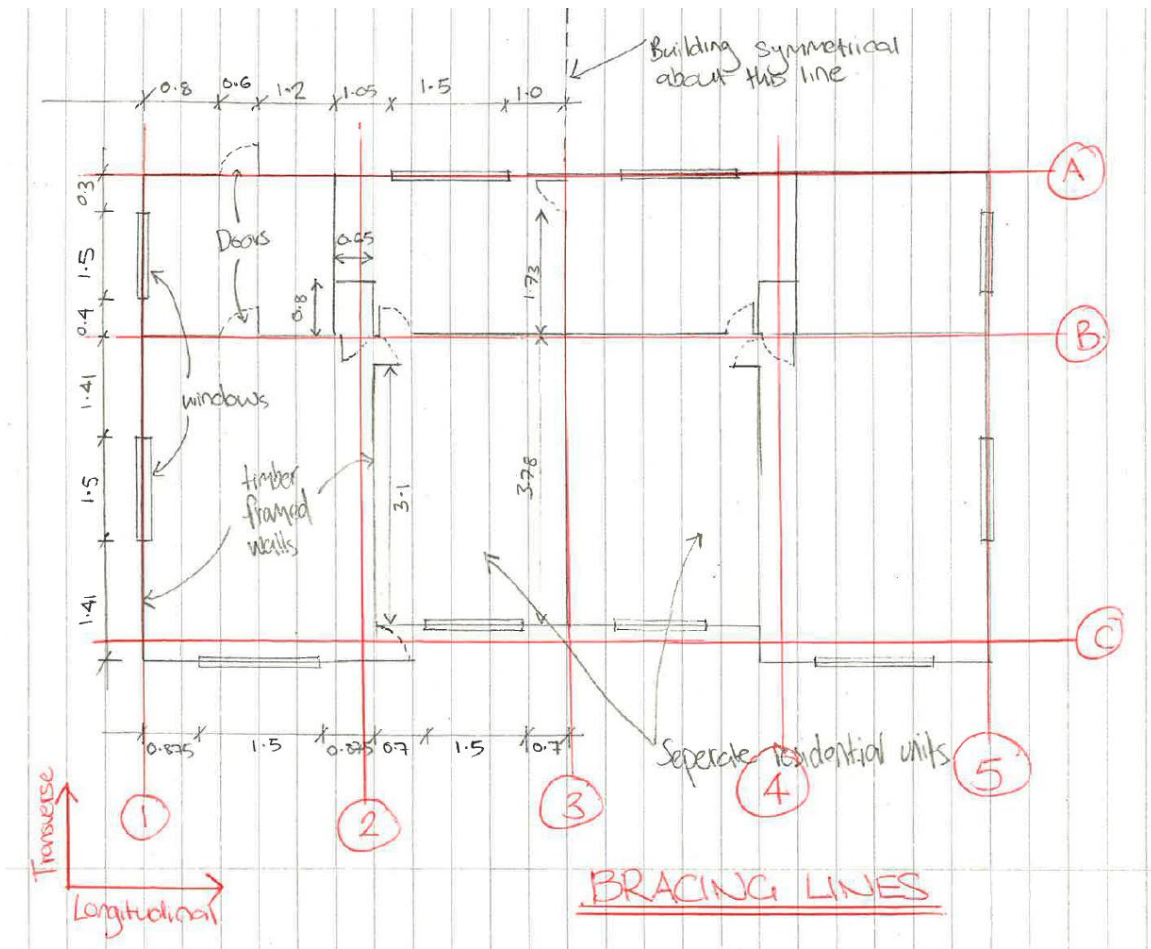
Figure 8.1 Longitudinal and transverse wall bracing lines for Blocks A to F

The bracing capacity for the lined timber framed walls in both the longitudinal and transverse directions has been reduced by 10% to account for the damage to the plasterboard linings. The fractures observed in the plasterboard panels are likely to reduce the bracing capacity of the individual panels and therefore the overall structure.

Bracing Line	Bracing Capacity (BUs)	10% Damage Reduction
Longitudinal Direction		
A	292	263
B	270	243
C	176	158
Total Bracing Capacity	738	664
Transverse Direction		
1	118	106
2	222	200
3	232	209
4	222	200
5	118	106
Total Bracing Capacity	912	821

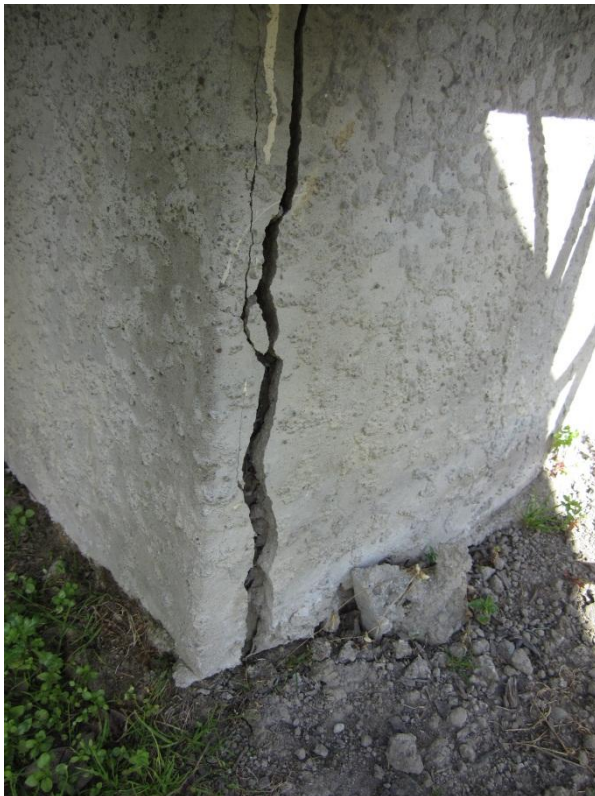
Cracking was observed in the reinforced concrete perimeter footing in Blocks A, D, E and F.

Cracking was observed in the reinforced concrete perimeter footing in Blocks A, D, E and F (see Photograph 2).

Photograph 2 Cracking to corner of concrete foundation wall in Block A

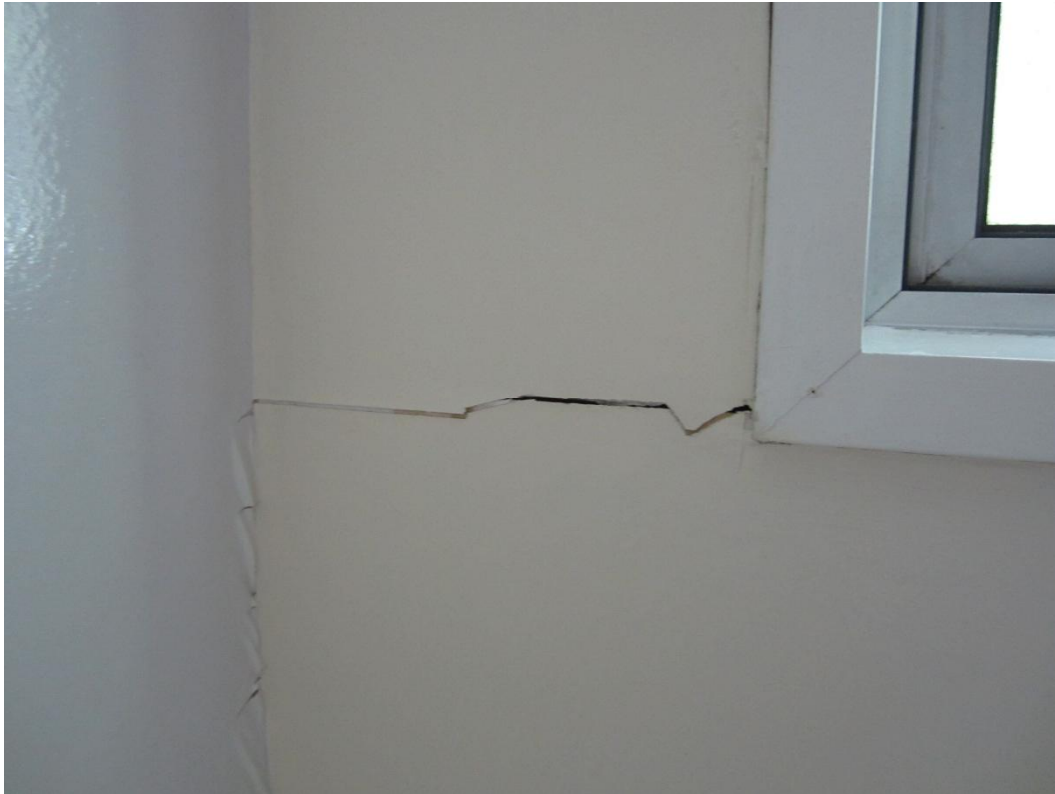
Cracking in the plaster lining of the timber framed walls (see Photograph 3) was observed in all units in Blocks A to F. Cracking was also observed in all of the units in the plasterboard linings at the corners of windows and door frames where stresses are likely to have been concentrated during an earthquake. The most significant cracking to the plasterboard linings has occurred where a timber lintel beam perpendicular to the wall is supported above a door or window opening (see Photographs 5 and 7).

Photograph 3 Cracking at corner of window in Block A

The plasterboard linings on the interior faces of the timber framed walls in each block have suffered damage during the recent seismic activity. In several locations, the plasterboard lining has fractured. It is recommended that where a plasterboard panel has fractured, it is replaced to ensure the full bracing capacity of the structure is achieved.

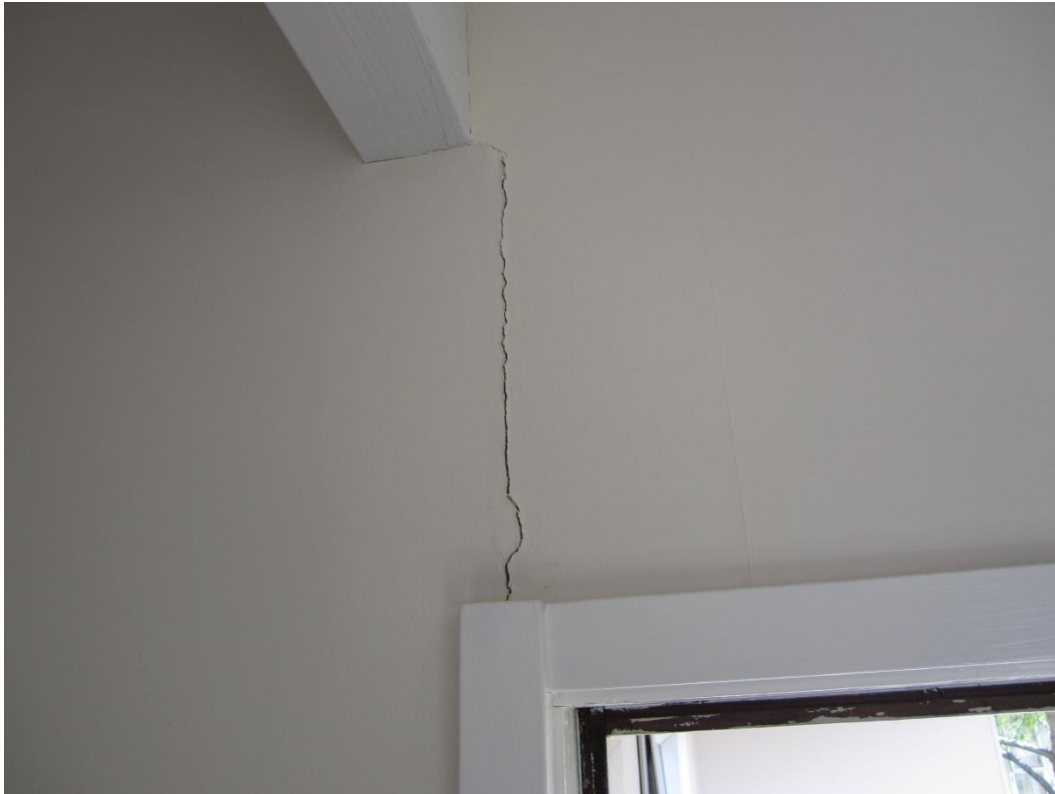
Photograph 5 Cracking between timber lintel and corner of window in Block B

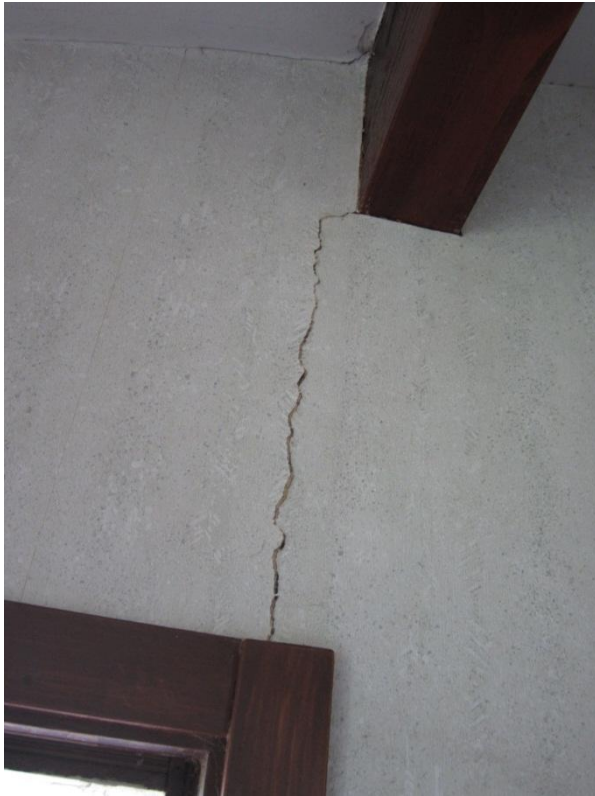
Photograph 7 Cracking between timber lintel and corner of window in Block C

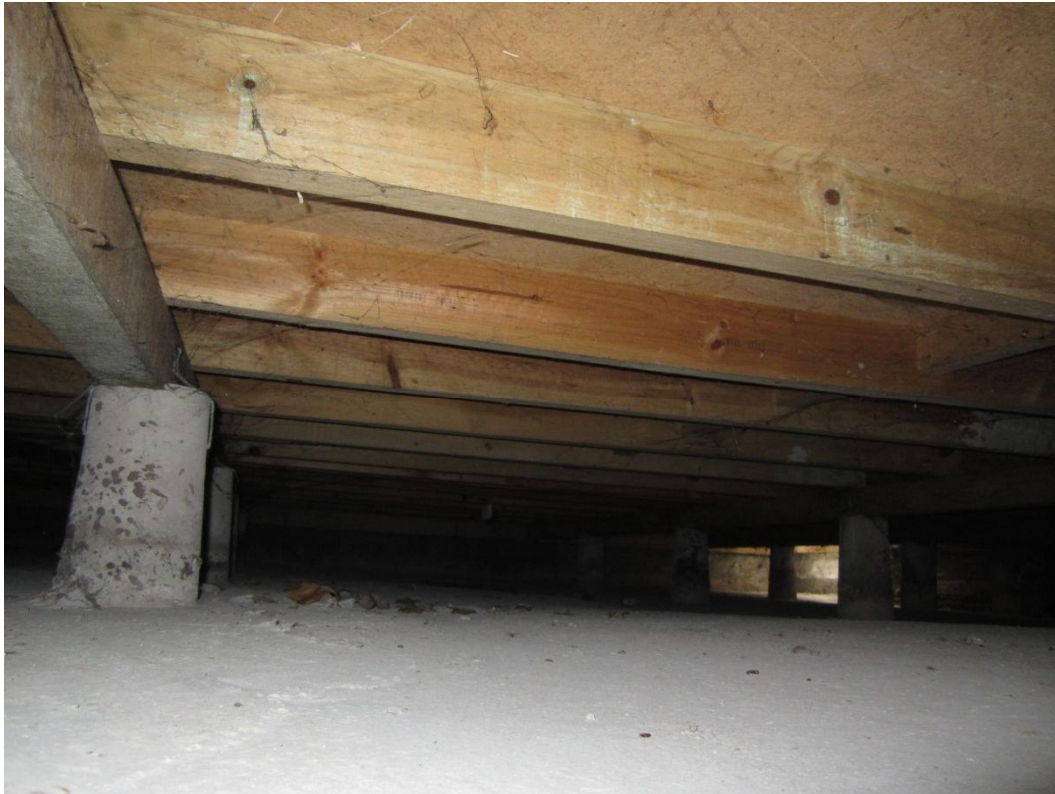
supported by reinforced concrete piles (see Photograph 11). There is a reinforced concrete foundation wall around the perimeter of each building.

Photograph 11 View of foundations of Block F
