**Bexley Park BMX Track Toilets**  
**PRK 1385 BLDG 002 EQ2**  
**Detailed Engineering Evaluation**  
**Quantitative Report**

Christchurch City Council

Date: February 2013  
Reference: 6-QUCC1.37  
Status: Final

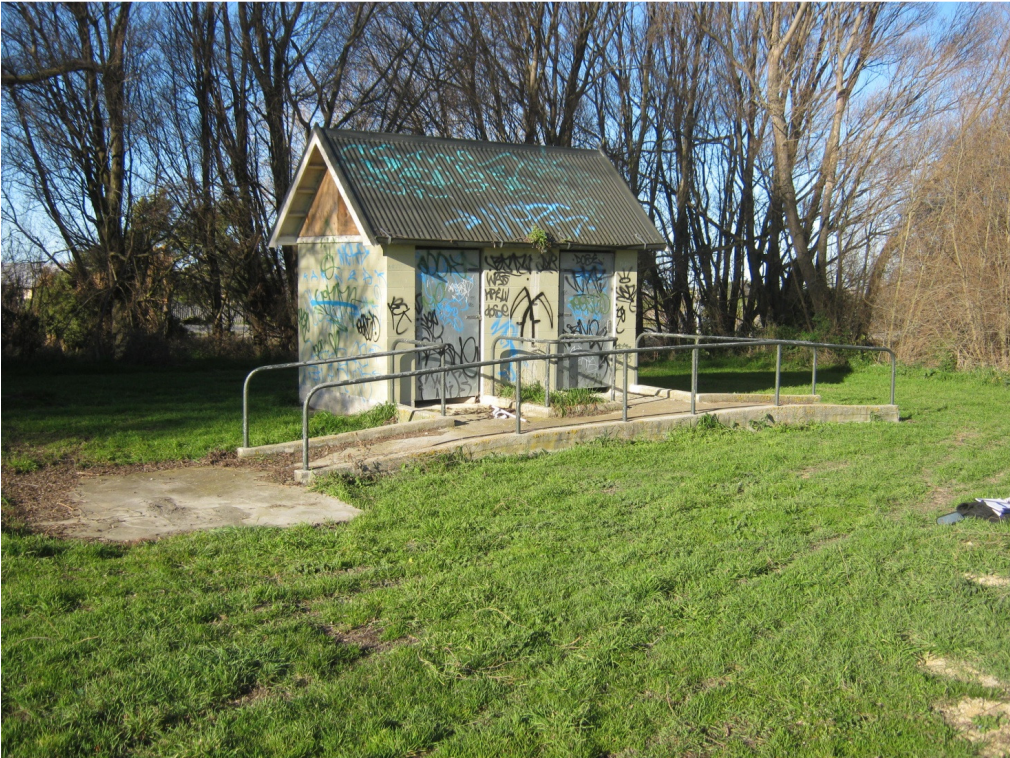
**Photo 1: The north and west wall of the building.**

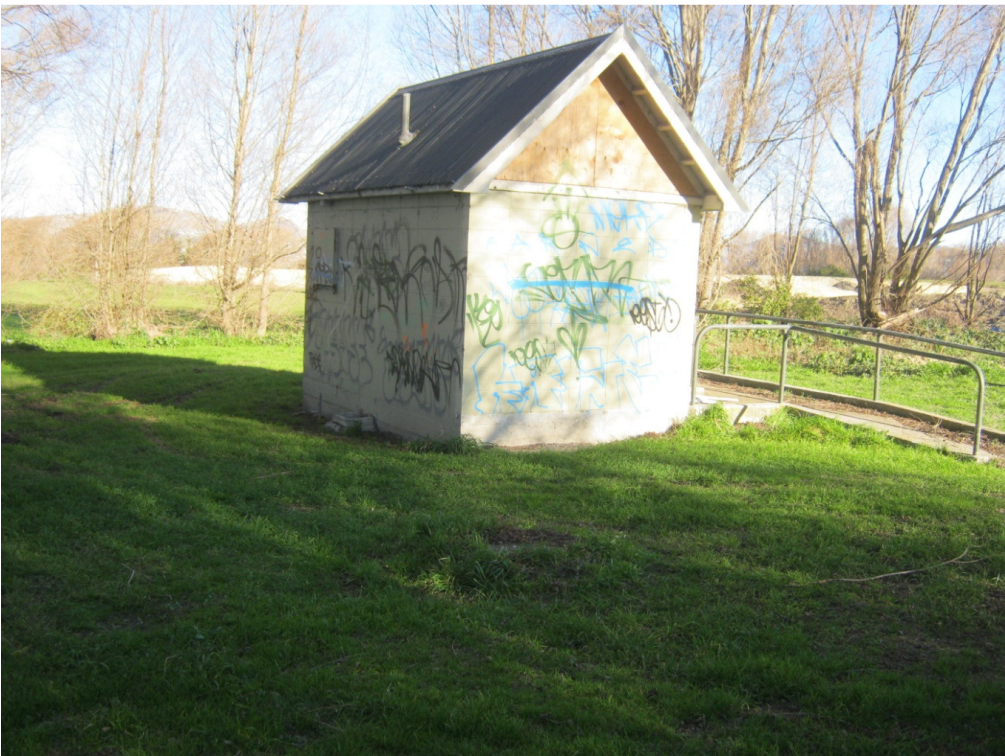
**Photo 2: The north and east wall of the building.**

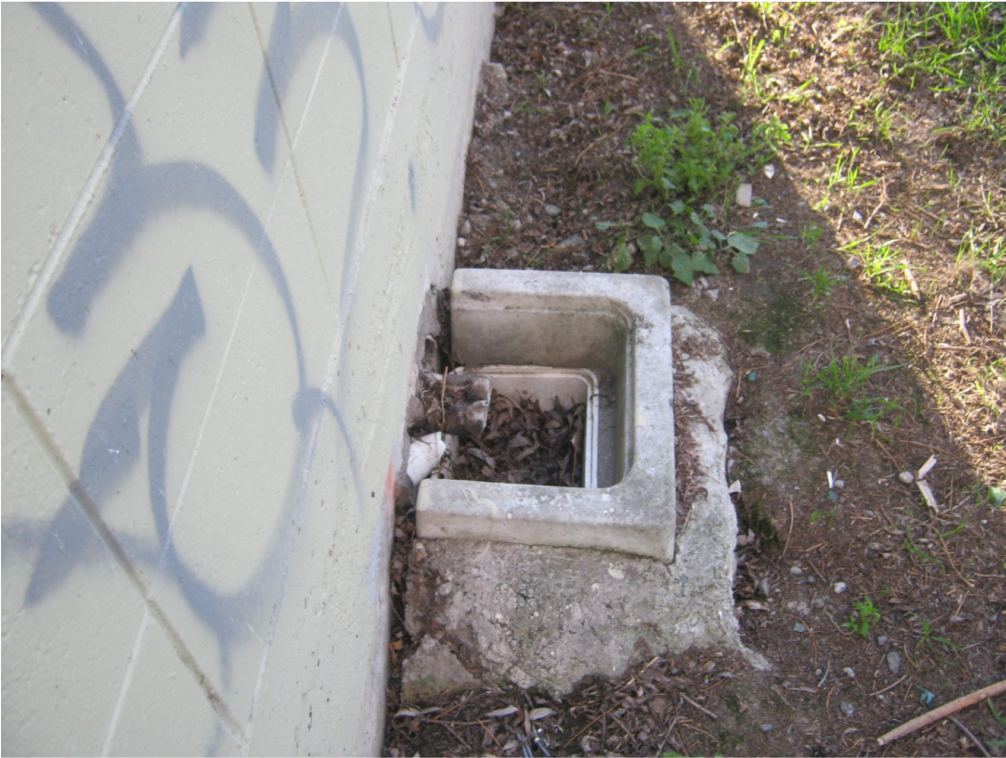
**Photo 3: Separation of 30mm between the toilets and the concrete grey water collection box.**

Cracking, possibly due to lateral spread, was observed running parallel to the creek along the edge of the grass area to the north of the toilets. The 30mm separation between the toilets structure and the concrete grey water collection box also shows that the toilets have moved. A series of minor lateral cracks were identified along the tree line, to the north west of the toilets. The cracks appear to be due to lateral spread towards the small creek.

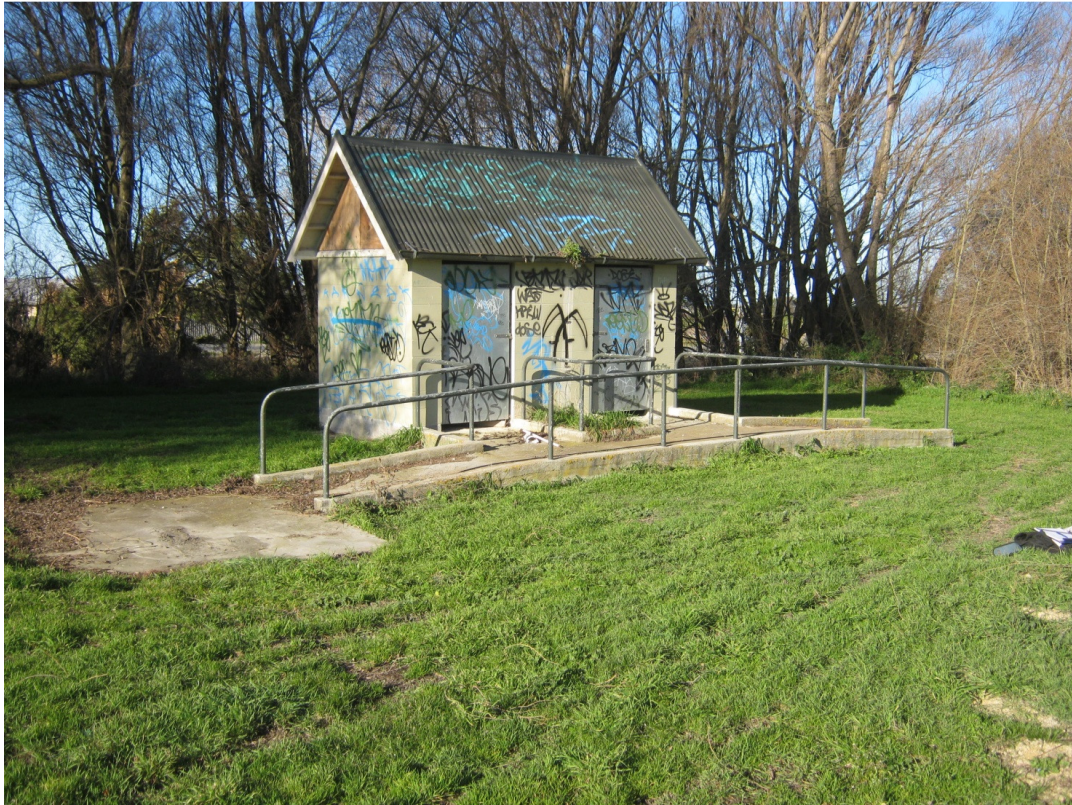
**Photograph 1. Western Elevation (Entrance to toilet from BMX track).**

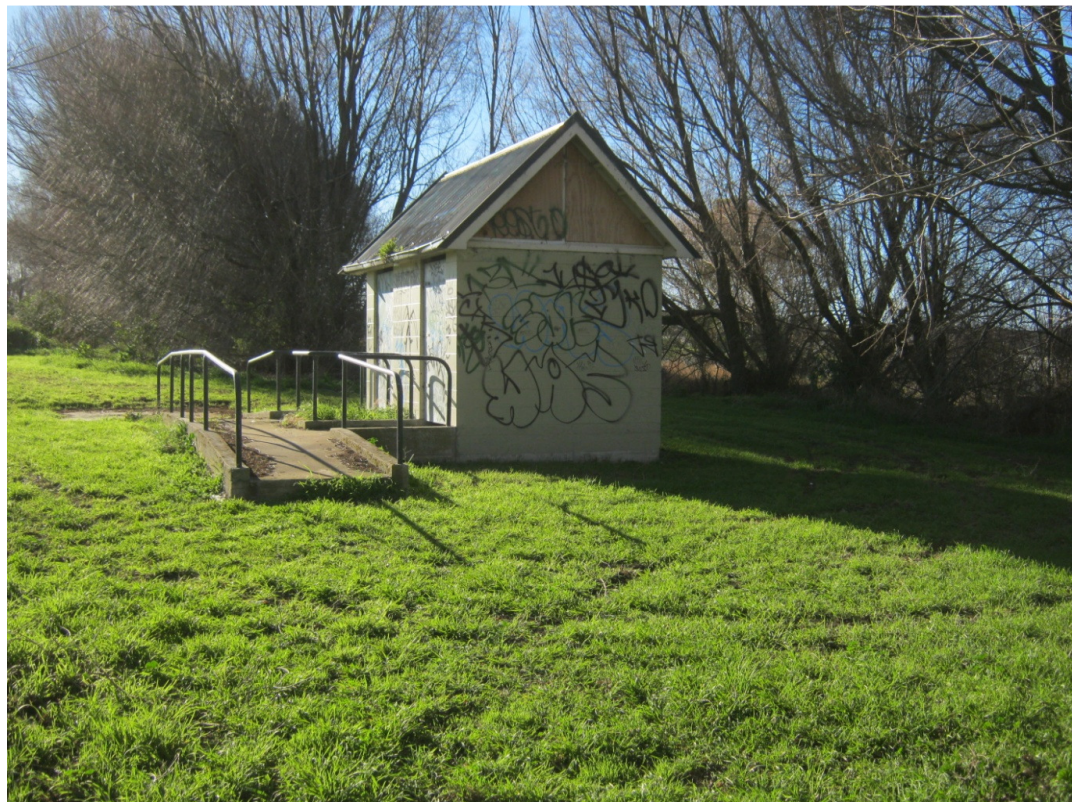
**Photograph 2. Southern Elevation.**

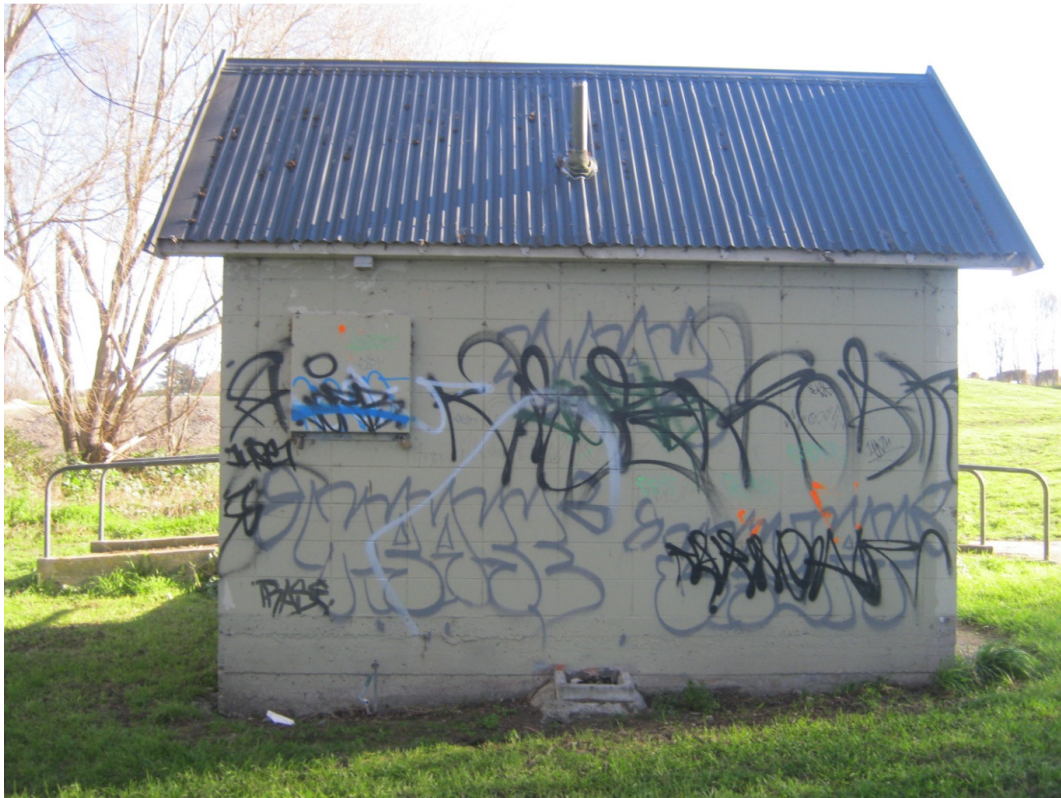
The existing toilet block appears to be founded on square concrete piles to an unknown depth. No cracks were observed along the concrete capping beam. Visual observations suggest that the toilet block has experienced approximately 150mm of differential settlement towards the north.

**Photograph 3. Eastern Elevation, showing differential settlement from south to north.**

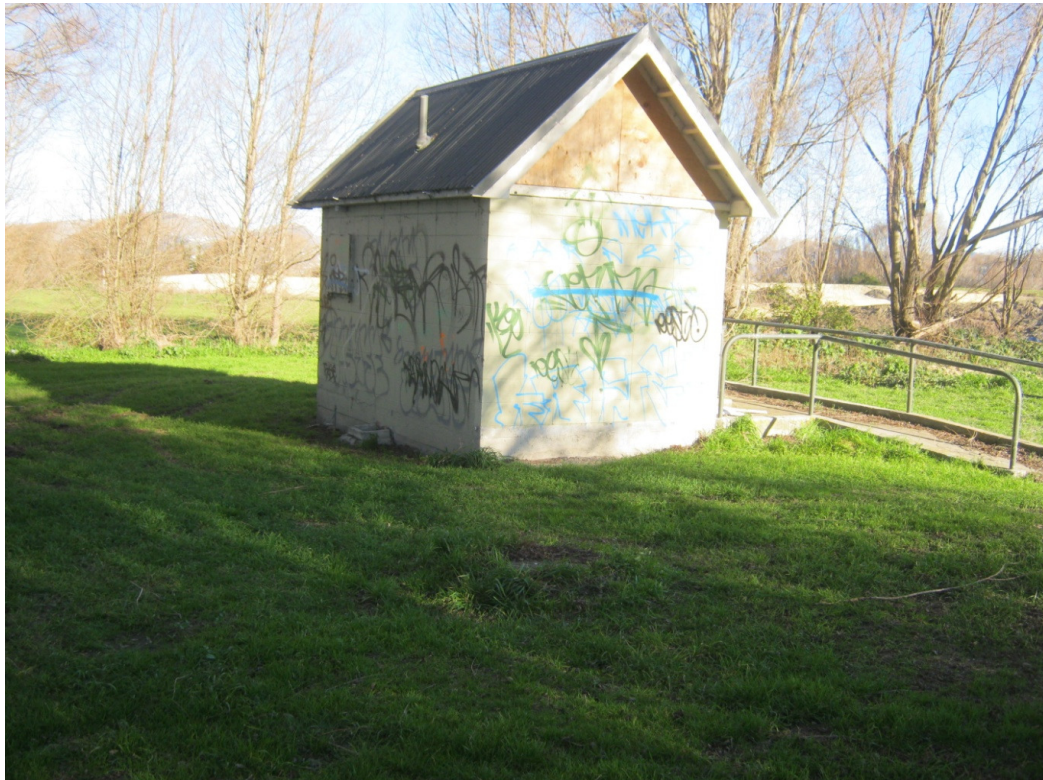
**Photograph 4. Northern Elevation.**

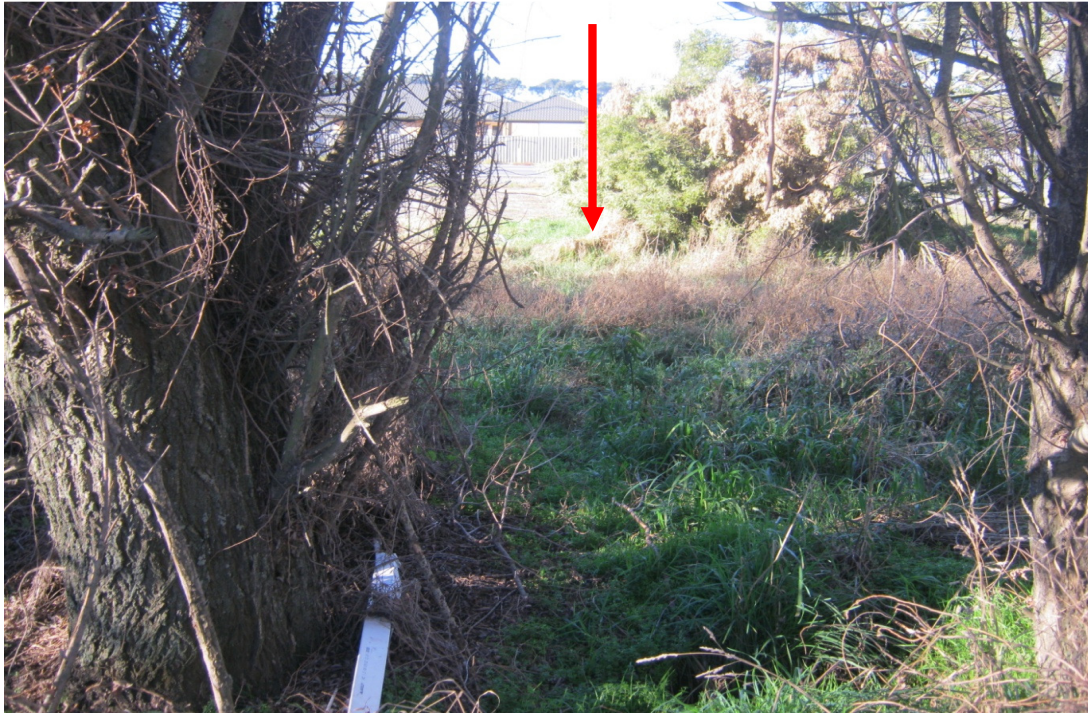
**Photo 5: From tree line to the east of the toilets looking to the small creek (red arrow) by Anzac Drive.**

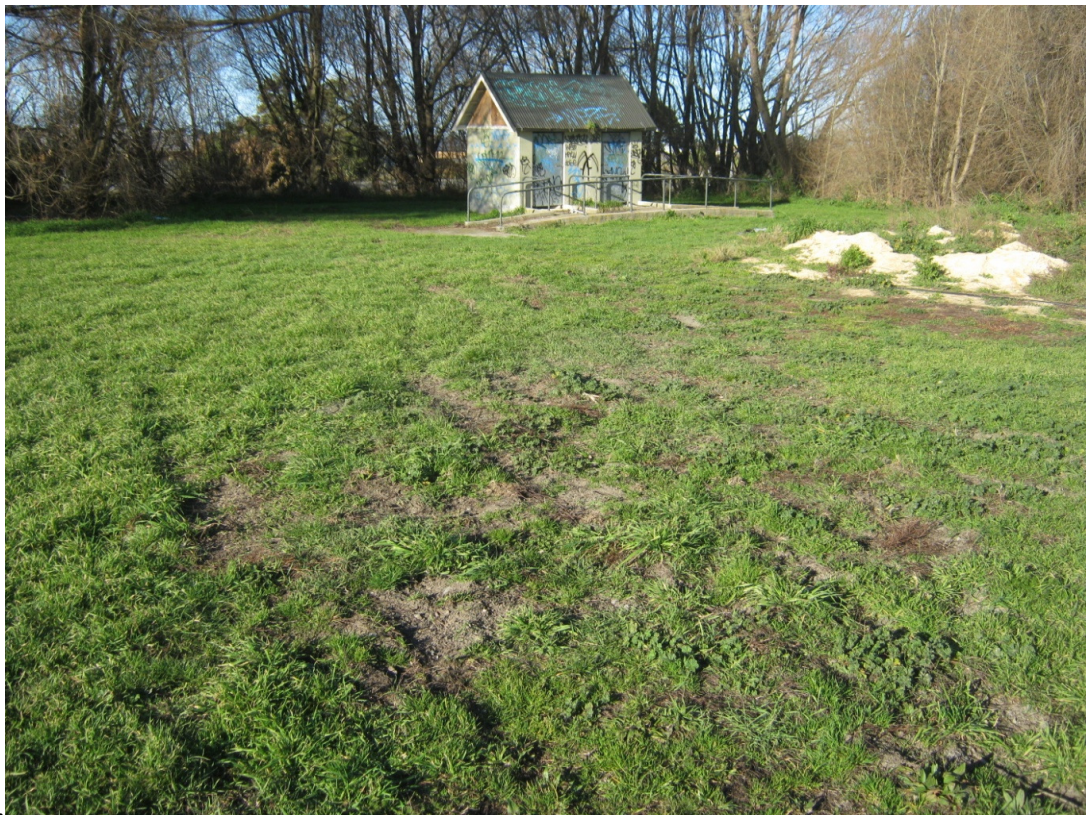
**Photograph 6. Ejected sand from liquefaction on the grassed area to the east of the toilets.**

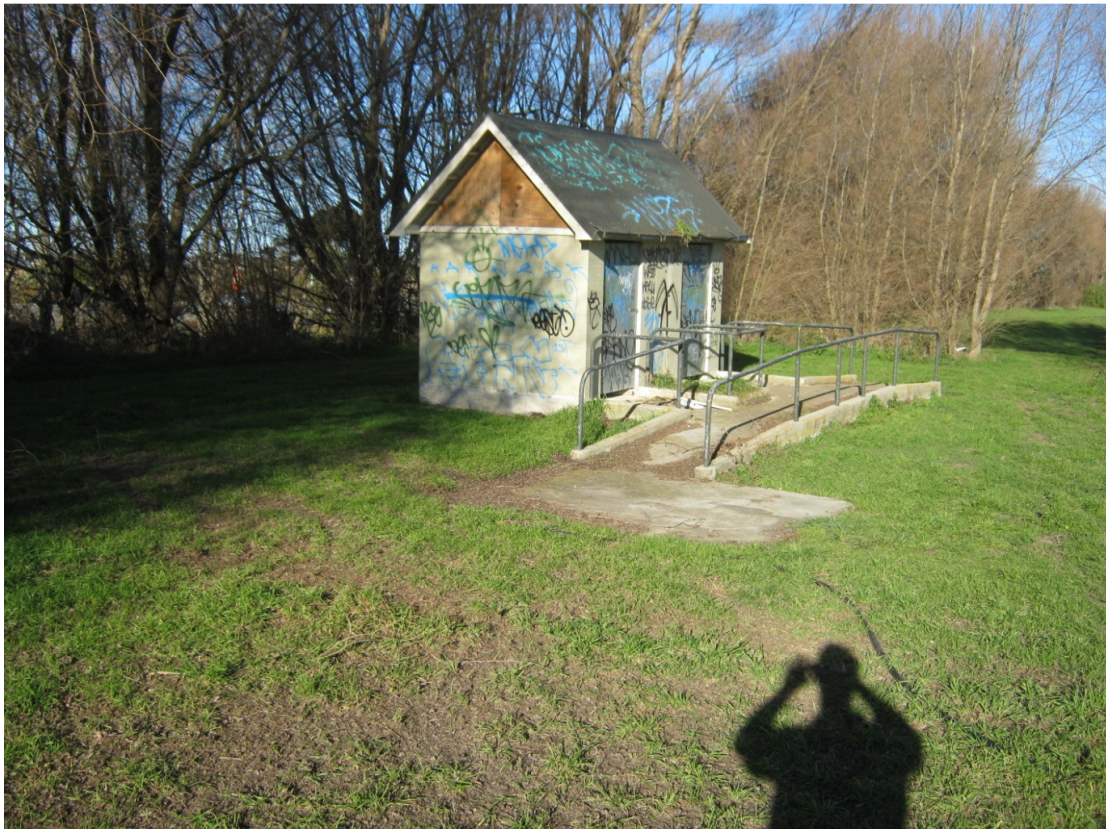
**Photograph 7. Ejected sand from liquefaction adjacent to the toilets.**

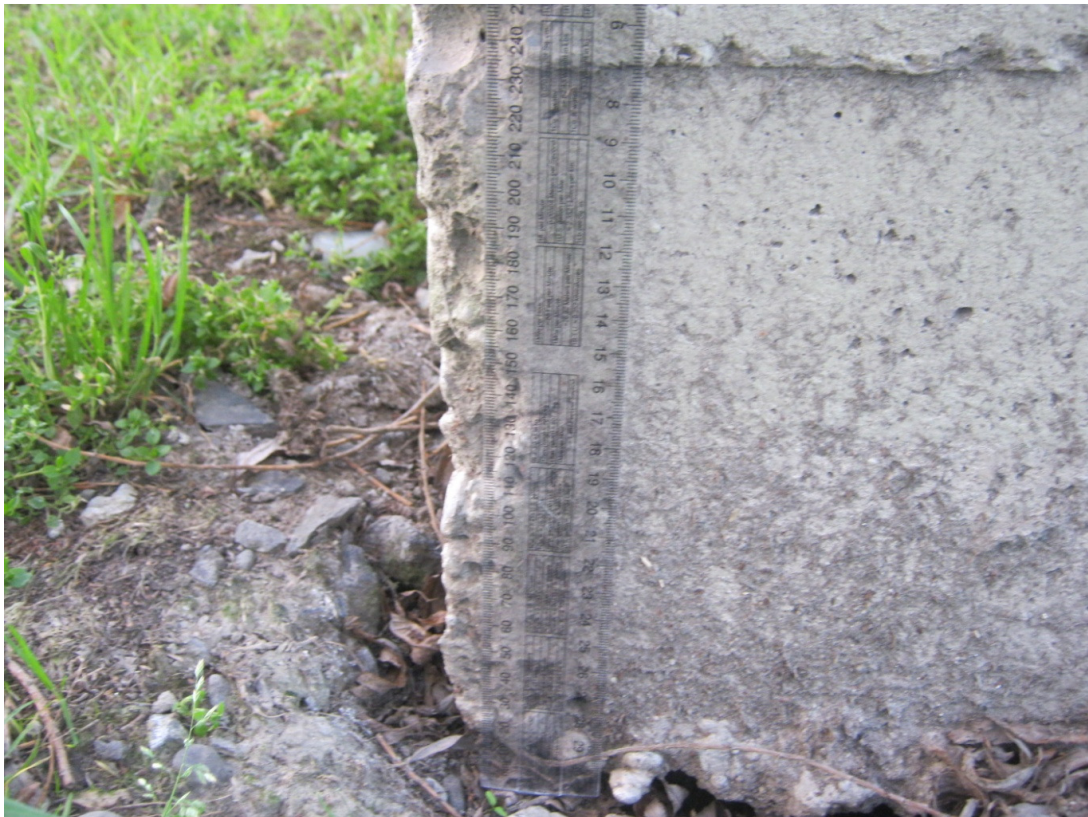
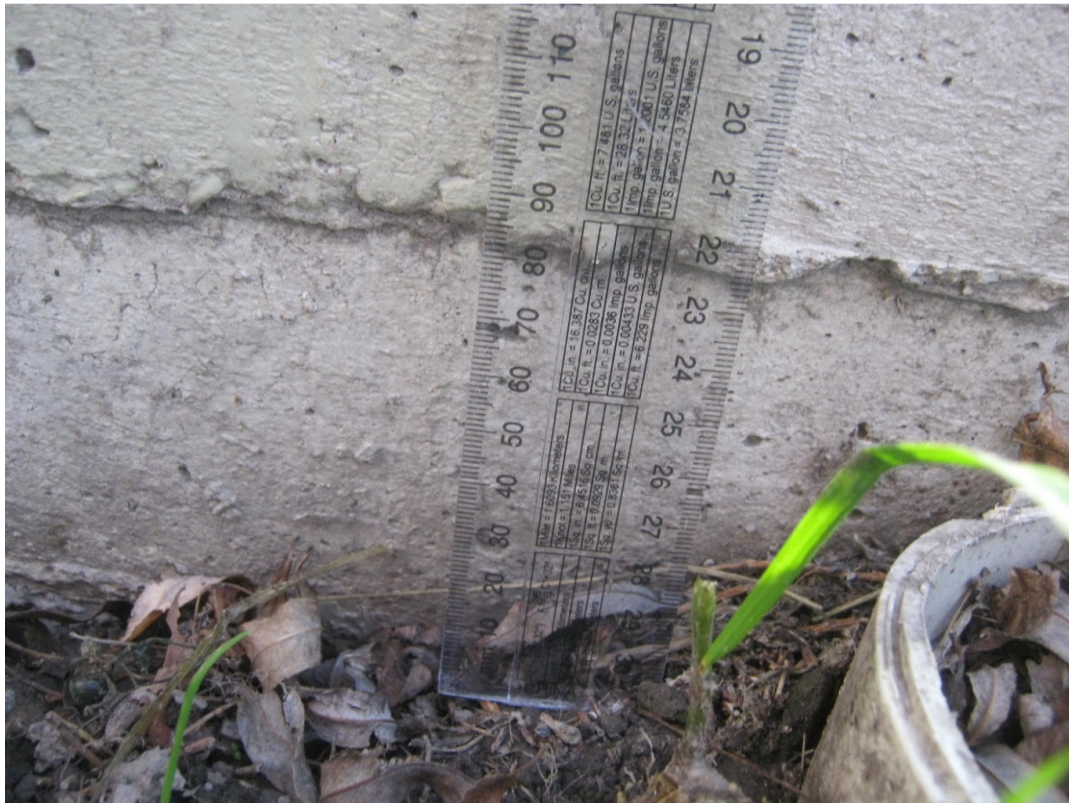
- The toilet block appears to have undergone approximately 150mm of differential settlement (Photographs 8 and 9);
- A 3mm to 5mm wide crack runs across the southern end of the concrete ramp (Photograph 11);

The existing foundations appear to have differentially settled by approximately 150mm following the Christchurch earthquake sequence of 2010 and 2011, which suggest that the current foundations are not appropriate for this site.

**Photograph 8. The top of the perimeter strip footing 230mm above ground level at the southeast corner of the toilets.**

**Photograph 9. The top of the perimeter strip footing 80mm above ground level at the northeast corner of the toilets.**

If rebuilding the toilet block is required, lightweight materials are recommended to reduce the load distributed to the underlying soil. The toilet block should also be built further away from the adjacent streams to reduce the damage induced from lateral spreading.

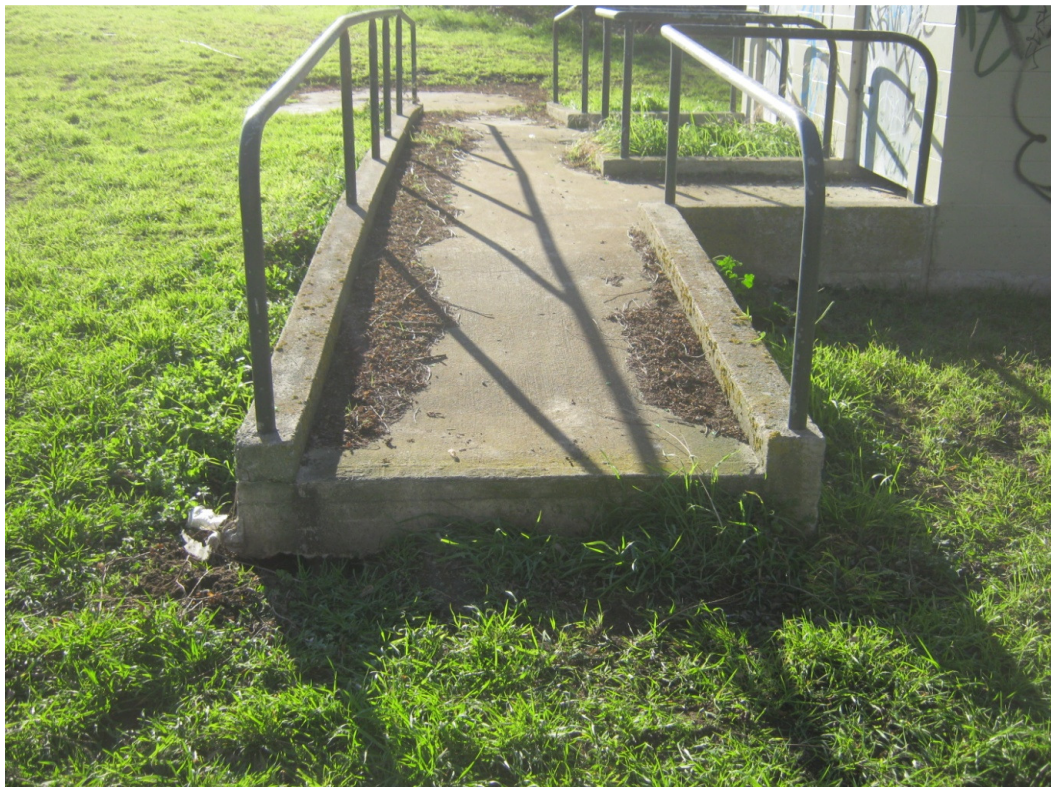
**Photograph 10. Southern end of concrete access ramp.**

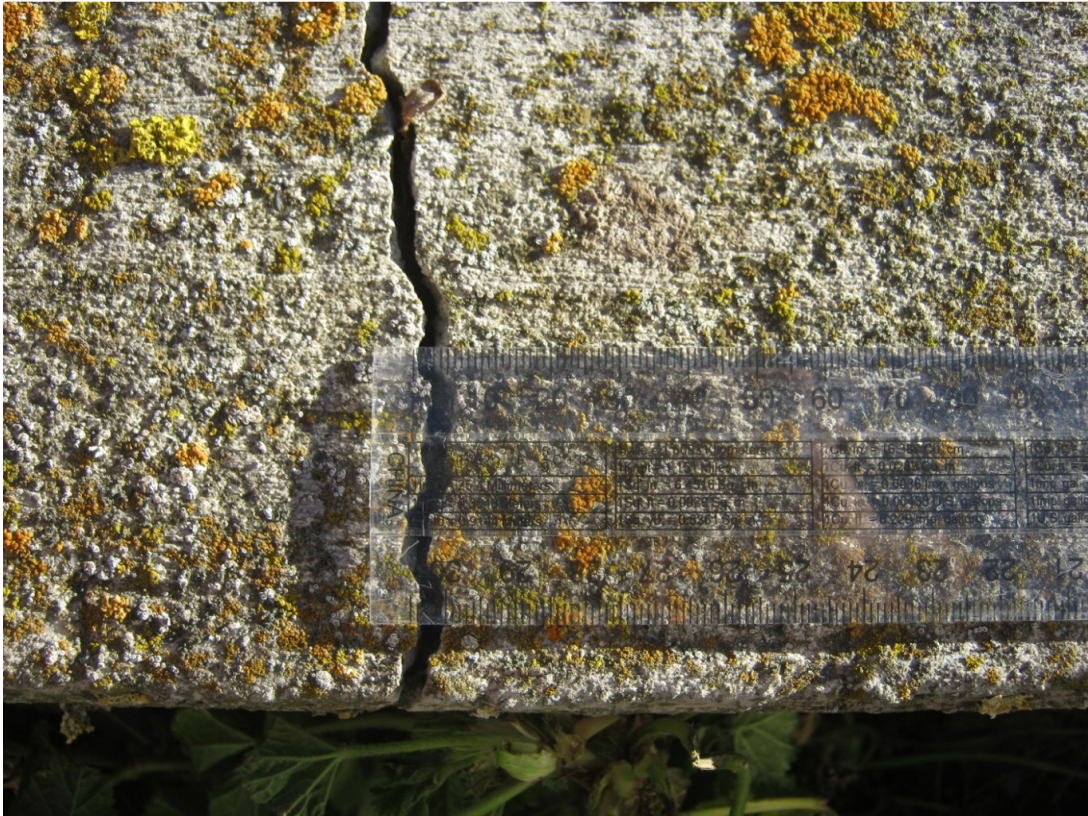
**Photograph 11. 5mm crack across the southern concrete access ramp.**

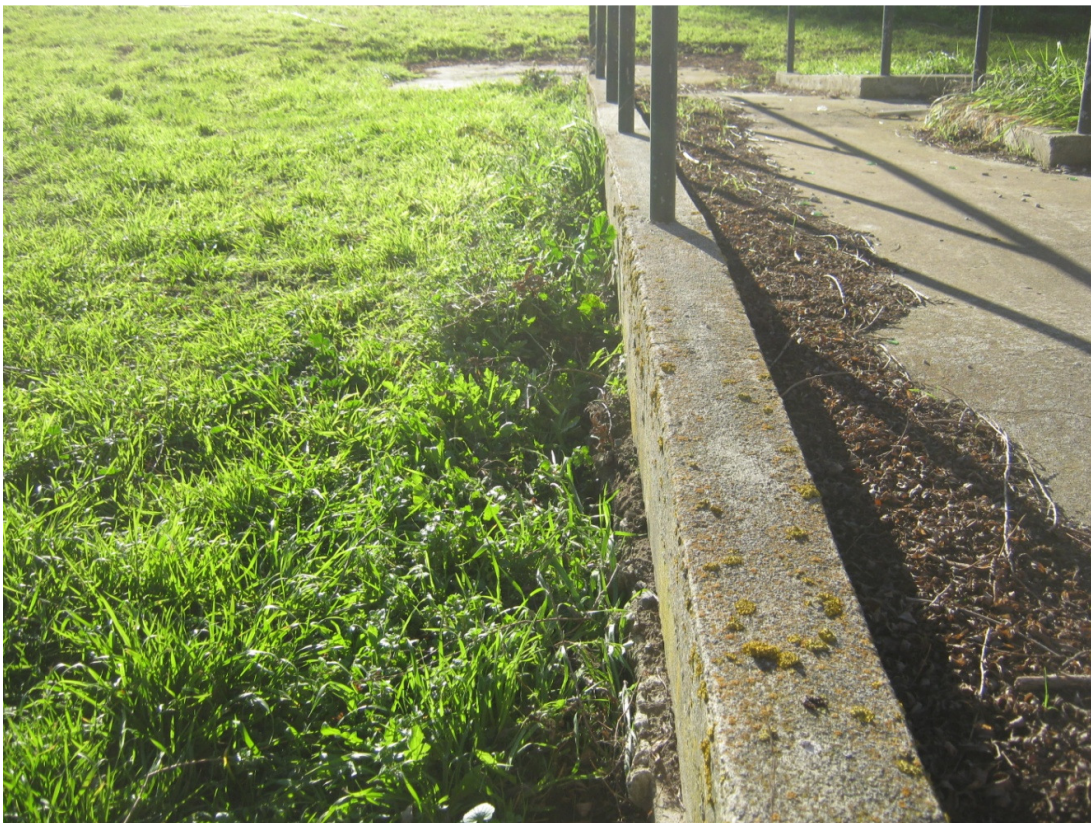
- A gap of approximately 50mm wide has formed along the western elevation of the concrete ramp (Photograph 12);
- A void was observed under the southern end of the concrete ramp exposing the concrete piles (Photograph 13);

The 50mm gap between the surrounding soils and the western elevation is likely to have been caused due to the lateral consolidation of the soil during the seismic shaking of the structure.

**Photograph 12. Separation of 50mm between the ground and the front of the concrete access ramp.**

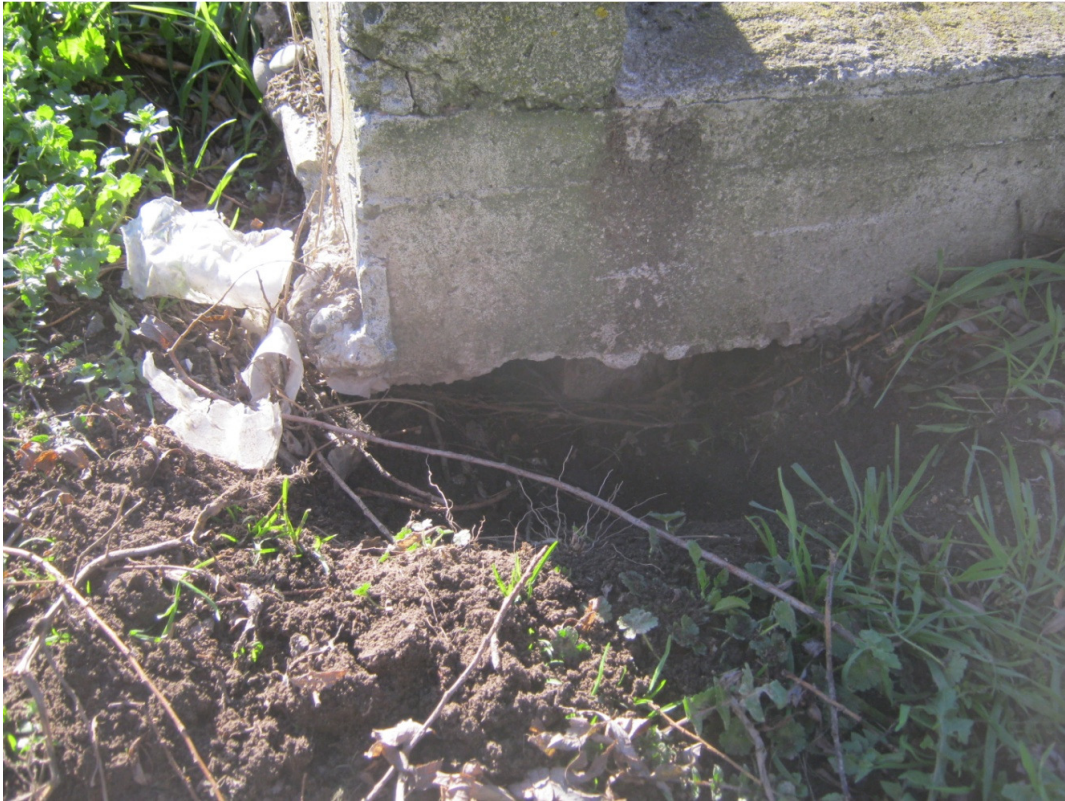
**Photograph 13. Void underneath the south-western corner of the concrete access ramp.**

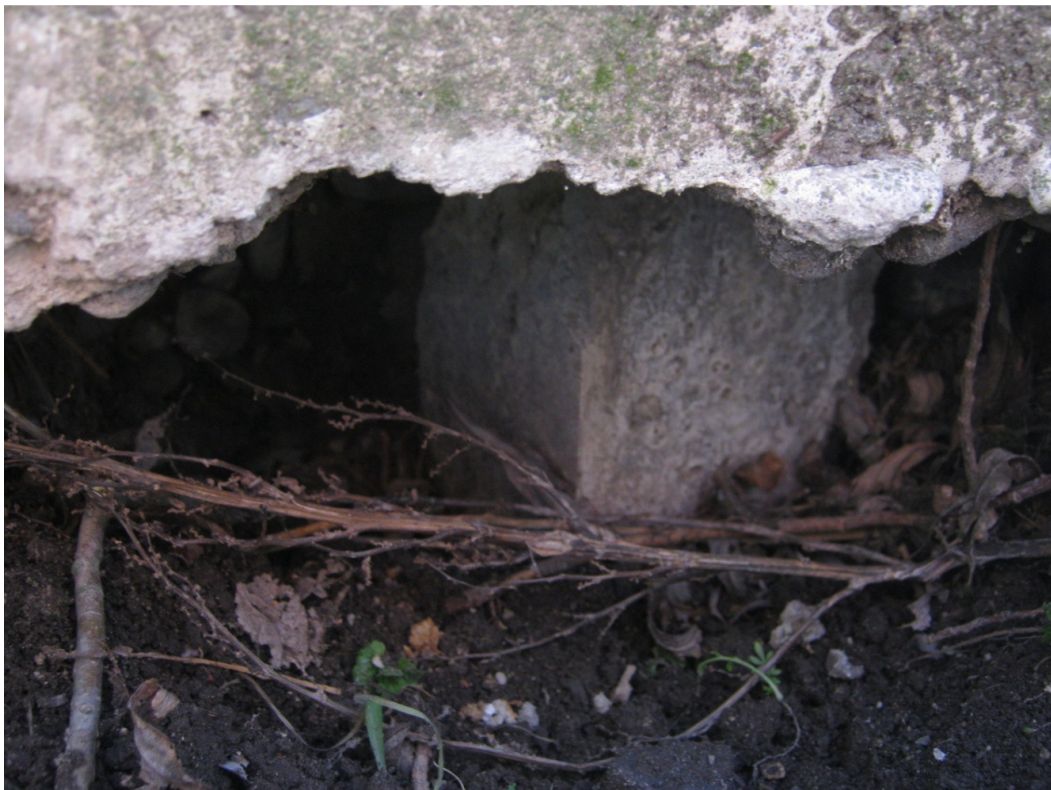
**Photograph 14. A pile within the void under the south-western corner of the concrete access ramp.**

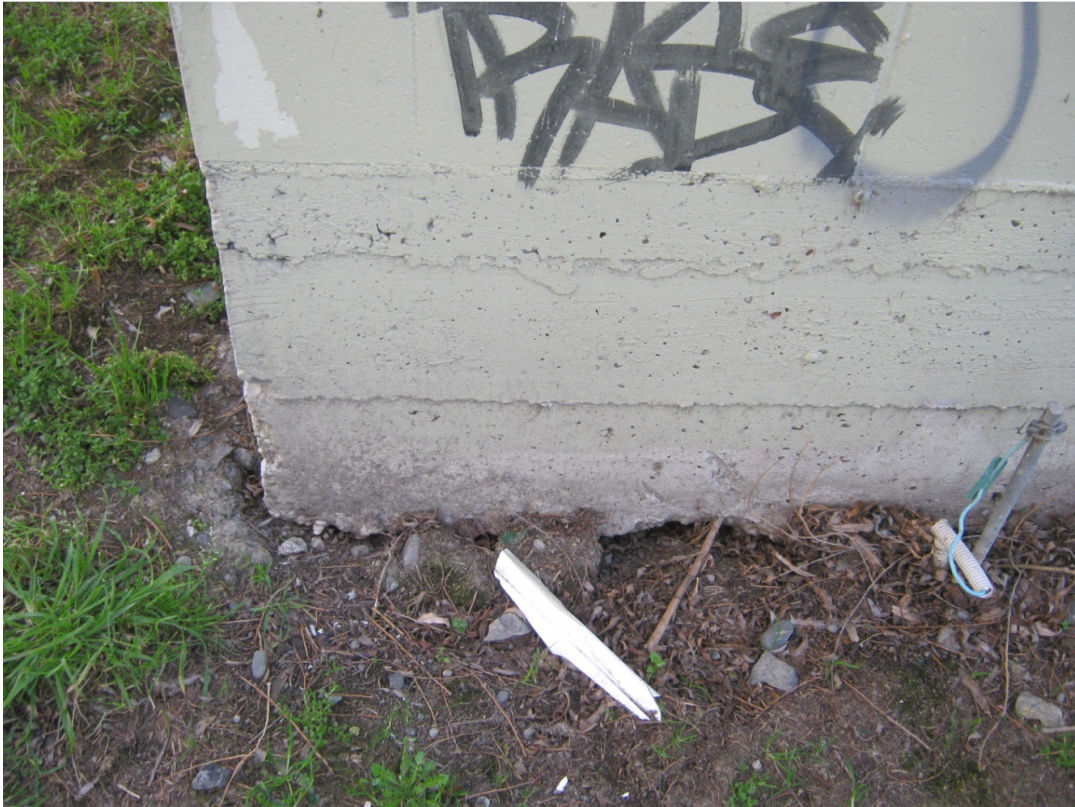
**Photograph 15. Void underneath the south-western corner of the toilets.**

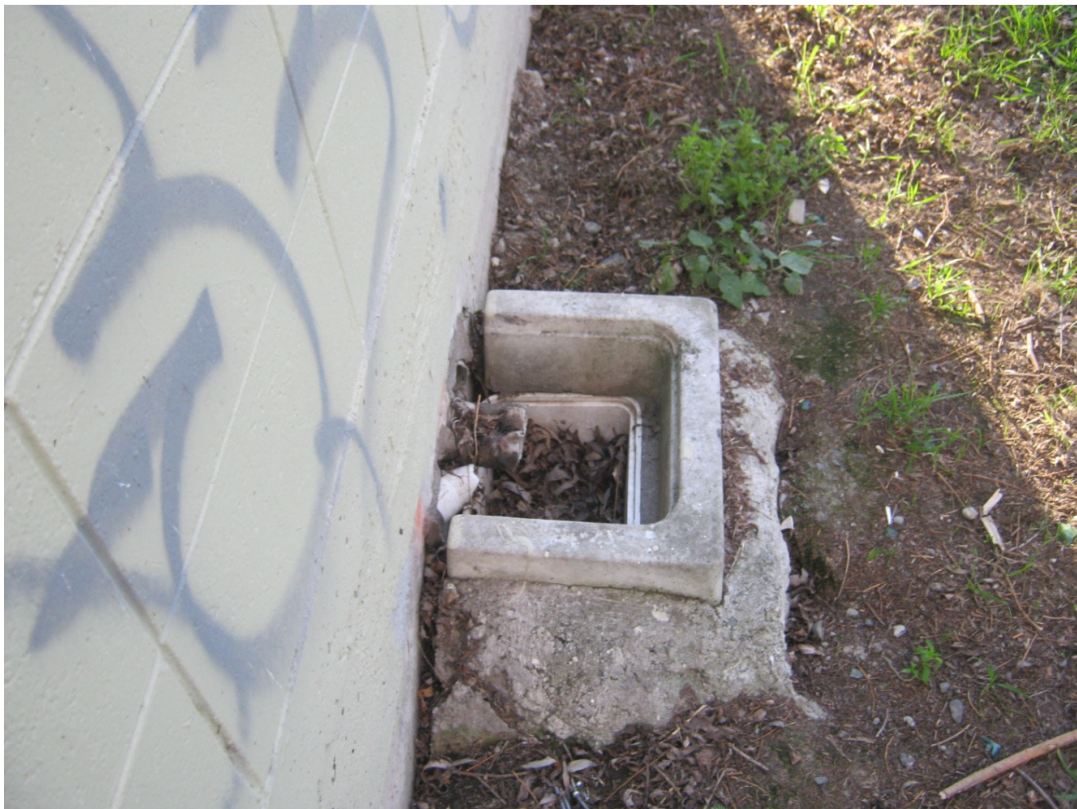
**Photograph 16. Separation of 30mm between the toilets and the concrete grey water collection box.**

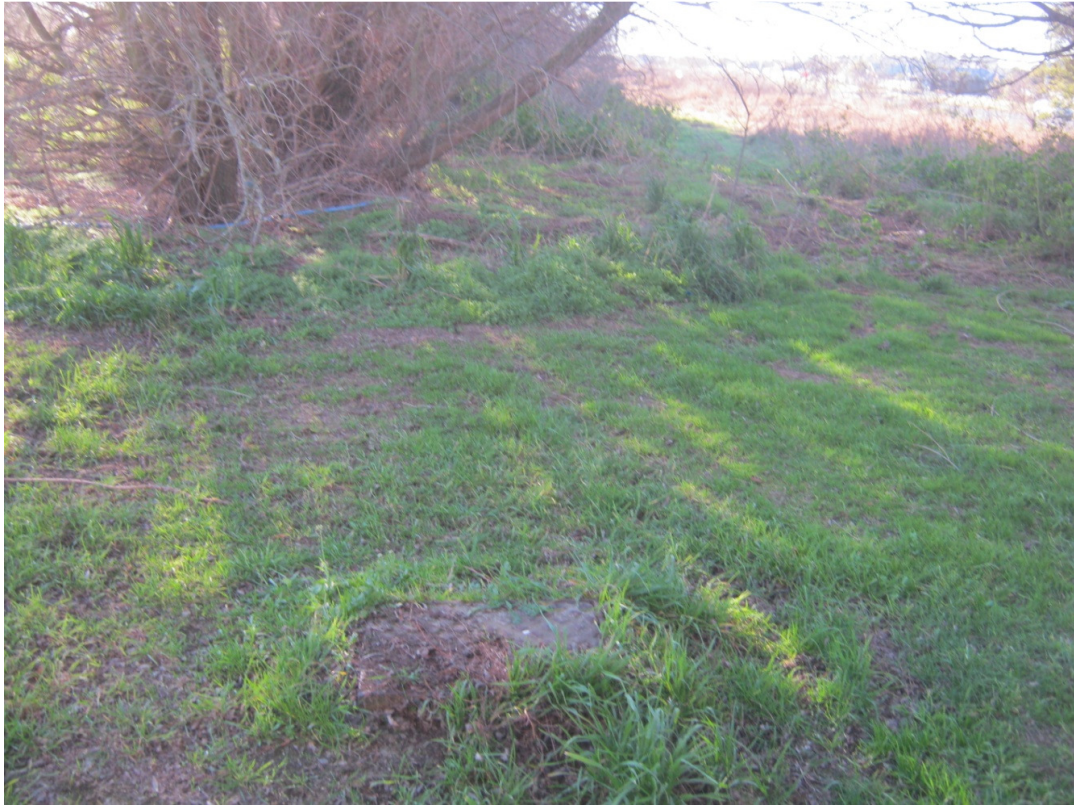
**Photograph 17. Manhole adjacent to the toilets that appears to have risen by approximately 100mm.**

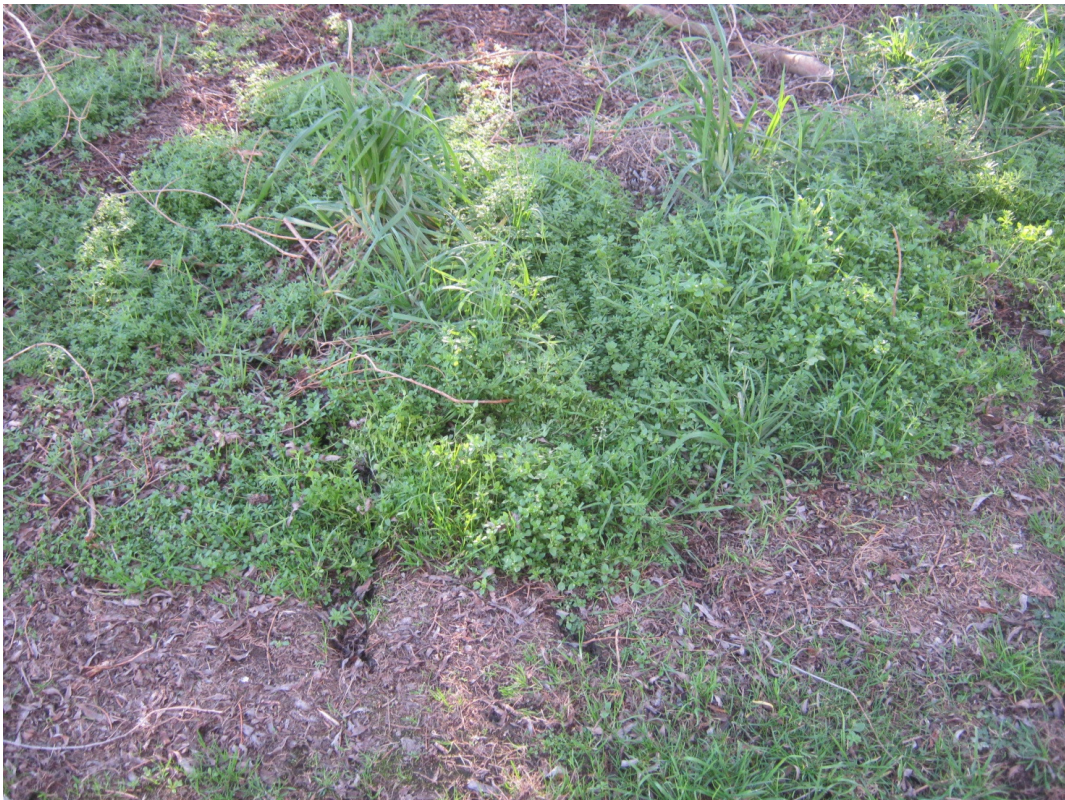
- Minor cracks in the soil, approximately 15mm wide were observed in the grassed area to 8m north of the toilet block (Photograph 18).
- A void approximately 500mm wide was observed in the tree line approximately 12 metres behind the toilet block (Photograph 19).

**Photograph 18. Minor cracking about 15mm wide approximately 6m north of the toilets.**

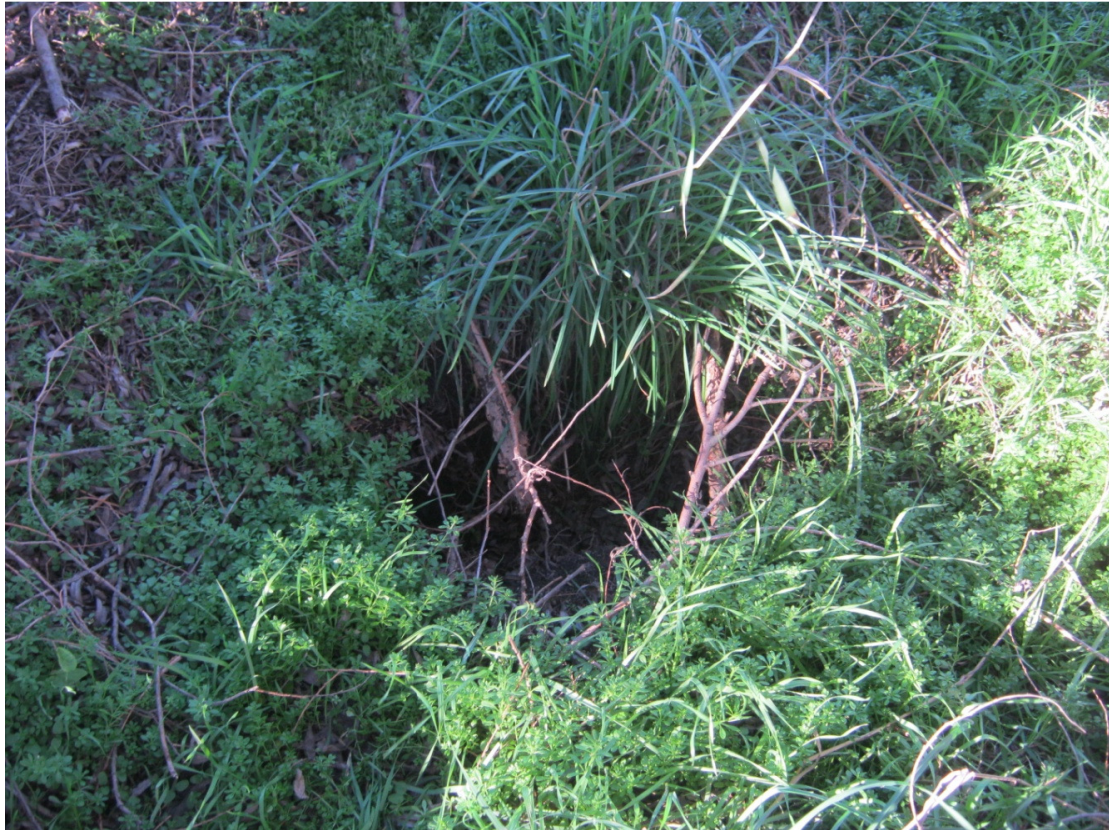
**Photograph 19. Collapsed void approximately 500mm wide in the tree line to the east of the toilets.**
