CHRISTCHURCH CITY COUNCIL
PRK_1385_BLDG_005 EQ2
Bexley Park Underground Bunker
194 Bexley Road, Bexley

QUANTITATIVE ASSESSMENT REPORT

FINAL

- Rev B
- 04 March 2013

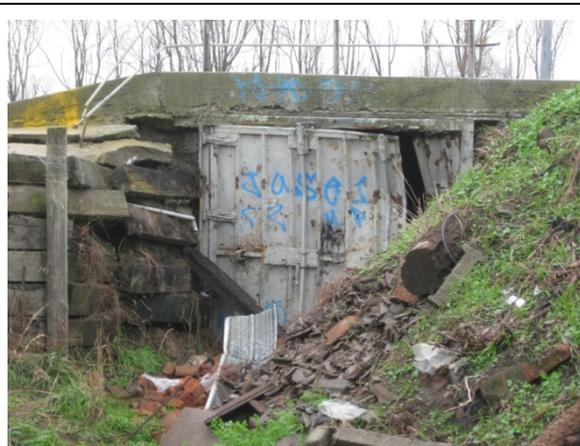
Photo 1: East elevation showing building entrance and timber retaining walls.

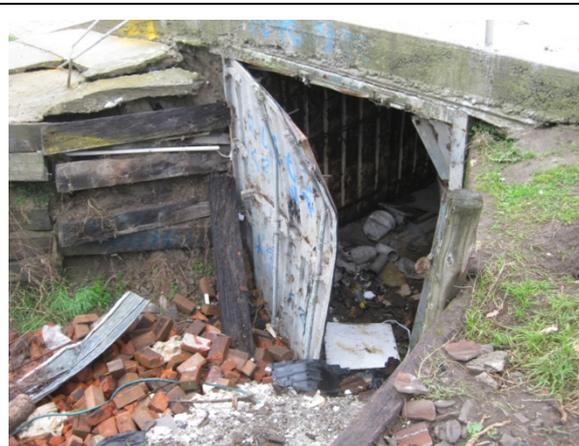
Photo 2: Northeast elevation showing building entrance and timber retaining walls.

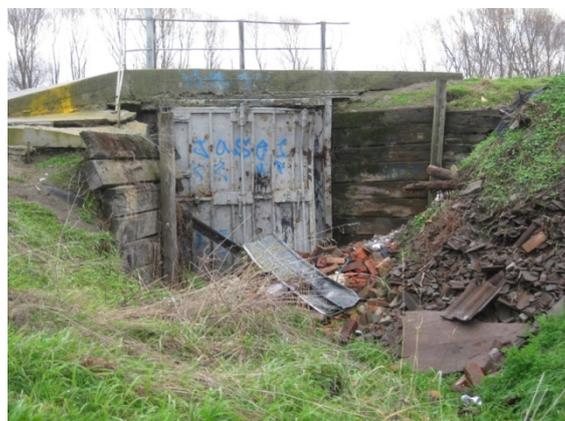
Photo 3: East elevation showing building entrance and timber retaining walls.

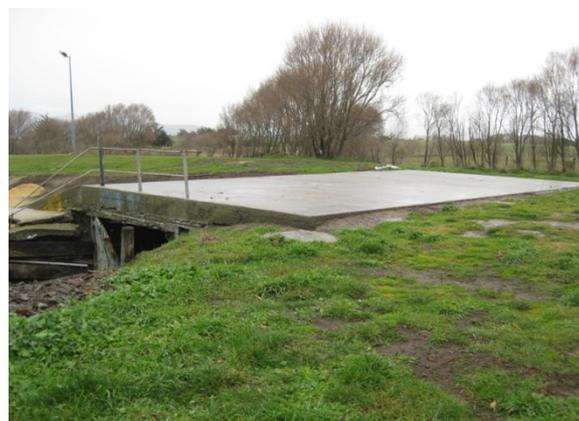
Photo 4: Northeast elevation showing 300mm deep concrete slab over building, incorporated into BMX track.

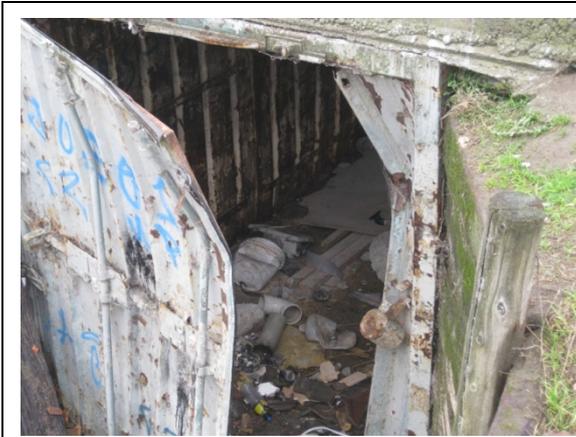
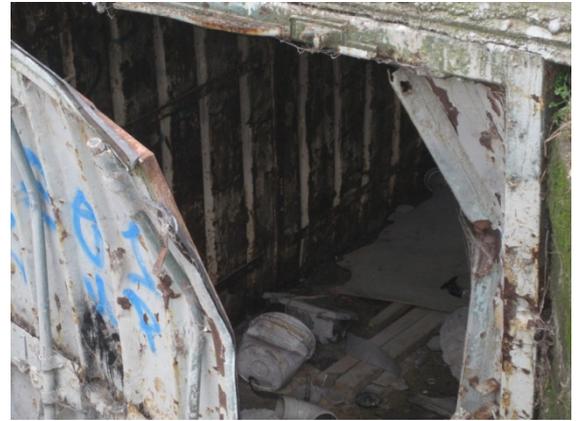
- 1) Southern wall of the shipping container appears to have buckled inwards.
- 2) Eastern entrance panel appears to have buckled inwards. However, this could also have been caused by impact damage unrelated to the earthquakes.

Photo 5: Entrance to shipping container, showing inwards buckling of southern wall.

Photo 6: Entrance to shipping container, showing inwards buckling of southern wall.

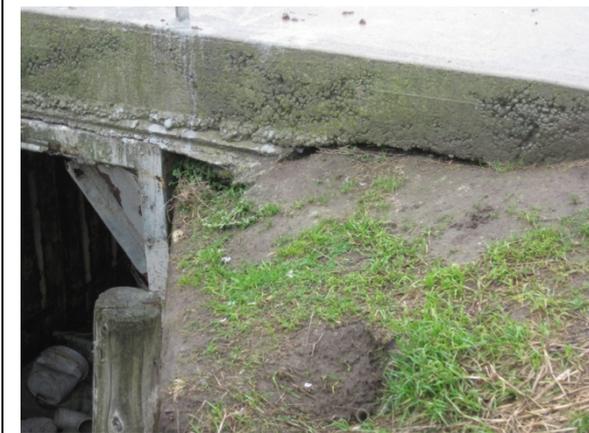
Photo 7: Retained soil to the north of the building, with 300mm deep concrete slab above.

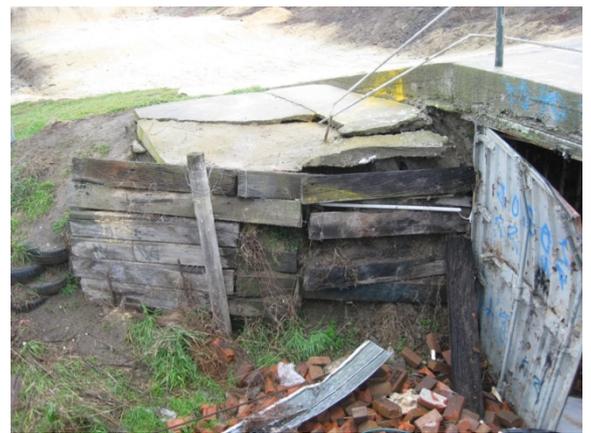
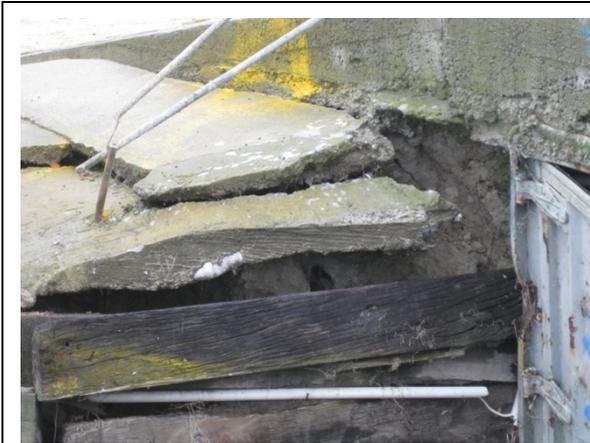
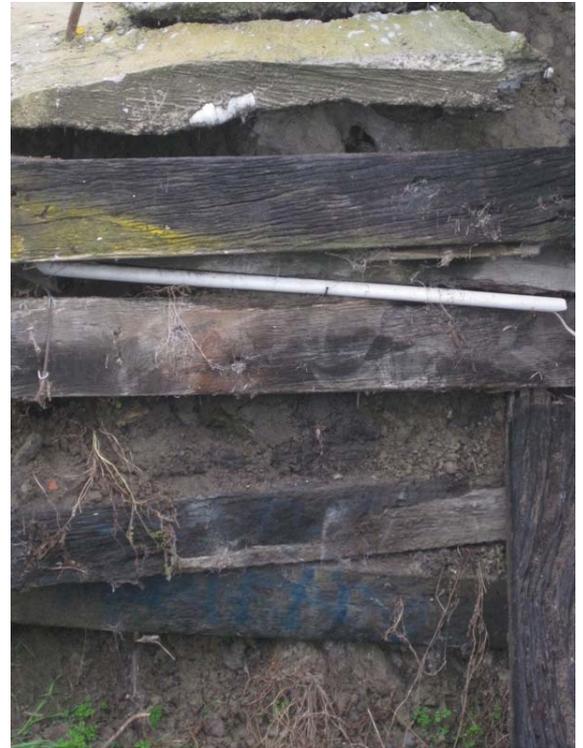
- 3) Southern timber retaining wall forming eastern entrance has no fixed connections and some timber elements are displaced. It should be noted that the retaining wall could have undergone damage before the earthquakes, with the damage being exacerbated by the earthquakes.

Photo 8: Southern timber retaining wall and east entrance to building, with cracked concrete slab above.

Photo 9: Southern timber retaining wall and east entrance to building, with cracked concrete slab above. Loss of retained material can be seen.

Photo 10: Southern timber retaining wall and east entrance to building, with cracked concrete slab above. Loss of retained material can be seen.

Damage	Site performance: _____	Describe damage: <u>Southern retaining wall at entrance no longer has secure fixings and soil has been displaced behind the wall, lowering the ground level directly above and causing cracking in concrete slab.</u>
Site: (refer DEE Table 4-2)	Settlement: <u>none observed</u>	notes (if applicable): _____
	Differential settlement: <u>none observed</u>	notes (if applicable): _____
	Liquefaction: <u>none apparent</u>	notes (if applicable): _____
	Lateral Spread: <u>none apparent</u>	notes (if applicable): _____
	Differential lateral spread: <u>none apparent</u>	notes (if applicable): _____
	Ground cracks: <u>none apparent</u>	notes (if applicable): _____
	Damage to area: <u>none apparent</u>	notes (if applicable): _____

Two options are recommended, depending on whether a structure is still required on the site to carry out the same or similar function as the current building. The preferred option is that the container is removed, the retaining walls be demolished and the site be filled with compacted backfill. The less-preferred option is that the building be strengthened to achieve life-safety only by strengthening the walls to 67% NBS. This acknowledges that the building may undergo settlement, differential settlement and/or flooding from site ejecta in another seismic event. The southern retaining wall would need to be reinstated with an appropriate design.

- Due to the structural instability of the southern timber retaining wall, we strongly recommend that the building should not be occupied until strengthening measures are carried out.

- a) The building is unsafe to occupy on the basis of the instability of the southern retaining wall.
- b) We consider that barriers around the building are necessary due to the collapse hazard represented by the south retaining wall.

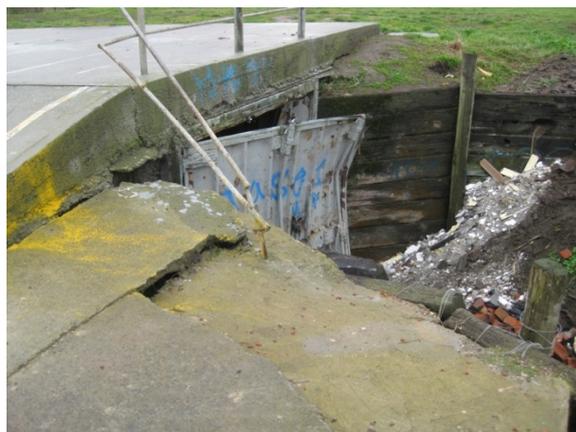
Photo 11: Southern view of east entrance with 300mm deep concrete slab extending either side of the entrance.

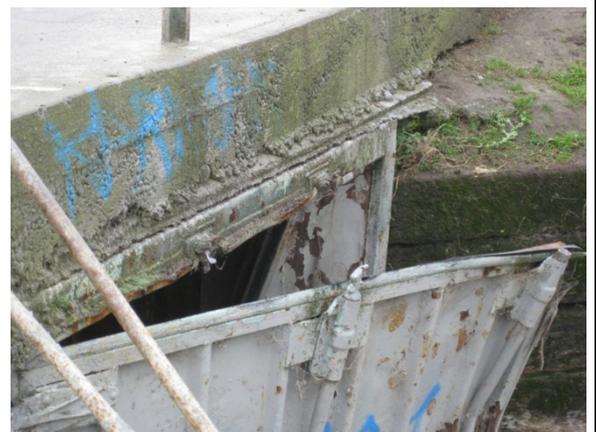
Photo 12: 300mm deep concrete slab over east entrance.

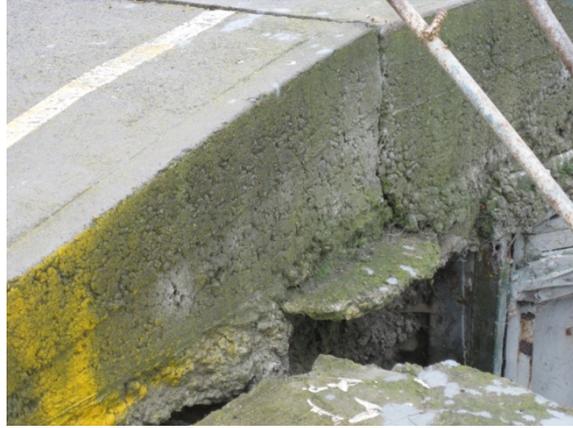
Photo 13: 300mm deep concrete slab over southern corner of east entrance. The slab slopes downwards to form a ramp for the BMX track.

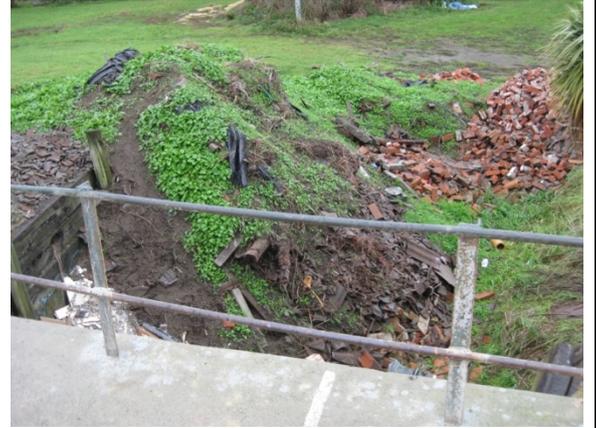
Photo 14: West view above east entrance.
