Hagley Park North – Band Rotunda
Quantitative Engineering Evaluation

Reference: 228660
Prepared for:
Christchurch City Council

Functional Location ID: PRK_1190_BLDG_033
Address: 6 Riccarton Avenue

Revision: 2
Date: 11 October 2013

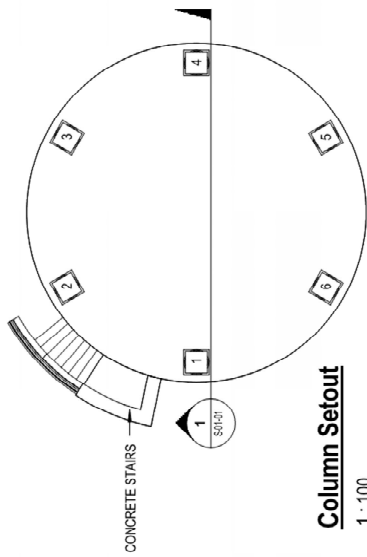
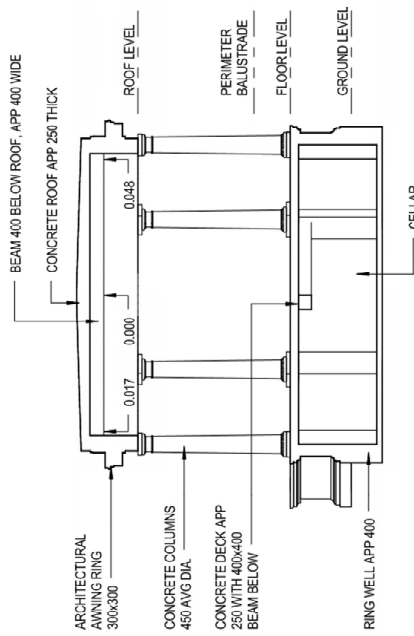
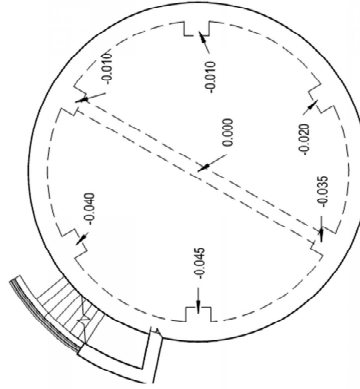
Geometry and Survey Levels of the Structure

A level survey was carried out of the roof and suspended concrete base to determine the extent of movement that has occurred. Our findings indicate that the roof requires re-levelling, which could be carried out during the replacement of the columns. The levels of the concrete base are acceptable. Refer to Appendix A for detailed survey data.
