Botanic Gardens Office Library
PRK 1566 BLDG 029
Detailed Engineering Evaluation
Qualitative Report
Version FINAL

7 Rolleston Avenue, Christchurch
Central

Christchurch City Council

Date
17/09/13

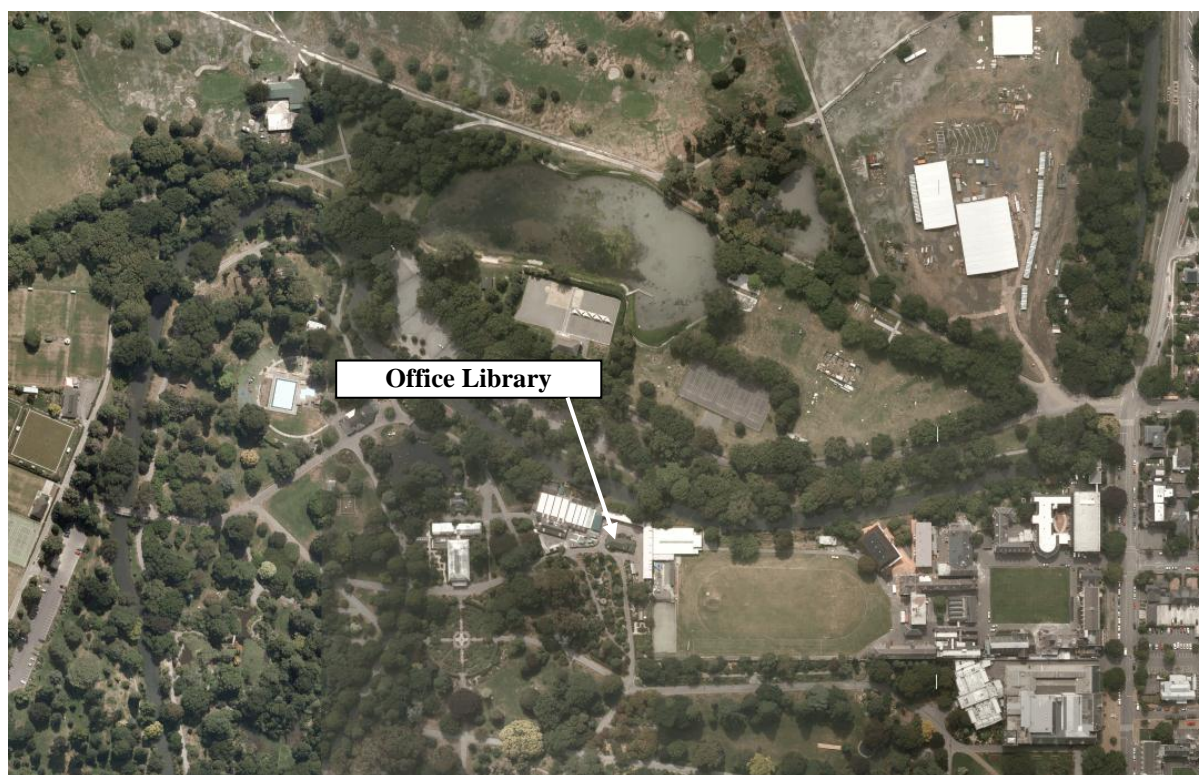
Figure 3 Post February 2011 Earthquake Aerial Photography²

Aerial photography taken following the 22 February 2011 earthquake shows moderate amounts of liquefaction on the northern side of the Avon and in Victoria Lake, in the top-left and top-right corners of Figure 3. However, there is no evidence of liquefaction at the surface within the botanic gardens themselves.

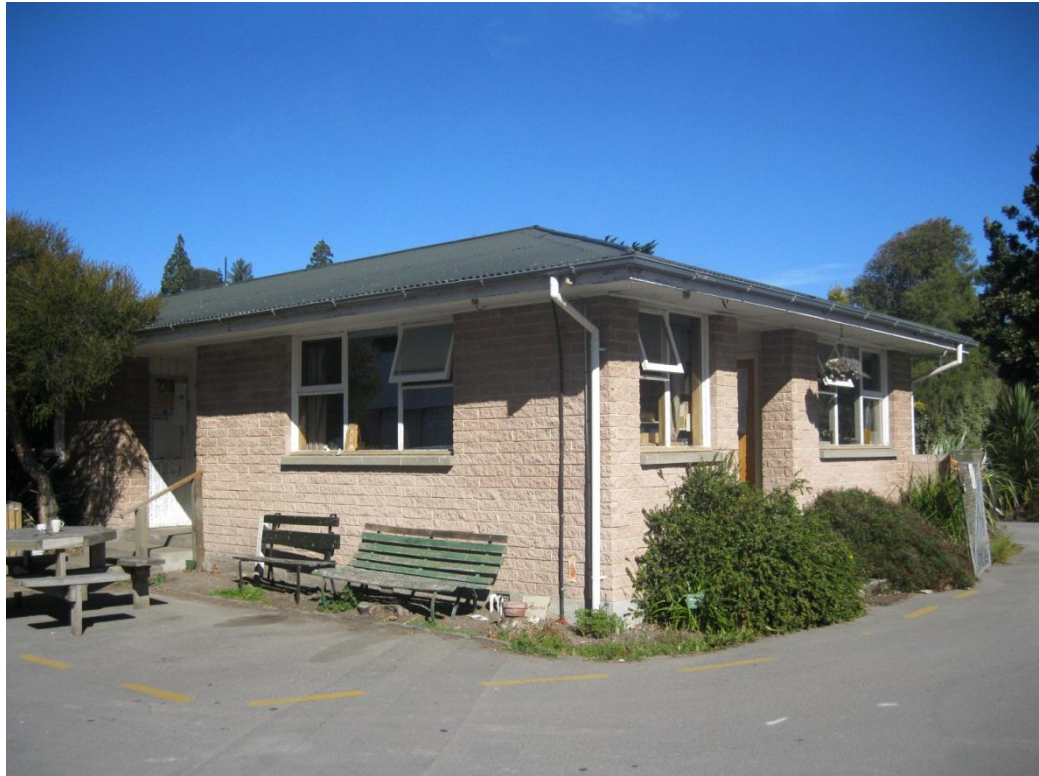
Photograph 1: North and west facing elevations

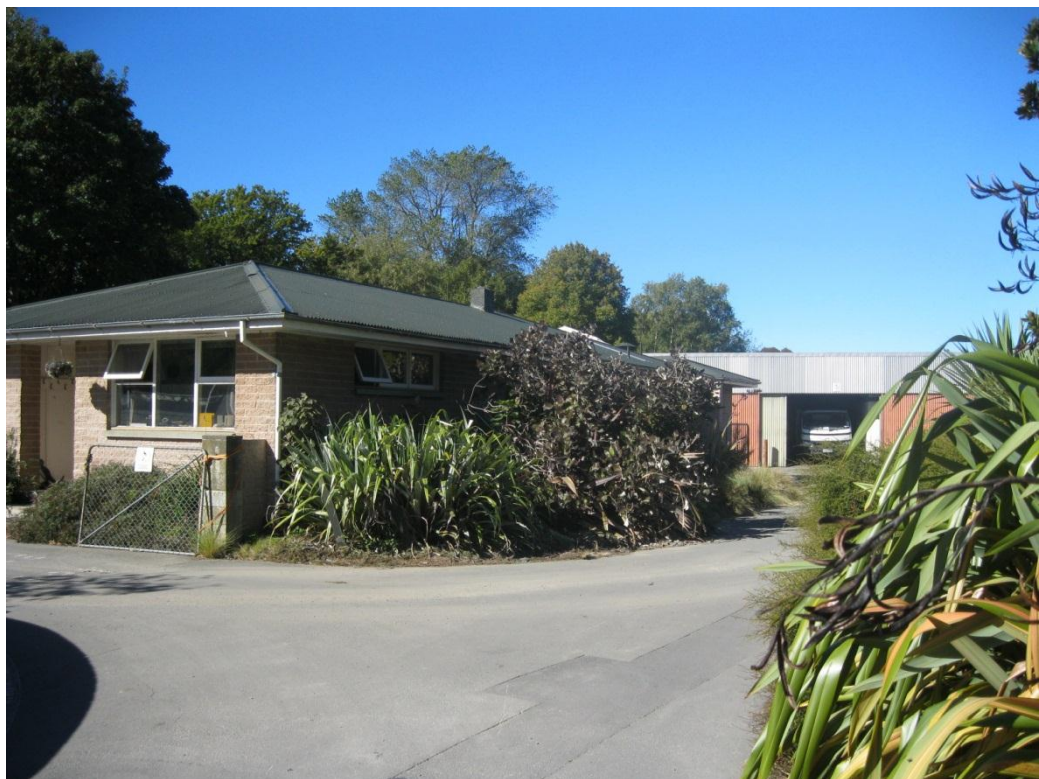
Photograph 2: South and west facing elevations

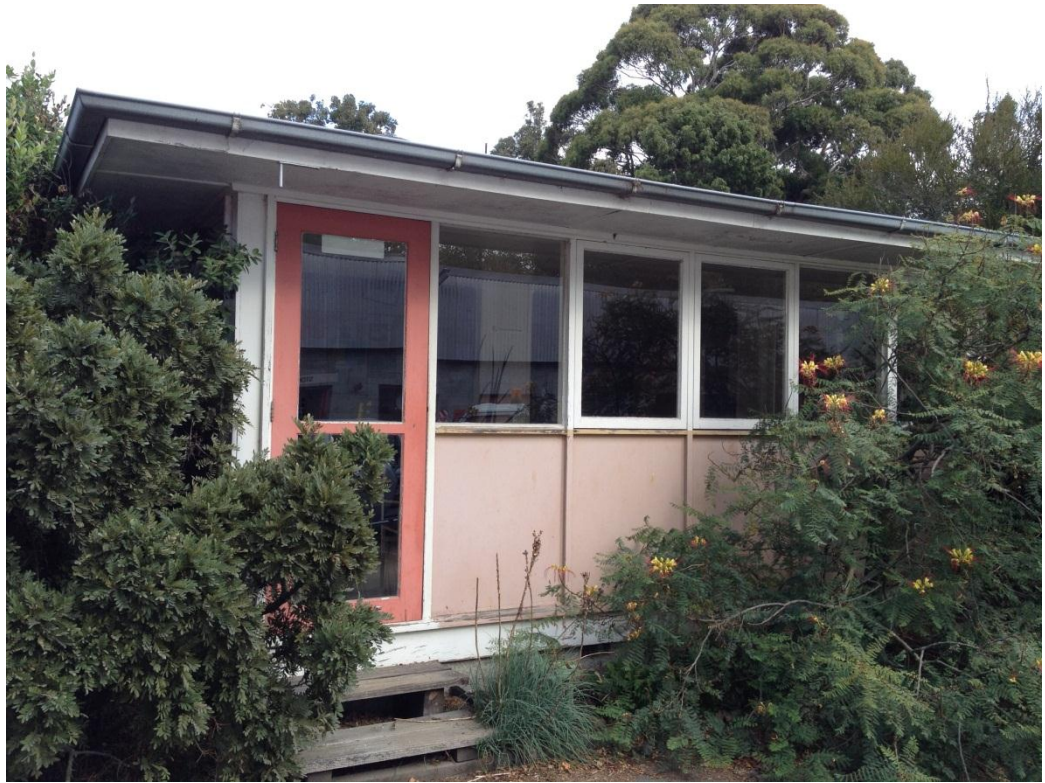
Photograph 3: Flat roof extension to the north side of the structure

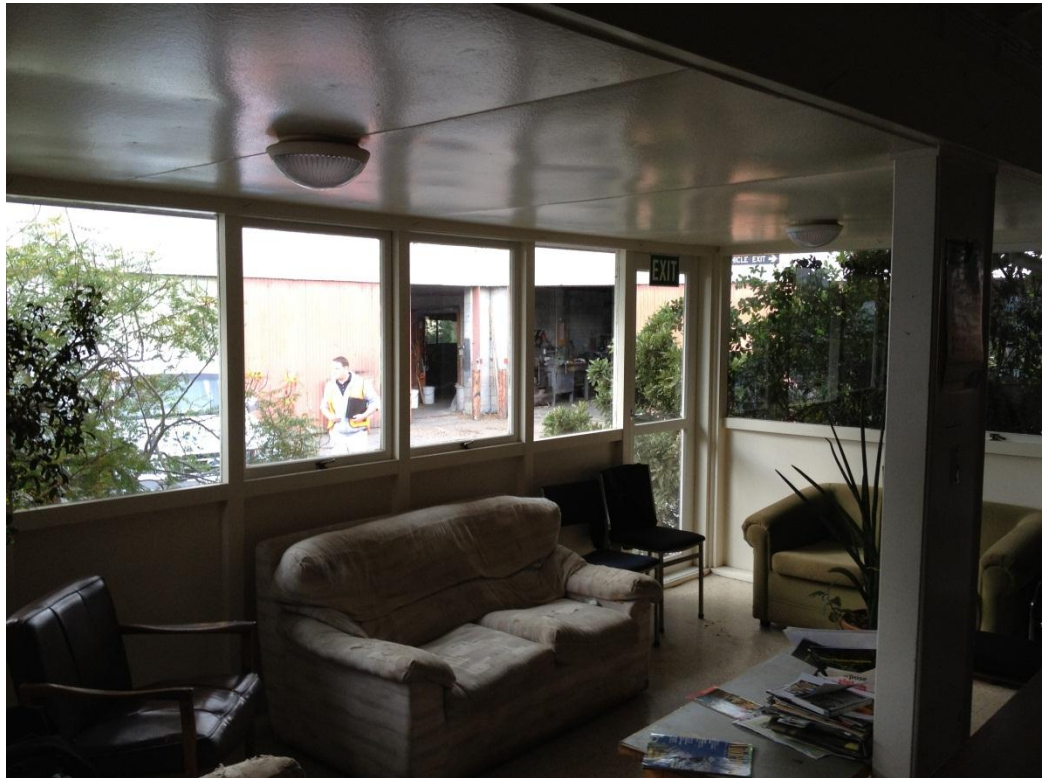
Photograph 4: Internal view of north side extension

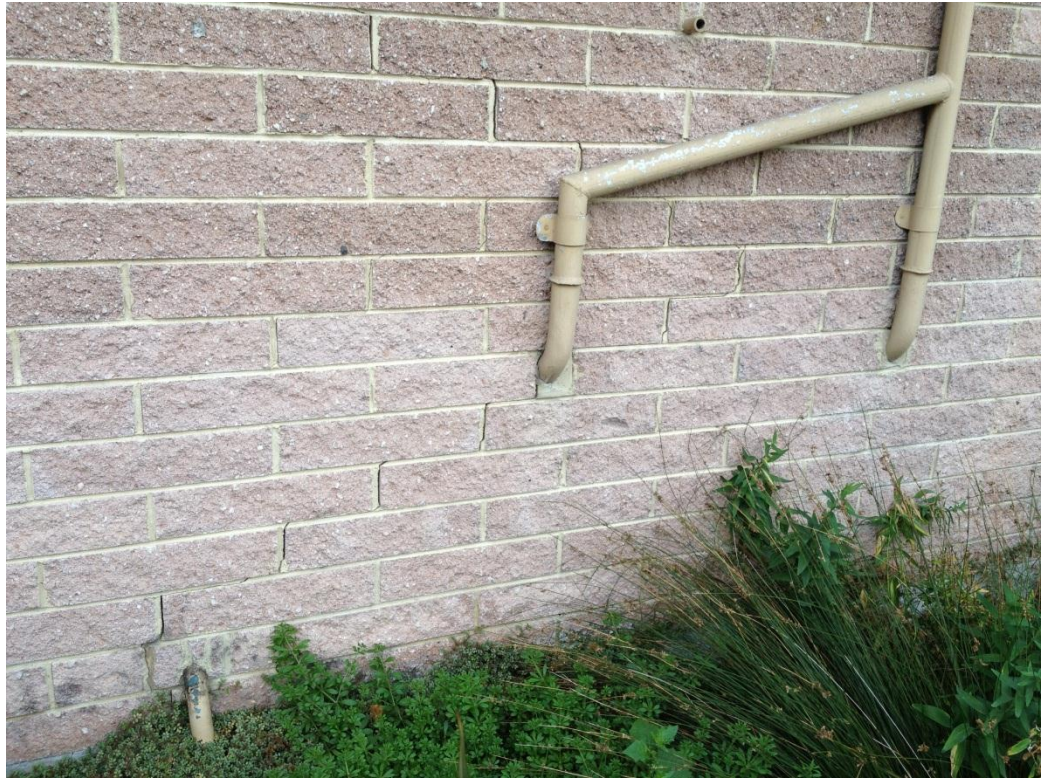
Shear cracking was observed to the exterior brickwork veneer possibly as a result of short column action. Temporary props have been erected to prevent further brickwork veneer collapse. (See photographs 5 and 7, Appendix A)

Photograph 5: Shear cracking to brickwork veneer located on south-east of the structure

It is recommended that the tying of the brick veneer to the timber framed structure is investigated.

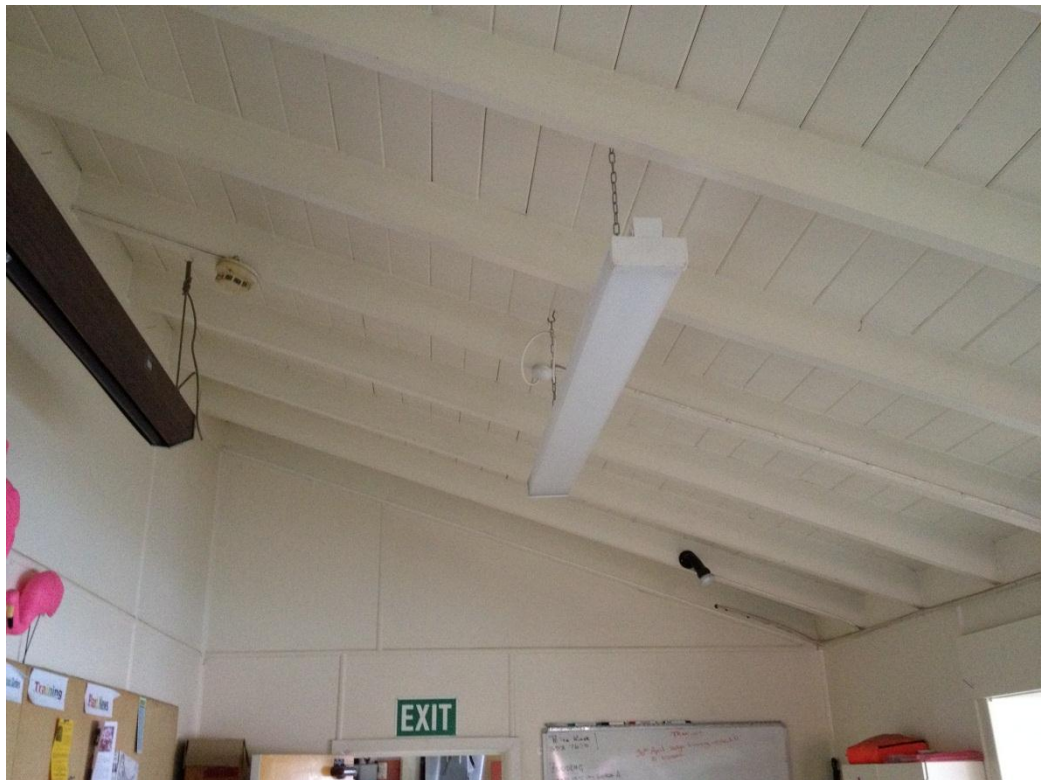
No critical structural weaknesses were observed in the roof structure. It is possible roof bracing exists but this could not be observed due to the presence of wall and ceiling linings. The timber sarking ceiling will act as a diaphragm to the structure.

Photograph 6: Timber sarking ceiling on exposed rafters

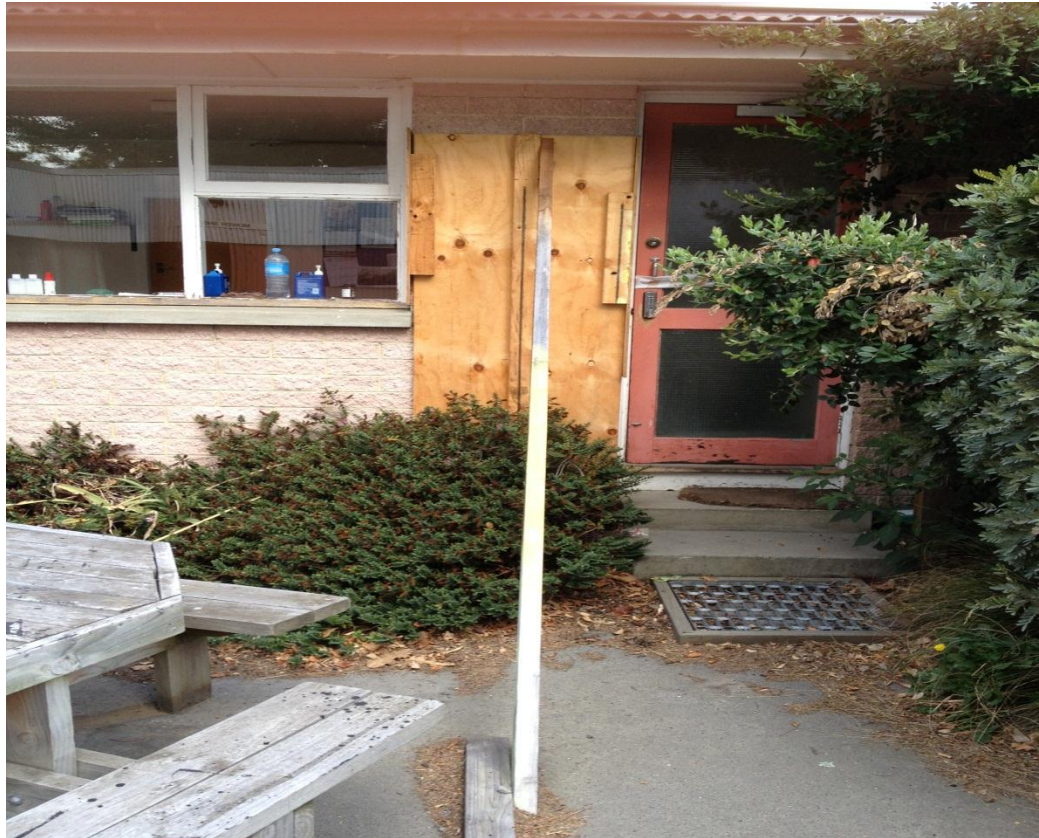
Photograph 7: Temporary propping to brickwork veneer on the north side of structure
