Botanic Gardens Office Store
PRK 1566 BLDG 003 EQ2
Detailed Engineering Evaluation
Quantitative Report
Version FINAL

7 Rolleston Avenue, Christchurch

Christchurch City Council

Date
16 September 2013

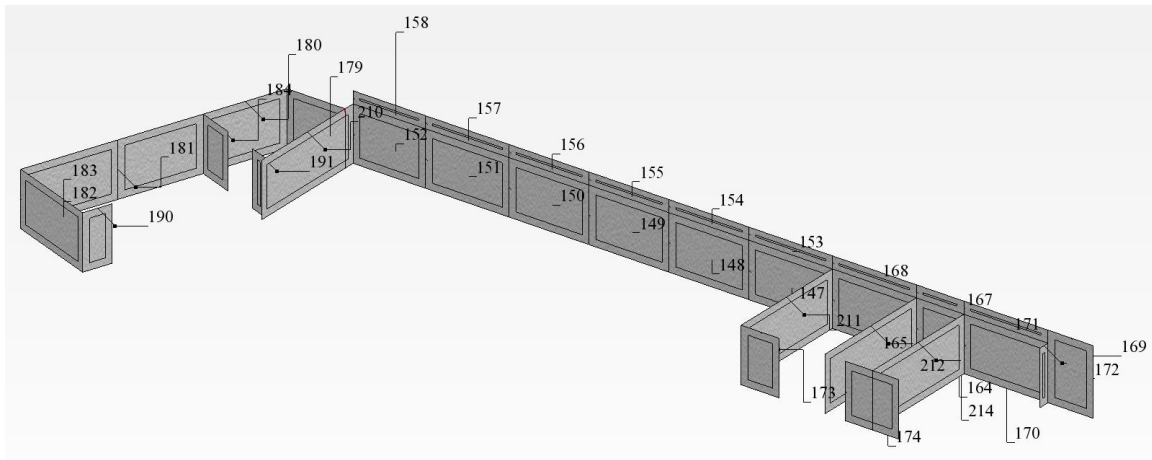
Figure 6 Wall numbers and locations of Office Store

Wall Number	Governing Mode	Critical shear capacity	Demand	Reduced Capacity	% NBS	Risk or Prone
		V_n kN	kN	ΦV_n kN		
147	Diagonal Tension	28.1	32.7	21.1	64.60%	Risk
148	Diagonal Tension	24.1	26.8	18.1	67.53%	Not Risk or Prone
149	Diagonal Tension	24.5	25.9	18.3	70.82%	Not Risk or Prone
150	Diagonal Tension	24.2	24.9	18.2	72.86%	Not Risk or Prone
151	Diagonal Tension	25.8	24.7	19.4	78.47%	Not Risk or Prone
152	Diagonal Tension	25.6	18.2	19.2	105.96%	Not Risk or Prone
153	Rocking Failure	19.5	7.4	14.7	199.47%	Not Risk or Prone
154	Rocking Failure	17.9	4.4	13.4	308.27%	Not Risk or Prone
155	Rocking Failure	17.8	3.5	13.3	377.39%	Not Risk or Prone
156	Rocking Failure	17.7	3.5	13.3	384.34%	Not Risk or Prone
157	Rocking Failure	19.3	3.8	14.5	376.64%	Not Risk or Prone
158	Rocking Failure	15.3	6.1	11.5	187.47%	Not Risk or Prone
164	Rocking Failure	13.9	23.4	10.4	44.61%	Risk
165	Diagonal Tension	29.8	37.5	22.3	59.61%	Risk

167	Rocking Failure	6.4	0.6	4.8	839.61%	Not Risk or Prone
168	Rocking Failure	19.5	3.9	14.6	379.37%	Not Risk or Prone
169	Rocking Failure	24.8	13.1	18.6	141.90%	Not Risk or Prone
170	Diagonal Tension	47.4	39.8	35.5	89.37%	Not Risk or Prone
171	Rocking Failure	19.8	12.7	14.9	117.35%	Not Risk or Prone
172	Toe Crushing	11.3	32.3	8.5	26.25%	Prone
173	Rocking Failure	18.3	38.6	13.7	35.67%	Risk
174	Rocking Failure	14.8	31.9	11.1	34.96%	Risk
179	Rocking Failure	18.2	57.1	13.7	23.95%	Prone
180	Diagonal Tension	32.7	31.3	24.6	78.41%	Not Risk or Prone
181	Diagonal Tension	25.5	22.0	19.1	86.92%	Not Risk or Prone
182	Diagonal Tension	26.8	26.4	20.1	76.18%	Not Risk or Prone
183	Diagonal Tension	36.9	45.8	27.7	60.42%	Risk
184	Rocking Failure	15.1	35.2	11.4	32.23%	Prone
190	Rocking Failure	8.5	22.3	6.4	28.53%	Prone
191	Rocking Failure	1.9	5.5	1.5	26.22%	Prone
210	Diagonal Tension	39.1	53.9	29.3	54.38%	Risk
211	Diagonal Tension	42.8	70.9	32.1	45.23%	Risk

The low in-plane shear capacity of a number of the walls was found to be the governing capacity and has resulted in a % NBS of less than 34% for the overall building.

The building has however been assessed as being a potentially Earthquake Prone building as it has achieved less than 34% NBS. As such, GHD Limited recommend that strengthening options be explored in order to increase the % NBS of the building to 67% NBS as recommended by the NZSEE Guidelines.

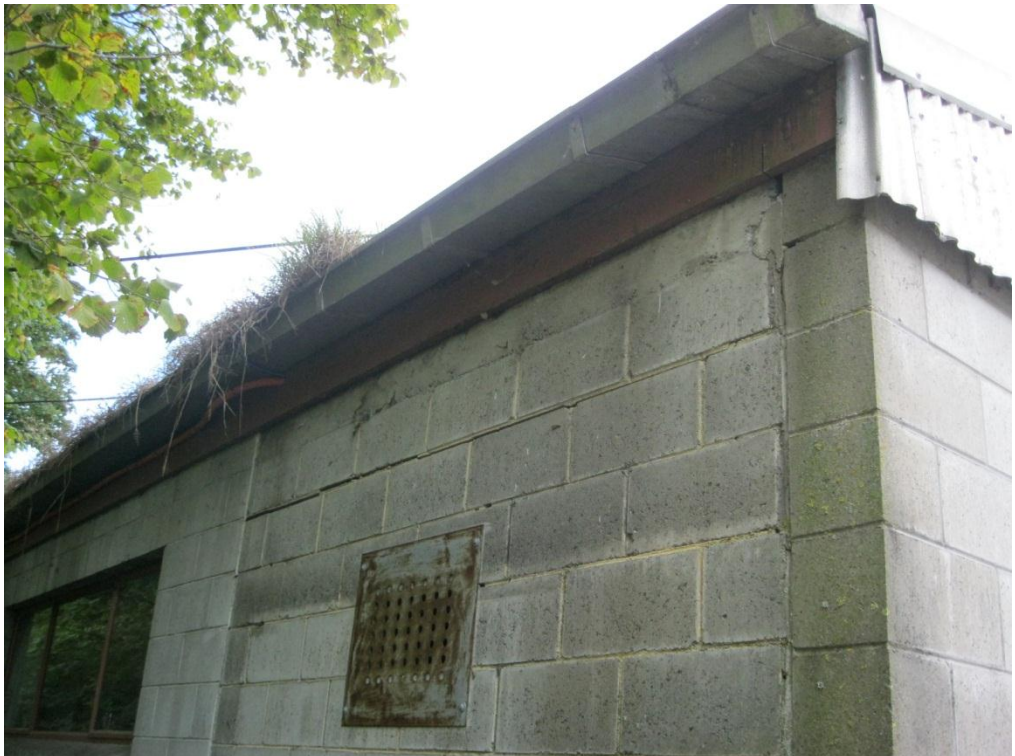
Photograph 4 Connection between pre-1969 pump house and office store building. Horizontal cracking along mortar line is visible.

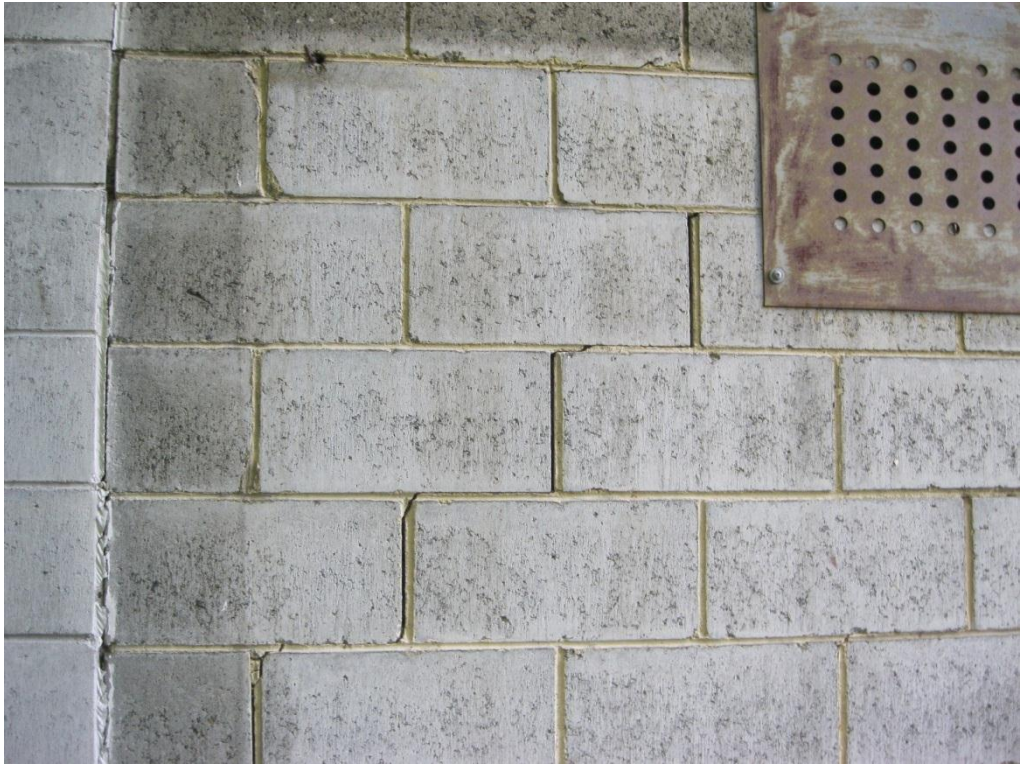
Photograph 5 Cracking to masonry wall of the pre-1969 pump house.

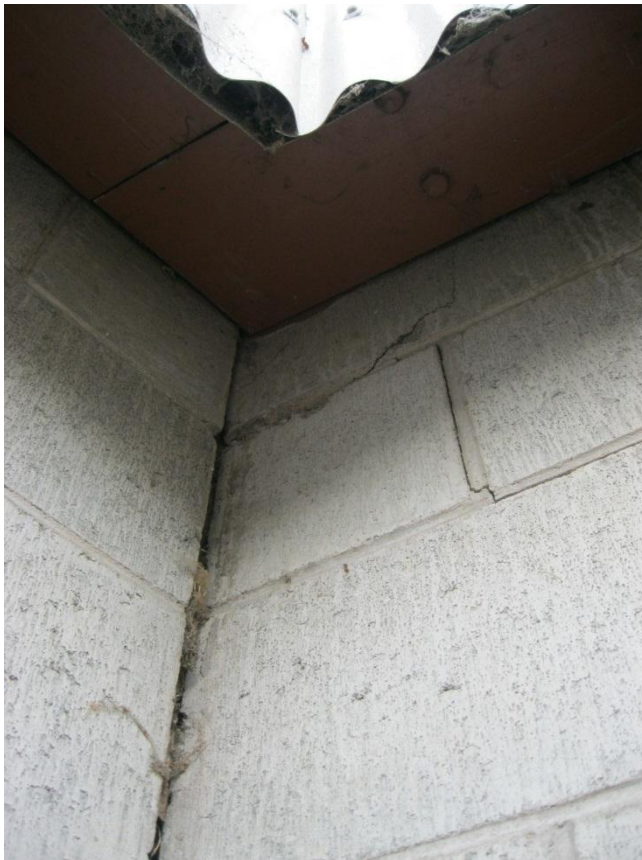
Photograph 6 Cracking to masonry walls at connection between Wings A and B.

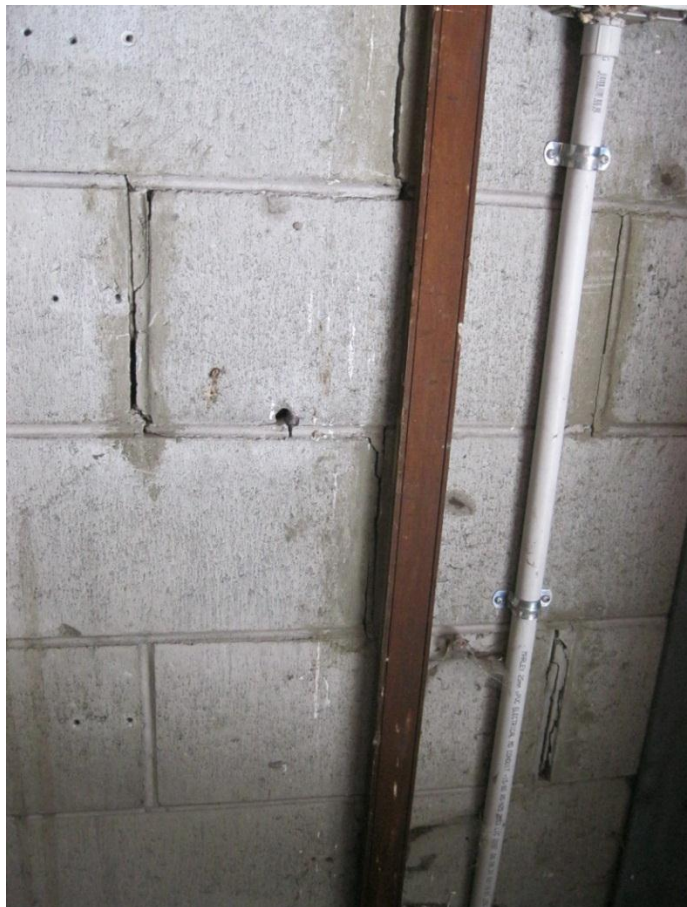
Photograph 8 Cracking to masonry wall at the northern end of Wing B.

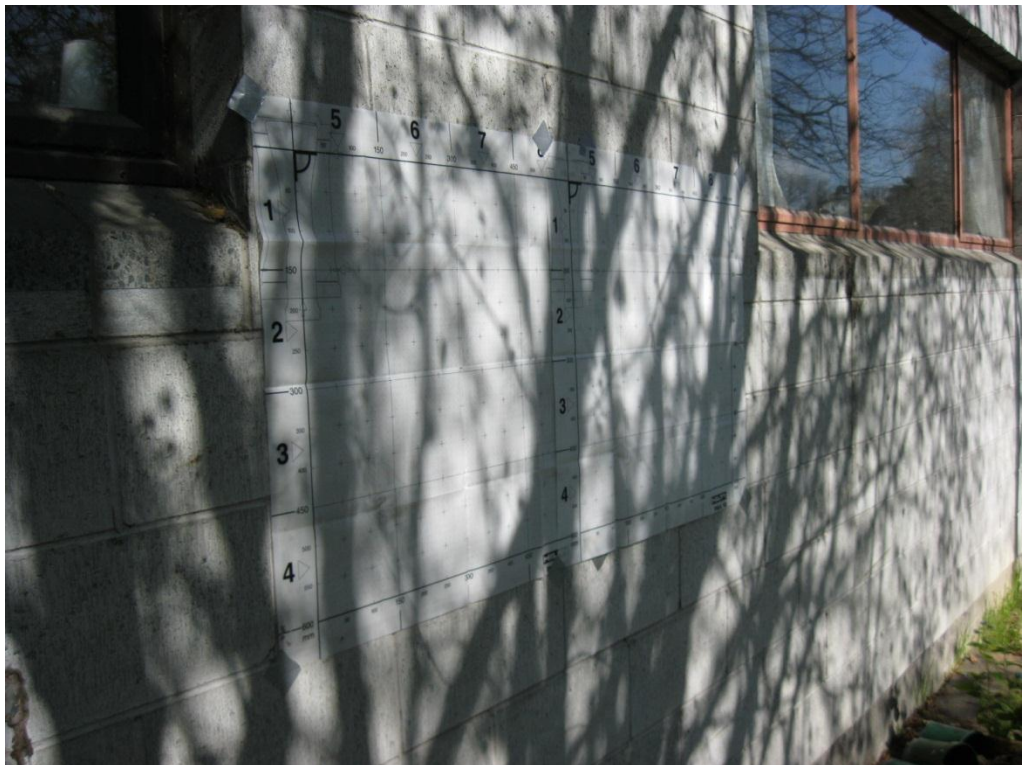
Photograph 14 Electromagnetic scan of wall revealed one single steel bar at locations of intersecting perpendicular walls.
