CHRISTCHURCH CITY COUNCIL

PRK_1566_BLDG_051 EQ2
Peacock Fountain Pumphouse
Rolleston Ave

QUALITATIVE ASSESSMENT REPORT FINAL

- Rev B
- 26 March 2013

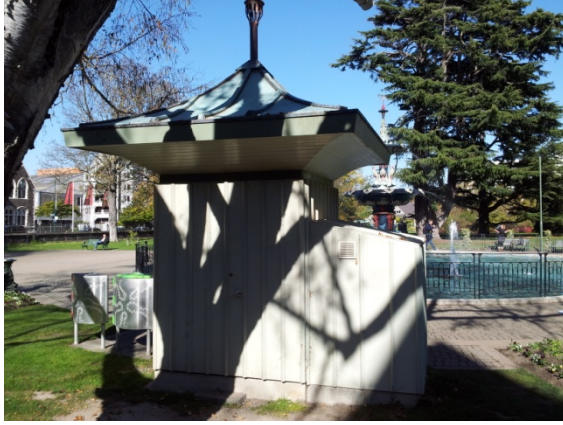
Photo 1: The north elevation of the pump house

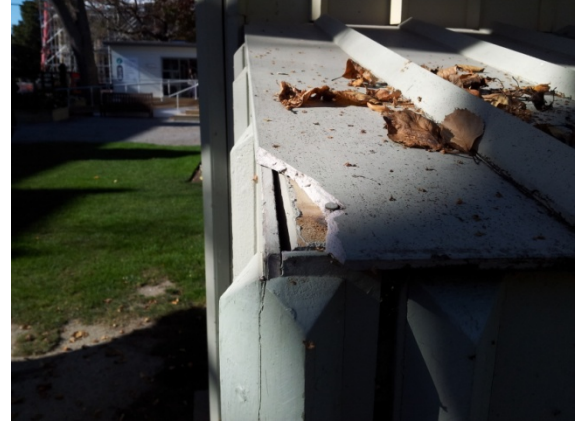
Some damage was found to the external lining on the lean-to on the west side of the structure (see Photo 2). The damage does not alter the strength of the structure and poses a durability issue. It is not clear whether this damage has been caused by the recent earthquakes.

Photo 2: Damage to the external cladding in the north west corner of the pump house lean-to

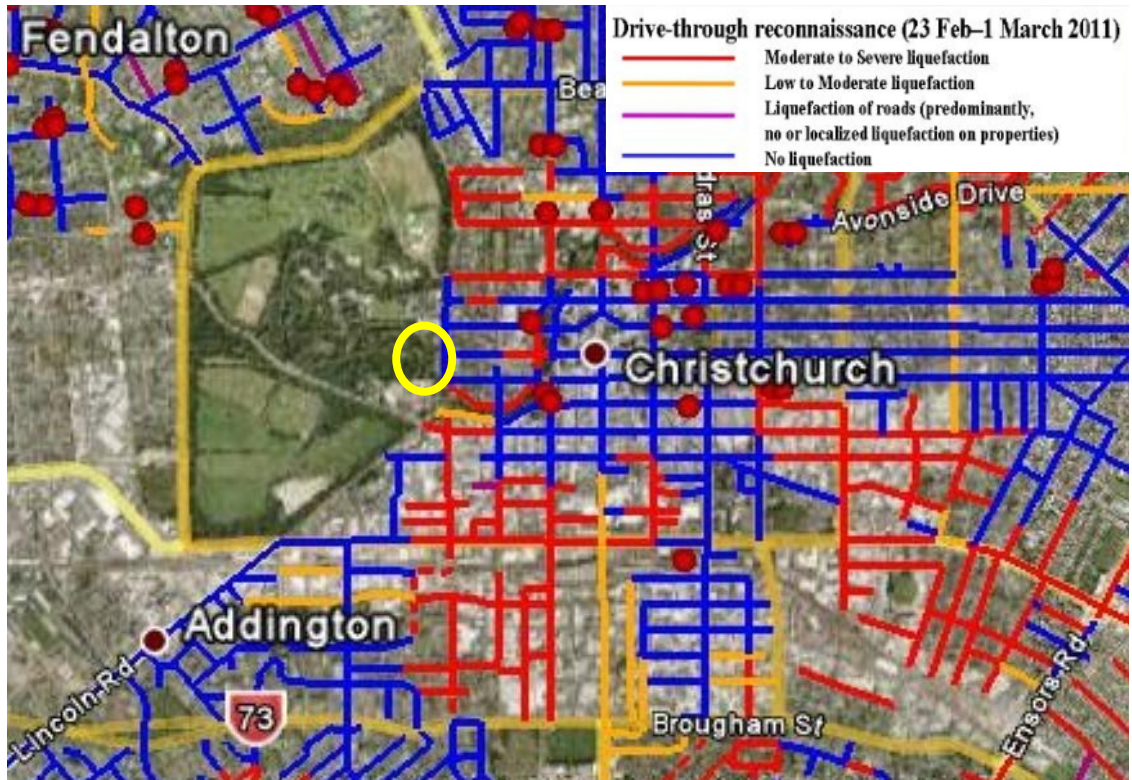
■ Figure 4 – Liquefaction map (Cubrinovski & Taylor, 2011). Site marked in yellow.

Their findings show no liquefaction on Rolleston Avenue to the west of the site.

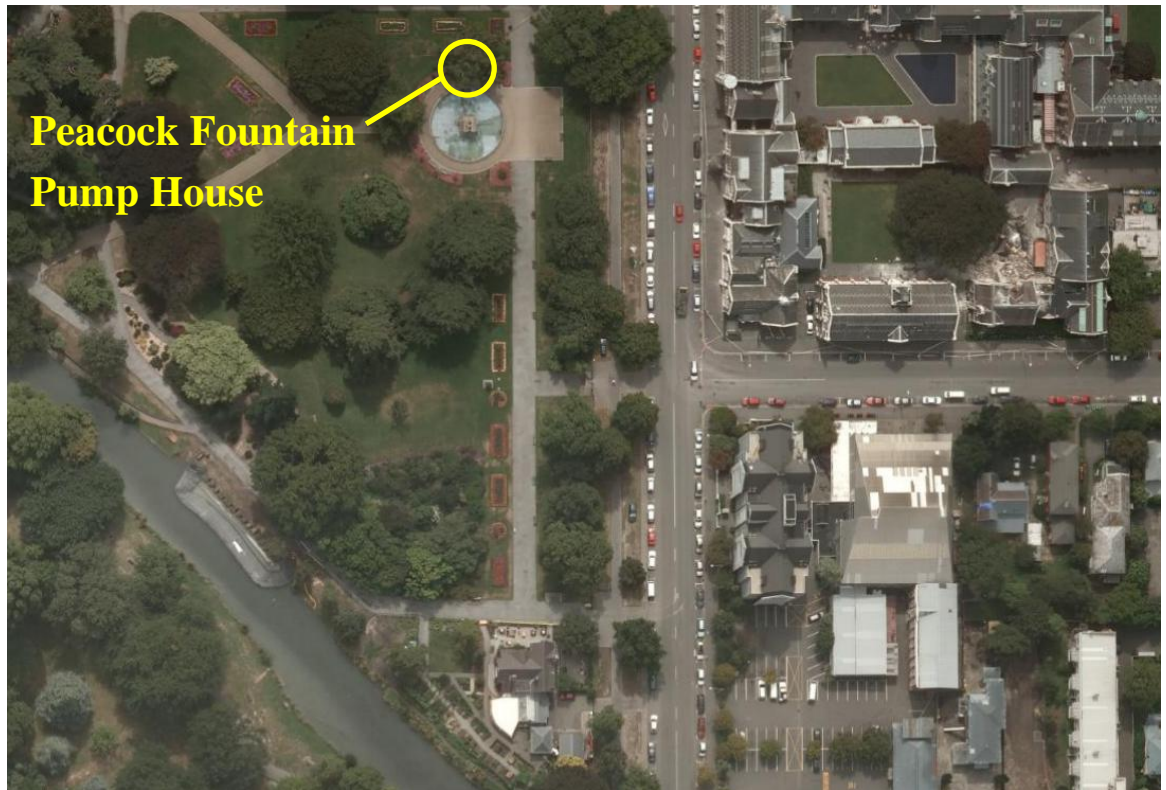
■ **Figure 5 – Aerial photography from 24 Feb 2011 (<http://viewers.geospatial.govt.nz/>)**

Aerial photography shows no evidence of liquefaction or other land damage due to the 22 February earthquake. Additionally, no significant damage to the structure is visible in the aerial photograph.

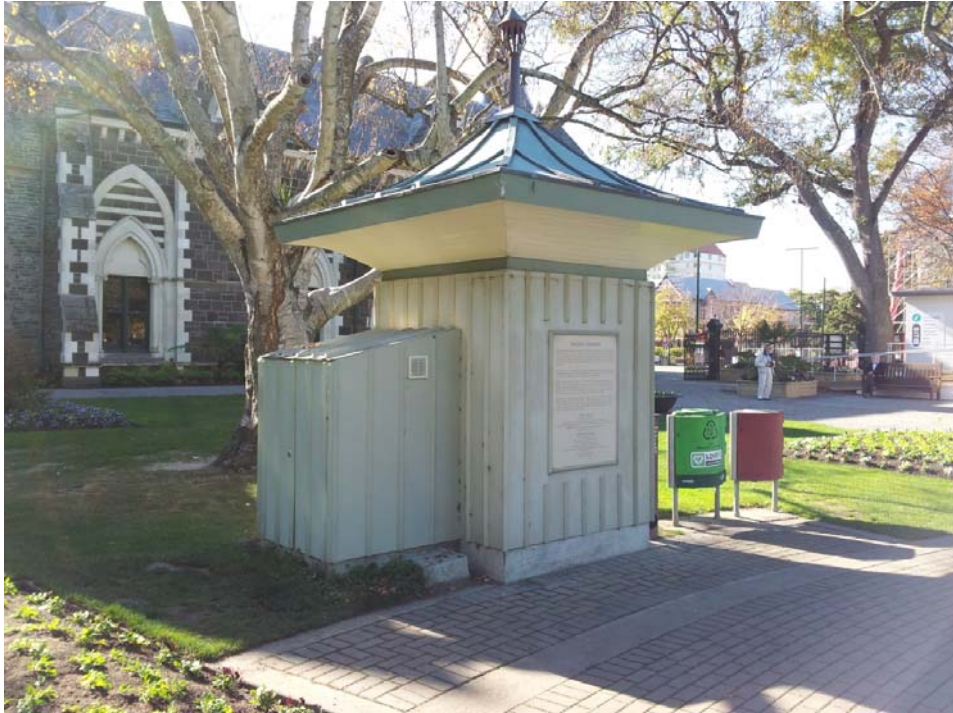
The structure was timber framed building with timber wall cladding, copper roof, and slab on grade foundations.

■ **Figure 7 - Overview of the pump house**

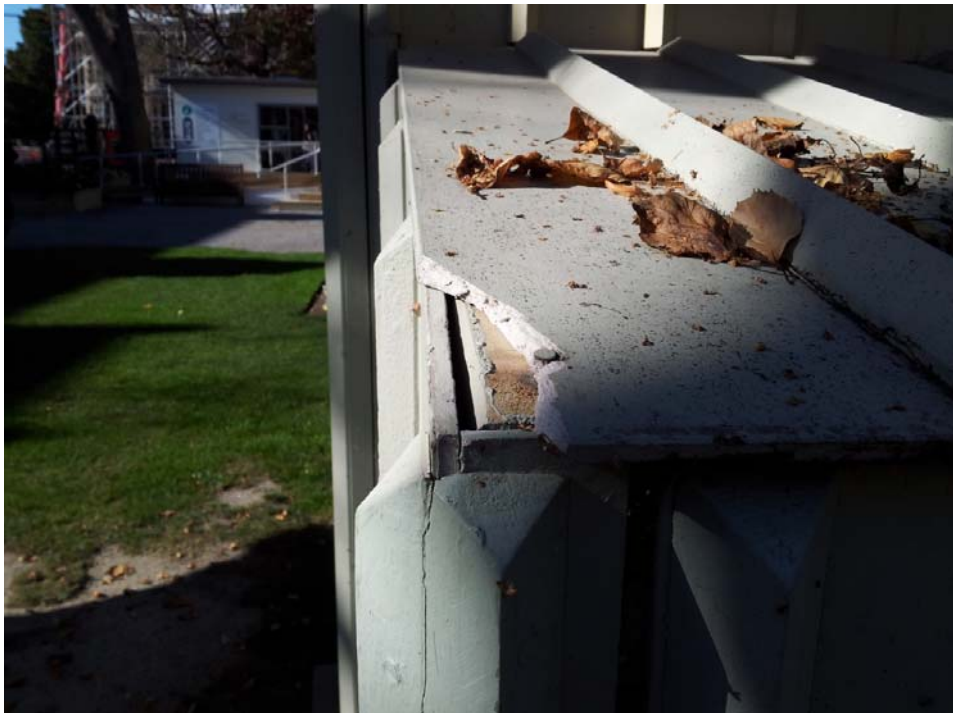
Minor separation between internal wall linings and damage to the roof of the lean-to at nail points was observed; otherwise no obvious structural damage was noted from the external site inspection. Additionally, there was no evidence of liquefaction or any land damage around the site.

■ **Figure 8 - Damage to the roof of the lean-to**
