Bottle Lake Forest Park Meeting
Room
Qualitative Engineering Evaluation

Reference: 228590
Prepared for:
Christchurch City Council

Functional Location ID: PRK 0158 BLDG 003 EQ2

Date: 21 December 2012

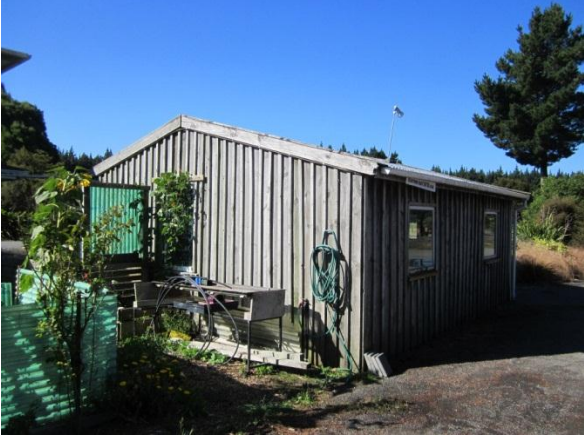
<p>Elevation showing the gable wall of the meeting room</p>

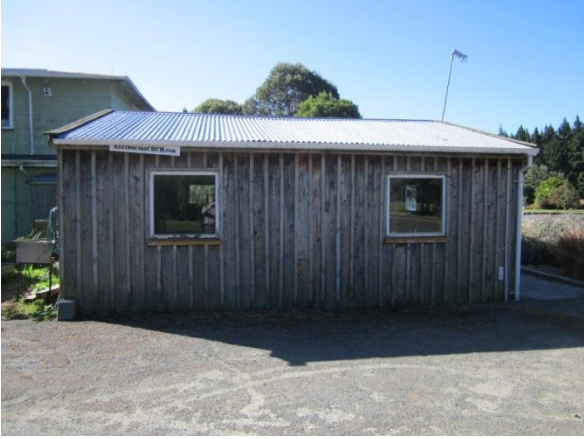
<p>Elevation showing the hip roof of the meeting room</p>

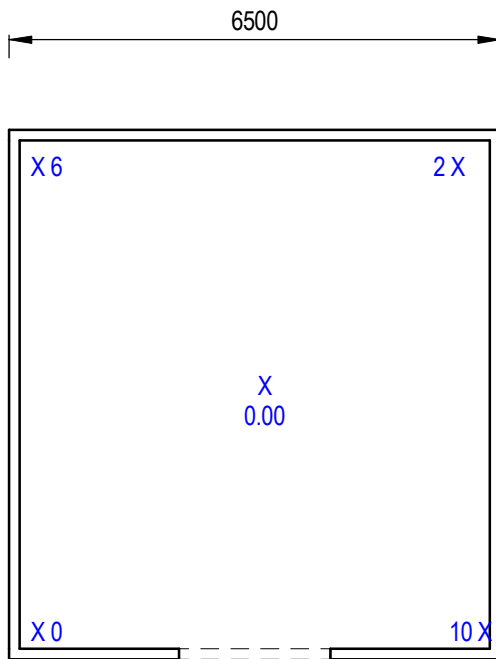
PROJECT
BOTTLE LAKE FOREST MEETING ROOM
TITLE
LEVEL SURVEY

The levels survey shows that existing floor levels are within acceptable limits.
