**Bottle Lake - Office & Mess Room  
Qualitative Engineering Evaluation**

**Reference:** 228591

**Prepared for:**  
Christchurch City Council

**Date:** 11 October 2013

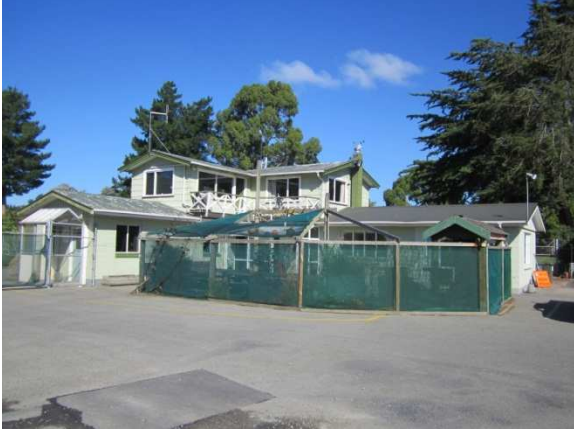
<p>North western elevation of the Office and Mess Room.</p>

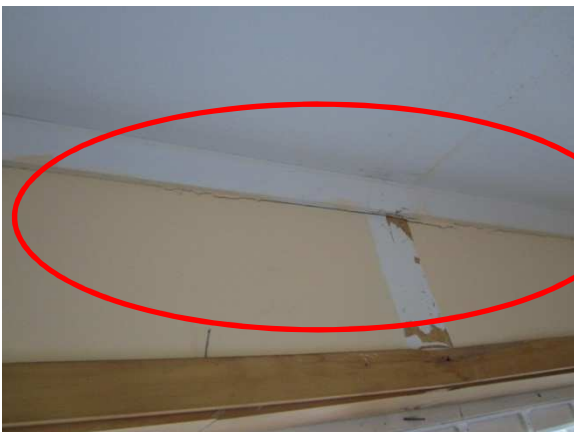
A photograph showing the eastern elevation of the building. It features a prominent gable roof and a small white entrance structure. The building is surrounded by trees and a paved area.
<p>Cracking in plaster board from the interior of the building</p>

An interior photograph of a room with white walls and a ceiling. A red oval highlights a significant crack in the white plaster board where it meets the ceiling.

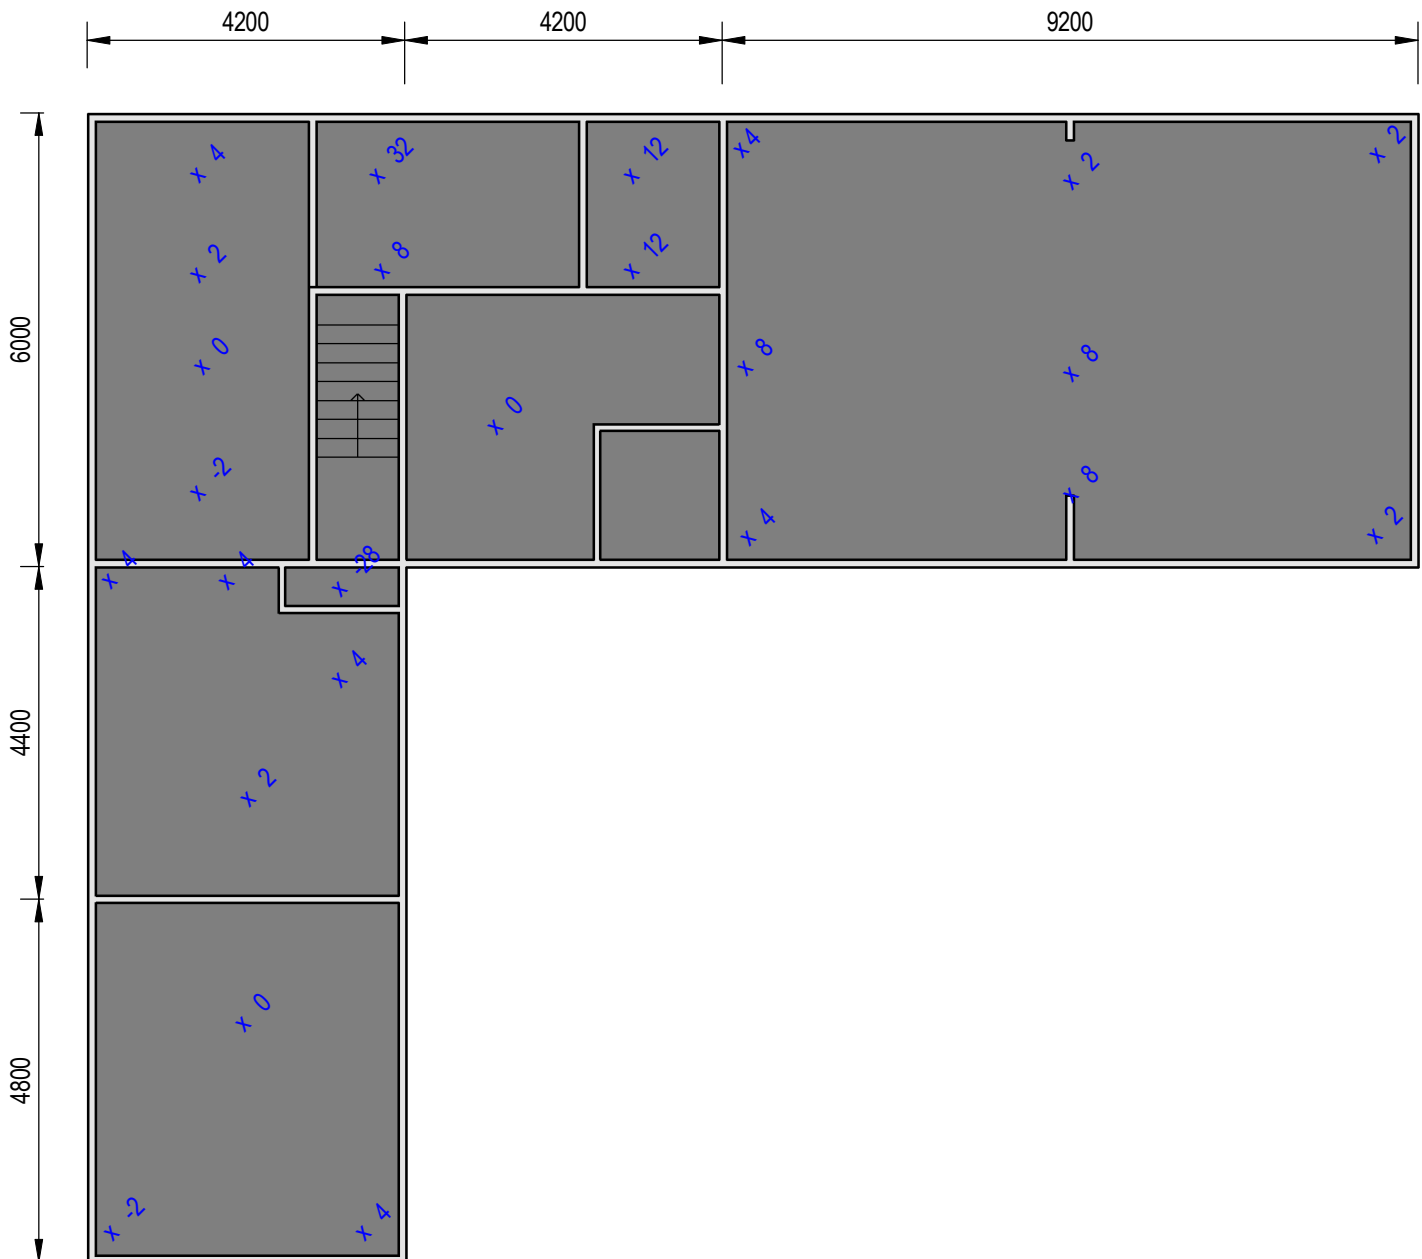
# GROUND LEVEL FLOOR LEVELS PLAN

A floor level survey was undertaken to establish the level of unevenness across the floors. The results of the survey are presented on the attached sketch in Appendix A. All of the levels were taken on top of the existing floor coverings which may have introduced some margin of error.

The floor levels for the Bottle Lake - Office & Mess Room are considered to be within the recommended tolerances above.

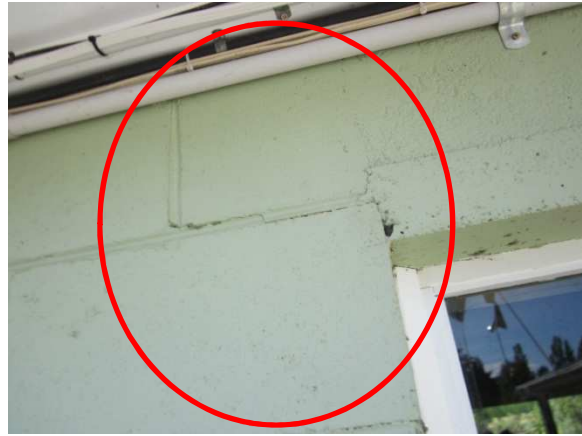
Cracking in mortar joints above window opening

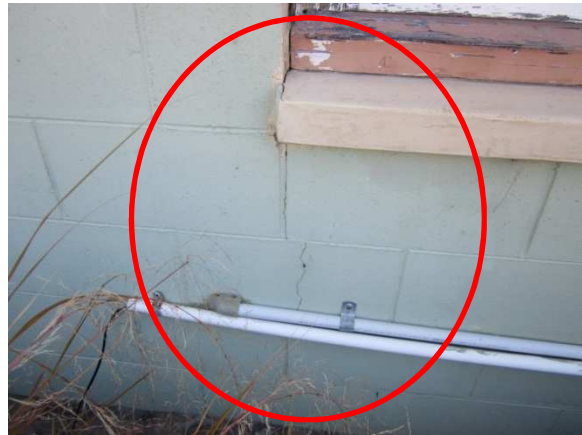
Cracking in mortar joints below window opening
