Christchurch City Council
PRK_2210_BLDG_001 EQ2
Toilets – Broadhaven Park
Rothesay Rd/Bower Ave

QUALITATIVE ASSESSMENT REPORT
FINAL

- Rev B
- 23 May 2013

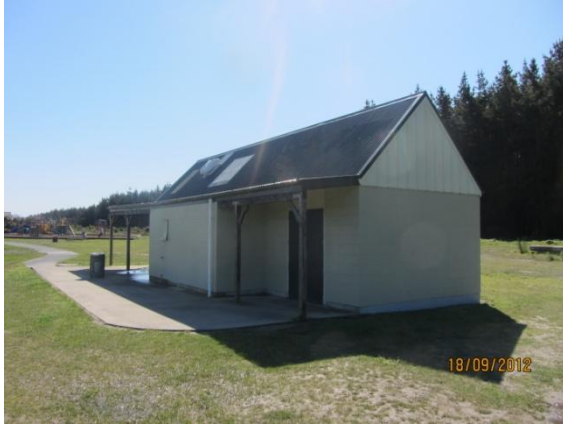
Photo 1: View of Broadhaven Park toilets

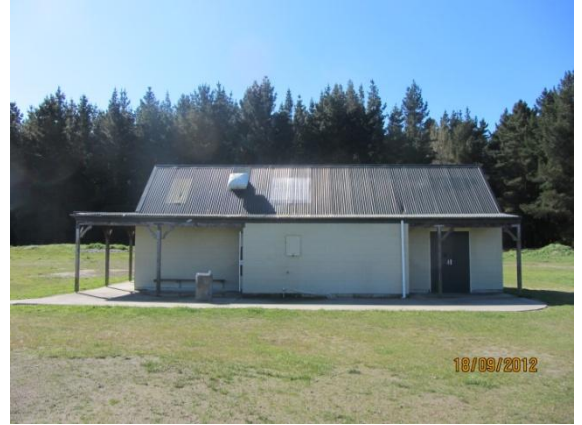
Photo 2: South elevation

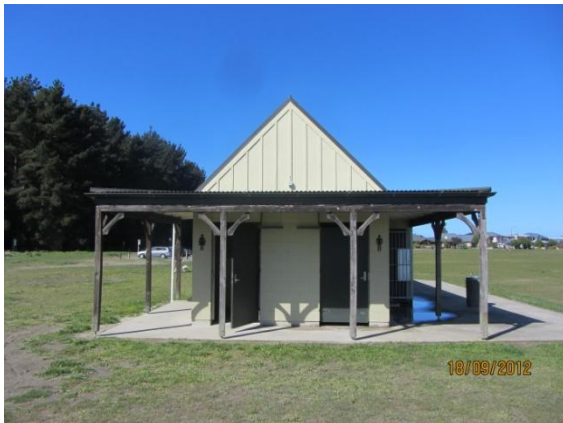
Photo 3: West elevation

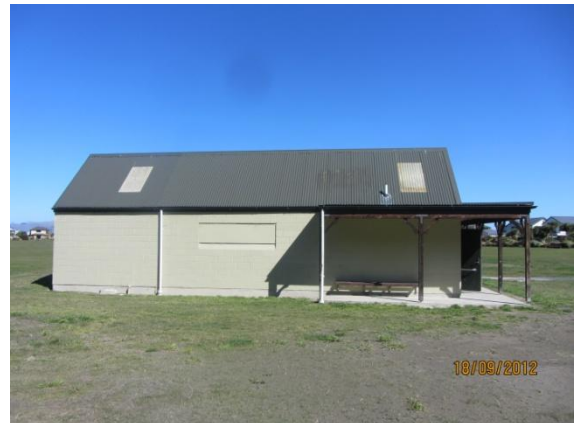
Photo 4: North elevation

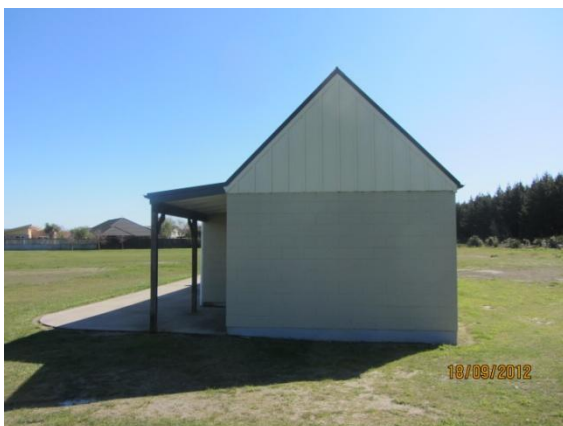
Photo 5: East elevation

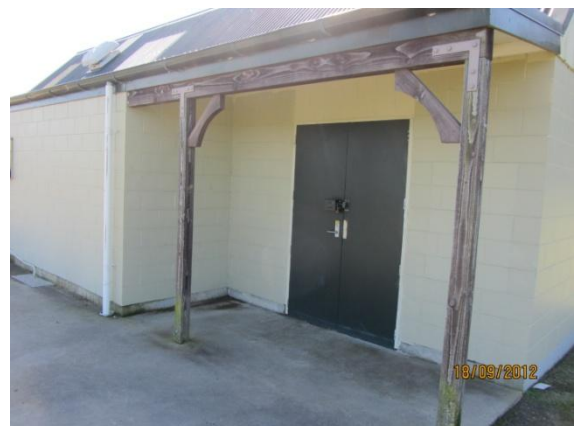
Photo 6: View of east room

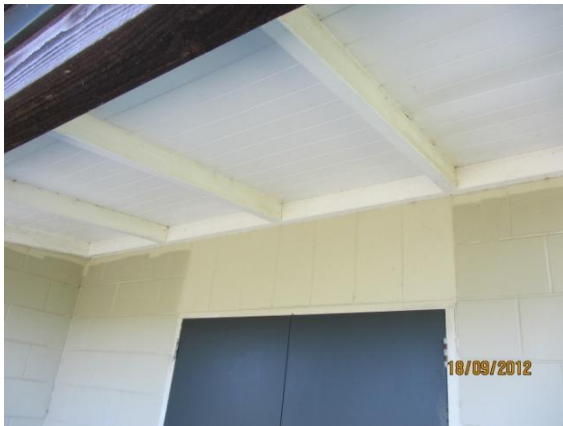
Photo 7: View of ceiling
