Bromley Community Centre
BU 0897-001 EQ2
Detailed Engineering Evaluation
Quantitative Report
Christchurch City Council

Detailed Engineering Evaluation Quantitative Report

Date: October 2012
Reference: 6-QUCCC.89
Status: Final

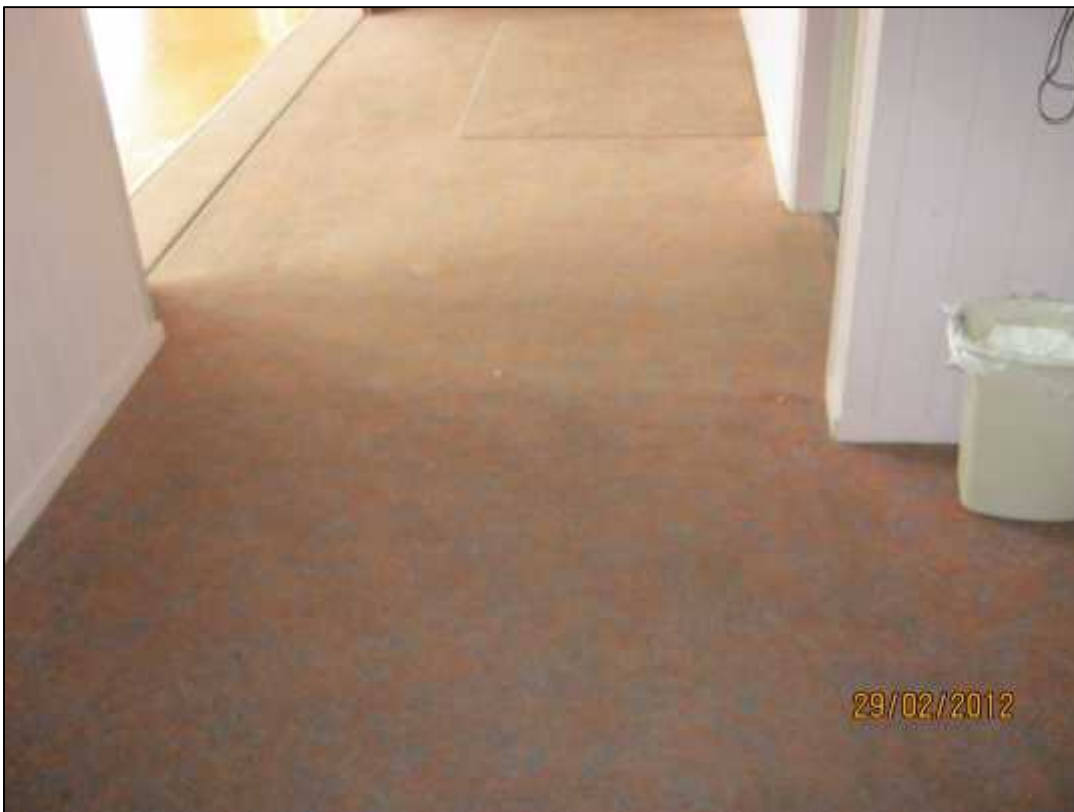
We observed evidence of floor heaving in front of the kitchen area and in the toilet at the northwest corner of the building (Appendix 1: Photograph 4).

Photograph 4: Floor heaving outside the kitchen

- a) Repair work to remedying the observed damage be carried out
- b) The building be strengthened to at least 67% NBS.

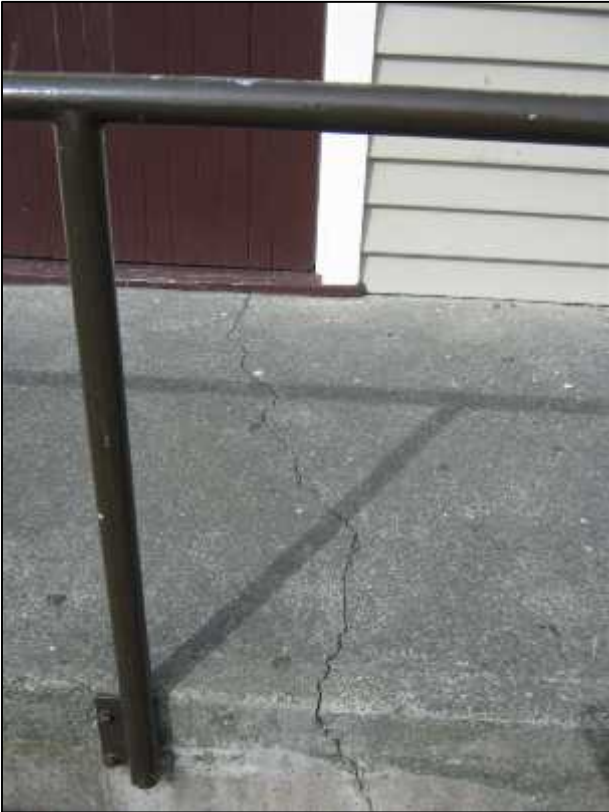
There are some non-structural cracks present in the footpaths and access ramp (Appendix 1: Photograph 5).

Photograph 5: Cracks in the concrete access ramp

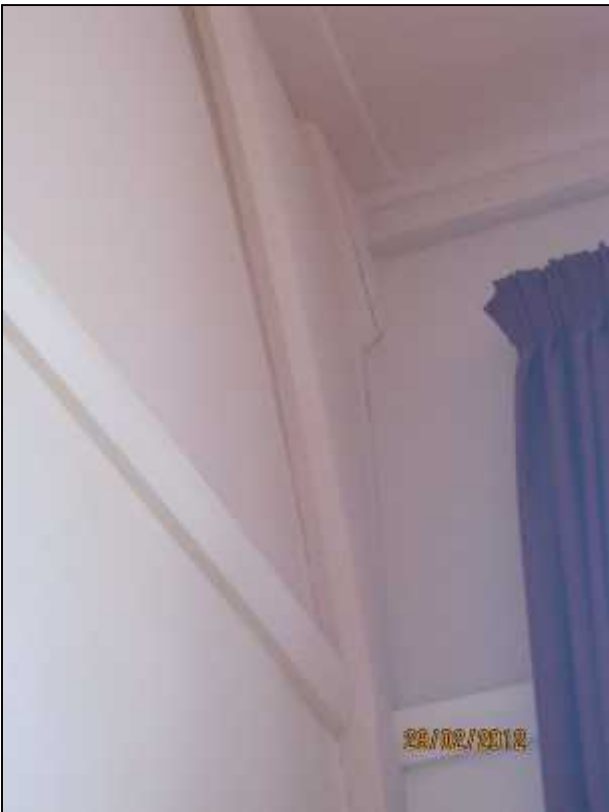
There are cracks present in the timber rafter near its support in the hall area (Appendix 1: Photograph 6).

Photograph 6: Cracks in the timber rafter support

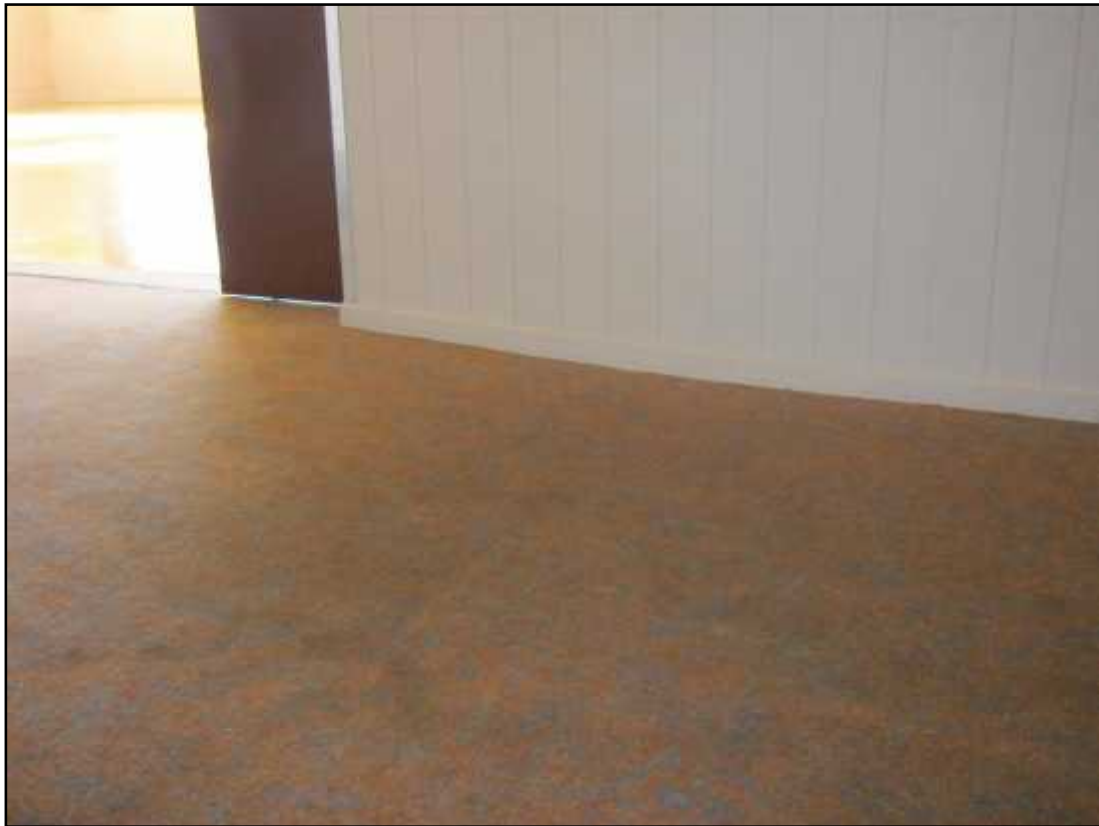
Photograph 6: View of bulging in floor to the front of the kitchen area.

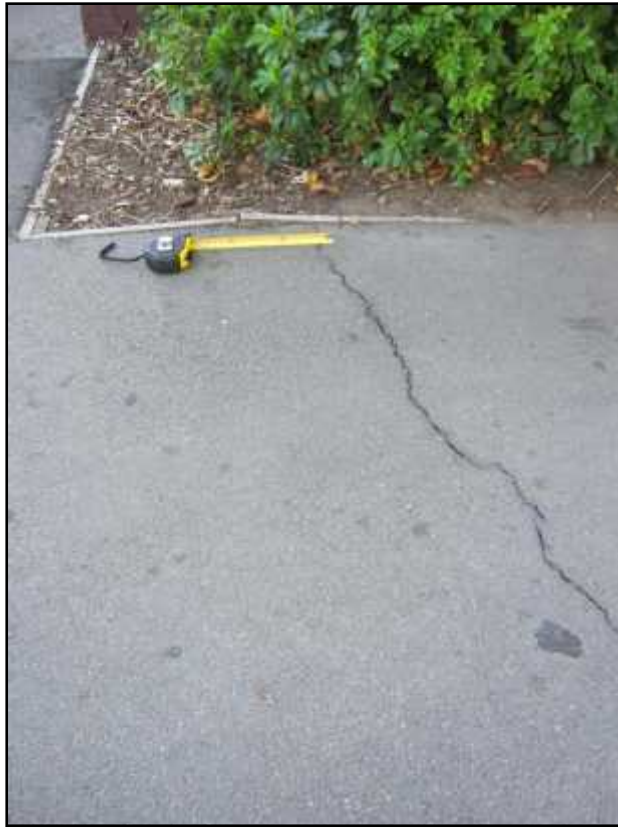
Photograph 7: cracking in footpath, south west corner.

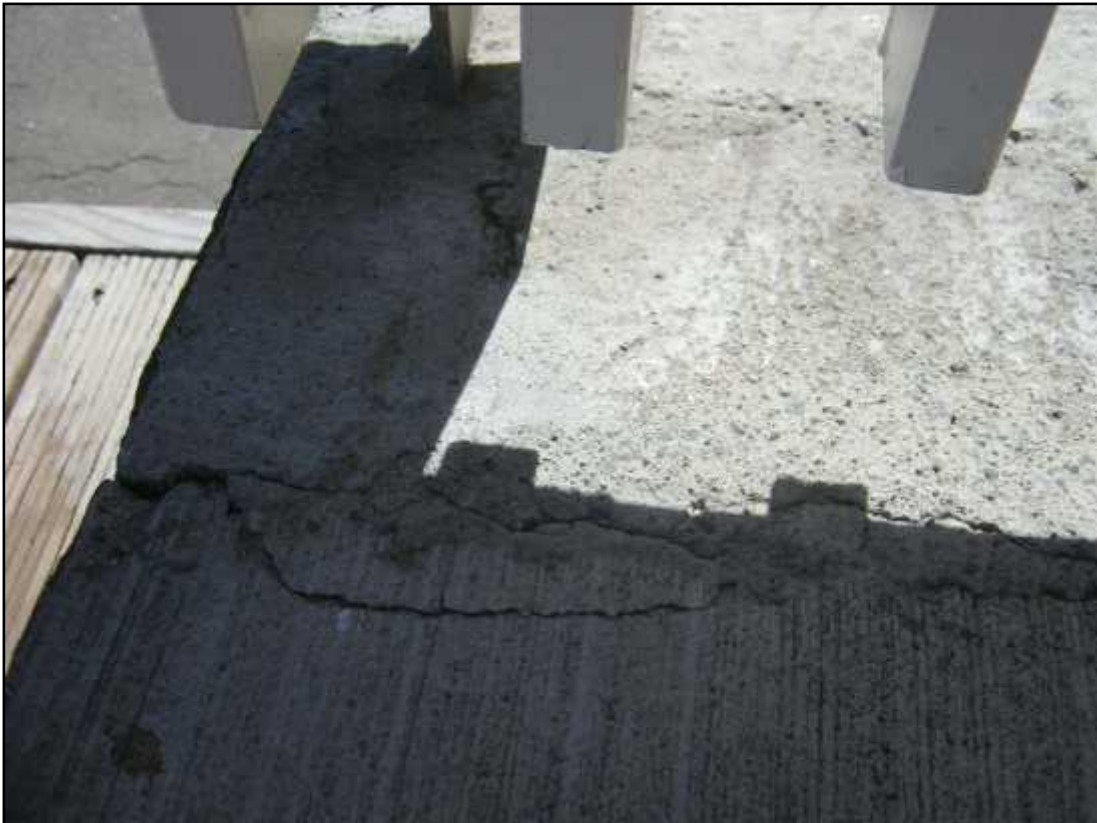
There is some minor cracking of the concrete around the support column in the north west corner porch.

Photograph 8: cracking around support column to porch, northwest corner.

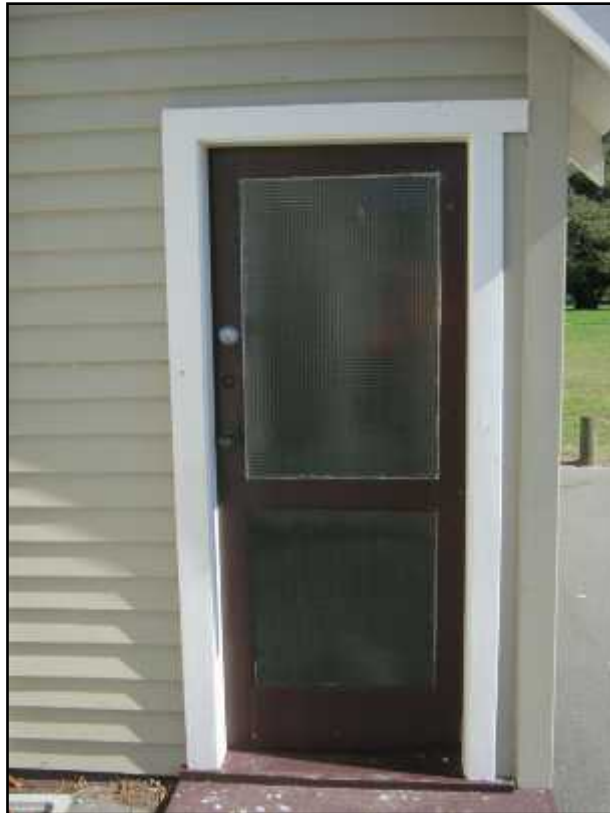
Photograph 9: Rear door way, northwest corner. Minor distortion to door frame.

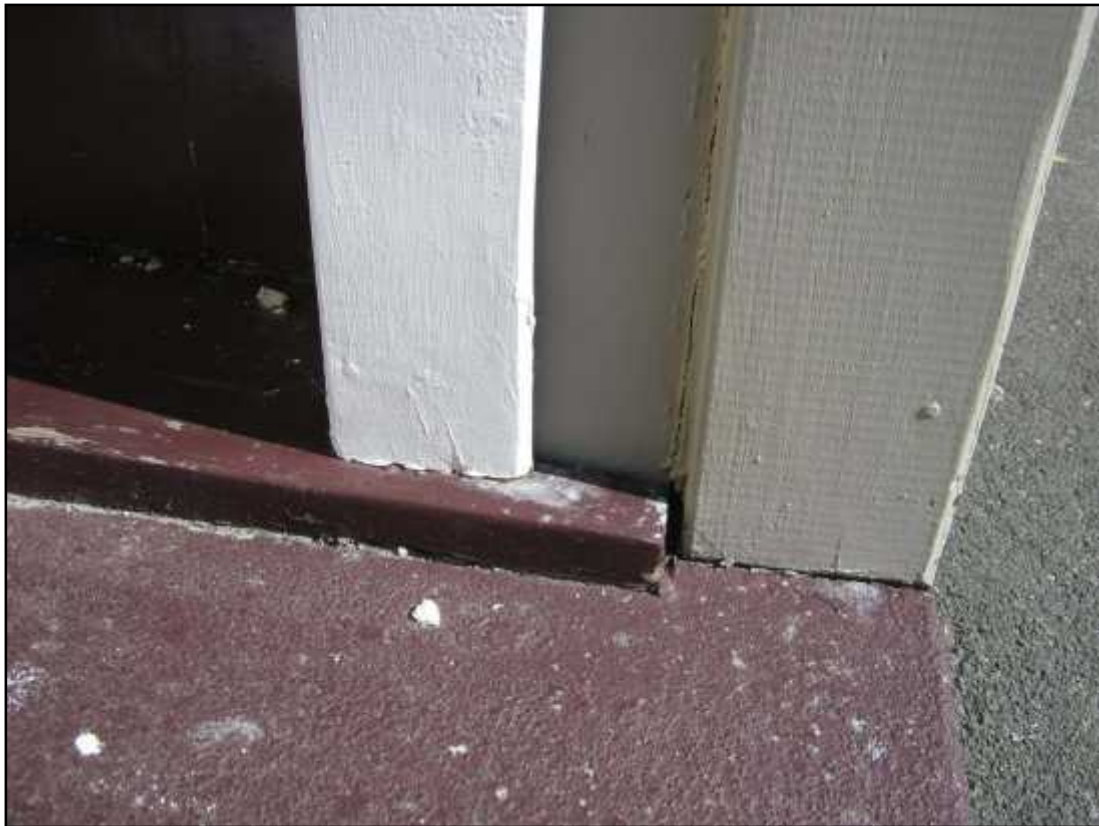
Photograph 10: Separation between rear door step and building frame/facing.

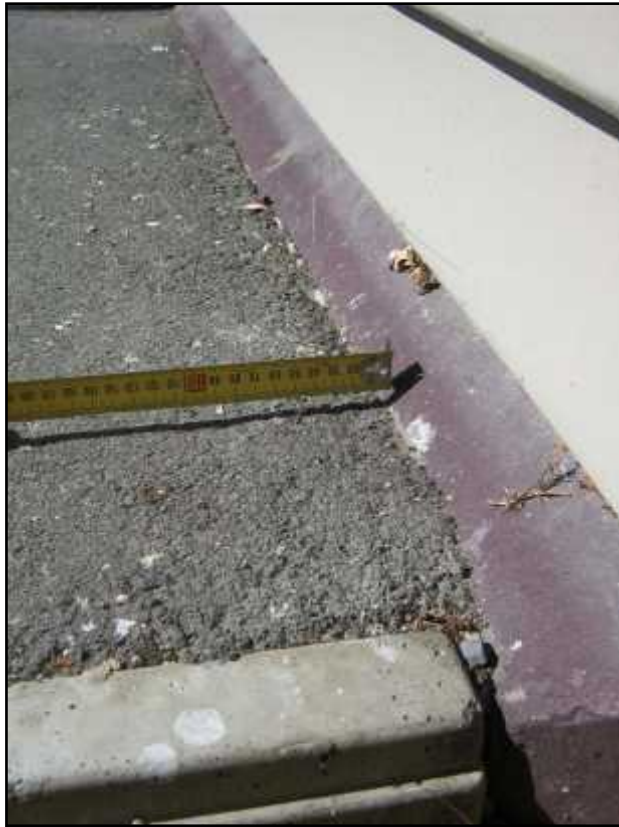
Photograph 11: Possible separation of asphalt seal away from footings (north face).

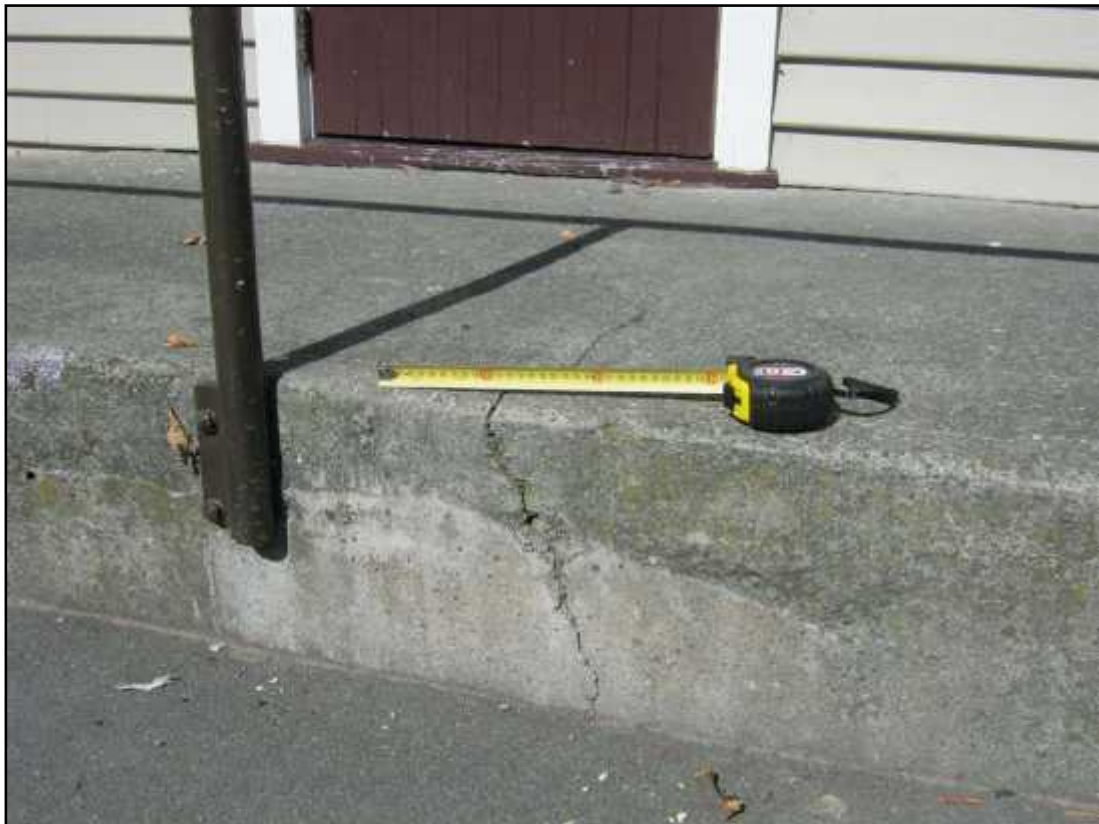
Photograph 12: 2mm wide cracking in rear access ramp (north face).

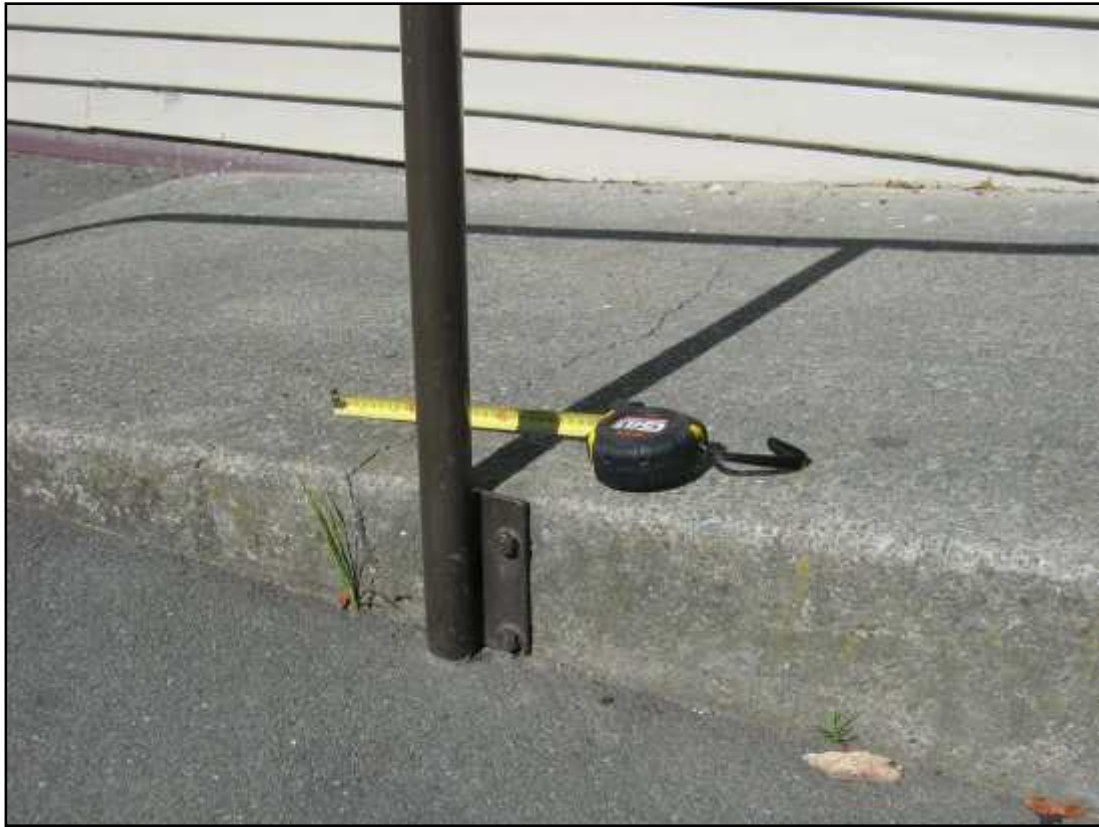
Photograph 13: 2mm wide cracking in rear access ramp (north face).

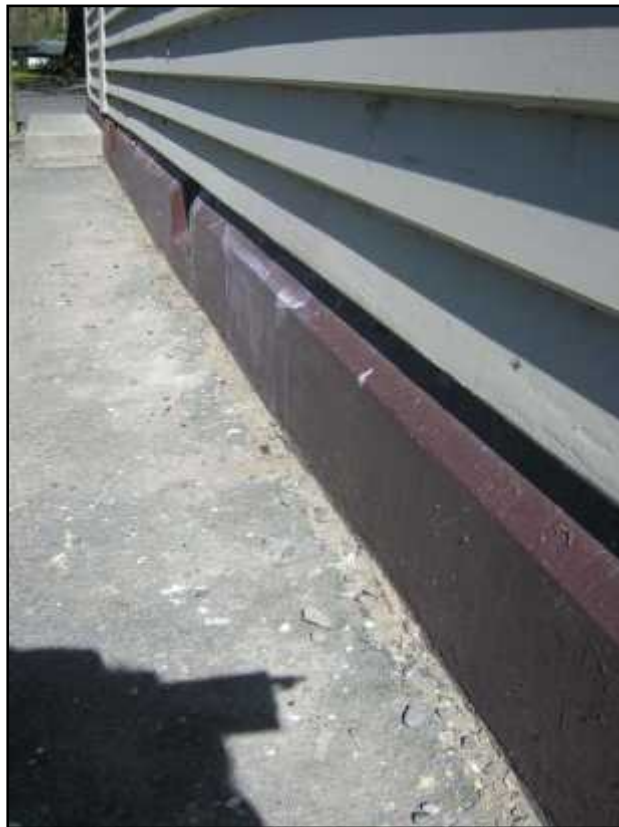
Photograph 14: Up to 50mm separation of asphalt seal away from footings (east face).

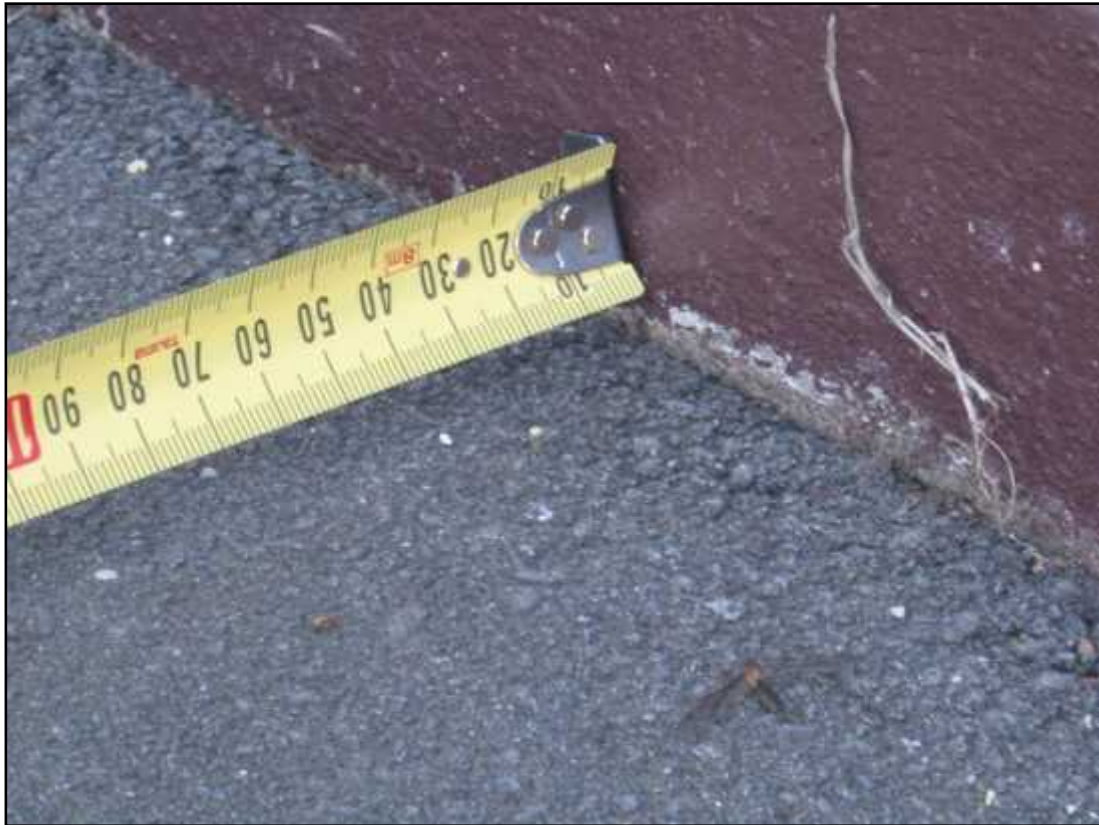
Photograph 15: Possible separation of asphalt seal away from footings (south face).

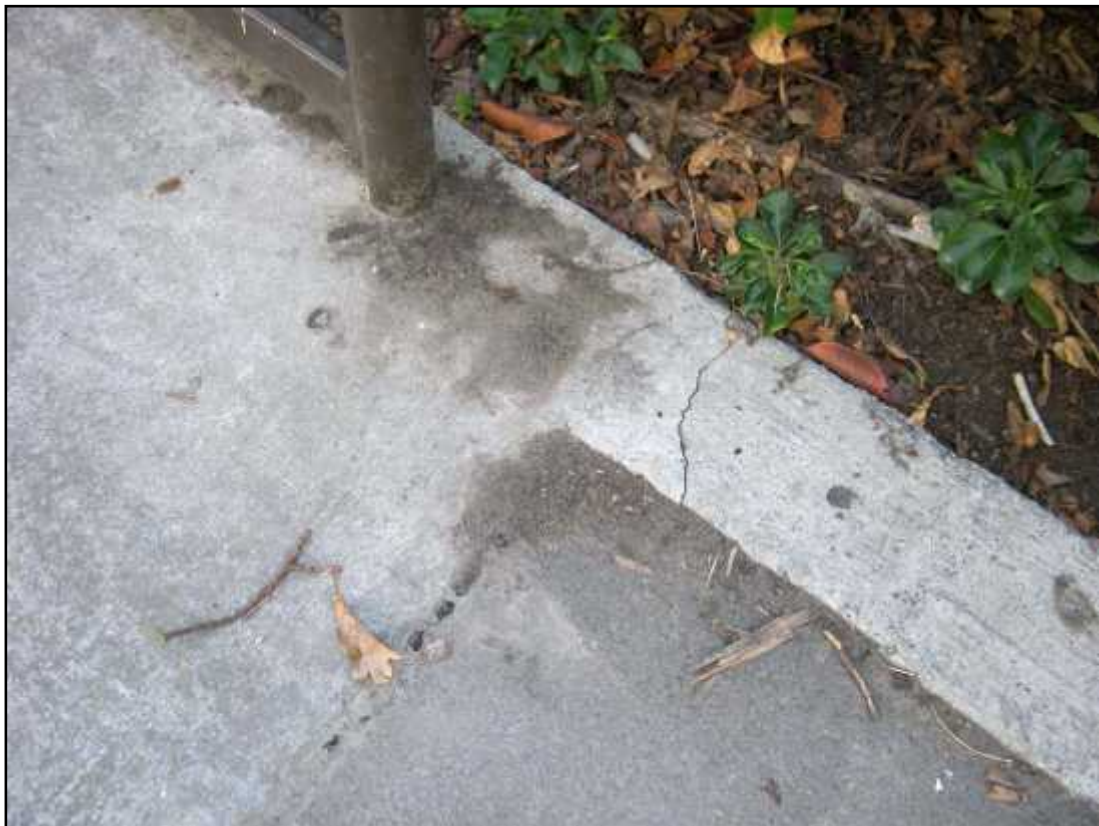
Photograph 16: Cracking in access ramp (south face).
