**Brougham Village Blocks A to E  
Detailed Engineering Evaluation  
Quantitative Report**

Christchurch City Council

Date: 3 October 2012  
Reference: 6-QUCCC.92

Detailed Engineering Evaluation  
Quantitative Report - SUMMARY  
Version 4 - Final

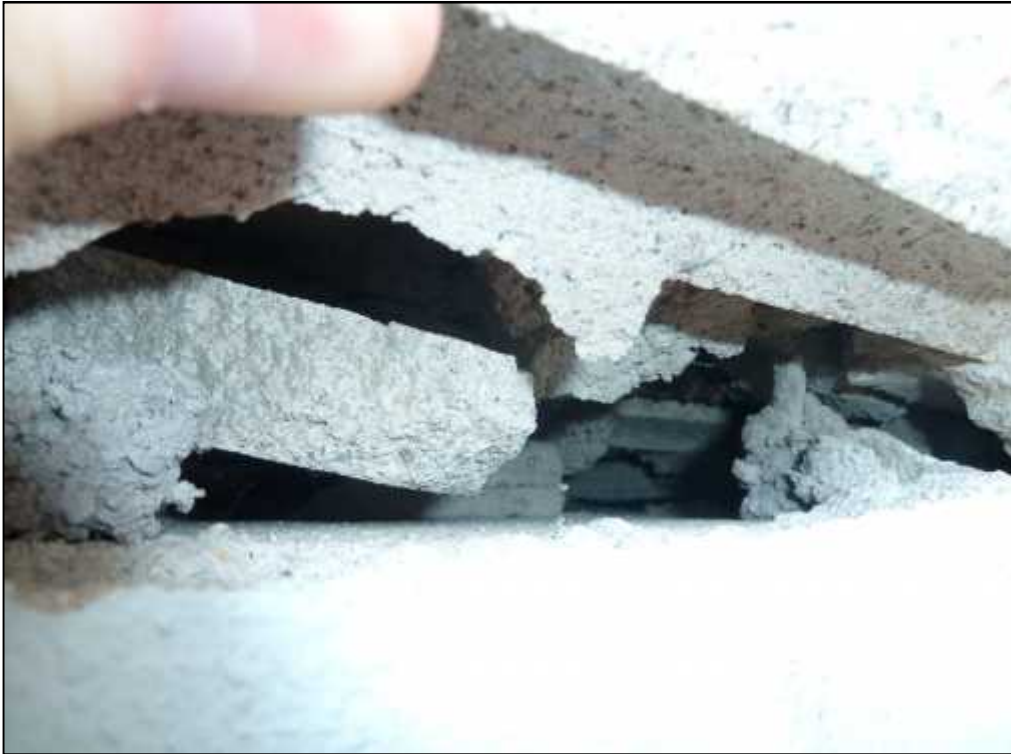
*Photo 6: Cracking of suspended slab*

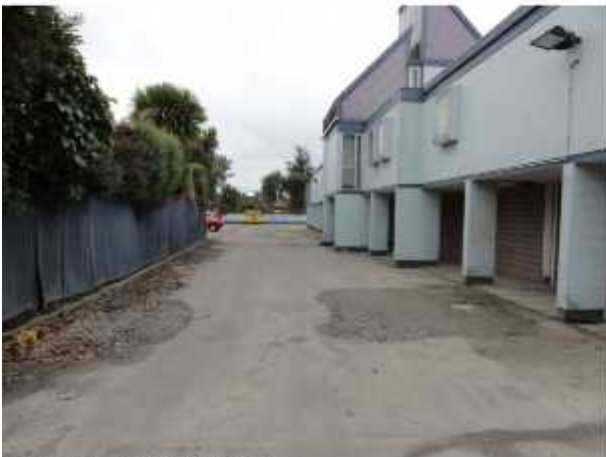
View East, damage to Asphalt

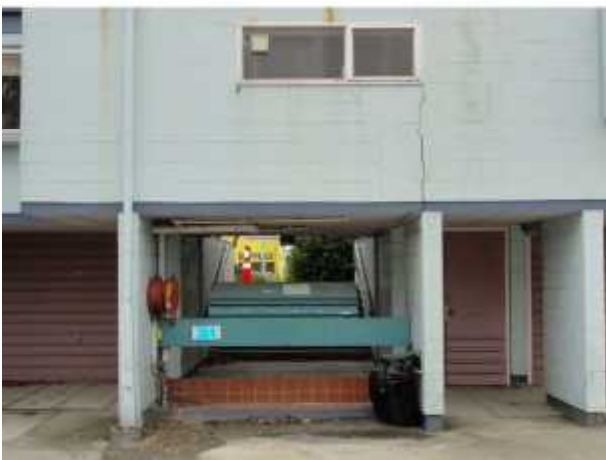
Structural Damage to 2<sup>nd</sup> and 3<sup>rd</sup> Storey at Unit 364

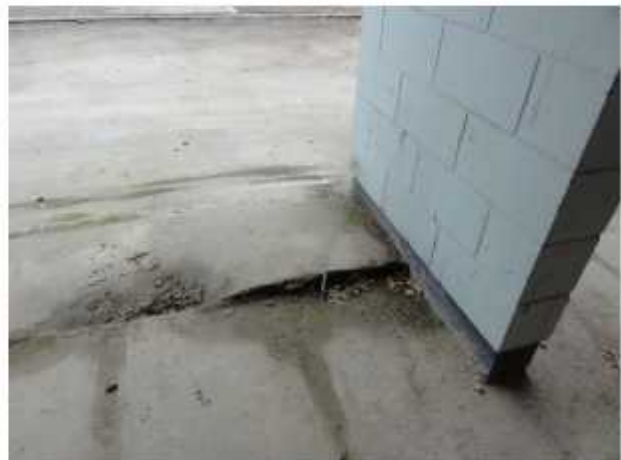
Ground Heave at footing adjacent to Unit 364

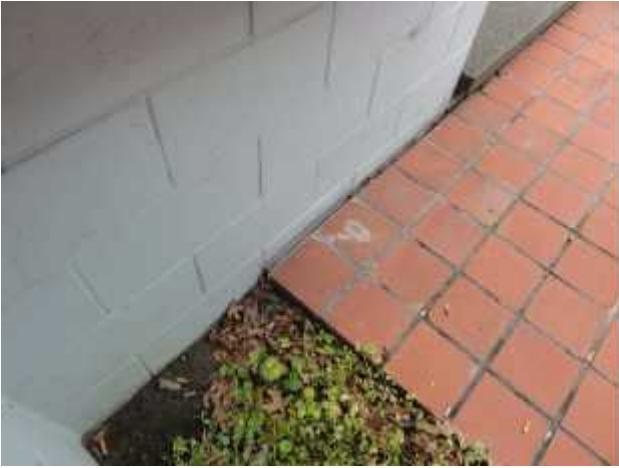
10mm crack, movement towards Brougham Street at Unit 368

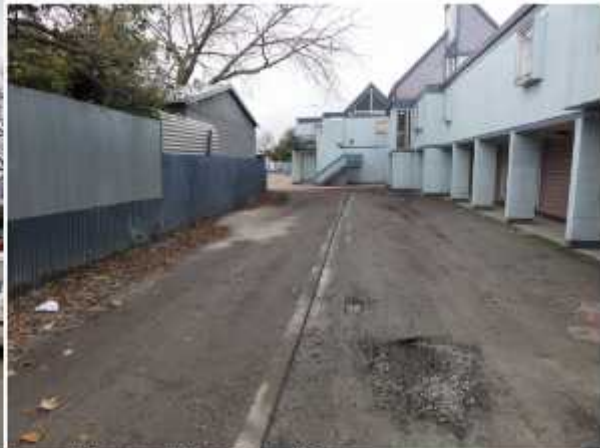
Heave and damage to driveway.

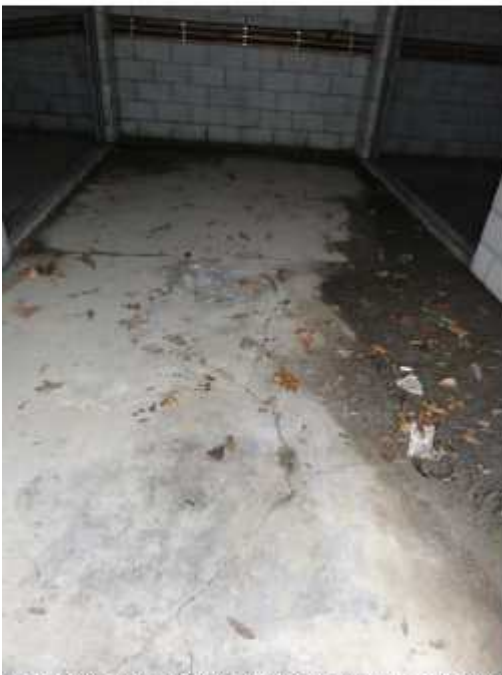
Garage 33 near Unit 388 crack in floor slab and liquefaction

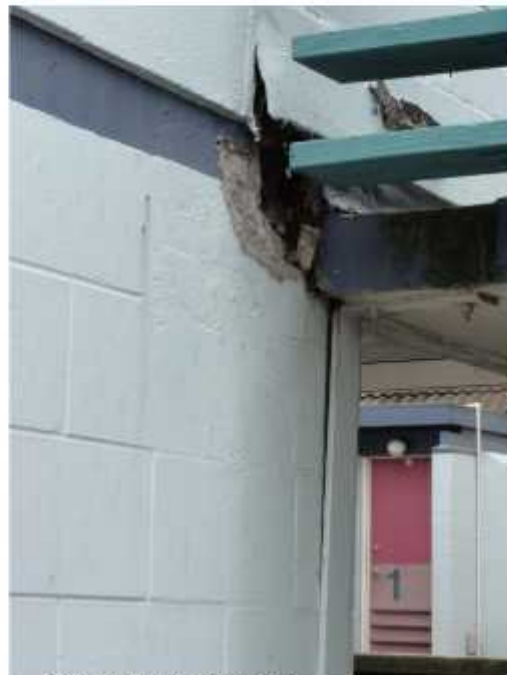
Typical Structural Damage

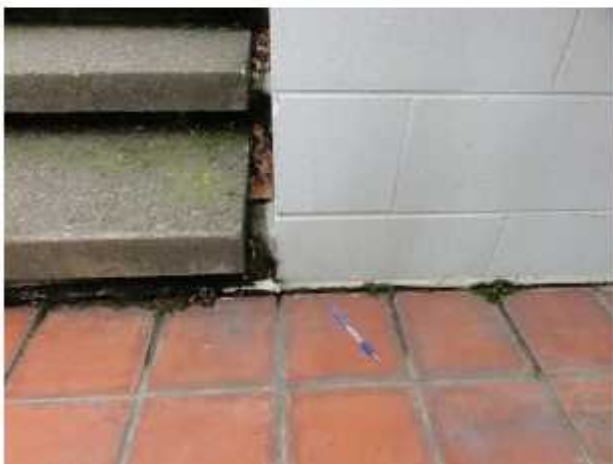
10mm settlement of patio tiles

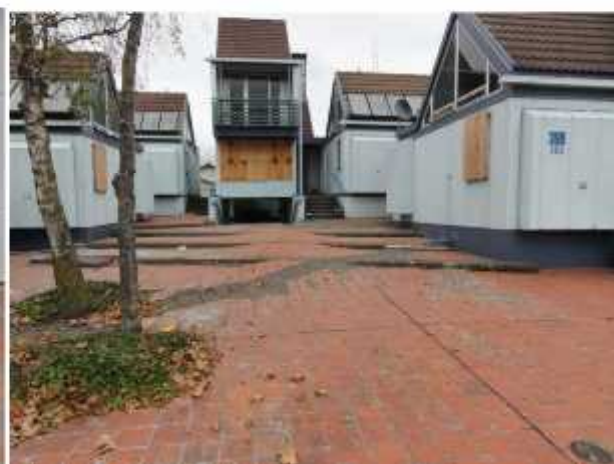
Typical damage to buried services

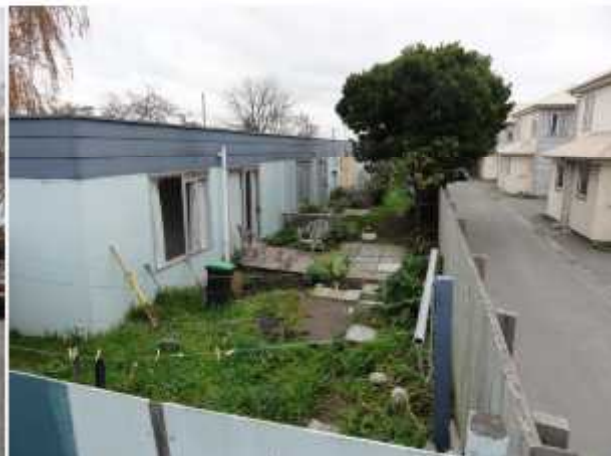
No visible damage, unit 2 yellow stickered due to severe liquefaction

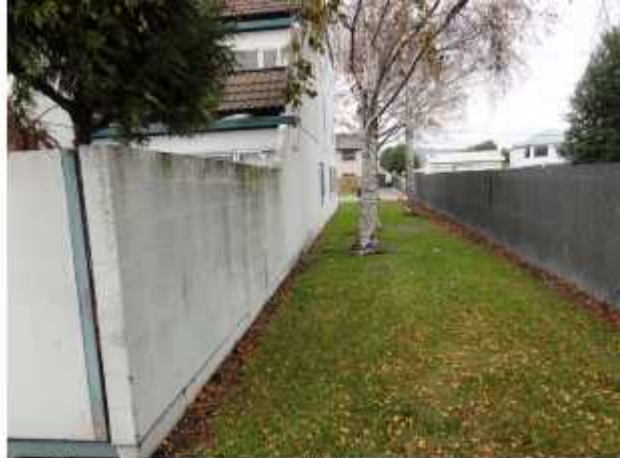
Western limit, no damage visible

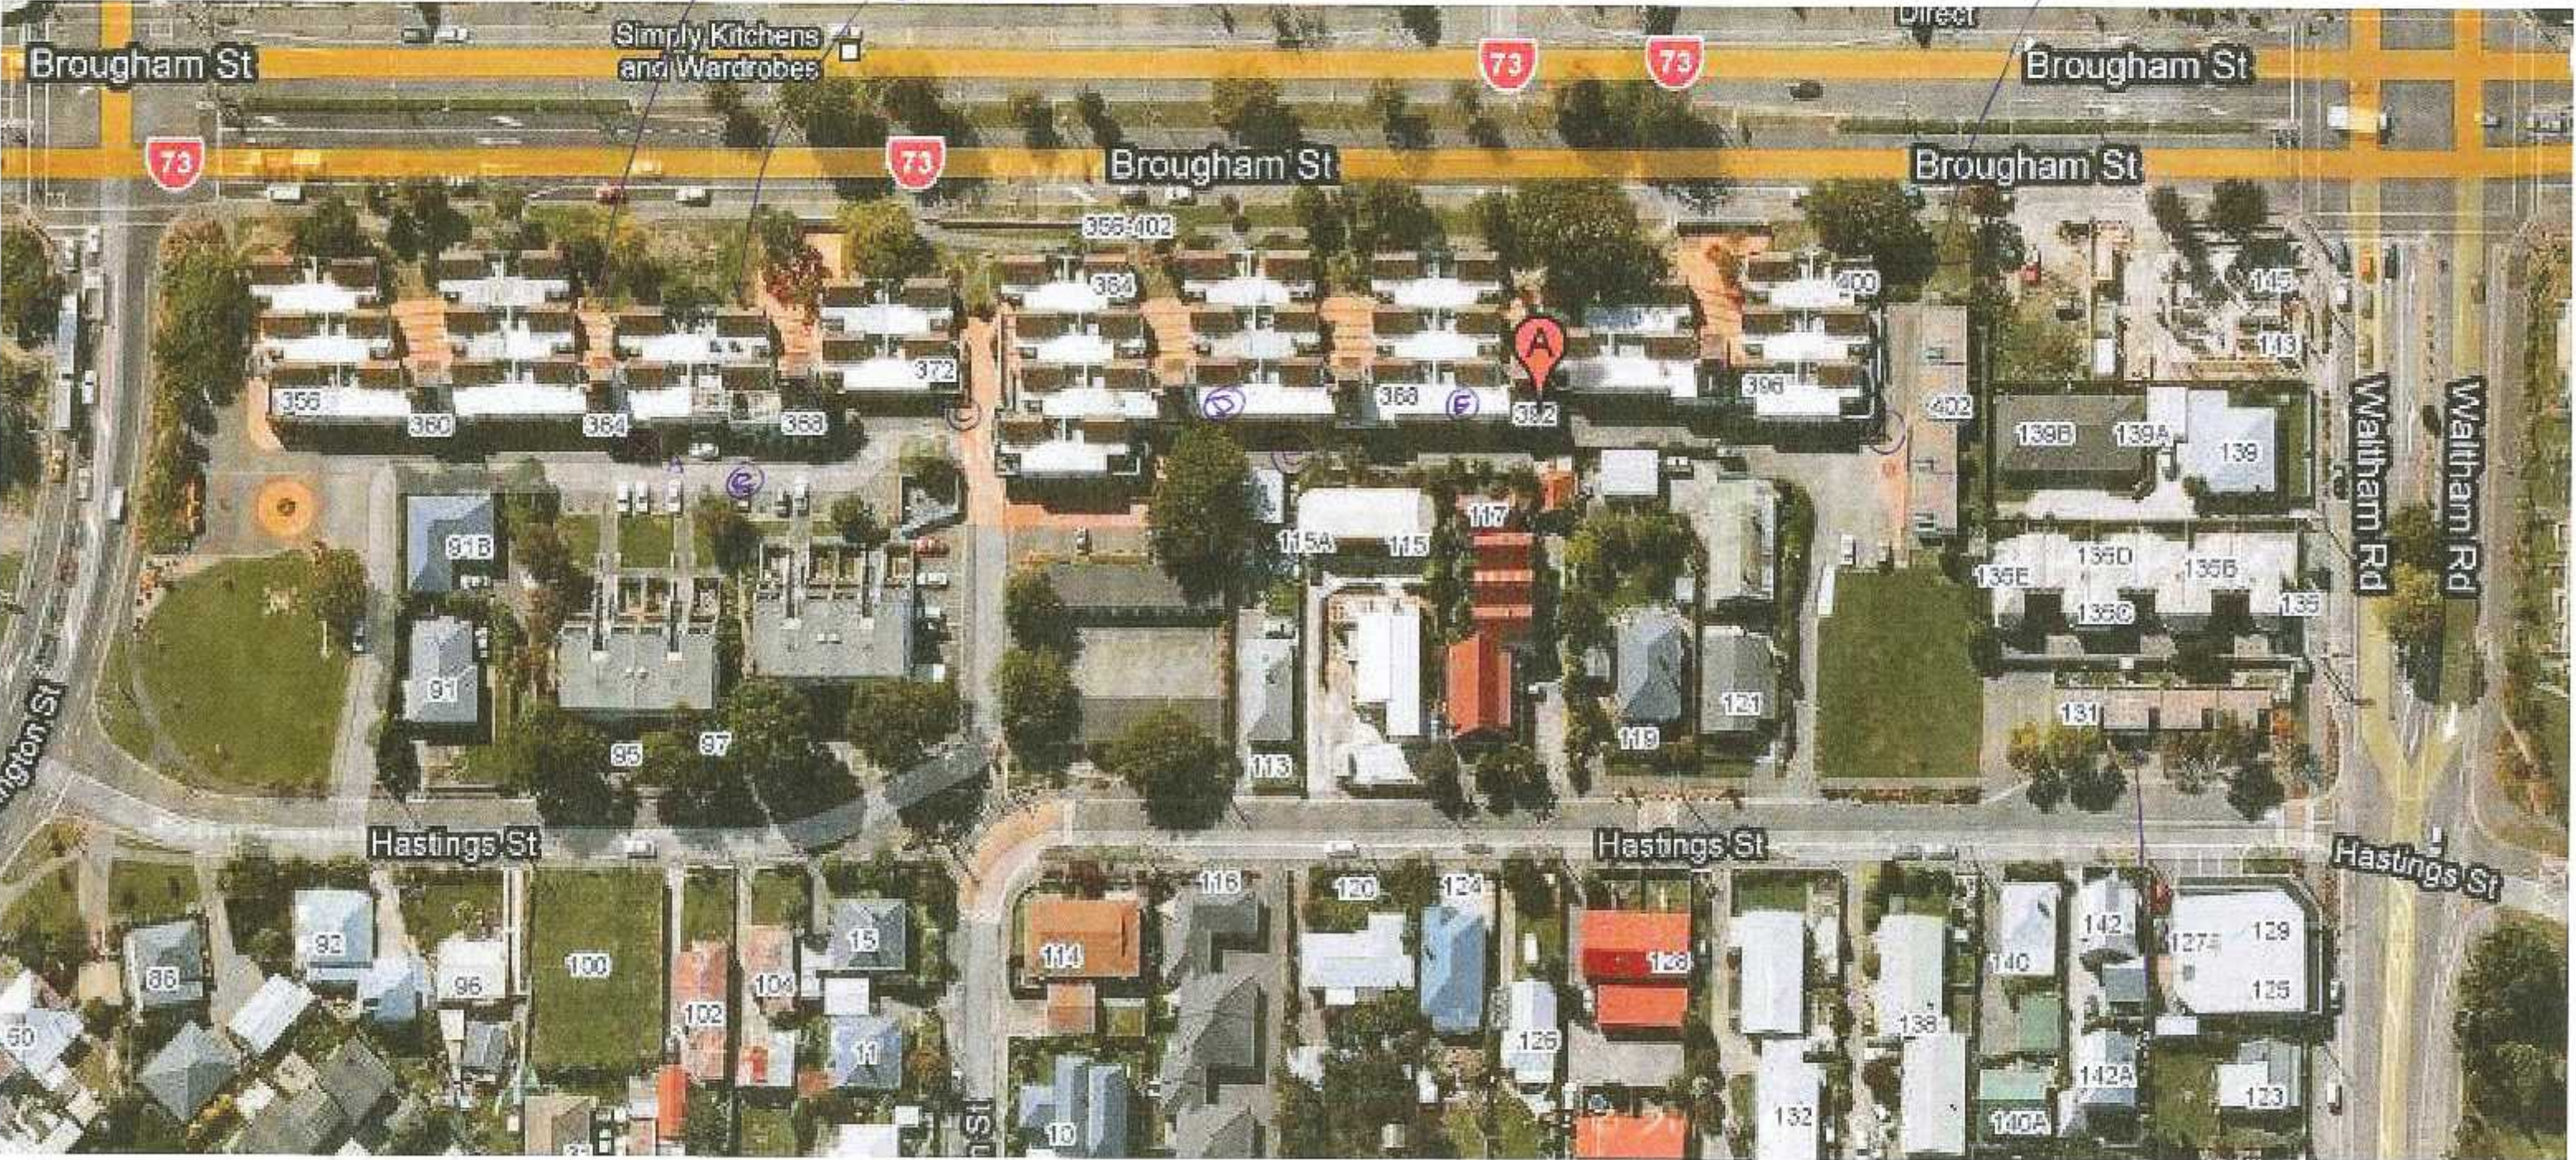
20mm gap in tiles  
15mm GAP in tiles

100mm of ground heave.

- (A) Wood heave 80mm
- (B) Damage to carpark area
- (C) Damage to buried services
- (D) Severe cracking in 1st Floor slab.
- (E) Heave in driveway 100mm
- (F) Heave 33 Cracking in ground floor slab.
- (G) Damaged services.
