**Burnside Park
Community Building
Storage Shed**

PRK 0275 BLDG 002 EQ2

Detailed Engineering Evaluation

Quantitative Assessment Report

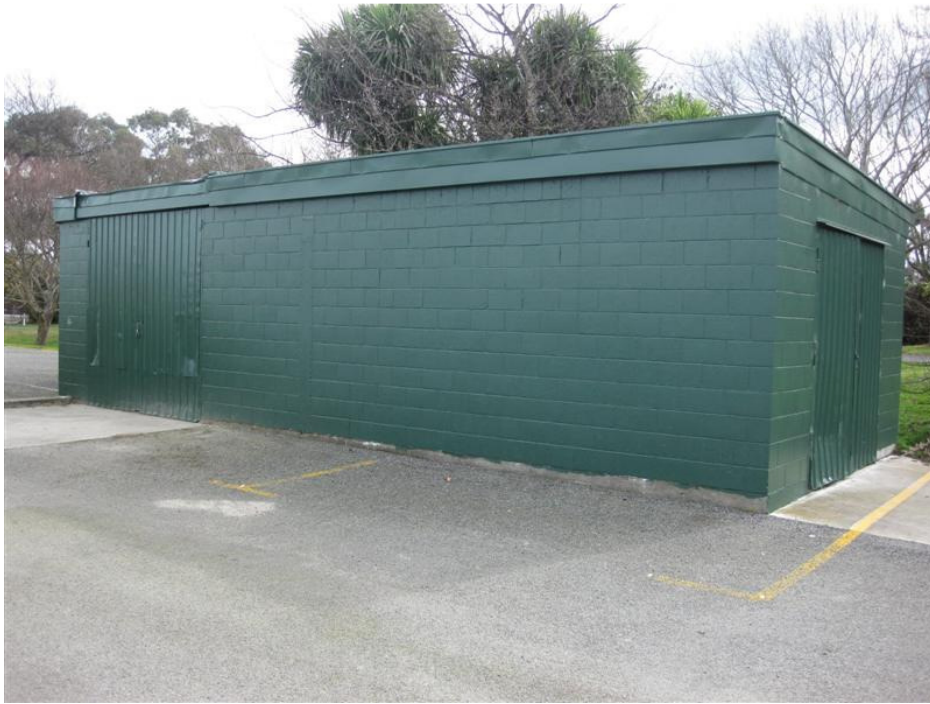
Building frontage

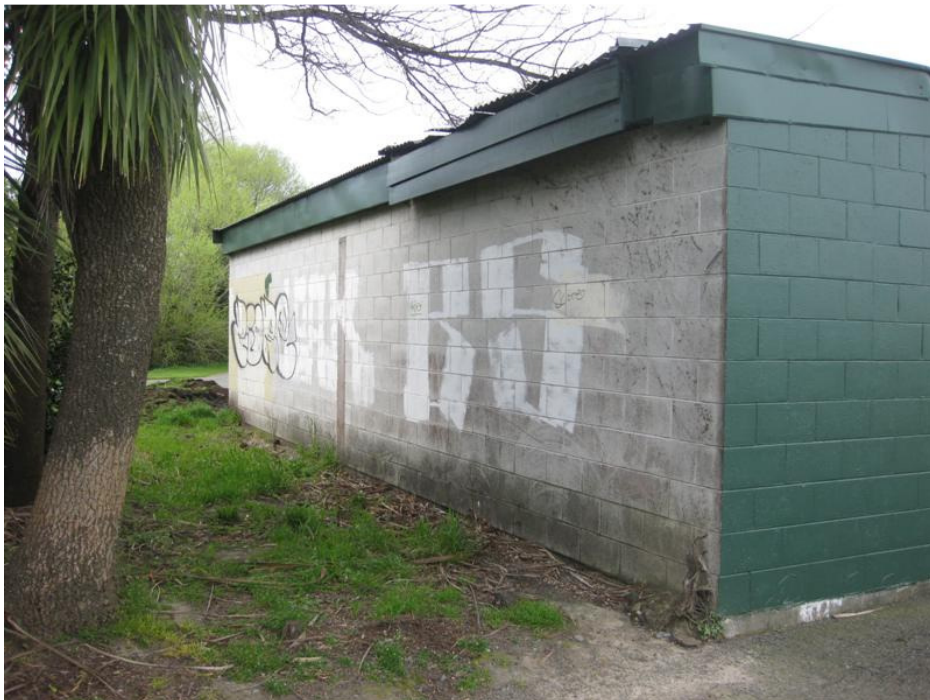
Building rear

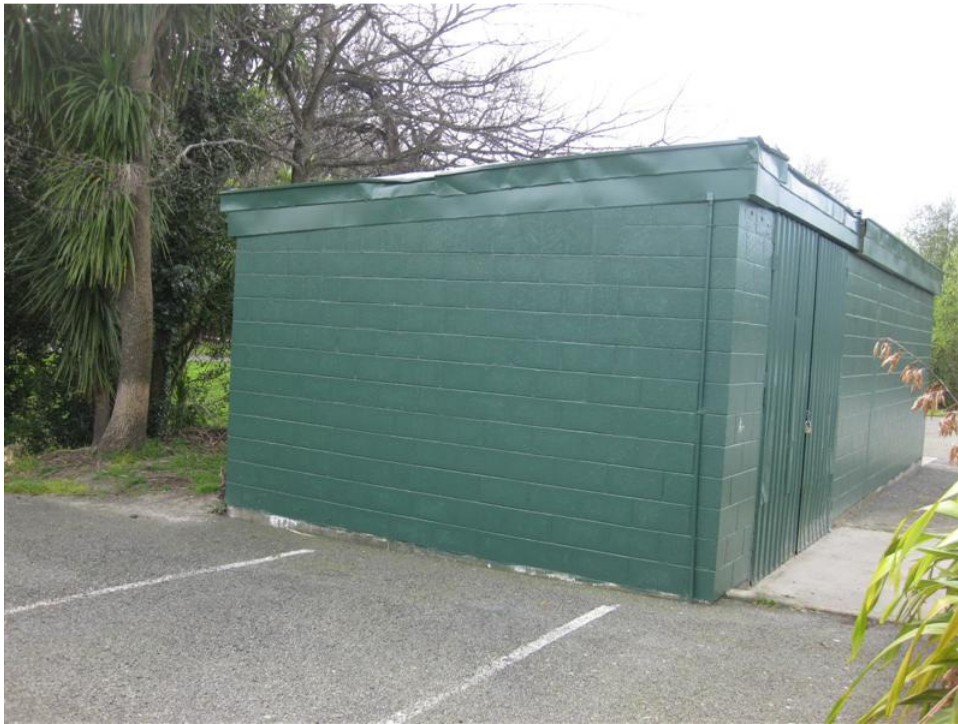
West end (The original door in this wall, has been filled with masonry)

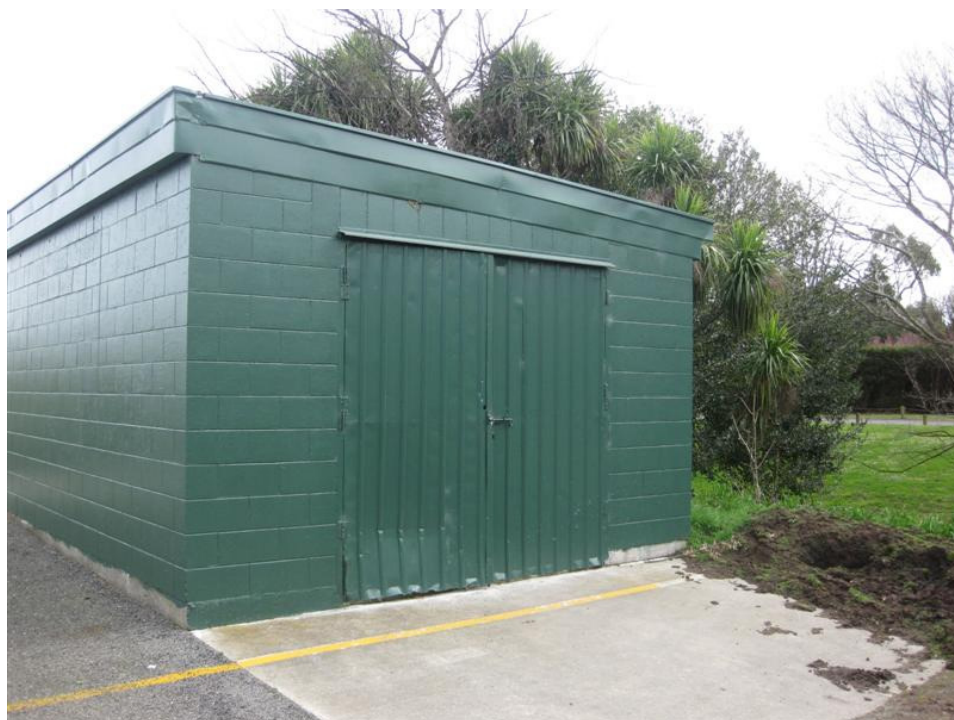
East end

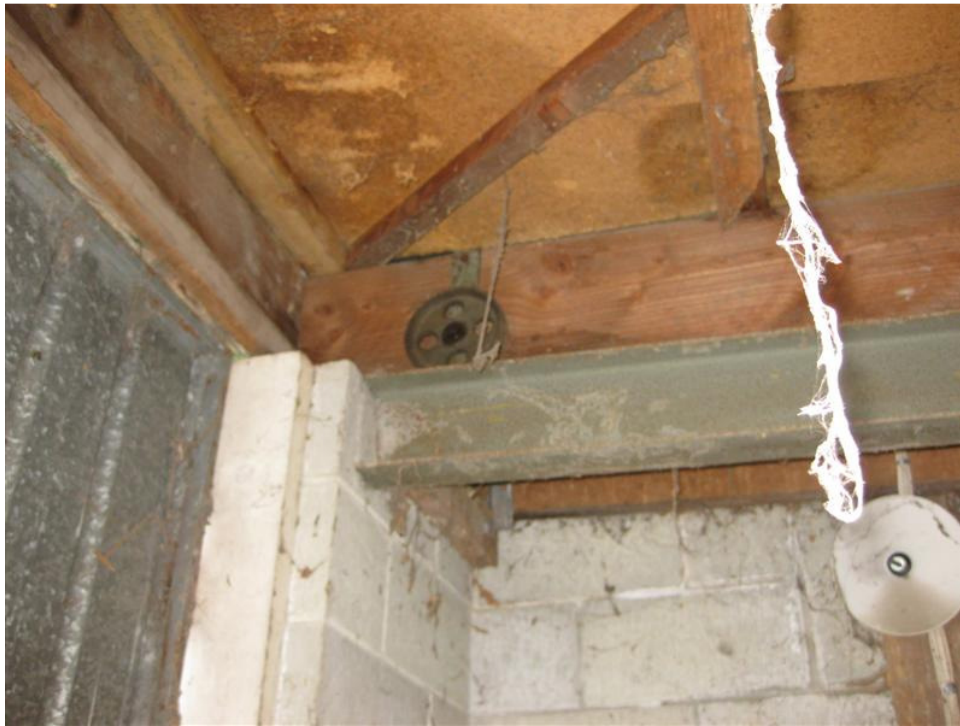
RSJ beams each side of front wall door

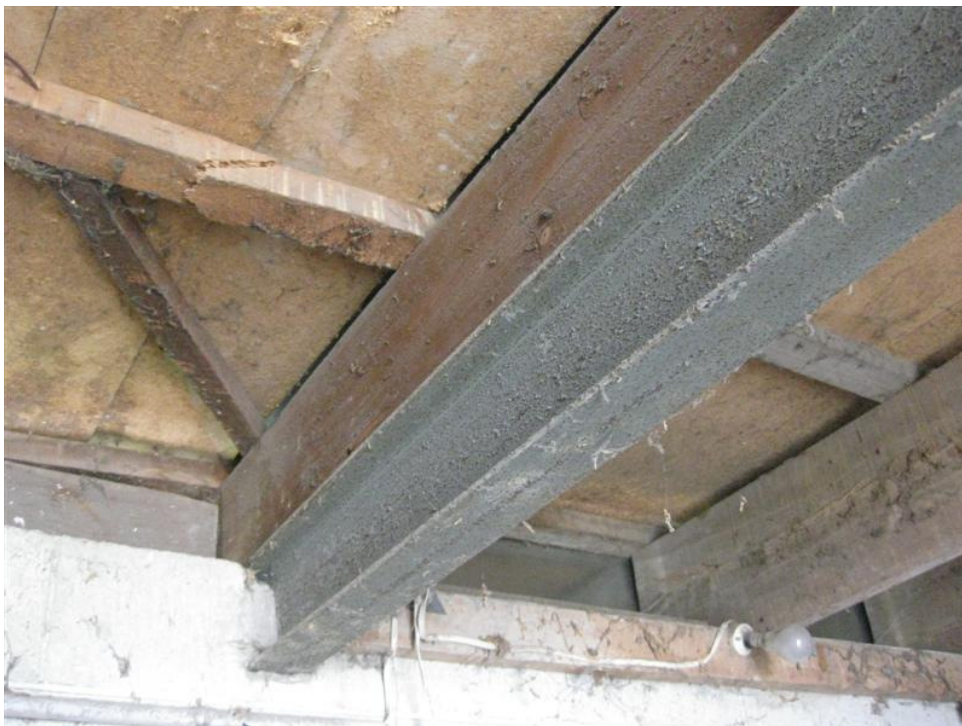
Typical RSJ beam connection to rear wall

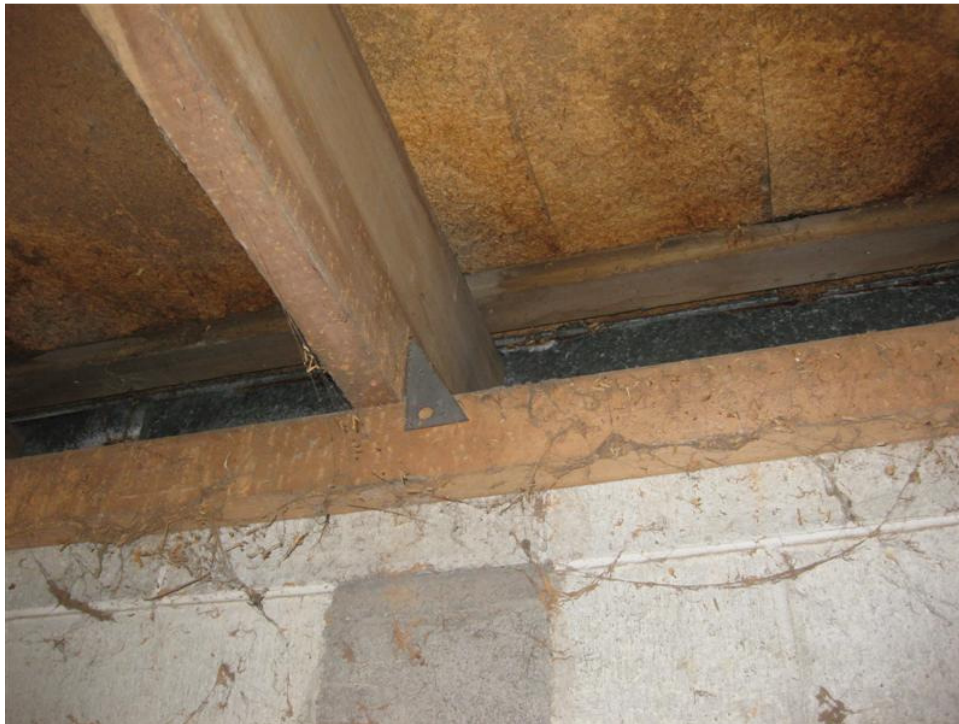
The roof structure consists of timber rafters as the primary support system, supporting a 'skillion' type roof where the external cladding is galvanised corrugated iron and the internal lining is 25mm medium density particle board. 150mm deep RSJ's are located each end of the side door, spanning transversely. The RSJ's act as horizontal props to the masonry at the side door, but may be there primarily to serve as runway beams. The roof structure is secured to the masonry walls via timber stringers bolted to the masonry bond beam. Fixings for load transfer appear insufficient to achieve roof diaphragm action.

Typical rafter connection with particle board lining over

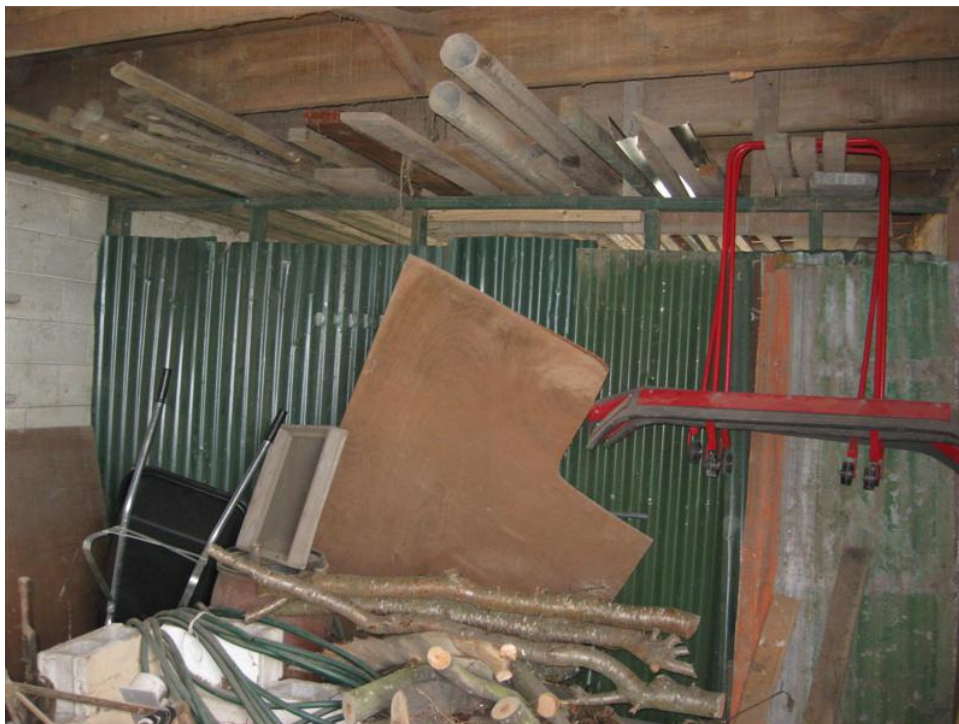
Internal partition wall
