Burnside Park Toilets

PRK 0275 BLDG 003 EQ2

Detailed Engineering Evaluation

Quantitative Assessment Report

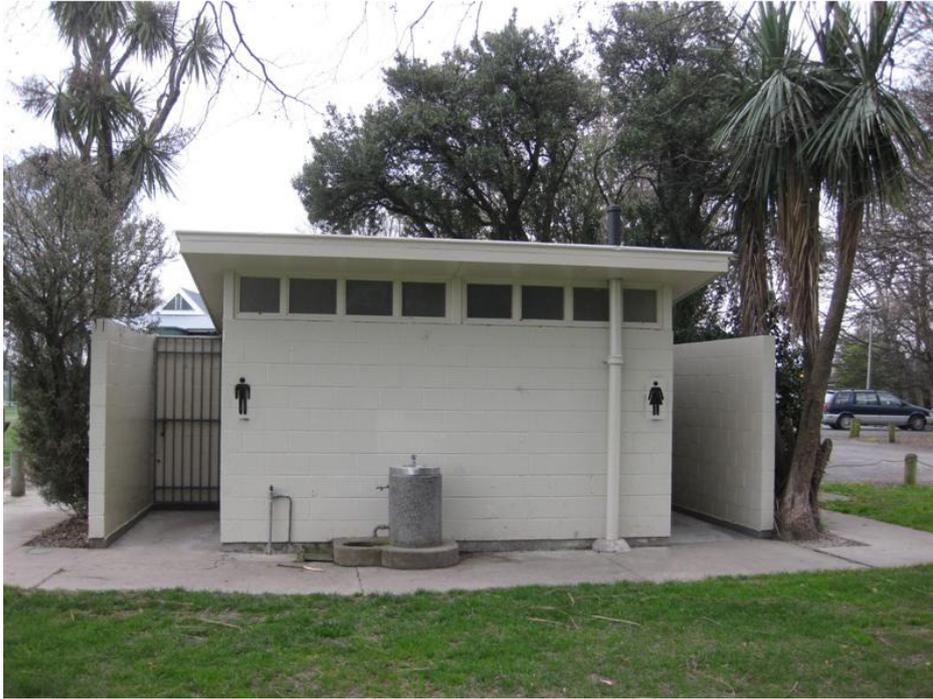
1. Building frontage

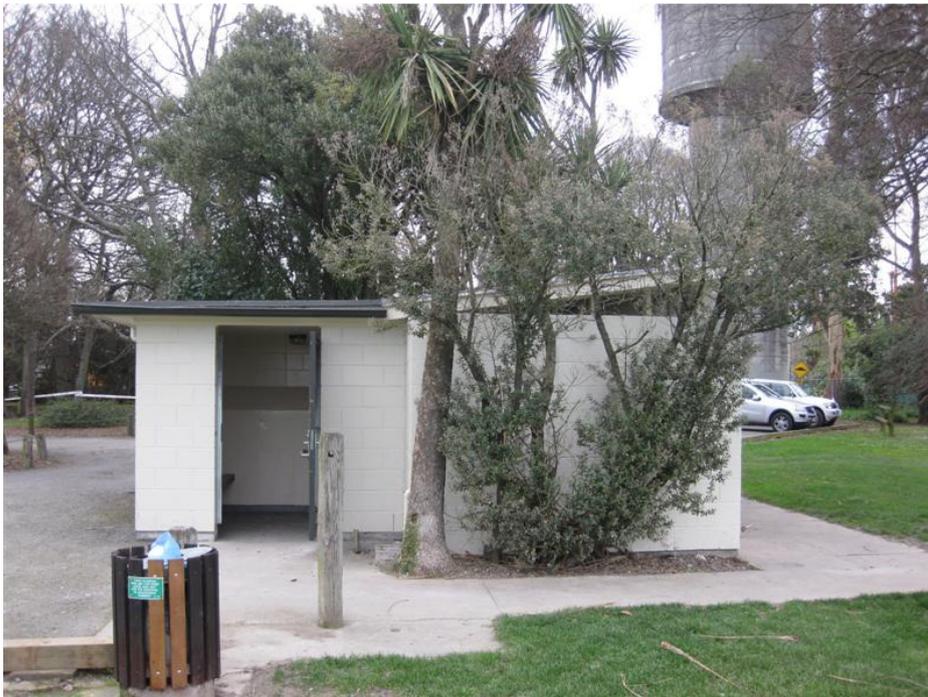
2. Building side

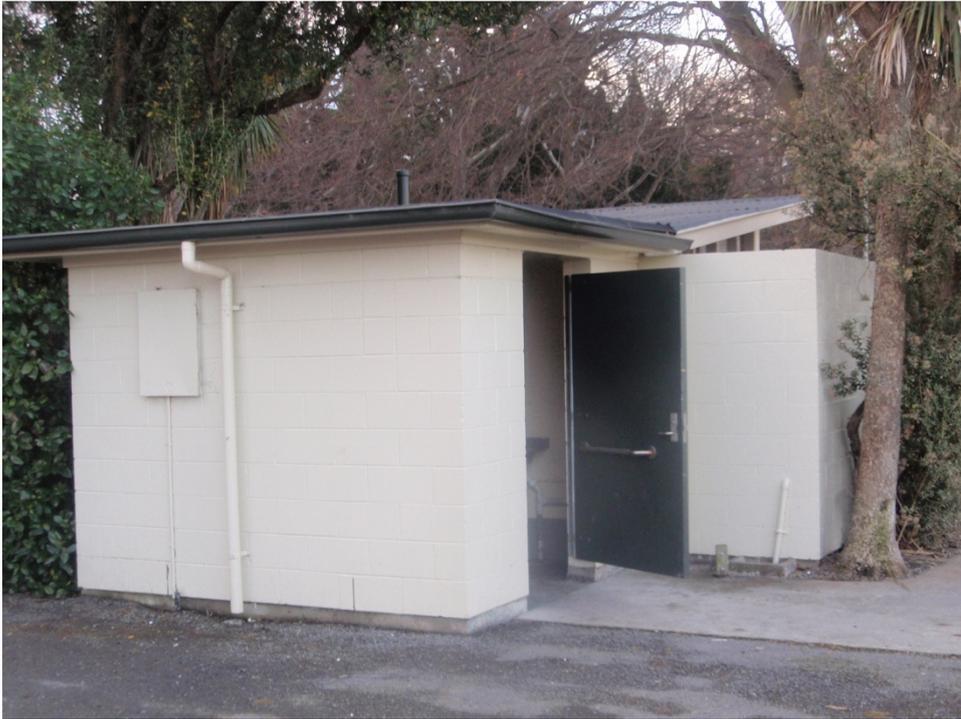
3. Rear extension constructed 2001

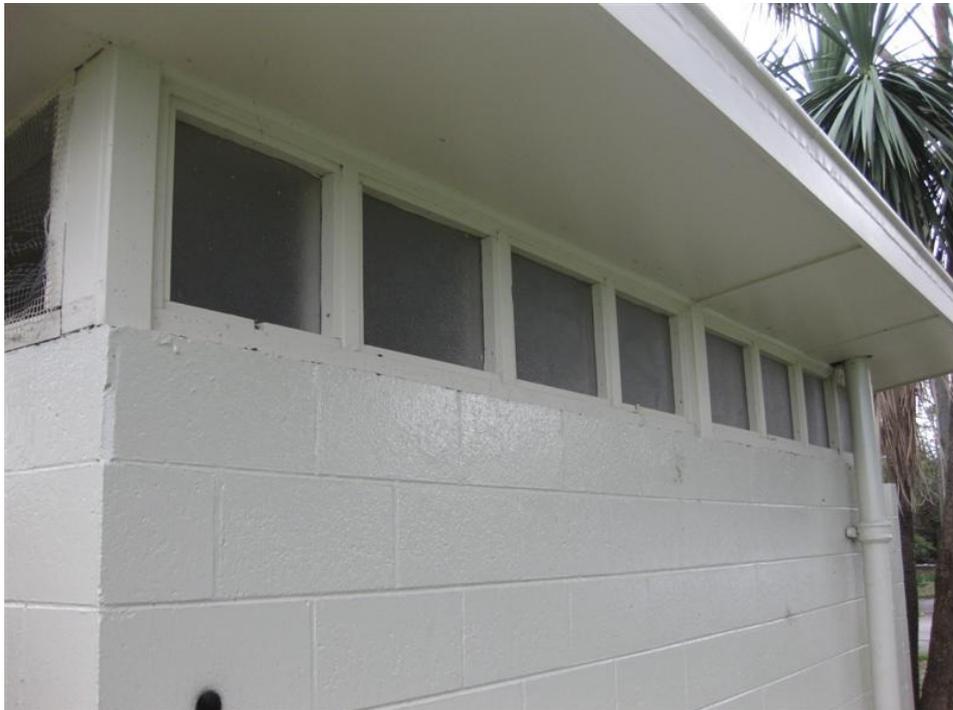
4. Front wall: roof/window/wall detail

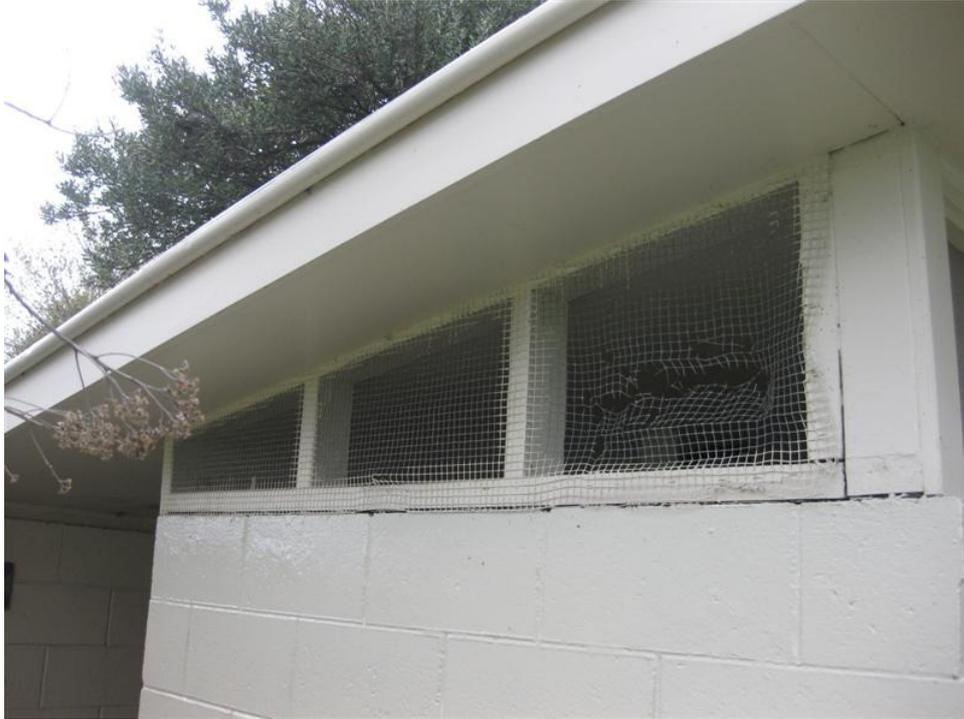
5. Side wall (typical): Roof/window/wall detail

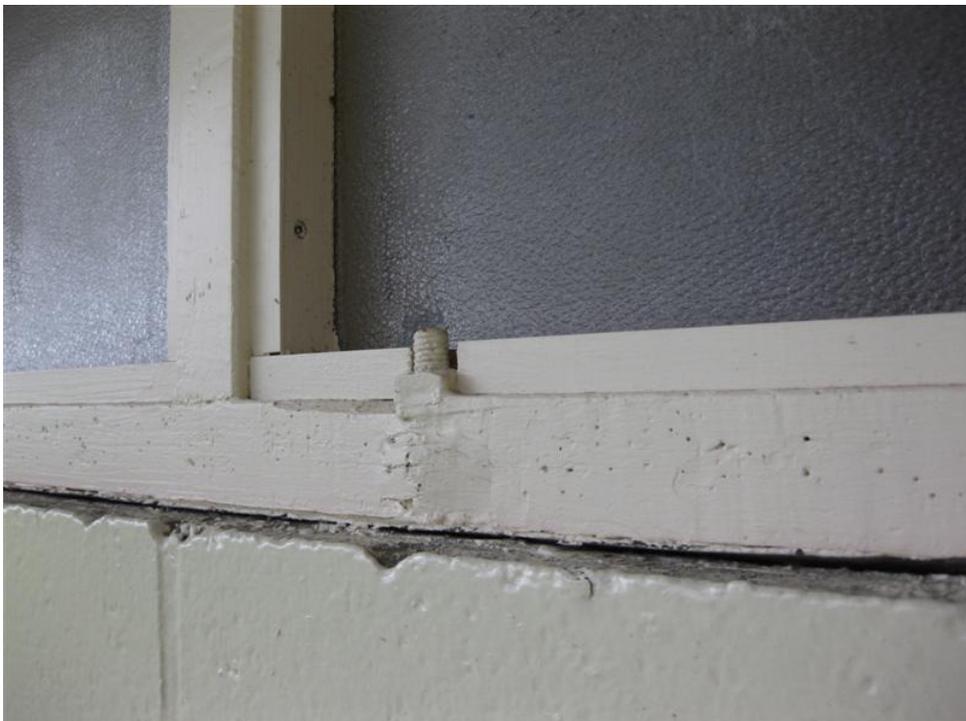
The roof structure is timber framed construction. Connections for the roof structure to the masonry walls appear weak for the original building but connections are adequate for the extension. The strength of the connections for the original building will need to be assessed if any strengthening options are to be developed.

6. Weak window connection to masonry wall

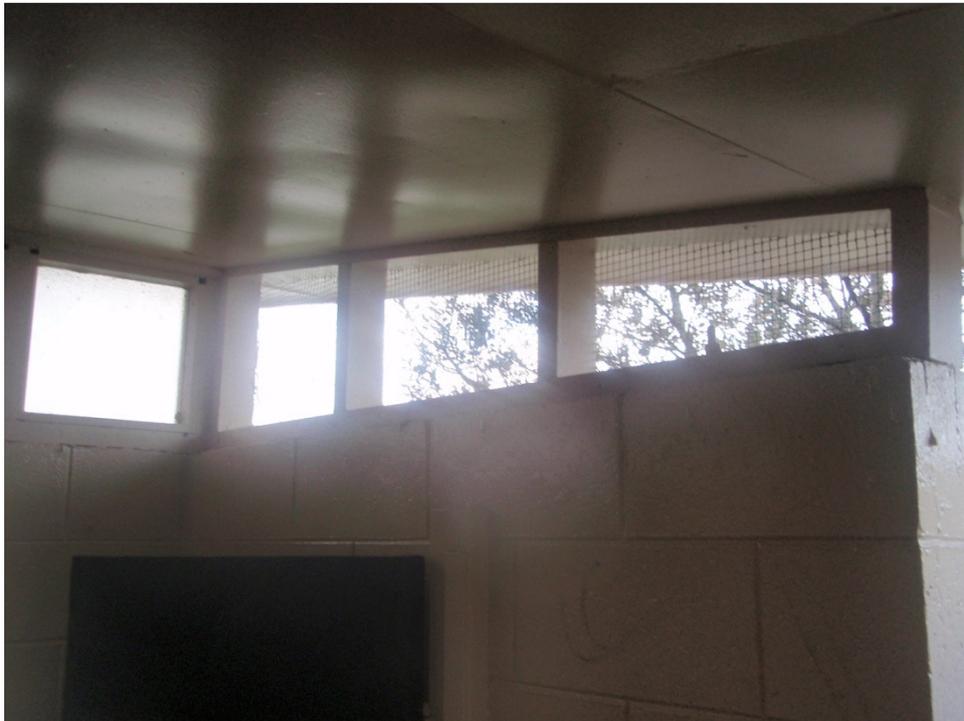
7. Typical internal wall corner detail

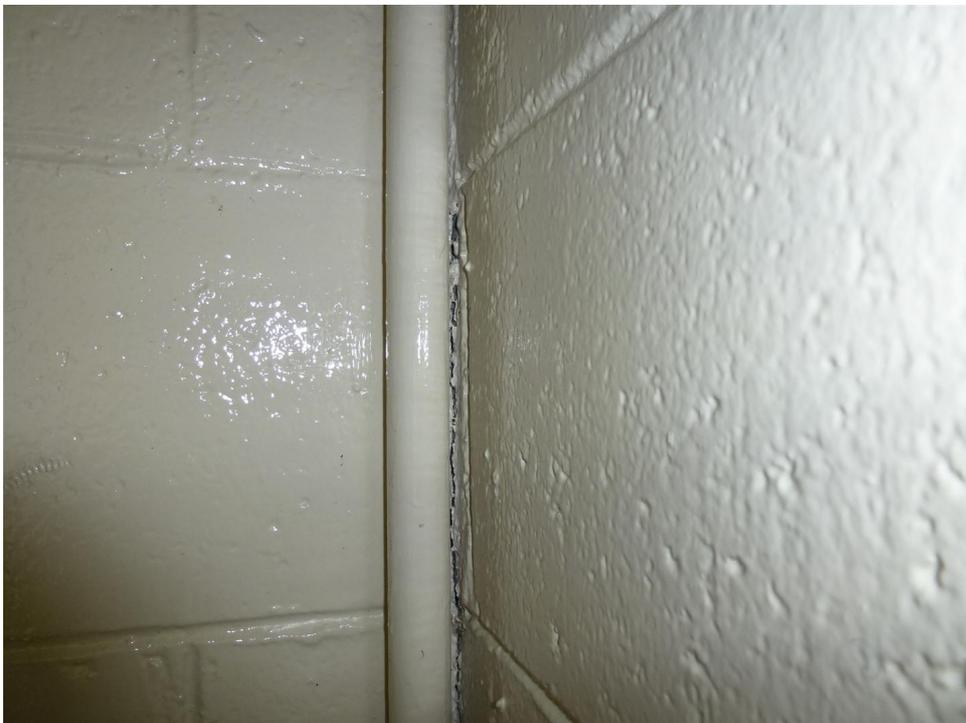
The building appears to have withstood the Canterbury earthquake sequence post September 2010 in a satisfactory manner with its structural integrity intact. Two vertical cracks were noted, one of which requires sealant applied to ensure weather tightness (refer Appendix 1, photo 8).

8. Moderate width wall crack requiring sealant

1. Strengthening options be developed to increase the seismic capacity of the building to at least 67%NBS.
2. The cracking and impact damage be repaired.

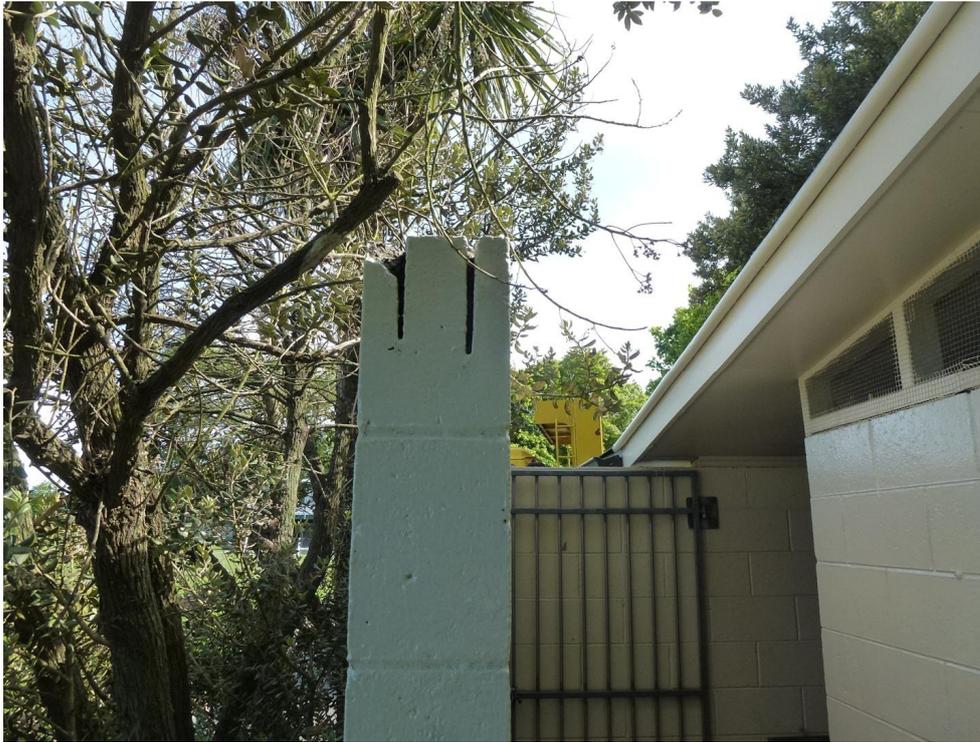
The top corner masonry block of the male toilet entry screen shows impact damage that is unlikely to be earthquake related. This item does not affect the structural integrity of the building however it does require minor remedial work (refer Appendix 1, photo 9).

9. Impact damage to top corner of the masonry screen to the male toilet
