Burwood Park North – Toilets
PRK 0724 BLDG 001
Detailed Engineering Evaluation
Qualitative Report
Version Final

75 New Brighton Road, Burwood

Christchurch City Council

Date
15 May 2013

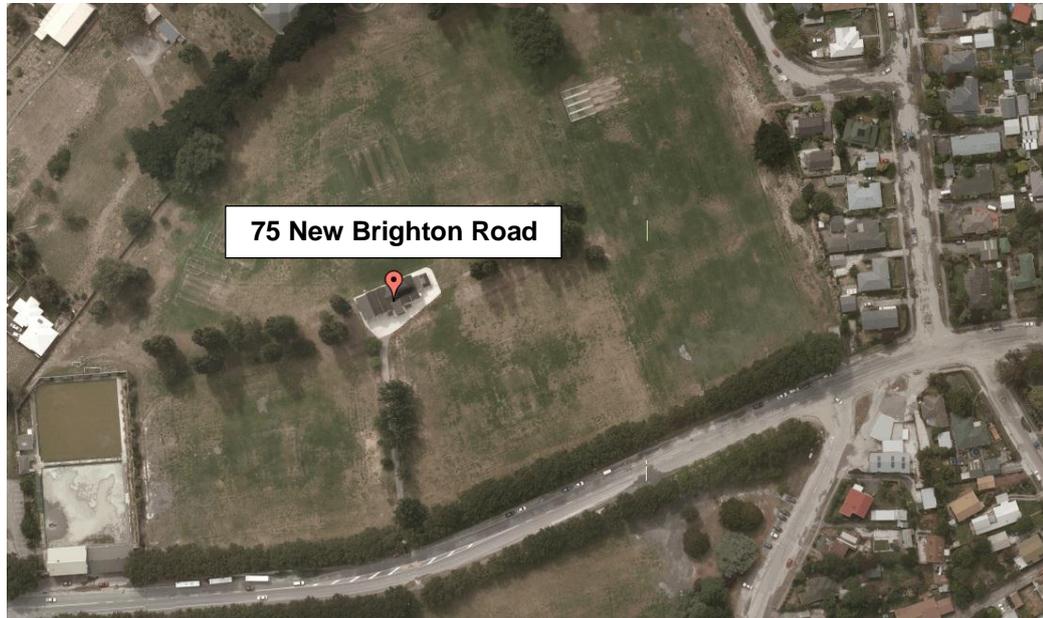
Figure 3 Post February 2011 Earthquake Aerial Photography³

Post-earthquake aerial photography of the site indicates that liquefaction has occurred on site. There was no indication of site settlement. Although liquefaction had occurred at the site, no evidence of liquefaction remained. No damage was noted to paving in the area.

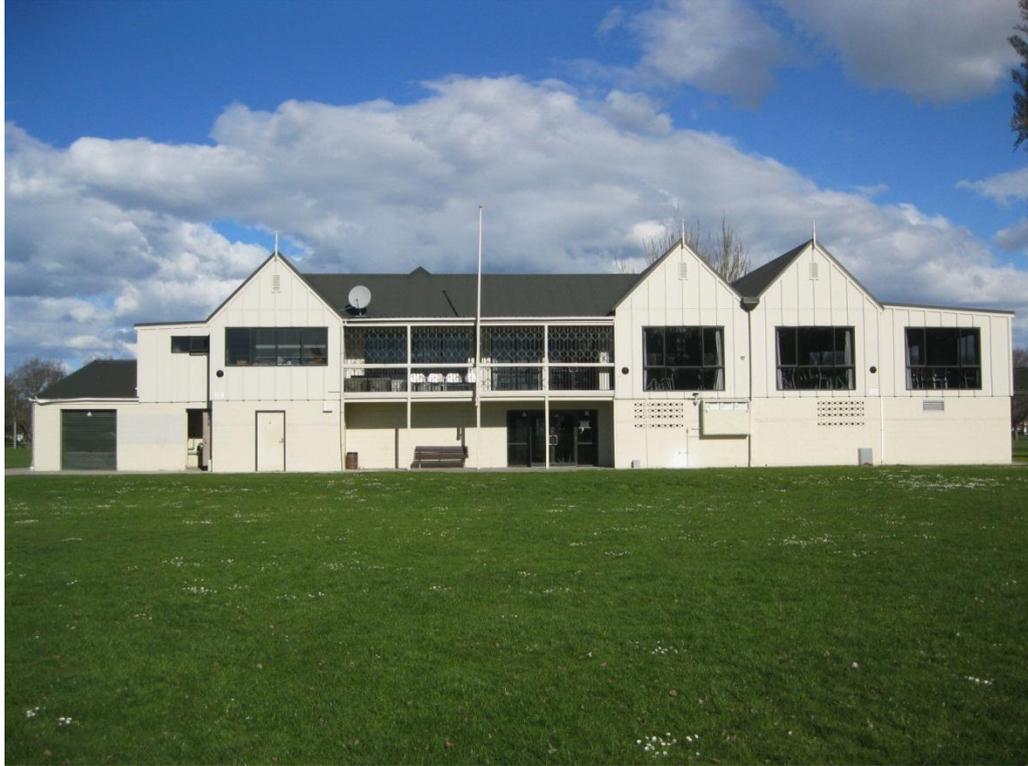
Photograph 1 North elevation.

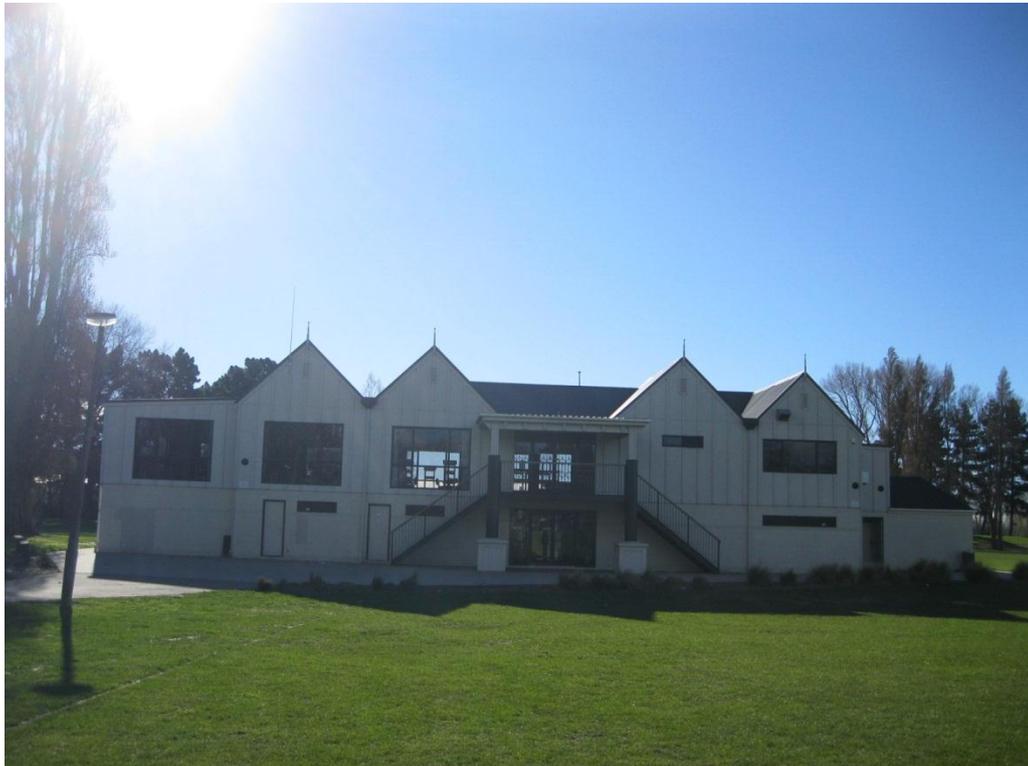
Photograph 2 Southern elevation.

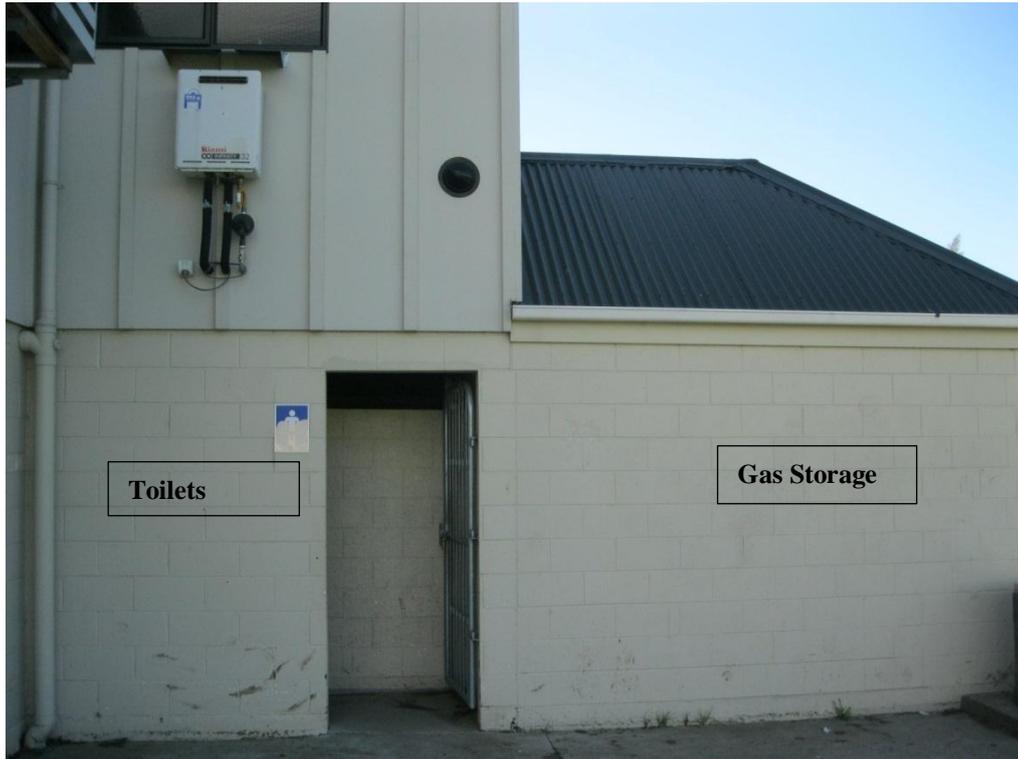
Photograph 3 Toilet and gas storage portions of the eastern end of the building.

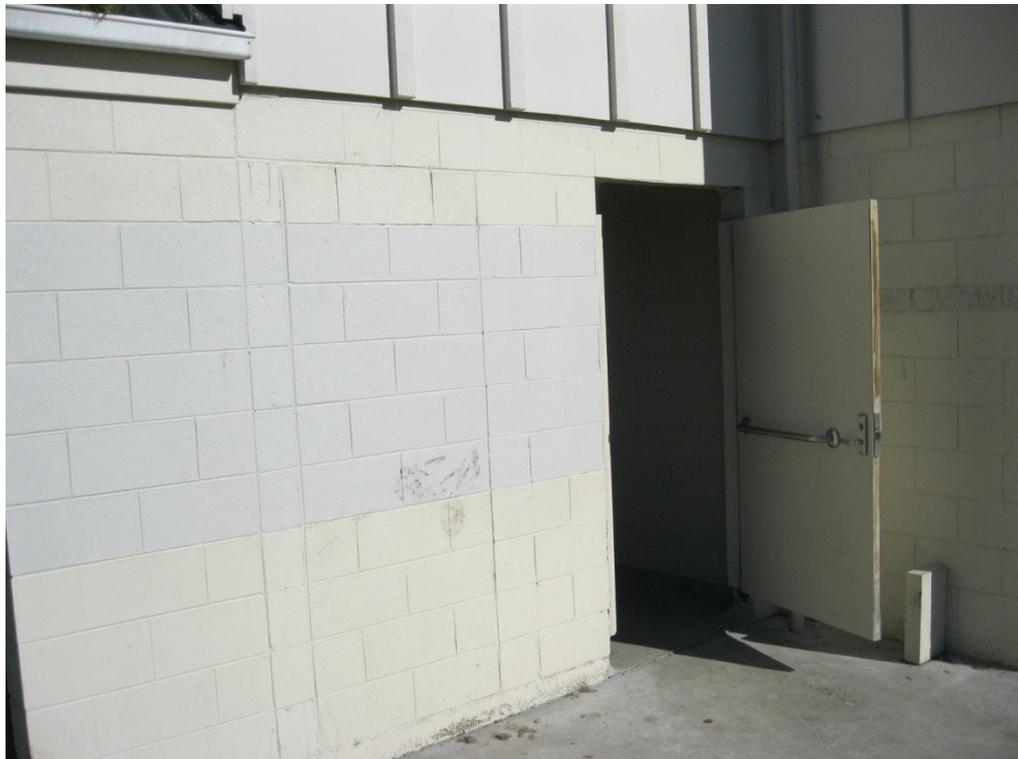
Photograph 4 Women's/disabled toilet on north eastern side of building.

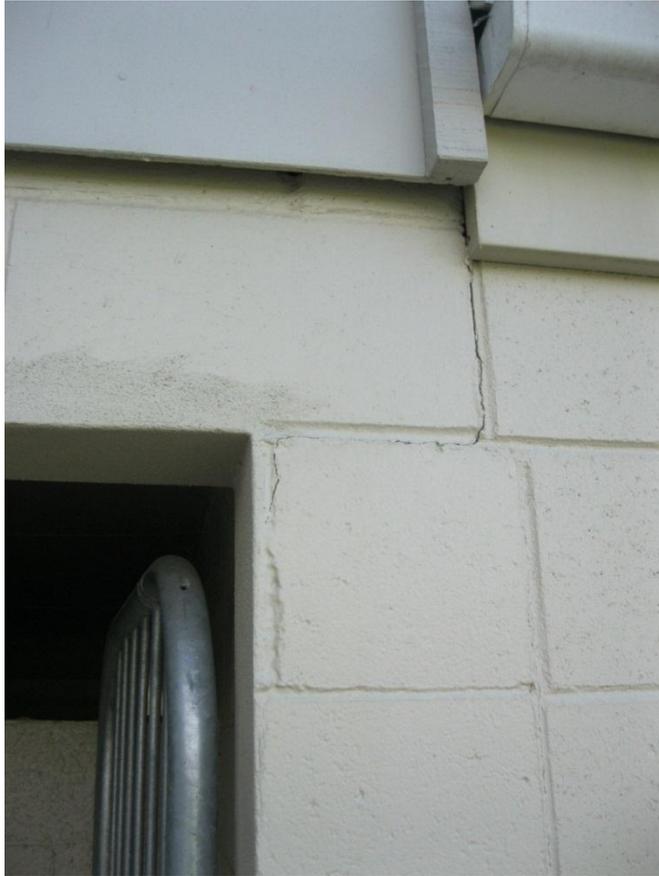
Cracking was noted along the mortar lines of the building in several locations. A strength reduction of 5% has been applied to the building as a result of this.

Photograph 5 Cracking to masonry walls at entrance to men's toilet.

The recent seismic activity in Christchurch has caused visible damage to portions of the building. As the building has achieved between 33% and 67% NBS following an initial IEP assessment of the building, GHD Limited recommends that a detailed quantitative assessment of the building's %NBS be carried out and possible strengthening options be explored.

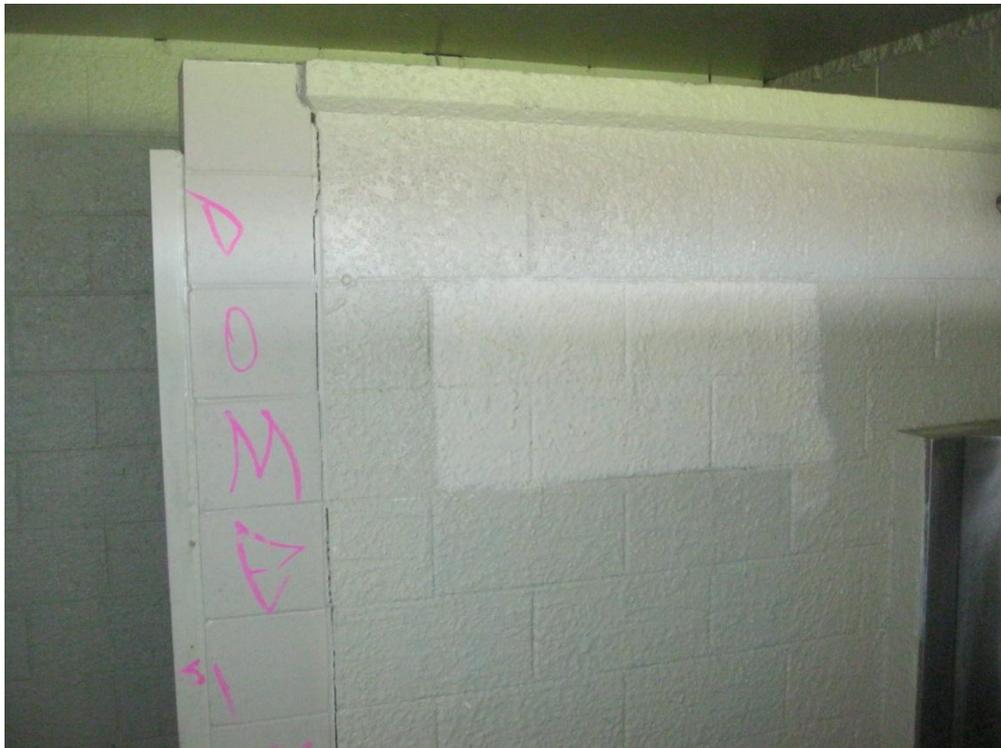
Photograph 6 Vertical cracking to internal masonry cubicle wall.

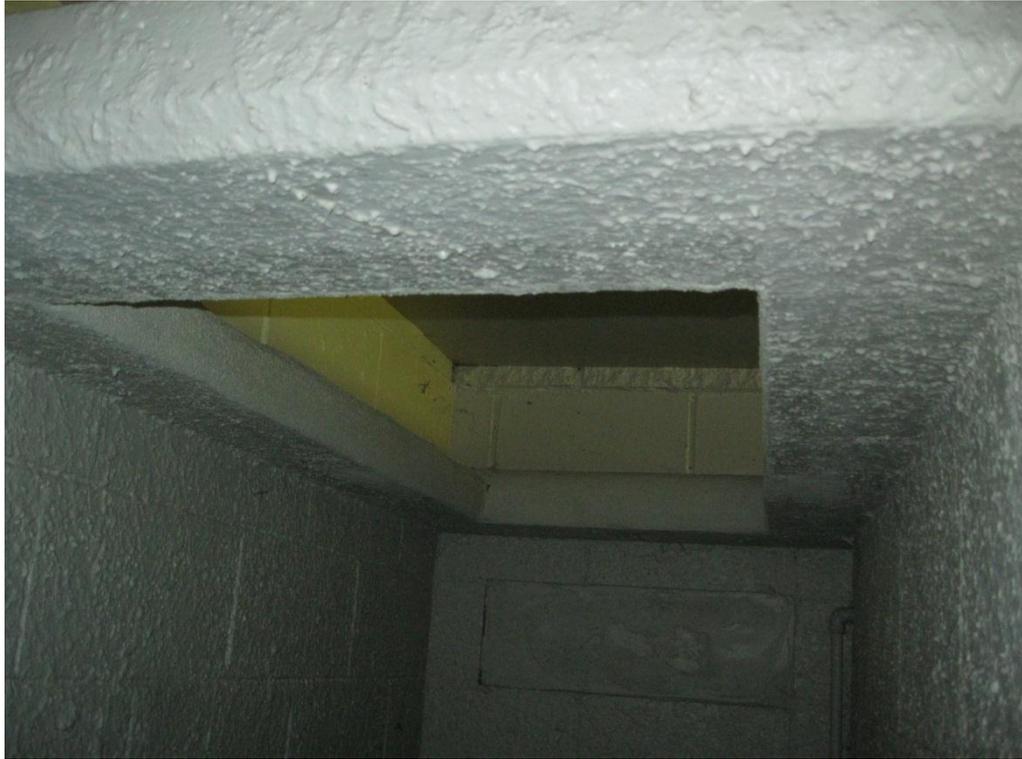
Photograph 7 Concrete panel capping the cubicle walls in men's toilet.

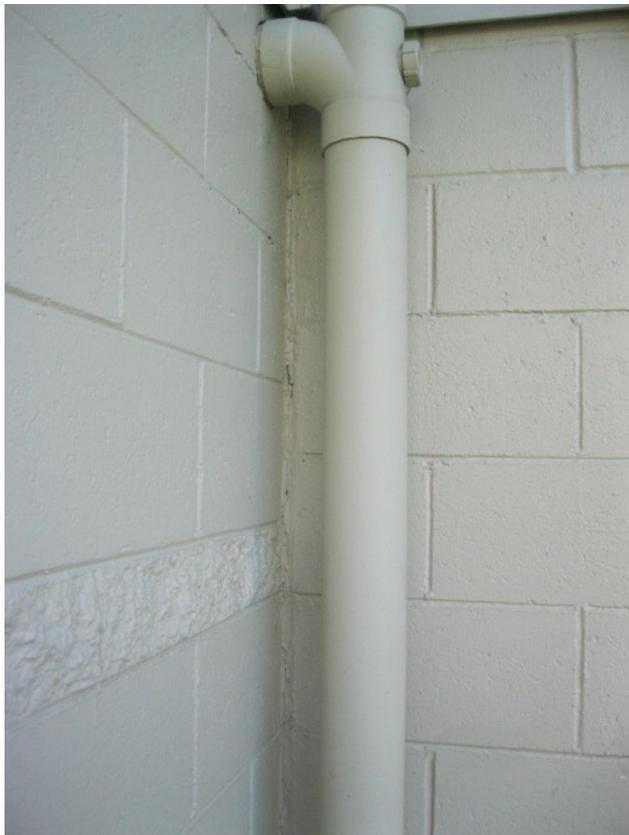
Photograph 8 Cracking to flexible seal.
