Canterbury Agricultural Park  
Toilets  
Qualitative Engineering Evaluation

**Reference:** 231550  
**Prepared for:**  
Christchurch City Council

Functional Location ID: PRK 2412 BLDG 002

**Date:** 5 July 2013

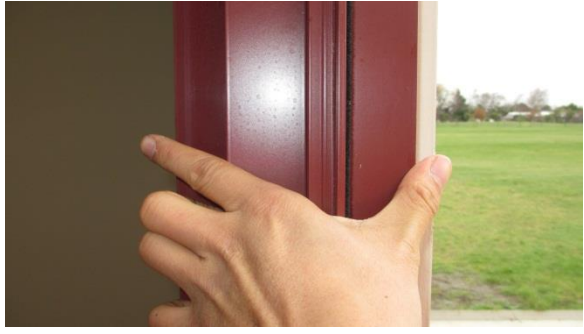
<p>Wall thickness approximately 120mm thick.</p>

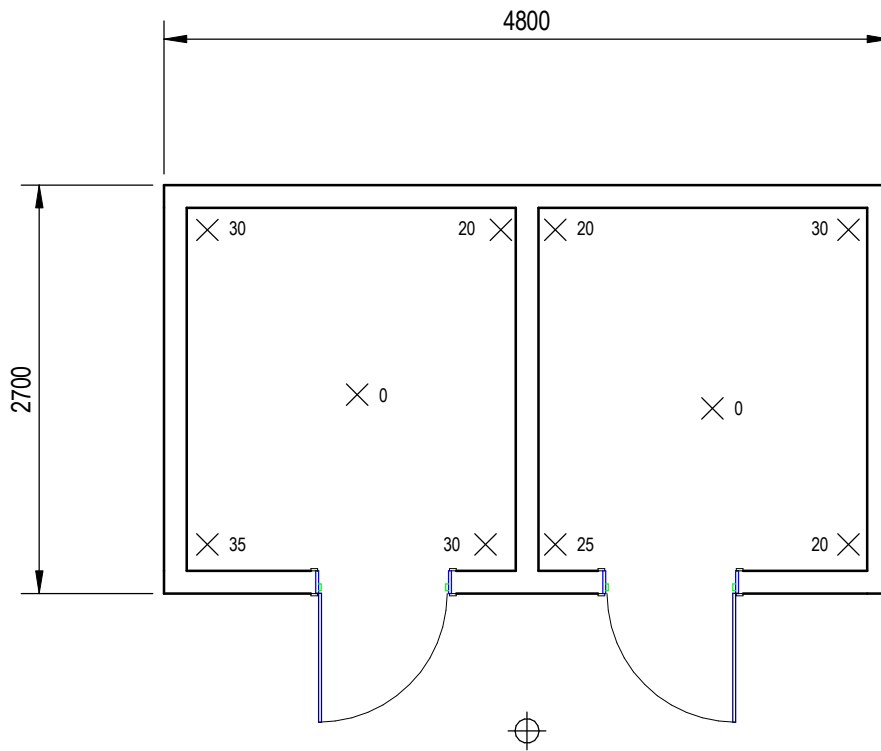
PROJECT
CANTERBURY AGRICULTURAL PARK TOILETS
TITLE
LEVEL SURVEY

The floor levels for the Canterbury Agricultural Park Toilets are considered to be acceptable despite not being within the recommended tolerances. This is because the toilet block floors have an in-built fall for drainage, which are often outside the DBH recommendations.
