Christchurch City Council

Cecil Courts

BE 1047 EQ2

Detailed Engineering Evaluation
Quantitative Assessment Report

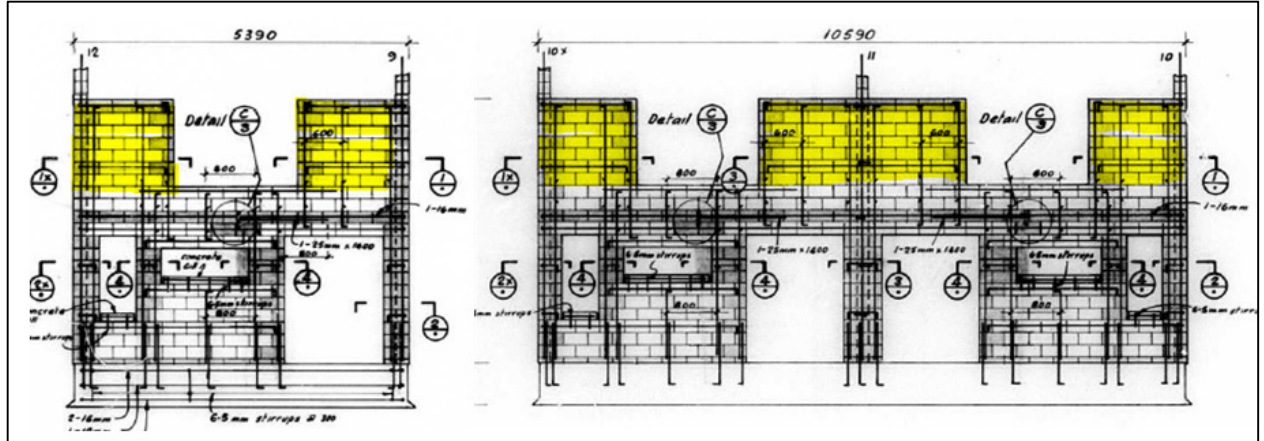
Figure 3: Masonry wall elevation at rear of the Residential block

- Discontinuous walls: Along the rear of the residential units, there are several walls above the first floor level that are not continuous to the foundation. Seismic overturning forces in these walls impose additional loads onto the spandrels. See Figure 3 below:

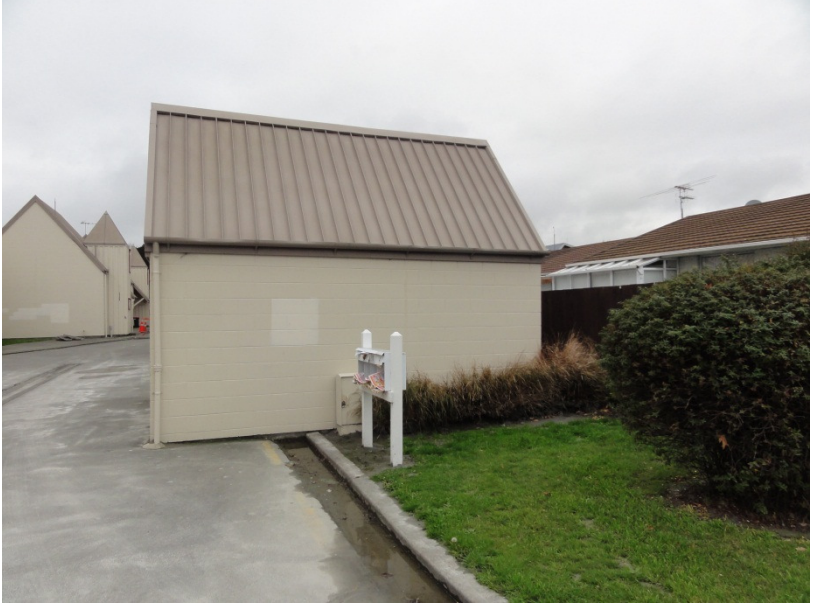
- b) Garage Block G, H, I and “turret” at Block C appear to be tilting, possibly due to differential settlement.
- c) The ground beam foundation has been exposed along the northern elevation of Unit 4 at 16 Cecil Place (within Block A) due to subsidence of the ground.

<p>8.</p>	<p>Western view of Garage Block G. Garage appears to be tilting to the south</p>

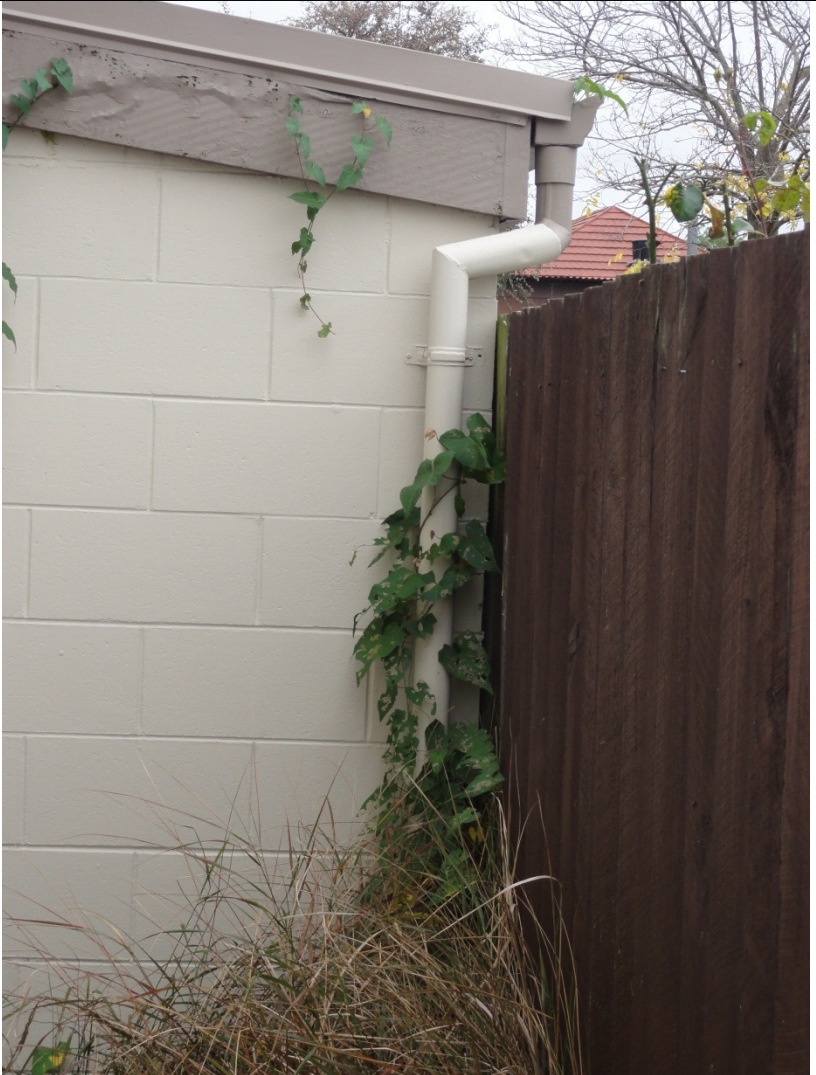
<p>9.</p>	<p>Settled Garage Block G appears to be leaning on wooden fence</p>

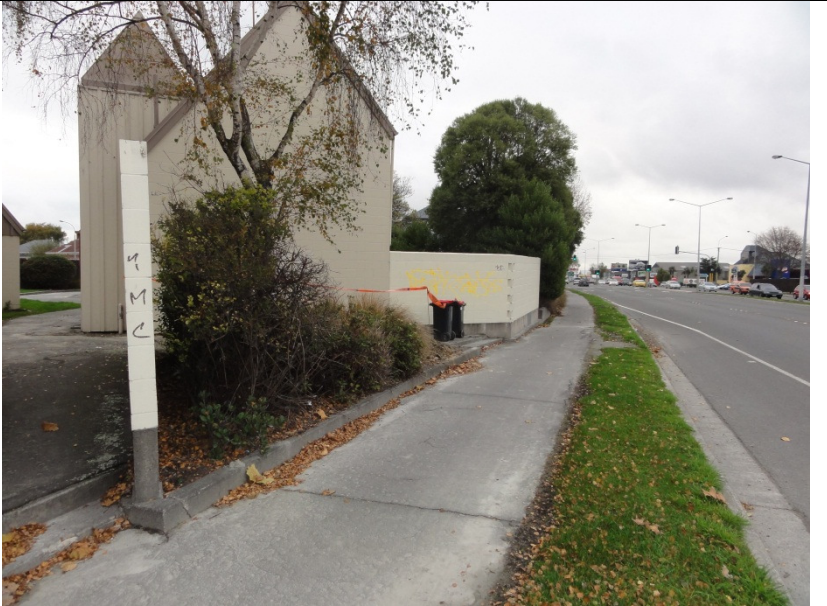
<p>11.</p>	<p>View of leaning masonry wall near Unit 4 at 16 Cecil Court; Masonry block wall in background exhibits structural damage</p>

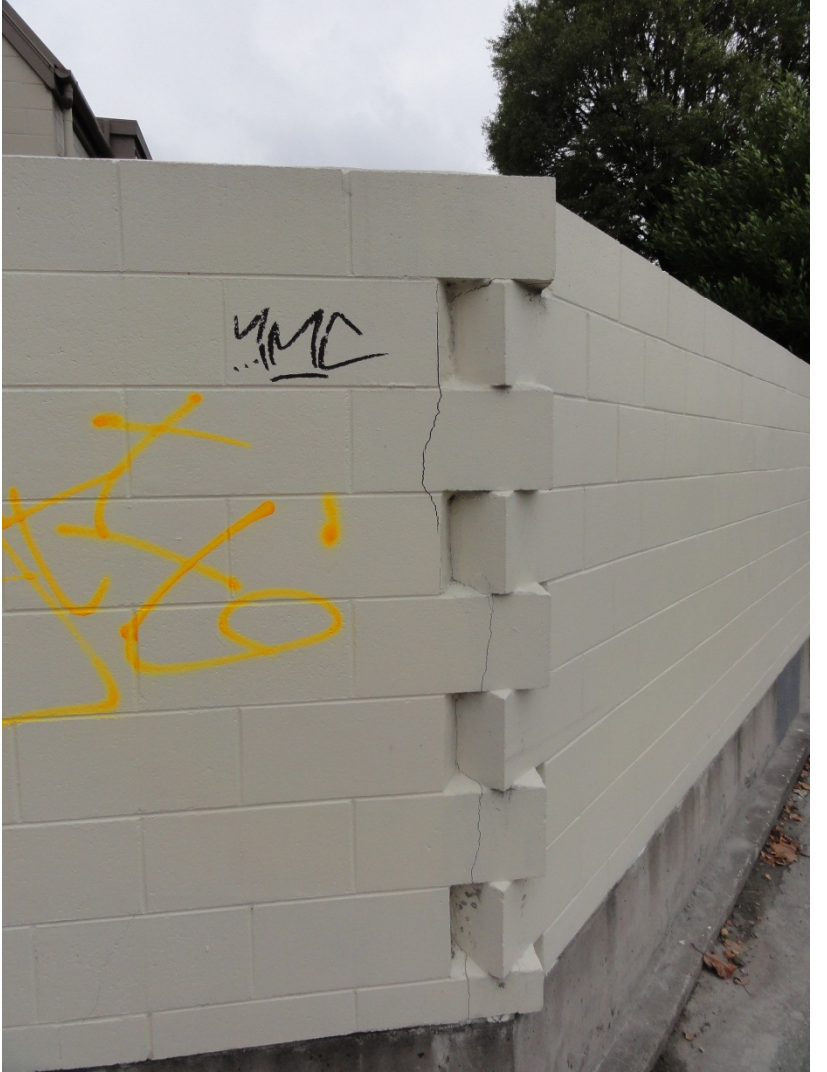
<p>12.</p>	<p>Structural Damage to masonry block wall</p>

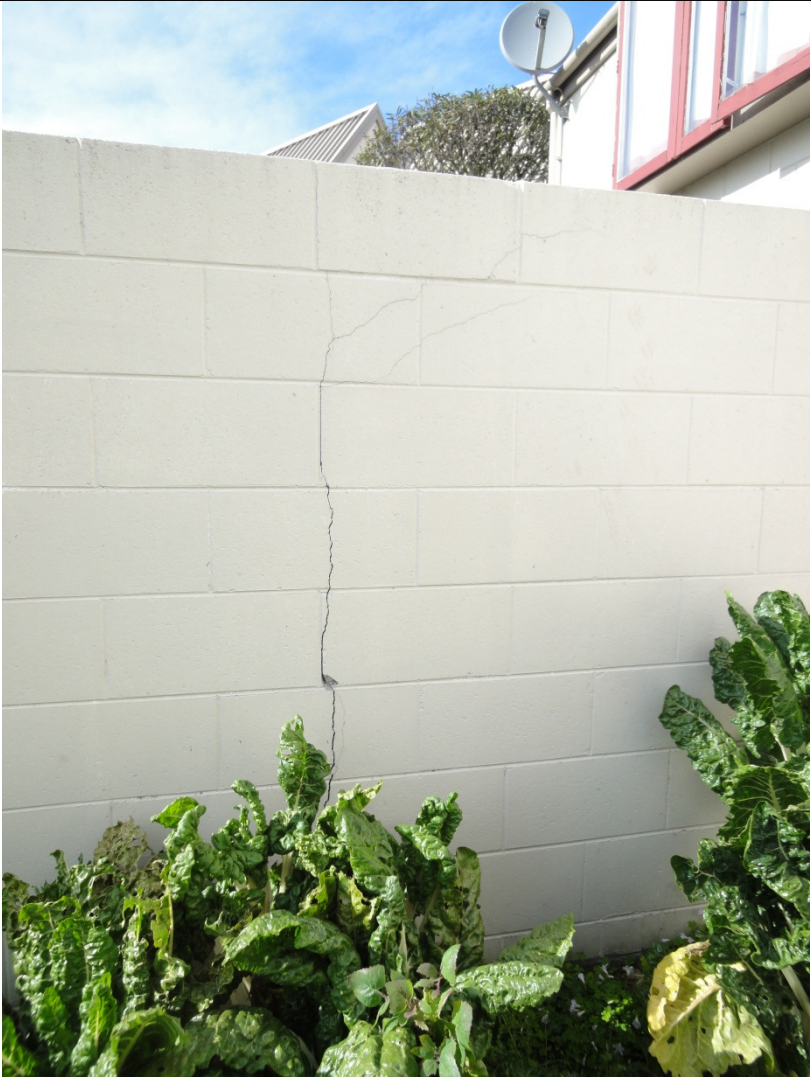
<p>13.</p>	<p>Structural damage to masonry block landscape wall</p>

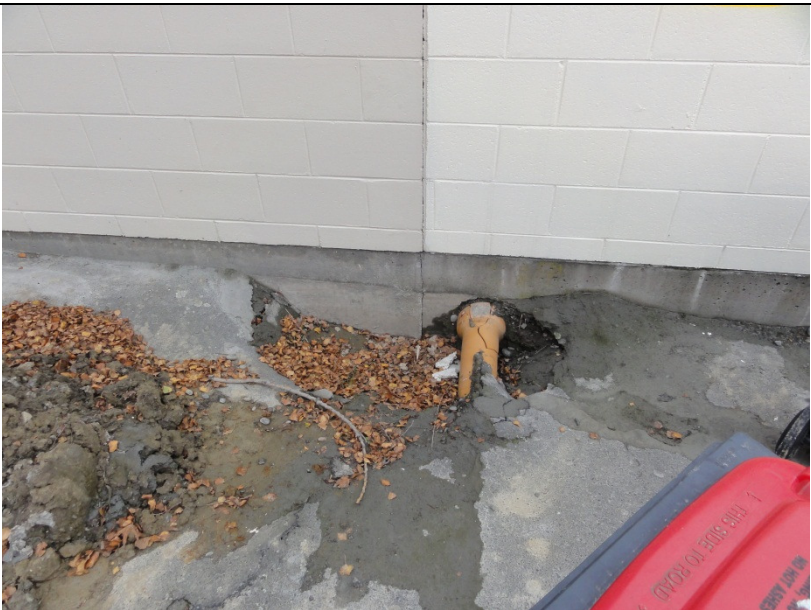
- The ground beam foundation has been exposed along the northern elevation of Unit 4 at 16 Cecil Place (within Block A. See Appendix 1, photo 14).

<p>14.</p>	<p>Exposed ground beam near Unit 4 of 16 Cecil Place due to ground settlement</p>

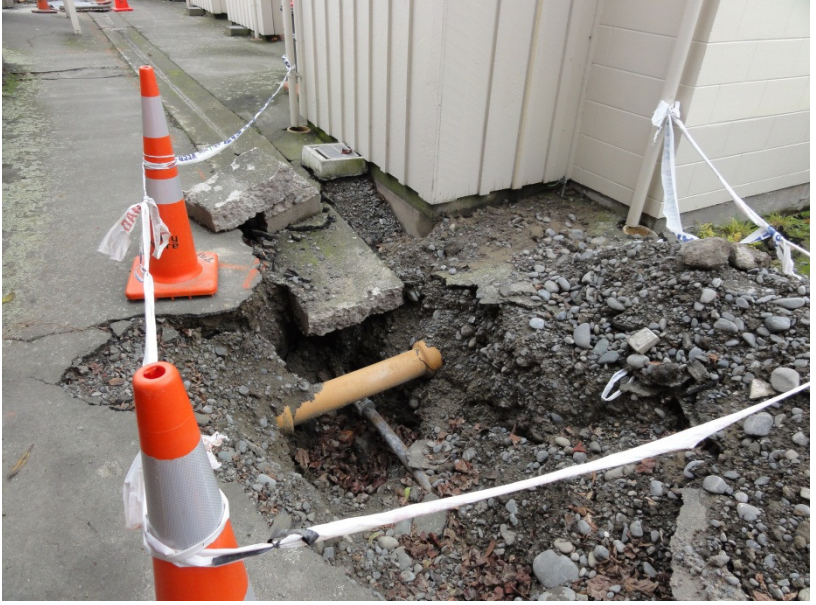
- A 4m long section of ground adjacent to the perimeter footing of Unit 9 at 16 Cecil Place (within Block C) collapsed. A void is located in the southeast corner of the foundation as evident by damaged services (see Appendix 1, photo 16).

<p>16.</p>	<p>Damage to buried services outside Unit 9 at 16 Cecil Place</p>

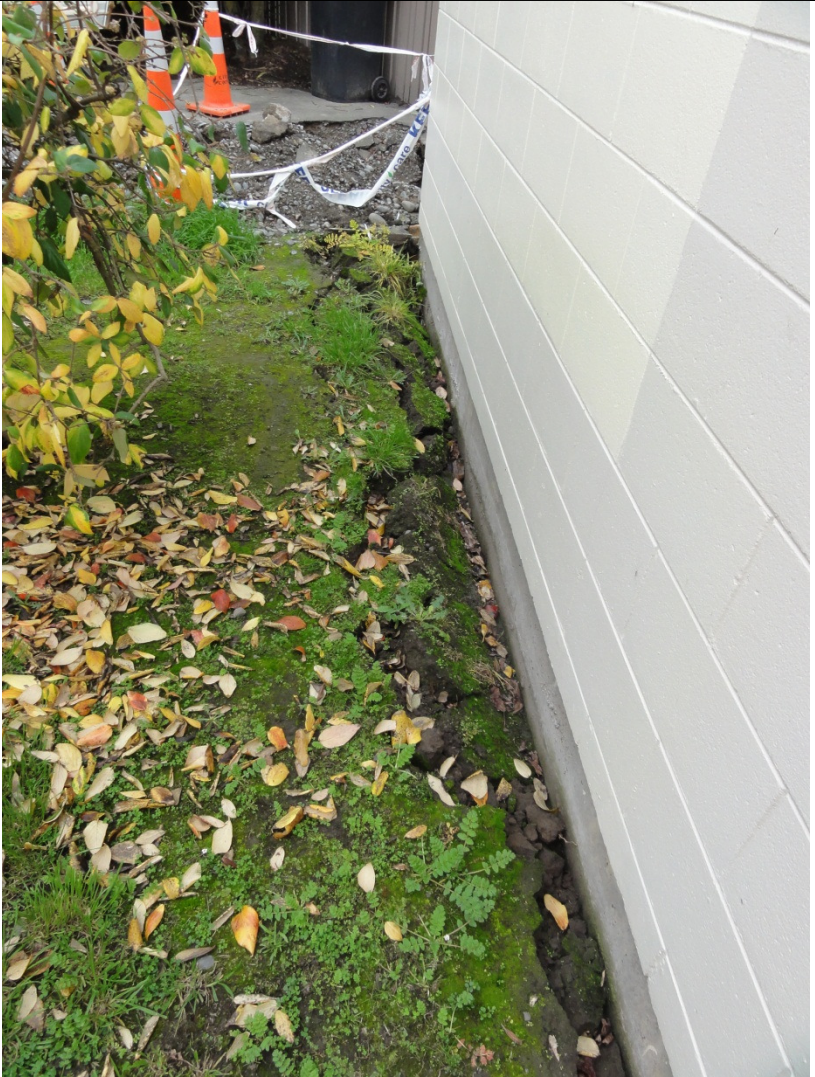
<p>17.</p>	<p>Settlement next to Unit 9 at 33 Vienna Place</p>

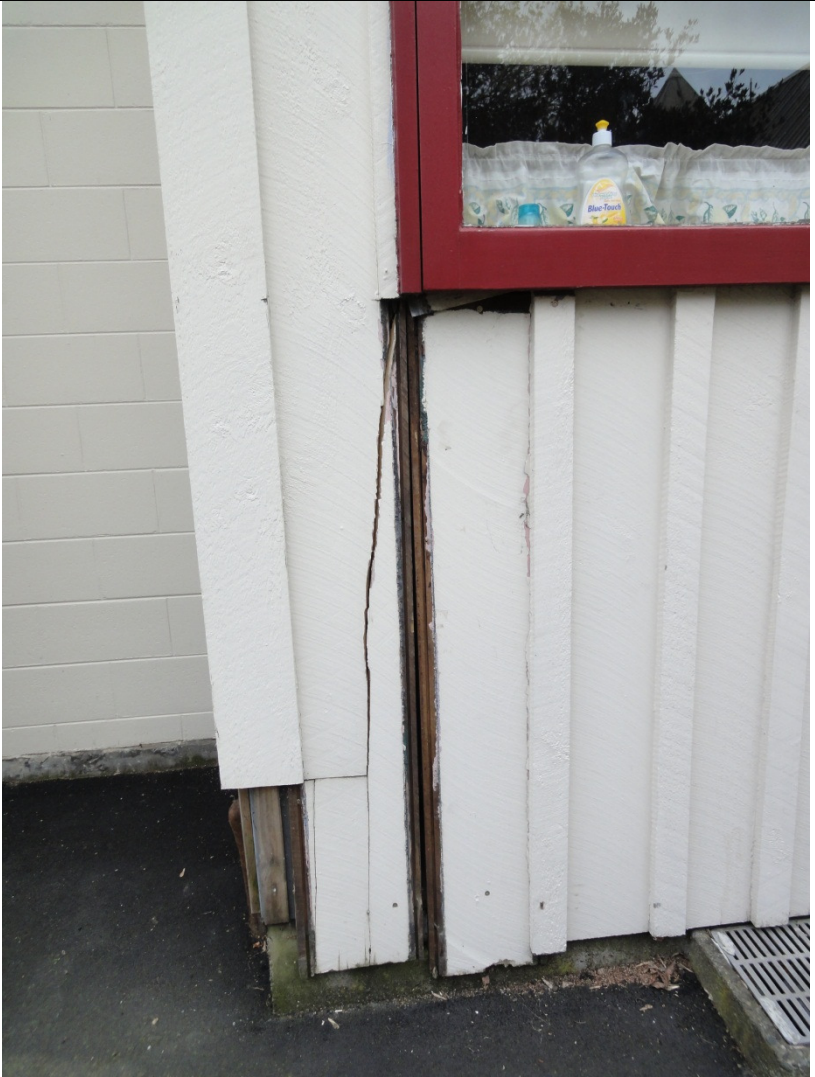
<p>23.</p>	<p>Close up of damage to wood siding</p>

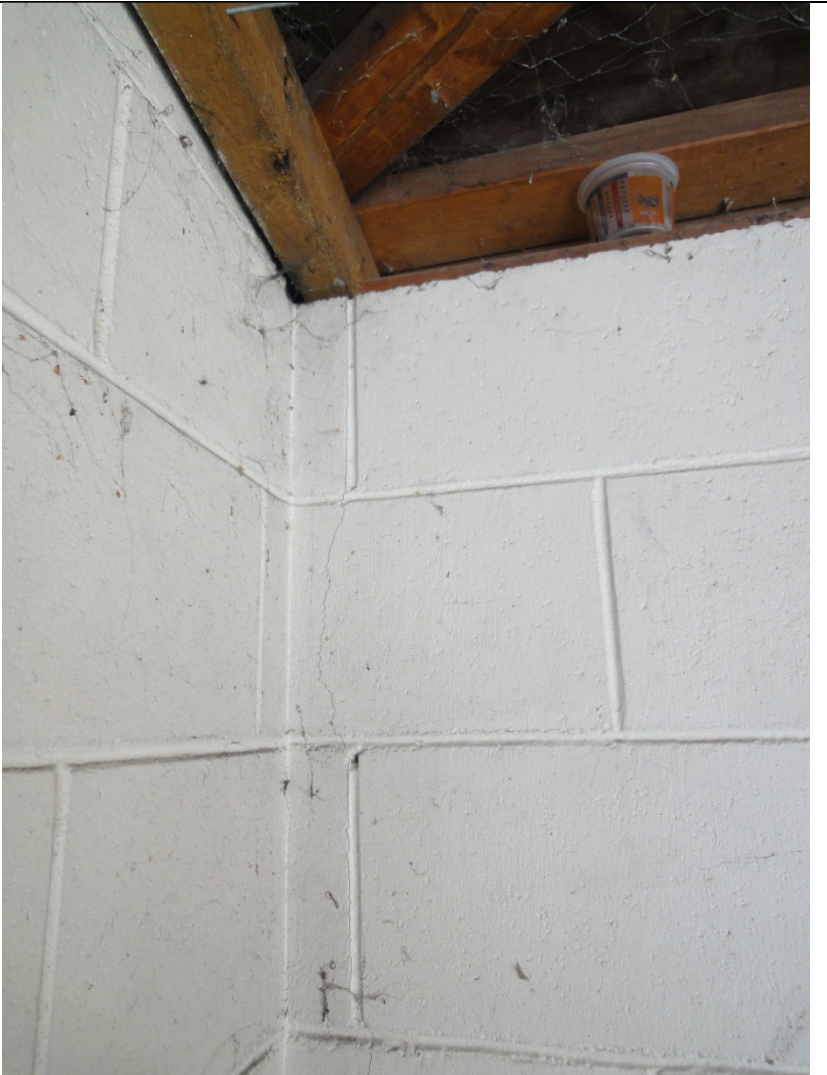
- Minor cracking less than 1mm in the masonry walls of the garages (see Appendix 1, photo 34).

A photograph showing the interior of a garage looking up at the roof structure. The roof is supported by a network of wooden timber trusses. Skipped wooden boards are laid across these trusses. A white corrugated metal roof sheet is visible on the right side. A silver metal pipe runs horizontally across the middle of the frame. A white mesh netting is attached to the trusses below the roof boards.
34.	Minor cracking in garage masonry walls

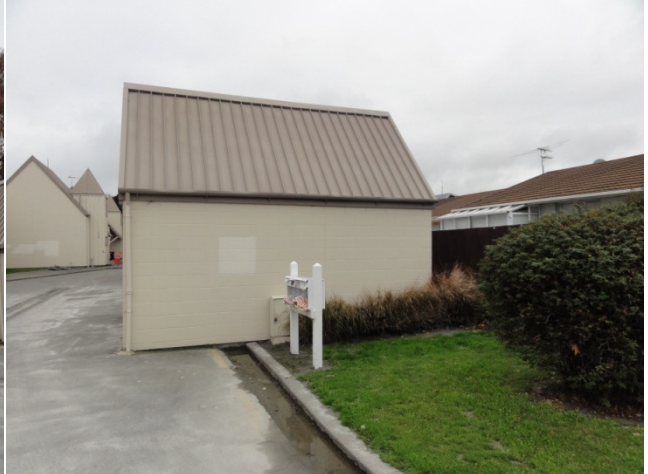
Garage Block G tilting south, up to 150mm settlement.

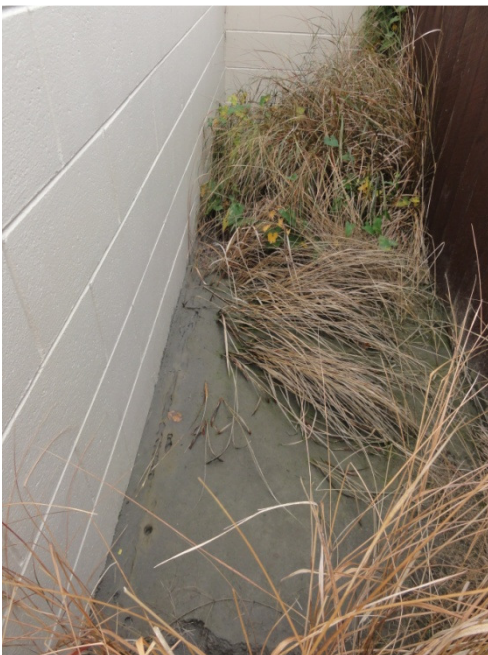
Liquefaction behind garage

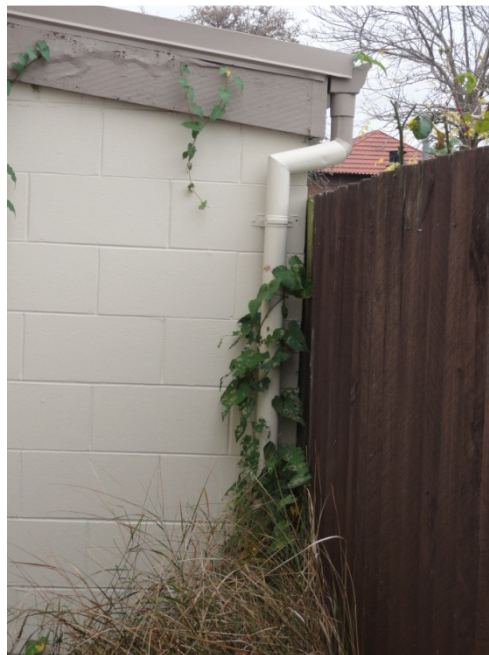
Garage leaning on fence

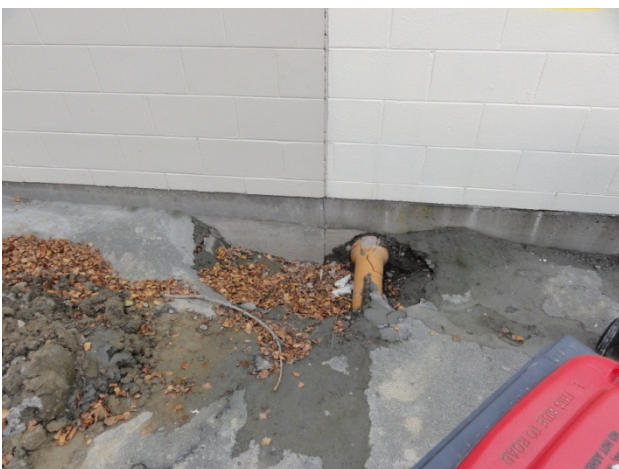
Exposed ring beam foundation Unit 4 16 Cecil Courts

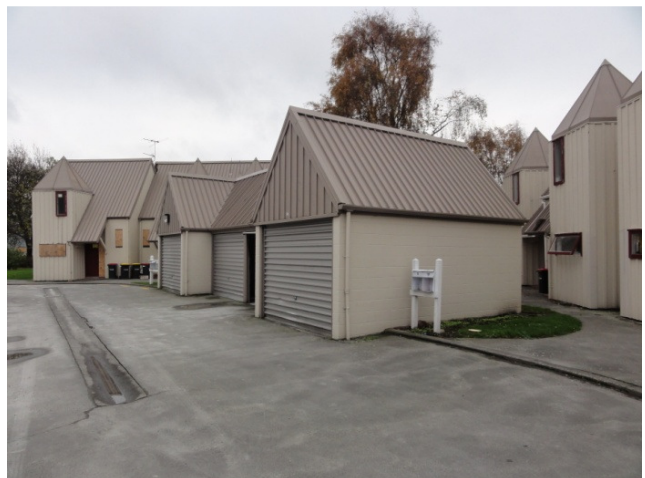
Garage Block H suspected subsidence on north side

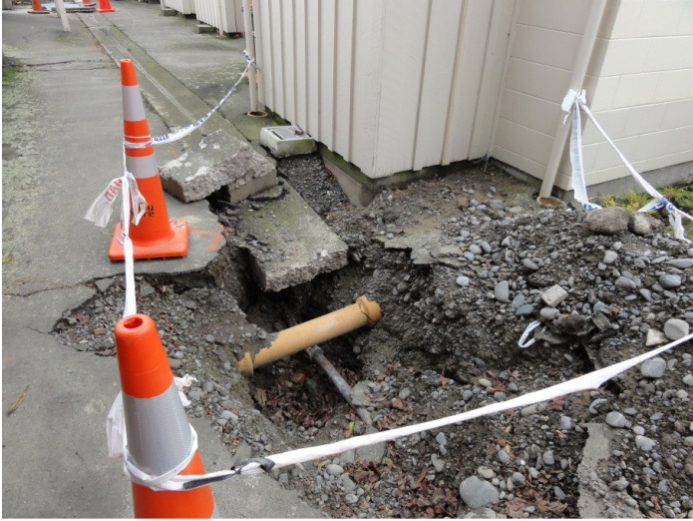
Ground Damage eastern corner of Unit 9 33 Vienna Courts

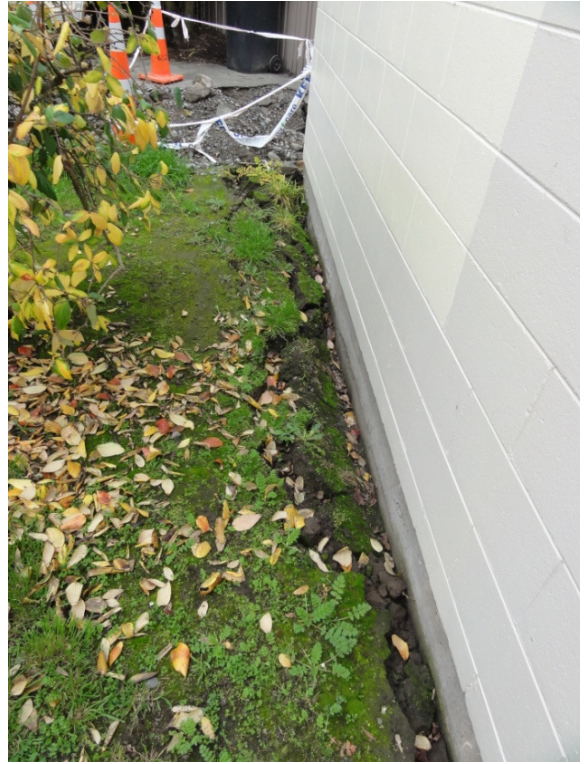
Ground Damage on eastern elevation of Unit 9 33 Vienna

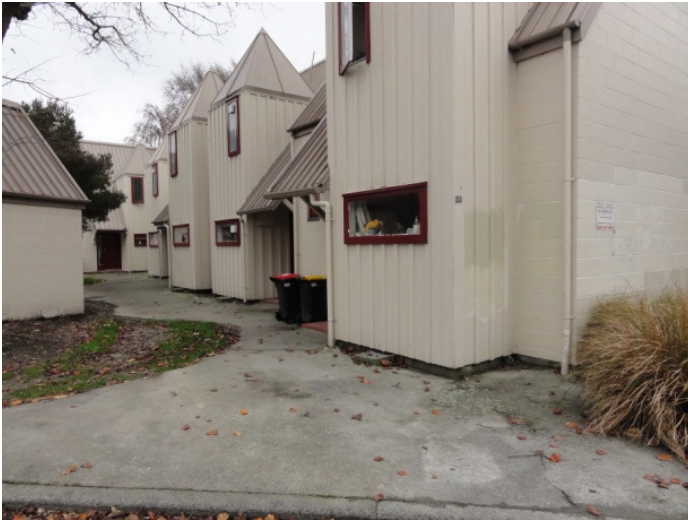
Possible ground heave of asphalt

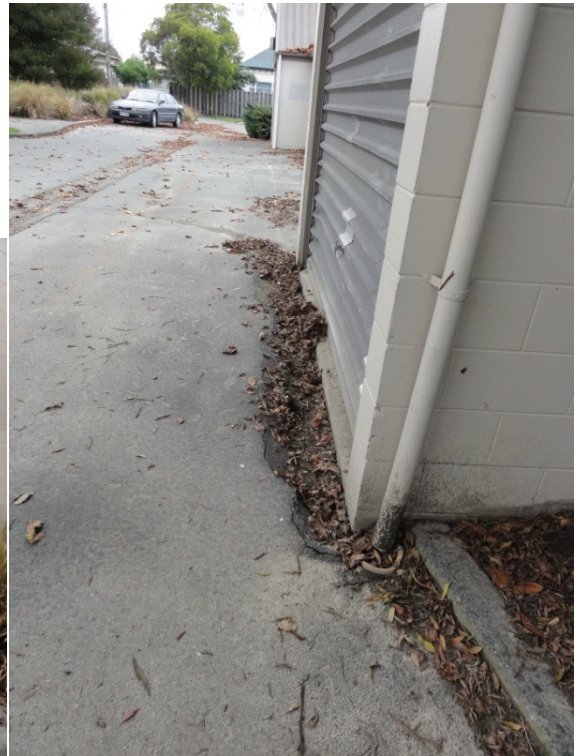
Subsidence in front of Garage Block J
