CHRISTCHURCH CITY COUNCIL
PRK_3563_BLDG_001 EQ2
Cholmondeley Reserve Toilet
102 Main Road, Governors Bay

QUALITATIVE ASSESSMENT REPORT

- Rev B
- 23 May 2013

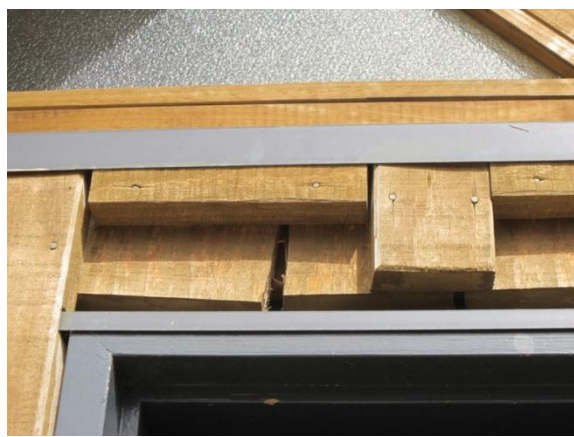
Photo 5: Cracking along the grain of external timber wall cladding elements

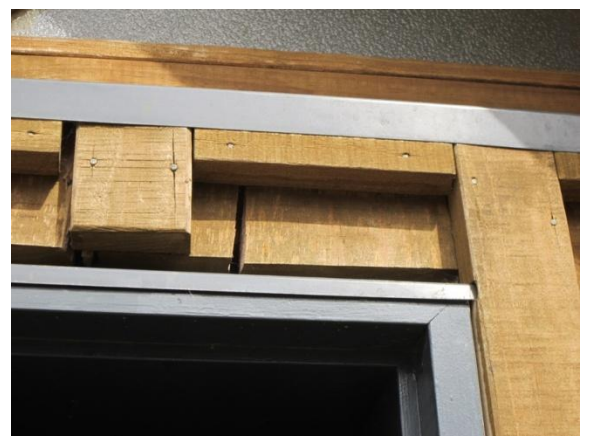
Photo 6: Cracking along the grain of external timber wall cladding elements

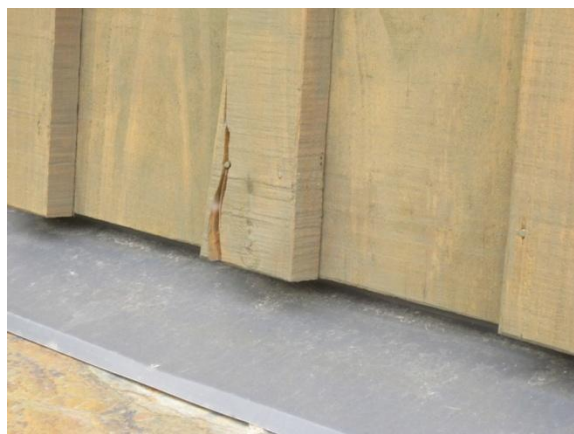
Photo 7: Cracking along the grain of external timber wall cladding elements

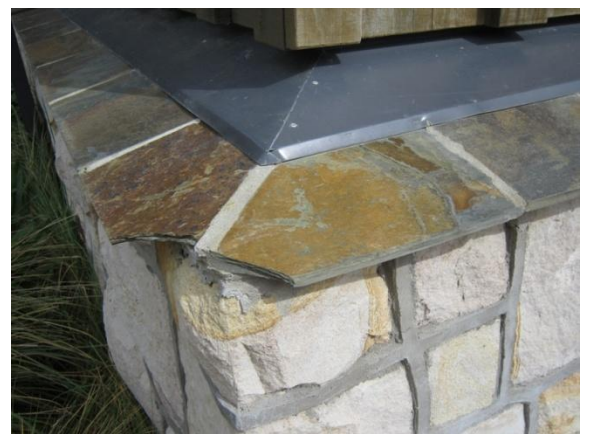
- 1) Tearing of internal wall linings at joints (refer to Photo 10)
- 2) Gap opening up between internal timber cladding elements at joints (refer to Photo 11)
- 3) Cracking along the grain of external timber cladding elements. This is believed to either be due to weathering or damage that occurred during or soon after construction (refer to Photos 5, 6 & 7)
- 4) Suspected impact damage to stone veneer on the southwest corner of the building. This is not considered to be earthquake damage (refer to Photo 8)

Photo 8: Suspected impact damage to stonework veneer on the southwest corner of the building

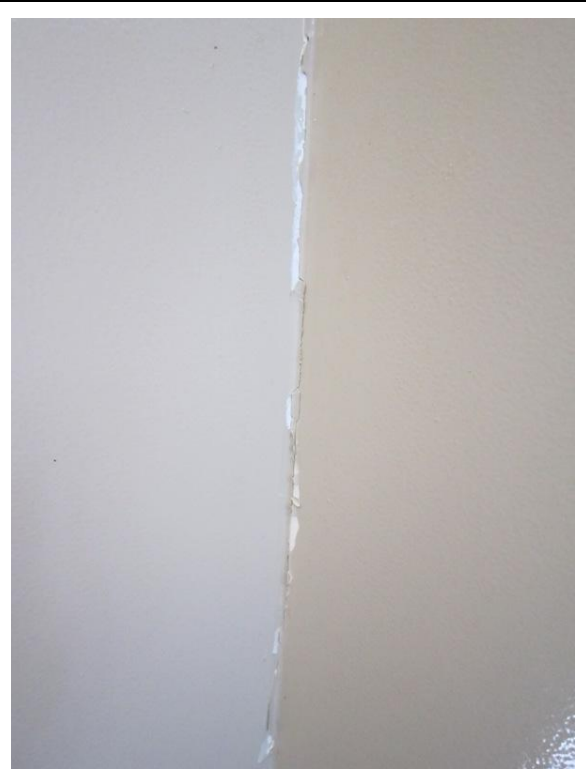
Photo 10: Tearing of internal wall layout at joints (typical)

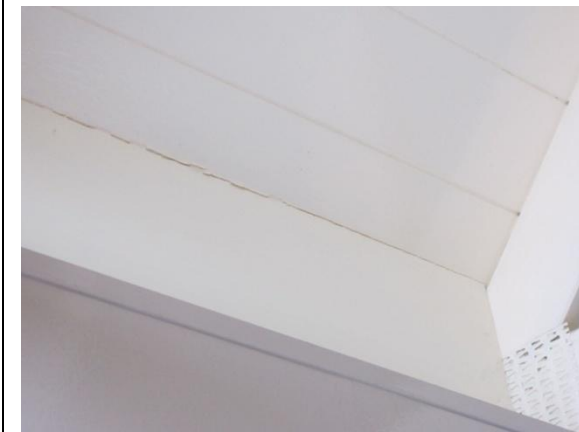
Photo 11: Gap opening up between internal timber cladding elements on the southern side of the building
