**Clare Park Pavilion and Toilets**  
**PRK 0104 BLDG 001 EQ2**  
Detailed Engineering Evaluation  
Quantitative Report  
Version FINAL

149 Burwood Road, Burwood

Christchurch City Council

**Date**  
8<sup>th</sup> March 2013

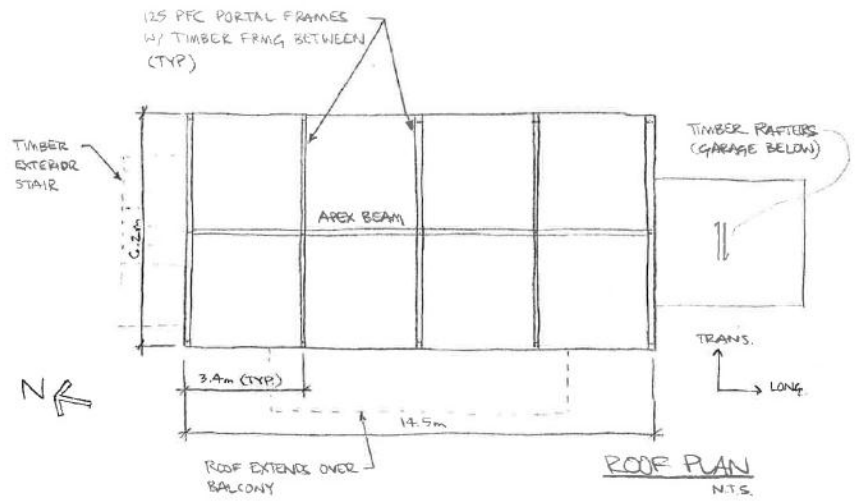
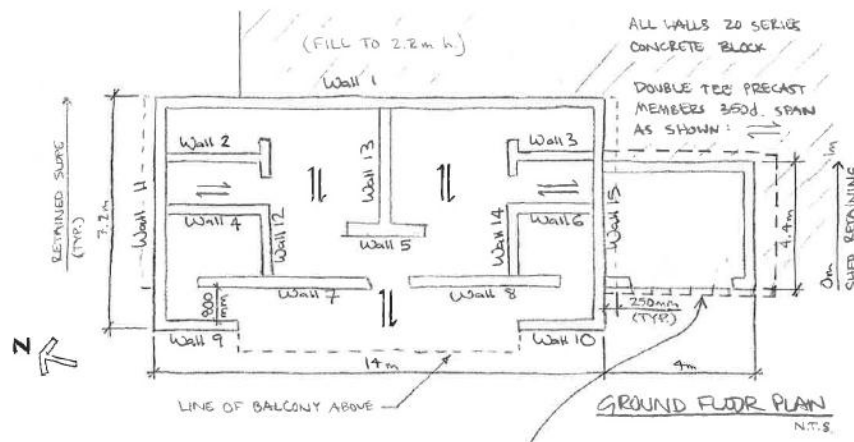
**Figure 2 Ground floor and first floor plans**

Notes this section of the building has become completely seperated (i.e. No structural ties) from the main building.

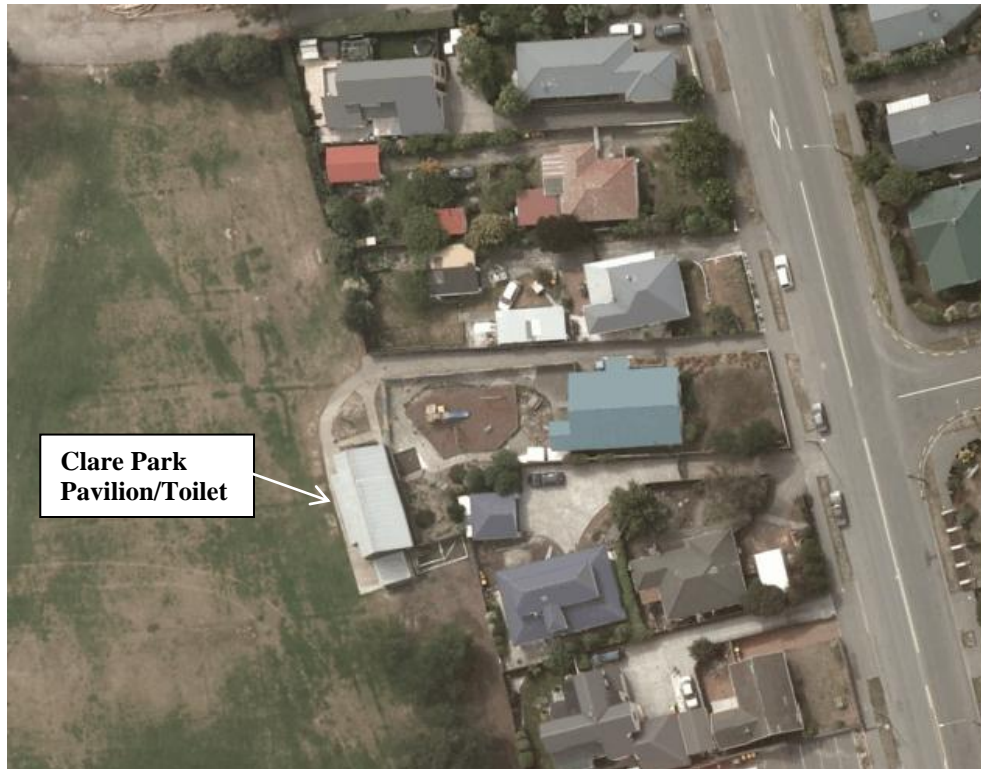
**Figure 4 Post February 2011 Earthquake Aerial Photography<sup>3</sup>**

Aerial photography taken within days following the 22 February 2011 earthquake doesn't show any sign of liquefaction around the pavilion, as shown in Figure 4.

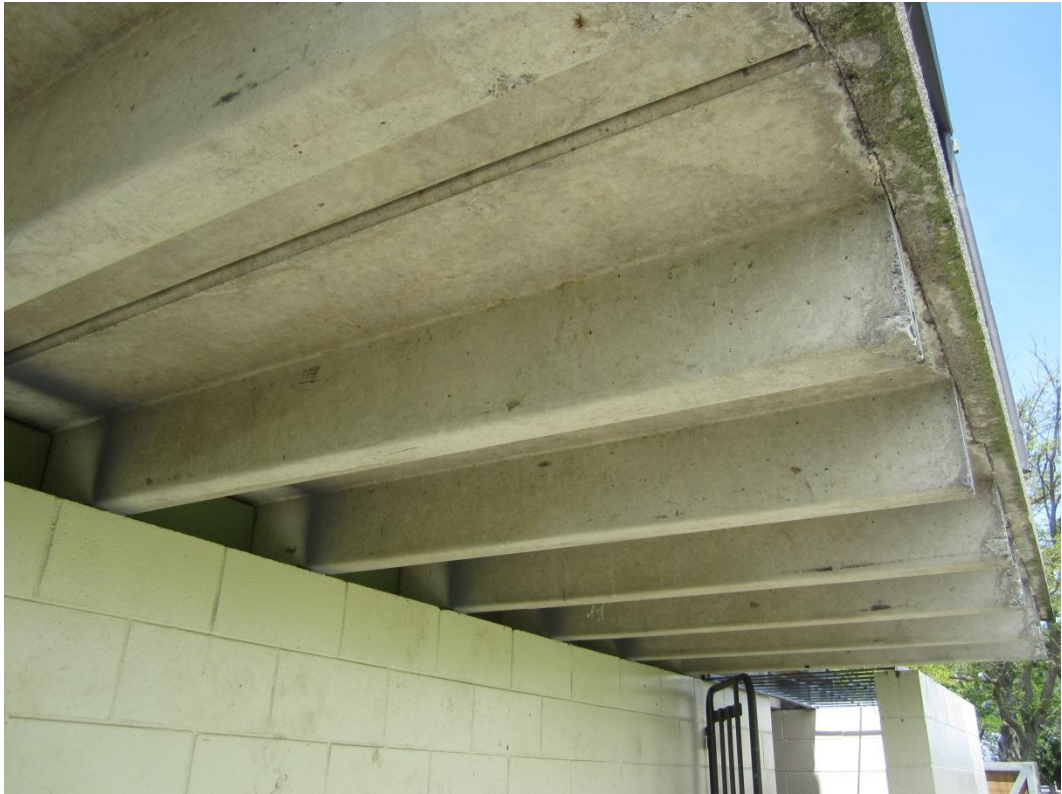
Residual displacements were observed in several areas of the building during inspections. The flange supported double tee precast floor units in the changing room area appear to have moved away from the supporting concrete masonry walls, reducing the seating.

**Photograph 5** Overhanging double tee units

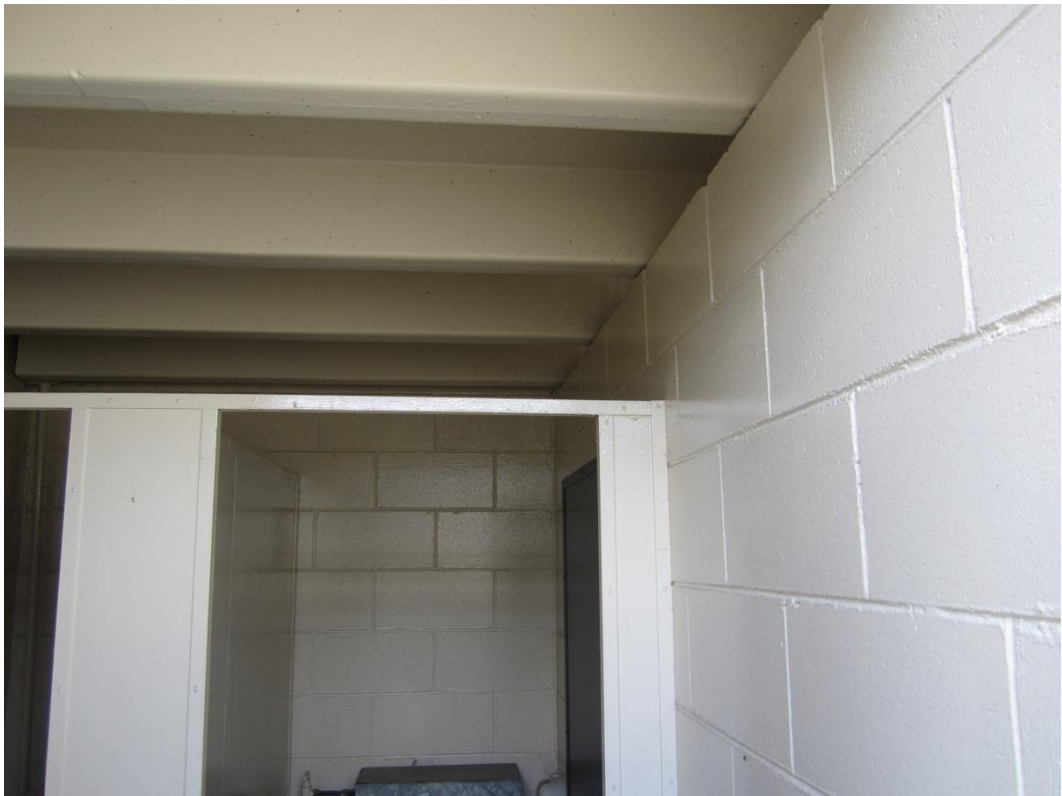
**Photograph 6** Double tee webs bearing on the concrete masonry walls

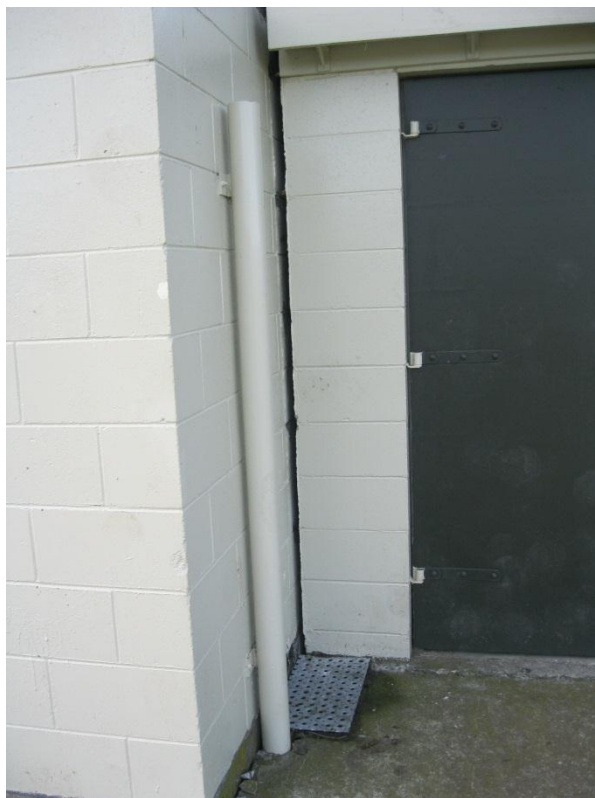
Separation between the pavilion building and the garage immediately to the south appears to have occurred during the recent seismic activity. Several steel ties connecting these two buildings have pulled out. The gap between the two buildings is approximately 35mm. The front of the pavilion building also appears to have settled by approximately 20mm.

Approximately 20mm of settlement was observed at the entrance to the pavilion building. Separation of the garage addition and the pavilion building and relative movement of the external stair landing and the staircase indicates that ground movement has occurred.

**Photograph 8** Separation between the pavilion building and adjacent garage

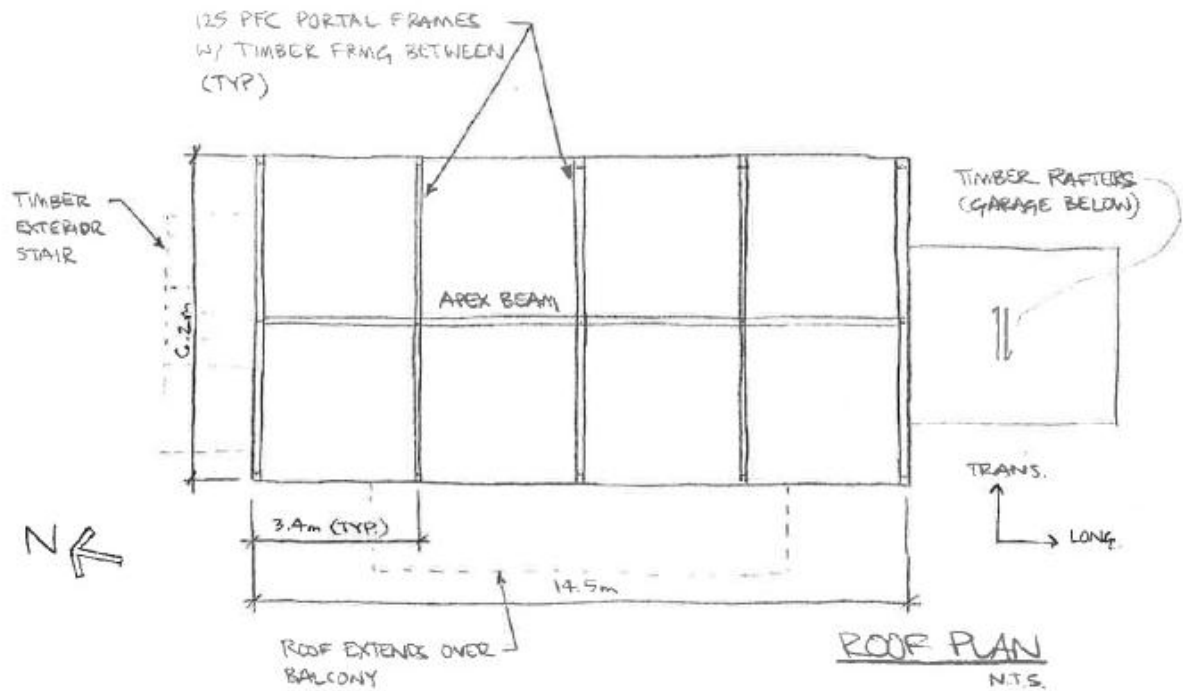
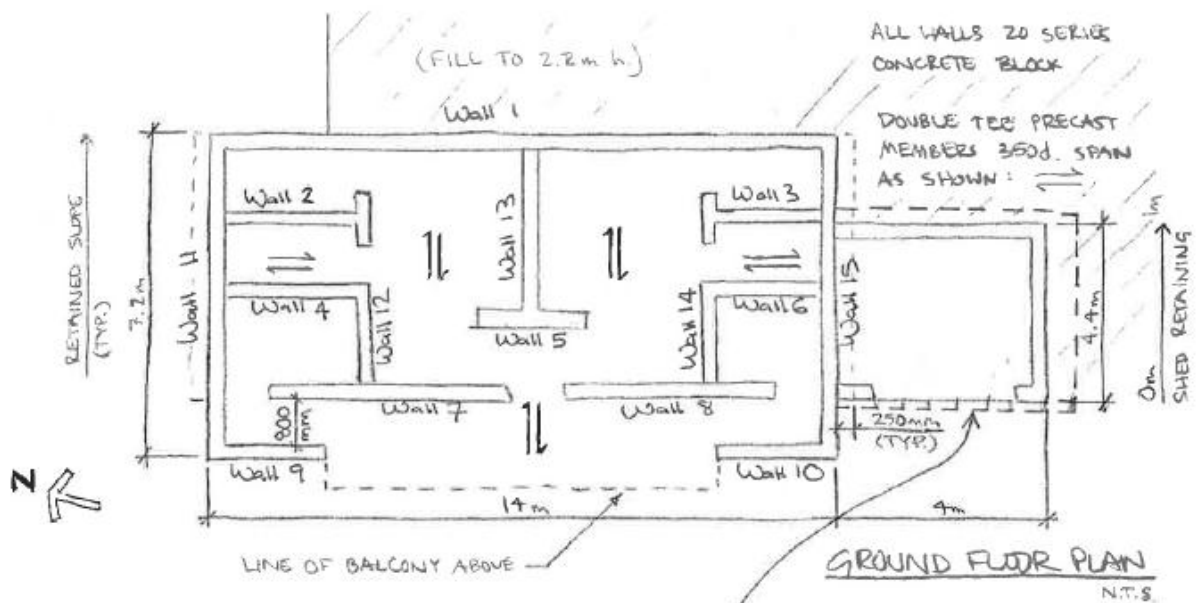
Notes this section of the building has become completely separated (i.e. No structural ties) from the main building.
