Cresselly Place Housing Complex PRO 0980

**Detailed Engineering Evaluation
Quantitative Assessment Report**

Cresselly Place Housing Complex Quantitative Assessment Report

Wilsons Road, St Martins, Christchurch

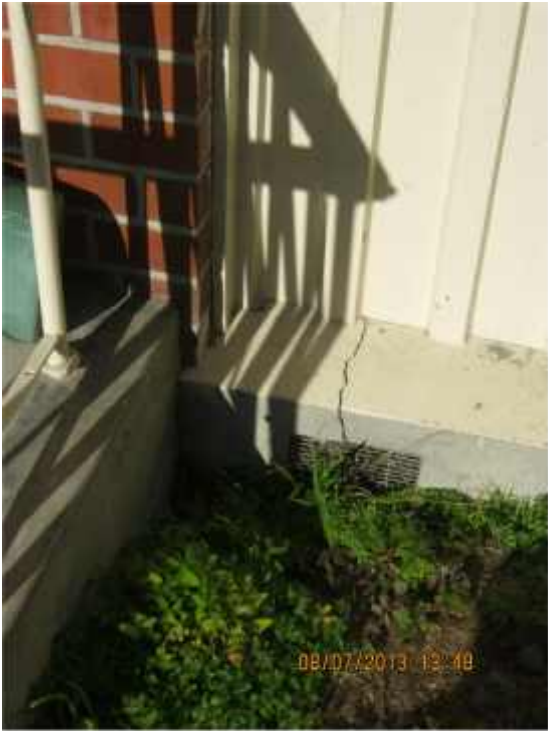
Major cracking (photo 4) was observed to the perimeter foundations of Blocks C, D, E, F, G and H. Cracks in these blocks were up to 40mm wide and stretched the structure laterally. As highlighted in section 5.1, the foundations have suffered large displacements causing significant damage.

4	Major foundation cracking, observed in Units 25 and 27 (Block G). Cracking up to 40mm.

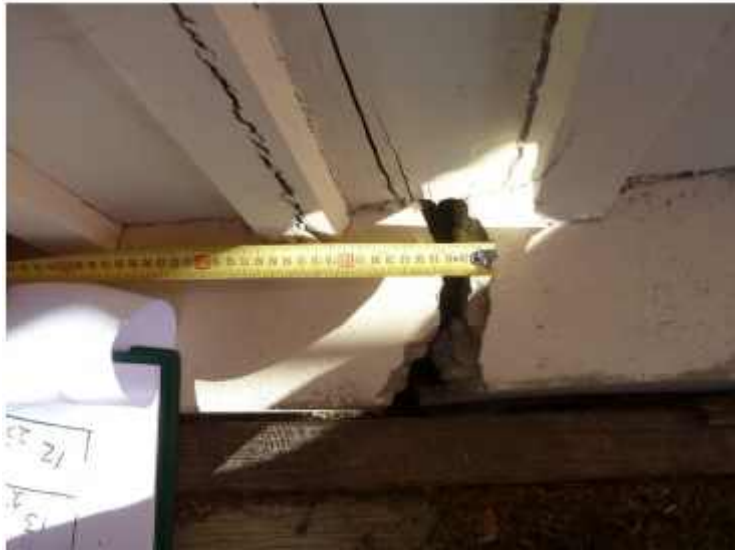
The timber framing in Blocks E and G has been racked due to movement in the foundations (photo 5); the brick firewalls are also cracked in these blocks. No damage was observed to the gravity structures of the other units.

5	<p>Interface of brick and window showing warping in timber framing in Units 19, 21, 23, 25, 27, 29 and 31.</p>

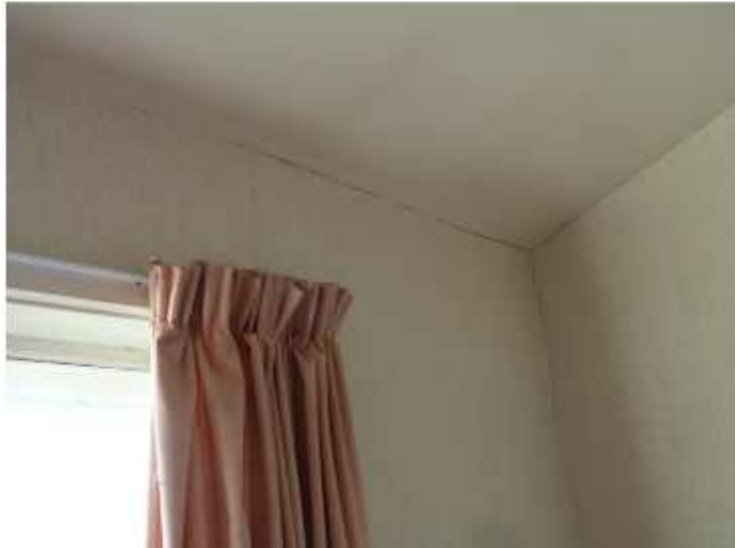
7	Typical cracking along ceiling beam, observed in all units.	  A photograph showing a corner of a room where a ceiling beam meets a wall. A distinct vertical crack is visible along the beam.
8	Typical GIB cracking from corners of windows and doors, observed in all units.	  A photograph of an interior wall corner next to a window. A crack runs diagonally down from the corner of the window frame into the wall. A timestamp '06/07/2013 14:08' is visible in the bottom right corner.
9	Loose bricks in gable end walls, observed at both ends of all blocks of units.	  A photograph of a red brick gable end wall. Several bricks are missing or crumbling, particularly near the roofline. A timestamp '06/07/2013 15:21' is visible in the bottom right corner.

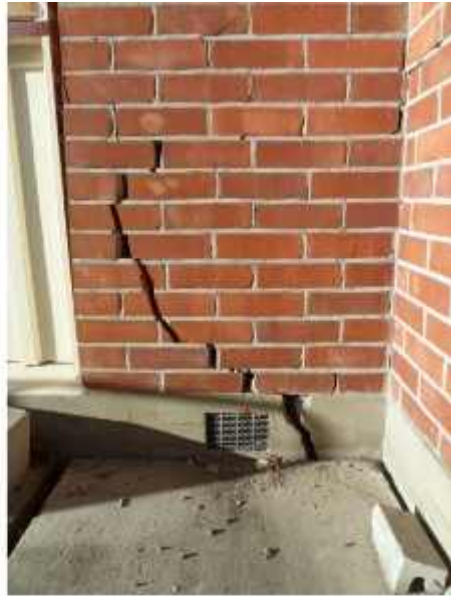
10	Example of the severe cracking observed to veneers around Units 19, 21, 23, 25, 27, 29 and 31.

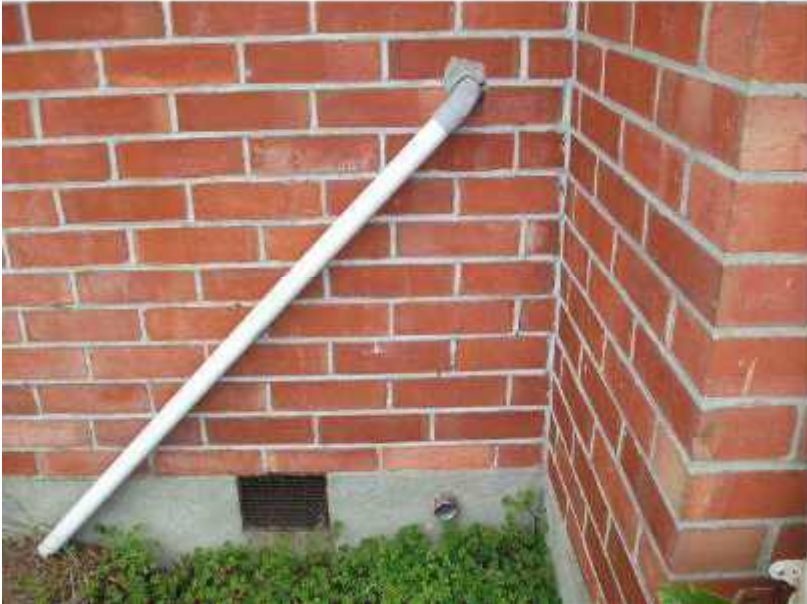
Photo 11: Small Stepping Crack in Brick Veneer behind Flat 3 Looking North

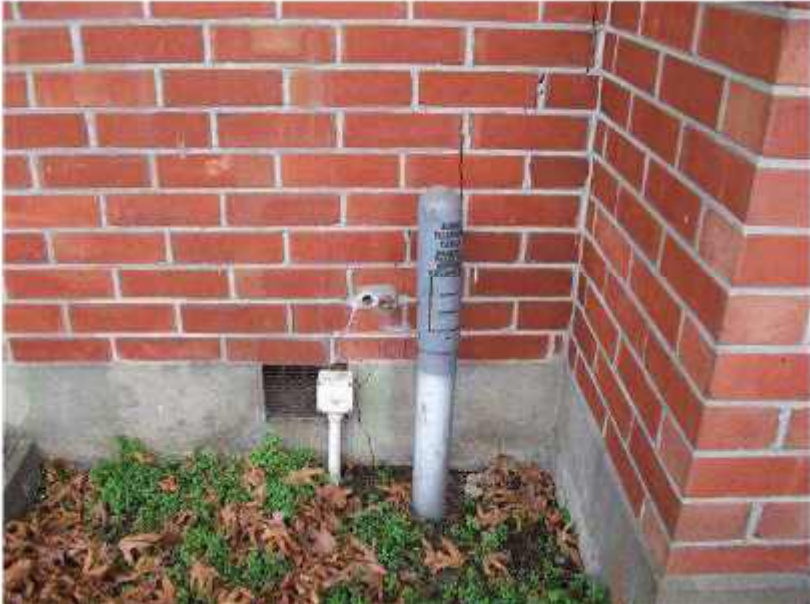
Photo 12: Bottom Portion of Medium Stepping Crack in Brick Veneer behind Flat 5 Looking North

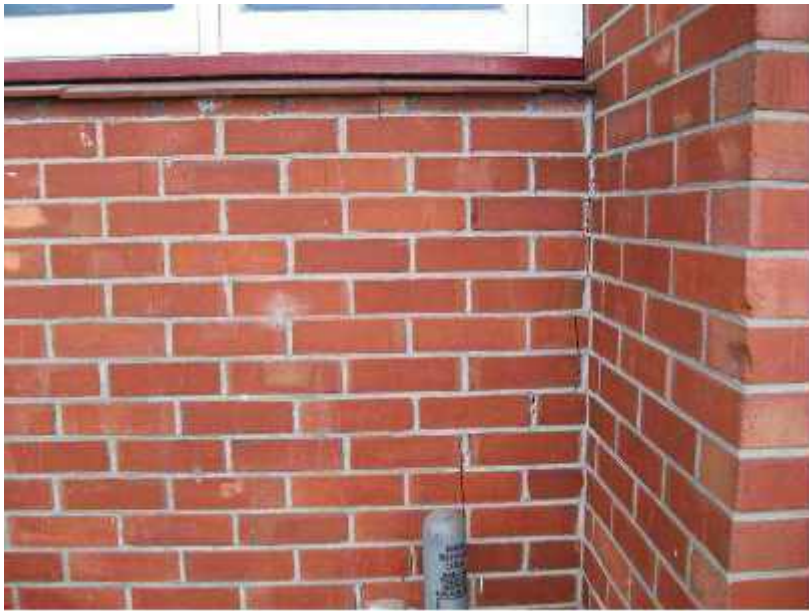
Photo 13: Top Portion of Medium Stepping Crack in Brick Veneer behind Flat 5

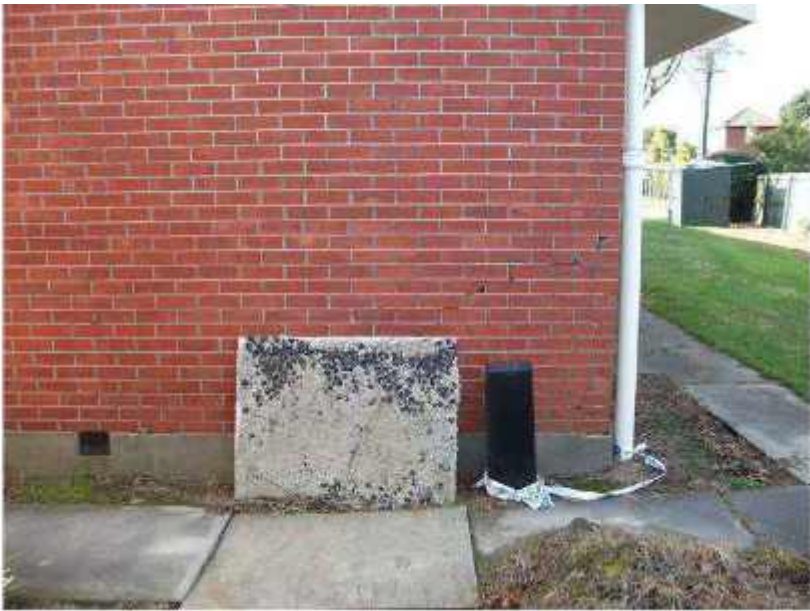
Photo 14: Major Stepping Crack in Brick Veneer in the Back Portion of the Right Wall of Flat 7 Looking East

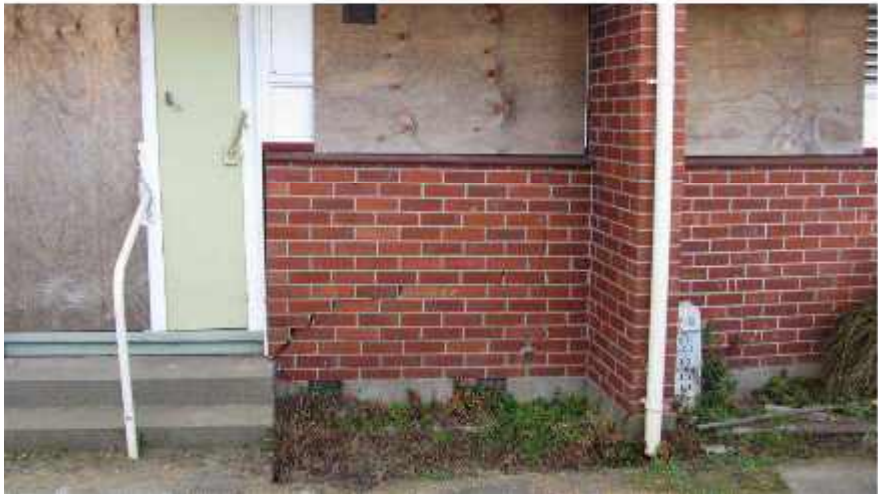
Photo 15: Severe Step Cracking in Brick Veneer at Back of Flat 21 Looking North

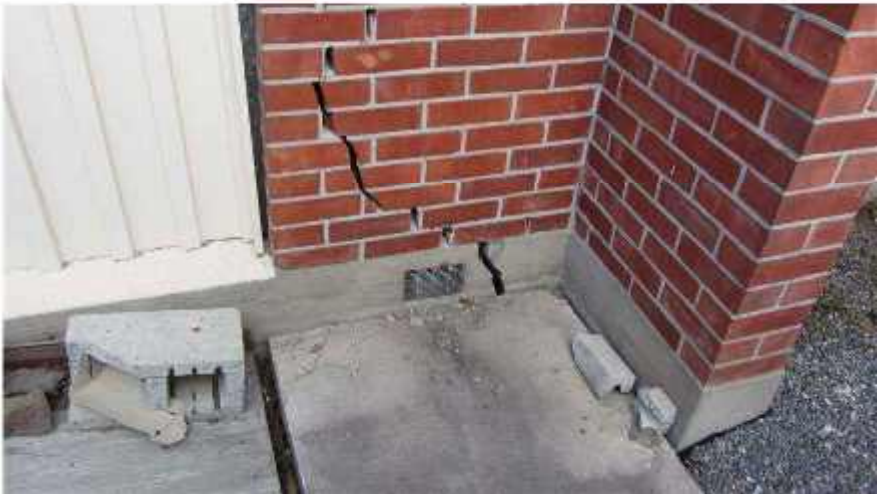
Photo 16: Severe Stepping Crack, Shearing Through Brick in Exterior Veneer and Cracking through Foundation at Front of Flat 27 Looking South

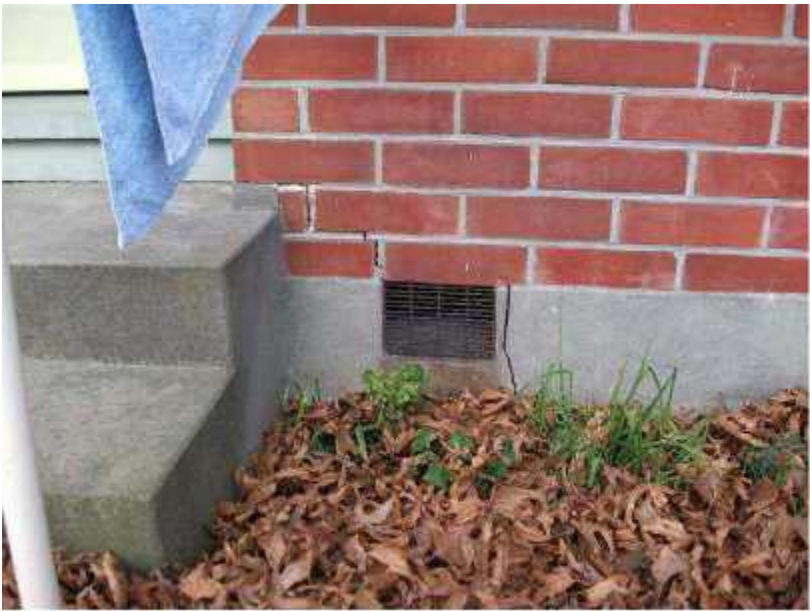
Photo 17: Moderate Crack in Foundation behind Flat 5 Looking North

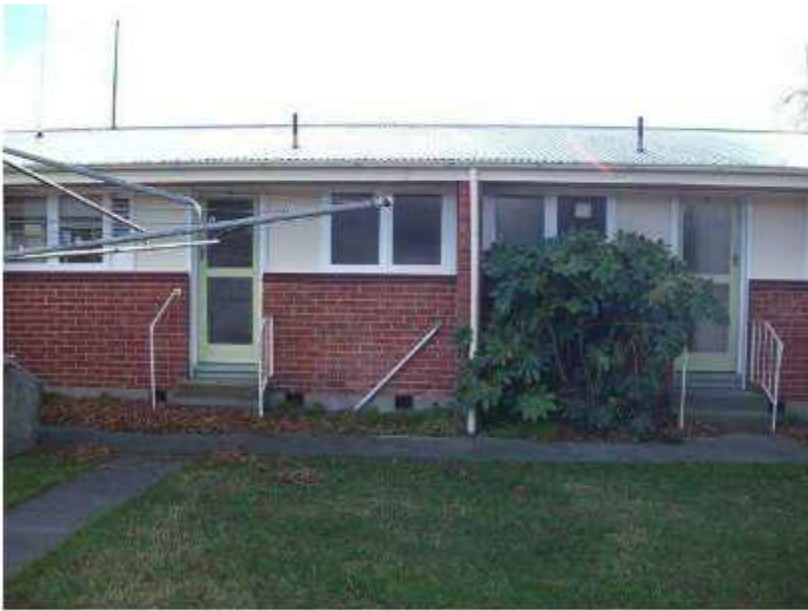
Photo 18: Stretching Separation of Fascia Boards at Back of Flats 1 and 3 Looking Northwest

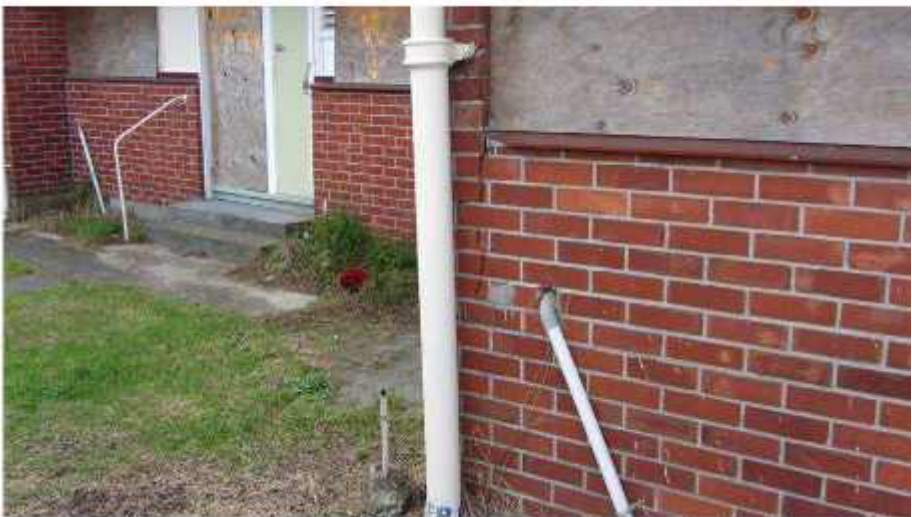
Photo 22: Shearing through Bricks of Exterior Veneer and Minor Vertical Cracking through Bricks in Corner Exterior Wall at Back of Flat 23 Looking West

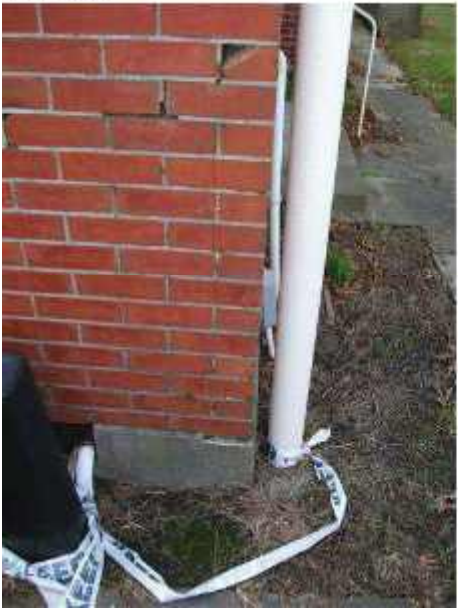
Photo 23: Shearing through Bricks of Exterior Veneer and Minor Vertical Cracking through Bricks in Corner Exterior Wall at Back of Right Wall of Flat 7 Looking East

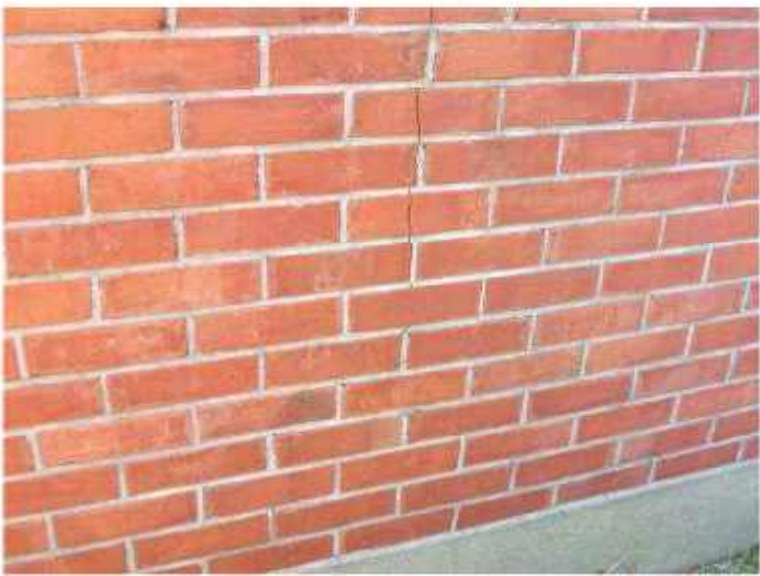
Photo 24: Moderate Vertical Cracking through Brick Veneer at Right Wall of Flat 7 (Photo 1 of 5) Looking Southeast

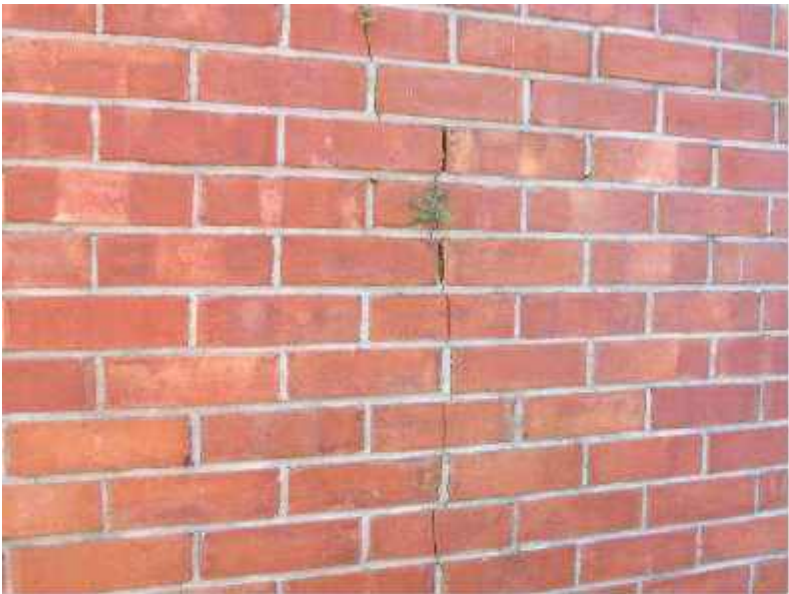
Photo 25: Moderate Vertical Cracking through Brick Veneer at Right Wall of Flat 7 (Photo 2 of 5) Looking Southeast

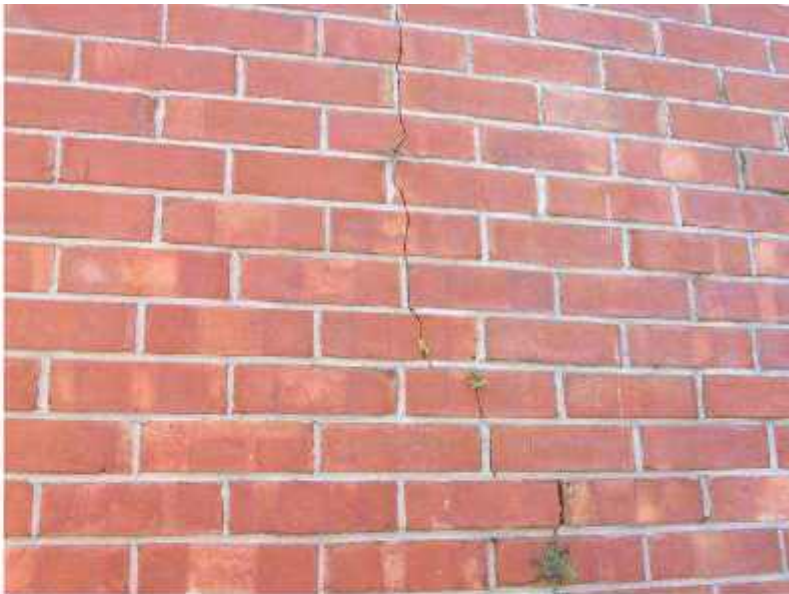
Photo 26: Moderate Vertical Cracking through Brick Veneer at Right Wall of Flat 7 (Photo 3 of 5) Looking Southeast

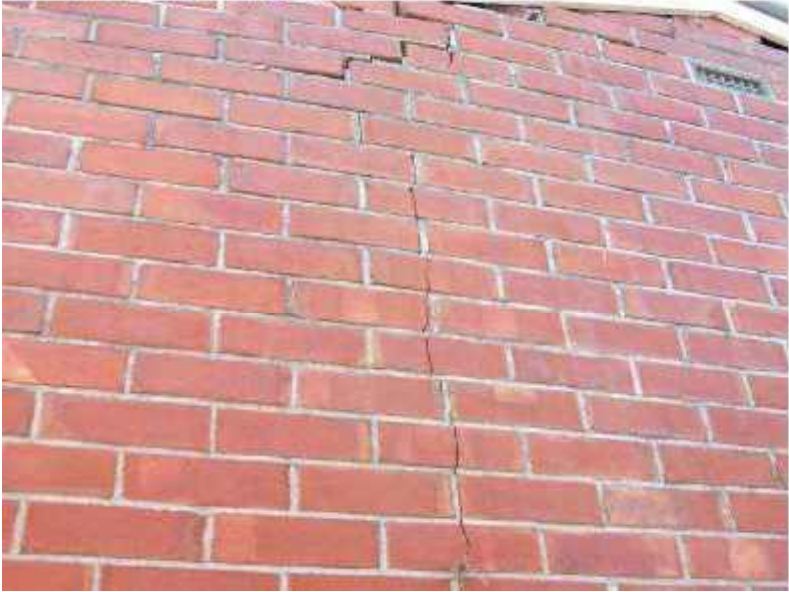
Photo 27: Moderate Vertical Cracking through Brick Veneer at Right Wall and Failing of Gable Bricks of Flat 7 (Photo 4 of 5) Looking Southeast

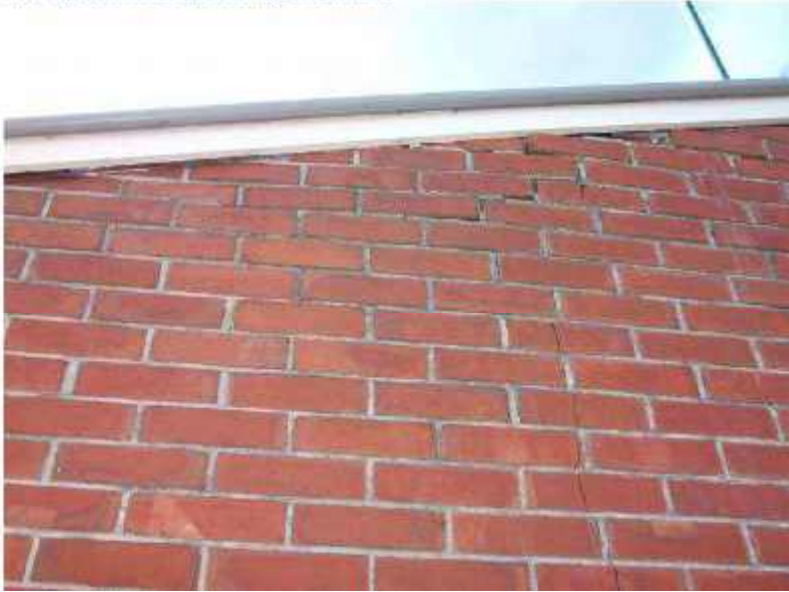
Photo 28: Moderate Vertical Cracking through Brick Veneer at Right Wall and Failing of Gable Bricks of Flat 7 (Photo 5 of 5) Looking East

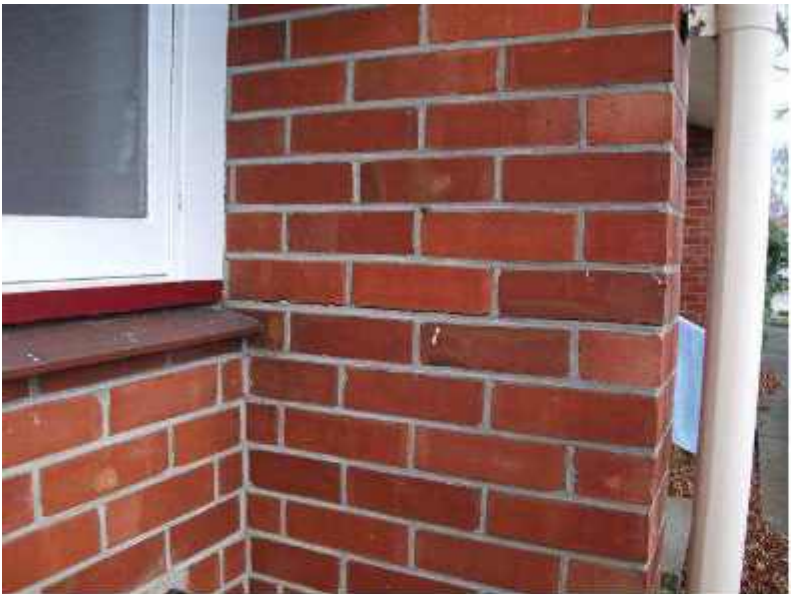
Photo 29: Tension Cracking of Pilaster between Rear of Flats 5 and 7 Looking East

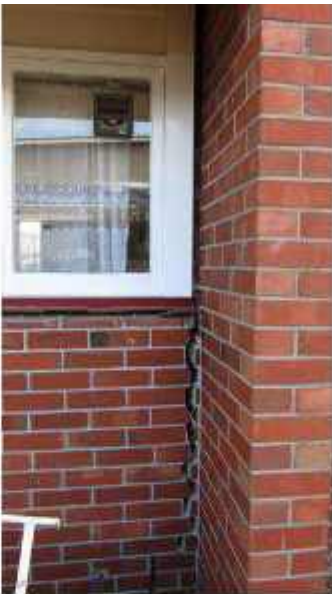
Photo 30: Severe Stretching of Walls at Rear of Flats 27 and 29 Looking North (Photo 1 of 2)

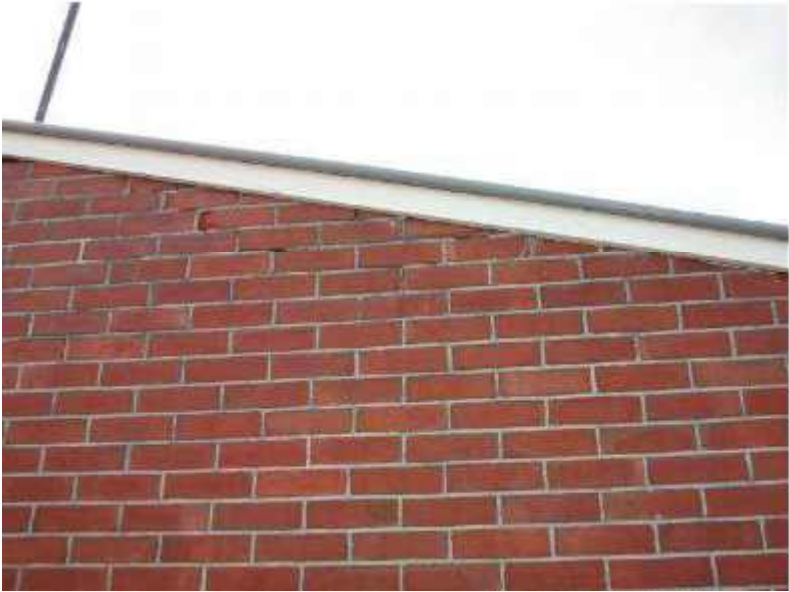
Photo 43: Cracking of Gable at Top of Right Wall of Flat 7 Looking Northeast

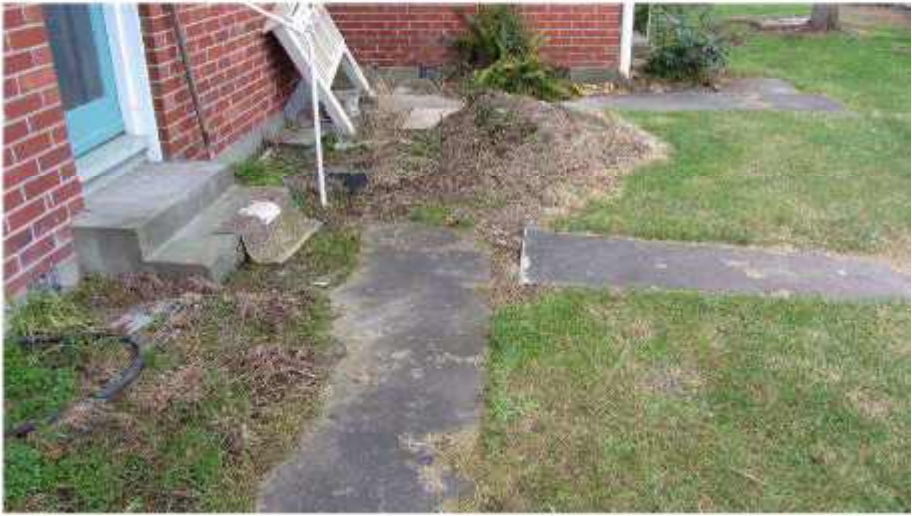
Photo 44: Differential Movement of Concrete Footpaths behind Flat 19 Looking Northeast

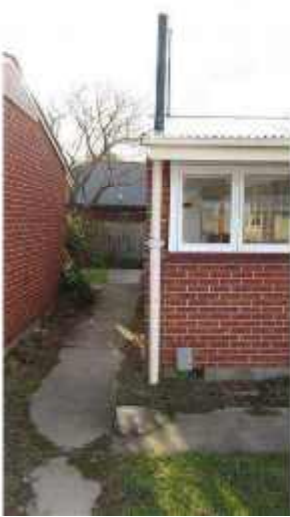
Photo 56: Shear Cracking of Downspout and Tilting of Exterior Wall at Flat 16 Looking Northwest

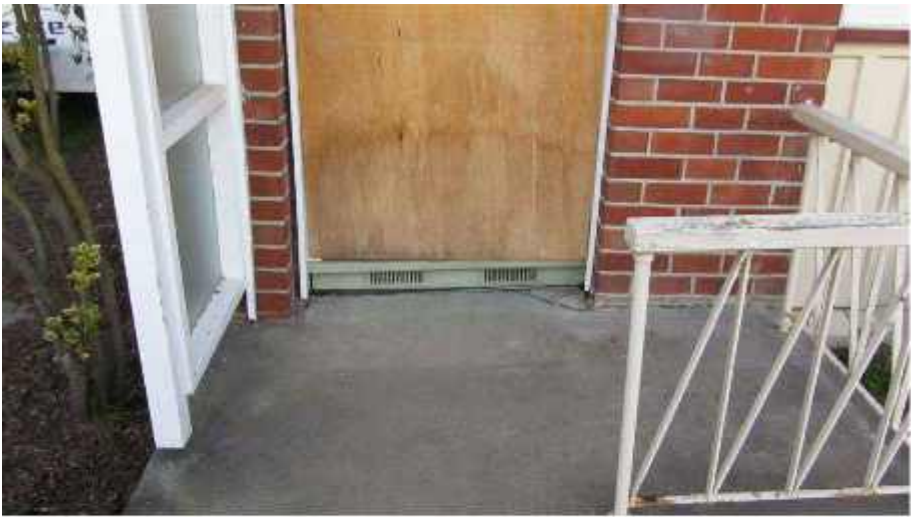
Photo 57: Cracking of Concrete Porch at Back of Flat 28 Looking Southeast

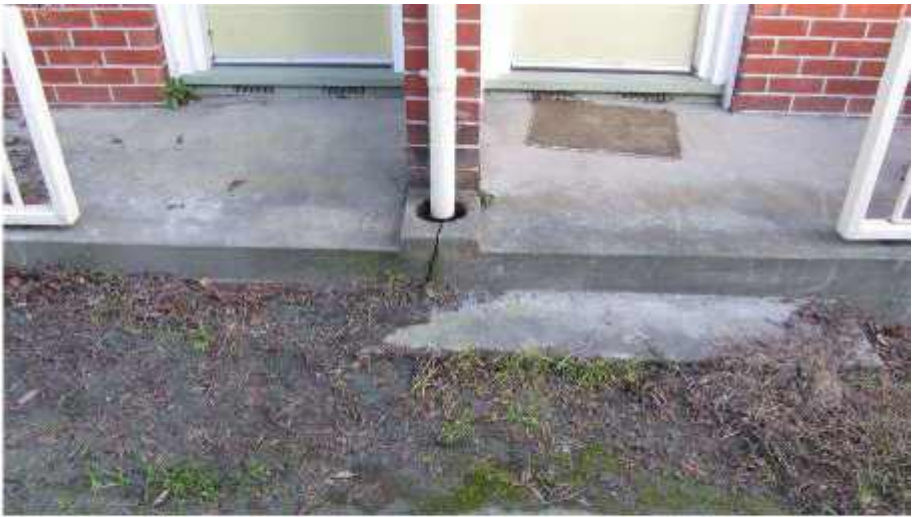
Photo 58: Cracking of Concrete Porch at Back of Flats 22 and 24 Looking Southeast

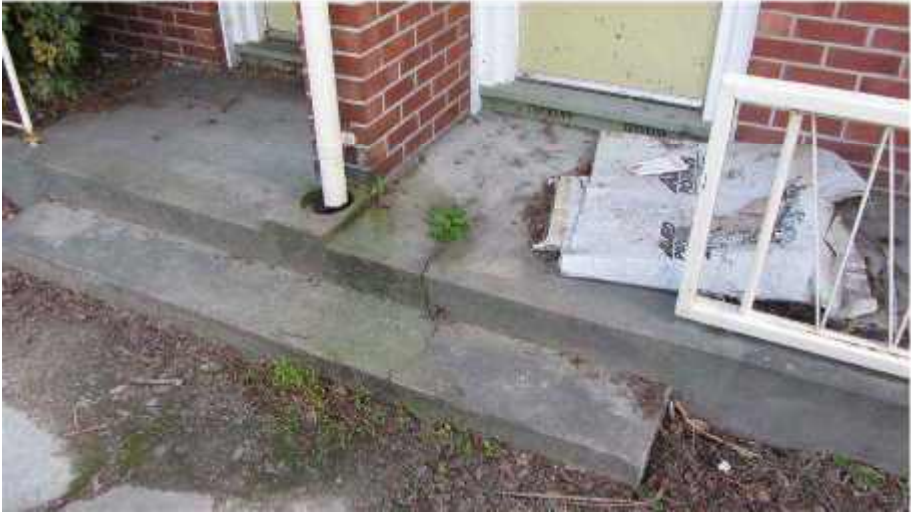
Photo 59: Cracking of Concrete Porch at Back of Flat 20 Looking Southeast
