Denton Park Lighting Towers
BU 0770-001 EQ2
Detailed Engineering Evaluation
Qualitative Report
Version FINAL

442 Main South Road, Hornby

Christchurch City Council

Date
11th June 2012

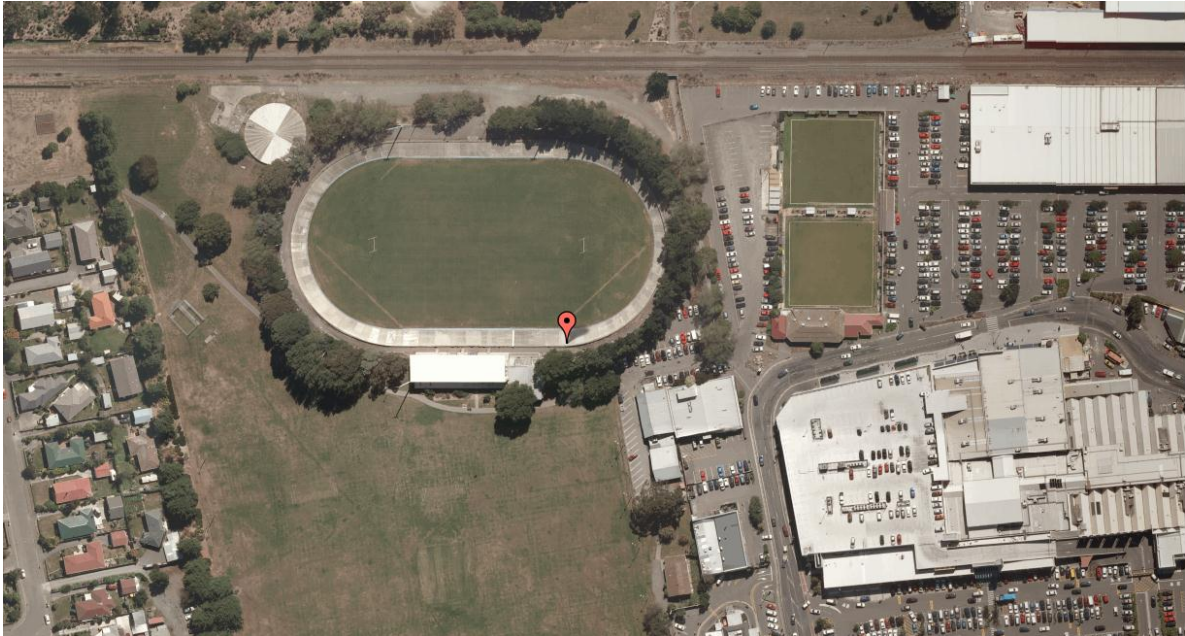
Figure 3 Post February 2011 Earthquake Aerial Photography¹

Aerial photography taken following the 22 February 2011 earthquake shows no signs of liquefaction outside the building footprint or adjacent to the site, as shown in the Figure 1.

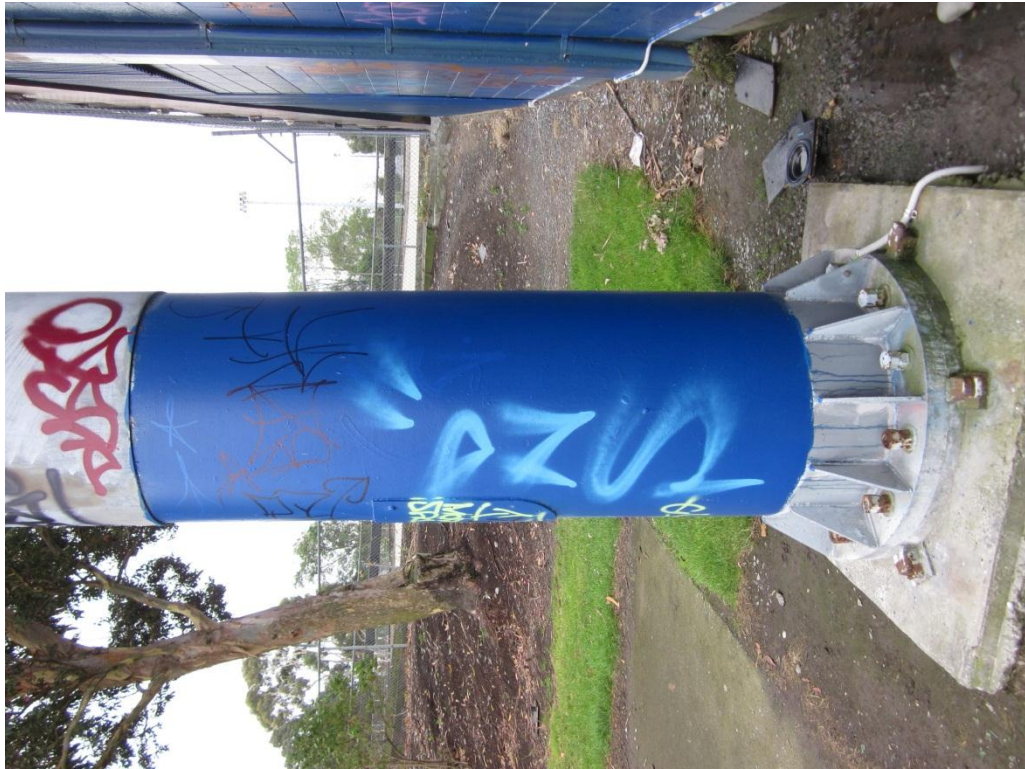
Rusting of the tension bolts and securing nuts at the base of all four towers was noted. This is shown in Photographs 1, 3, 6, 8 and 9.

Photograph 1 Lighting tower base showing rusting of tension bolts and nuts.

The minor damage in the form of partially rusted anchor bolts has been considered in the analysis. The anchor bolts should be monitored, and if loss of section due to rust continues the bolts should be replaced with similar new anchor bolts.

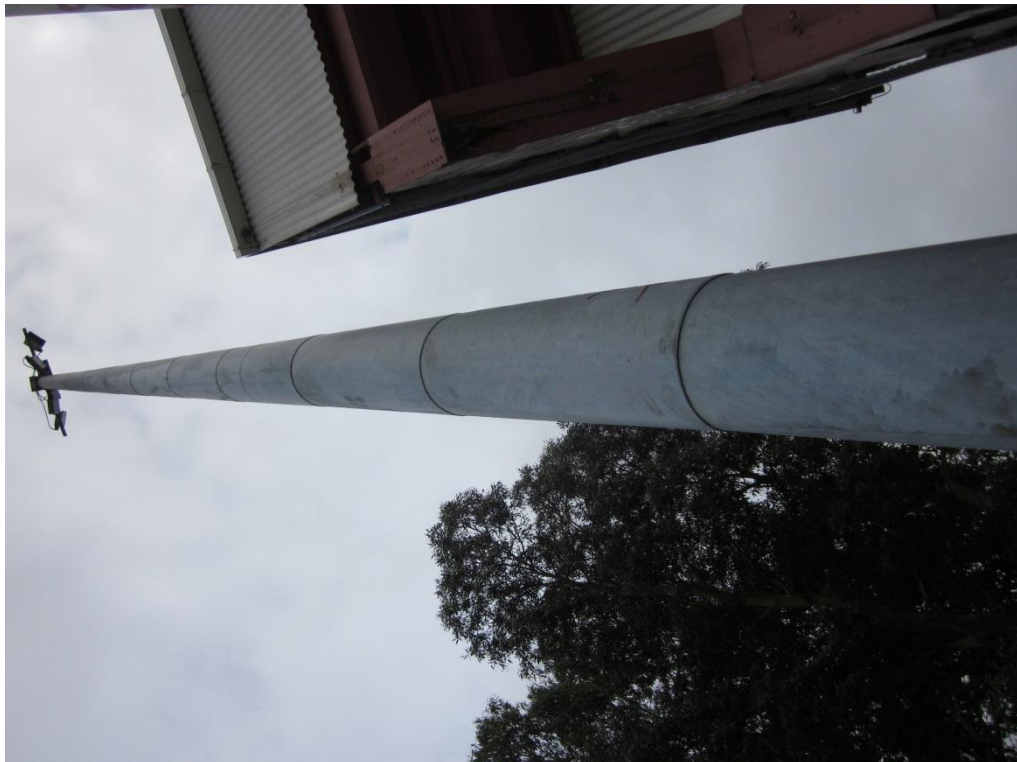
Photograph 2 Lighting tower elevation.

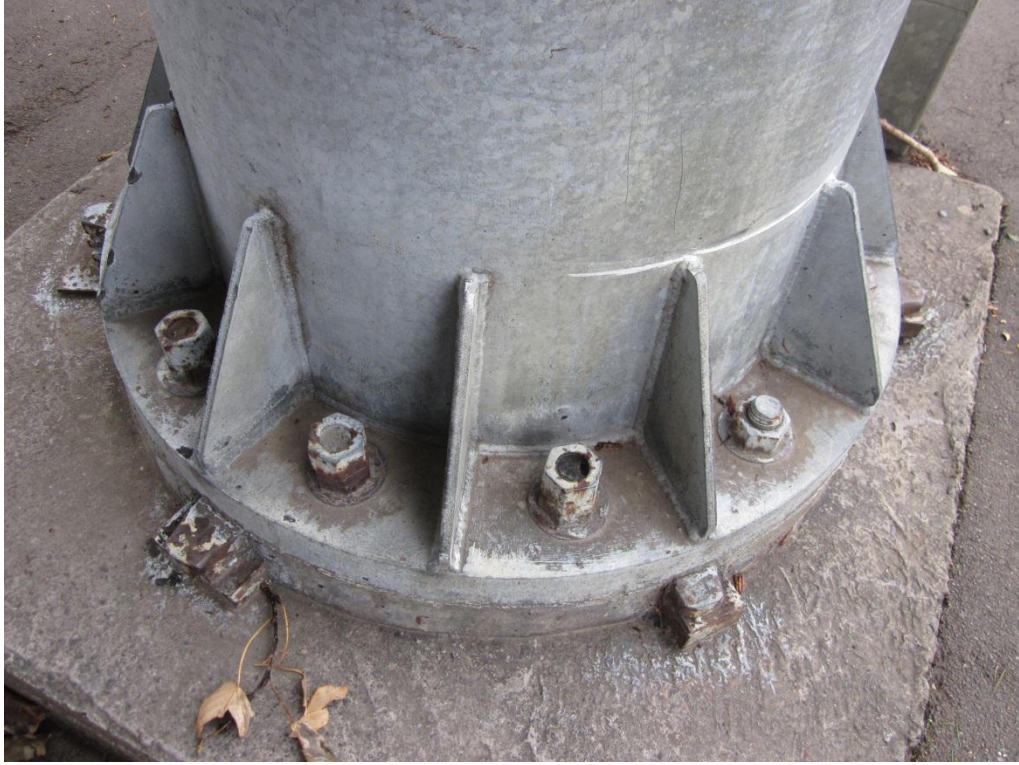
Photograph 3 Lighting tower base showing some rusting of tension bolts.

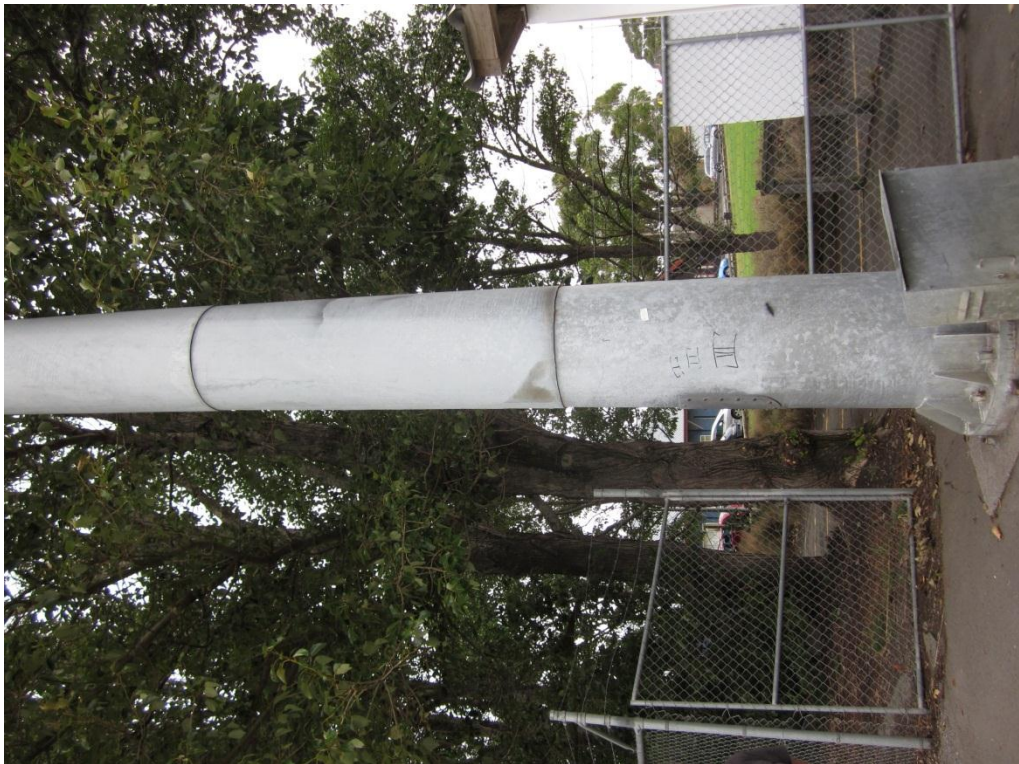
Photograph 4 Connection between CHC sections on the South East tower.

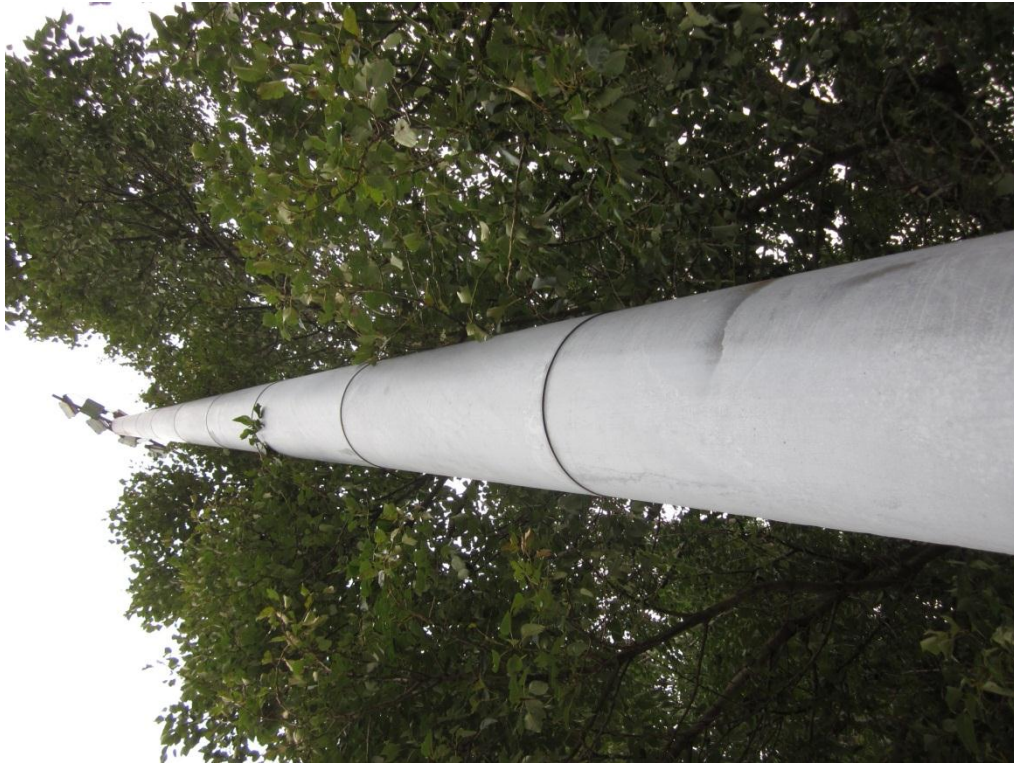
Photograph 5 Lighting tower at the South East of Denton Oval.

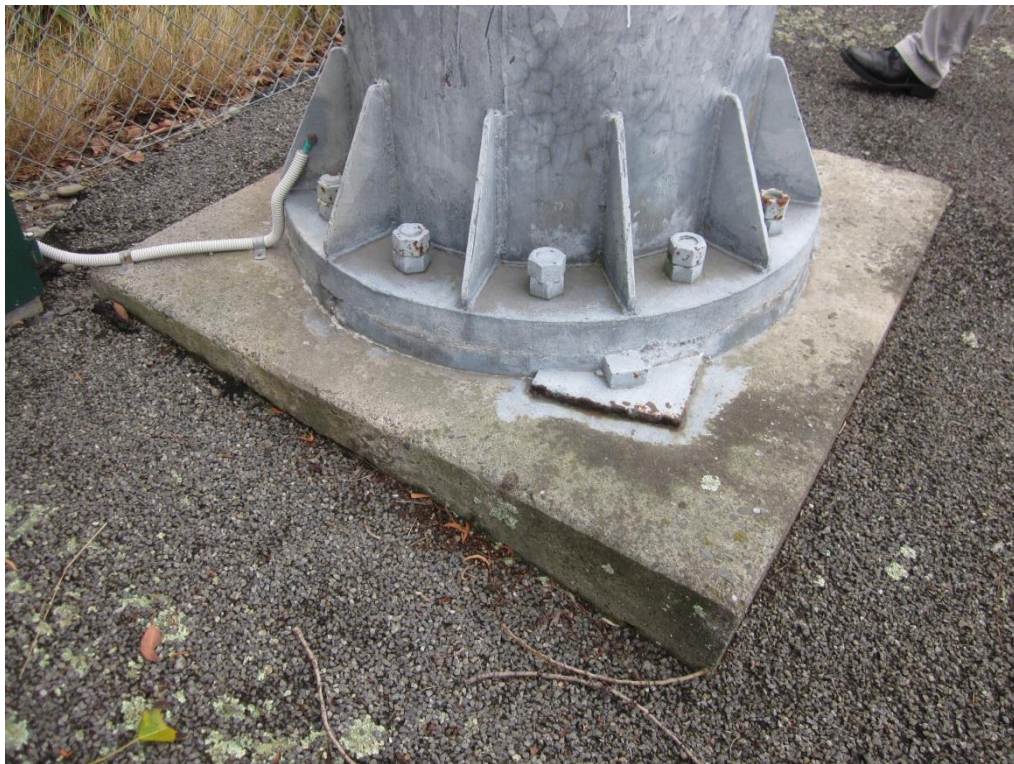
Photograph 6 Base of lighting tower at the North West of Denton Oval showing minor rusting to elements.

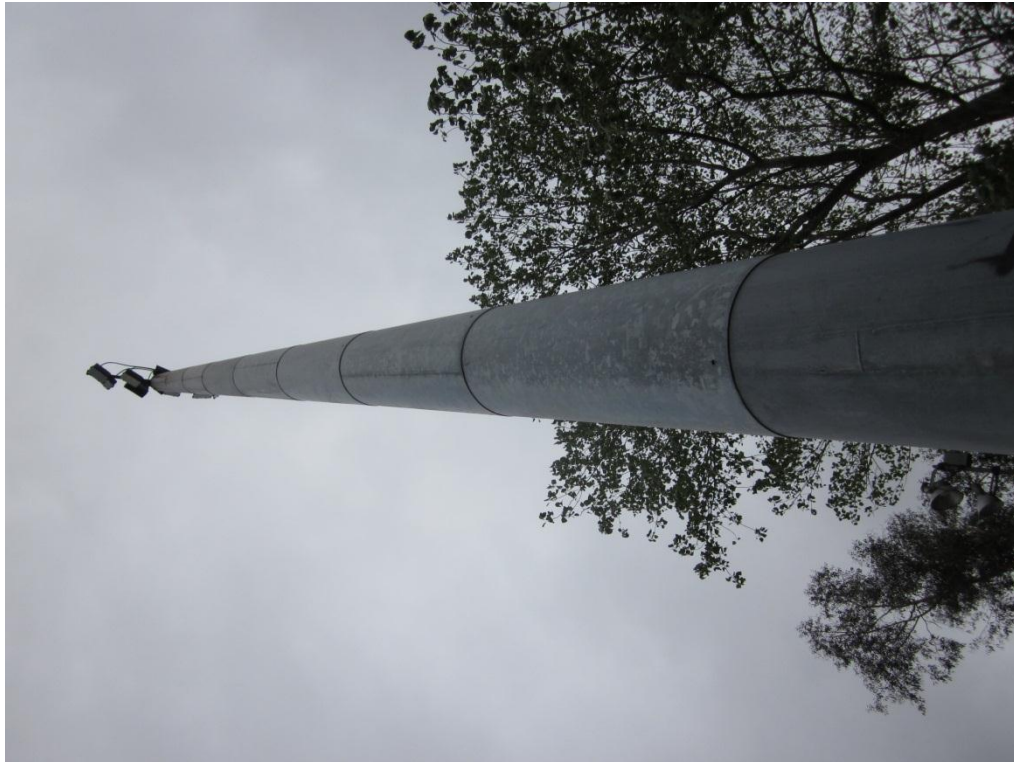
Photograph 7 Lighting tower at the North West of Denton Oval.

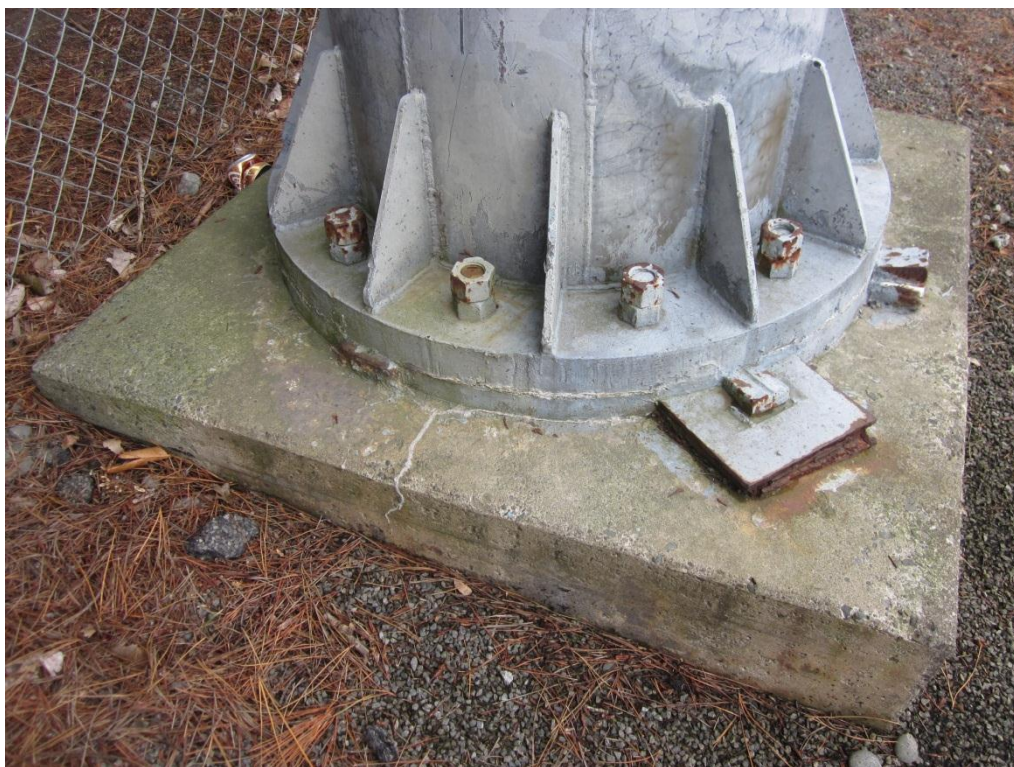
Photograph 8 Base of the lighting tower to the North East showing rusting of restraining elements.

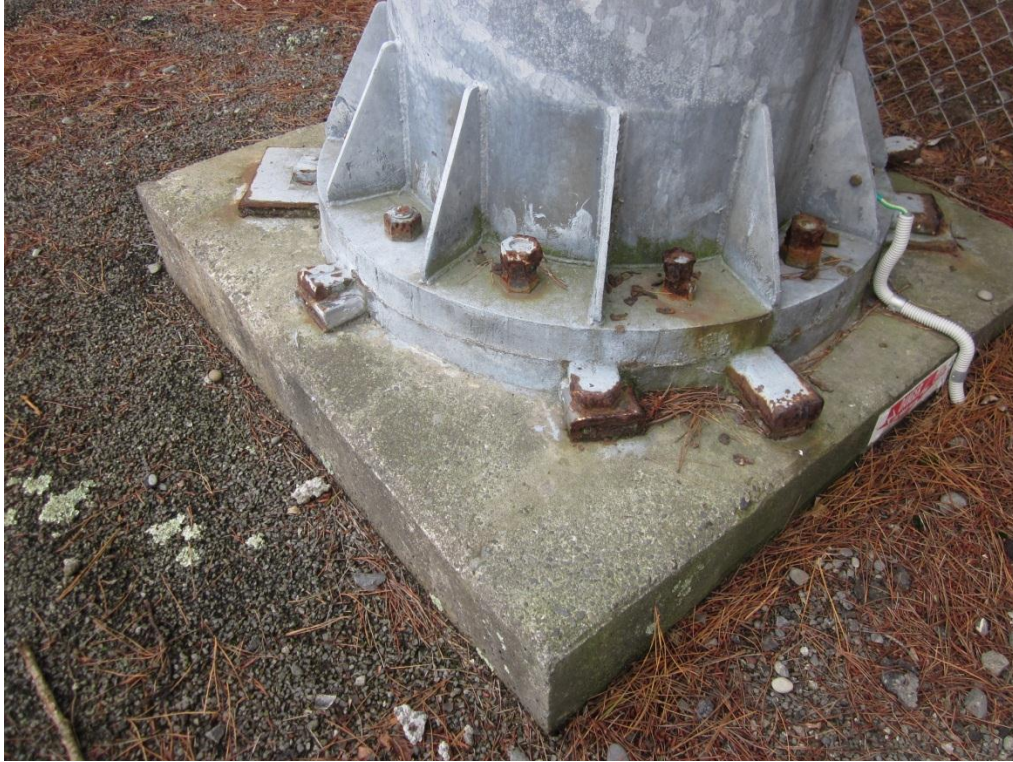
Photograph 9 Base of the North East lighting tower showing severe rusting to tension bolts and respective nuts.

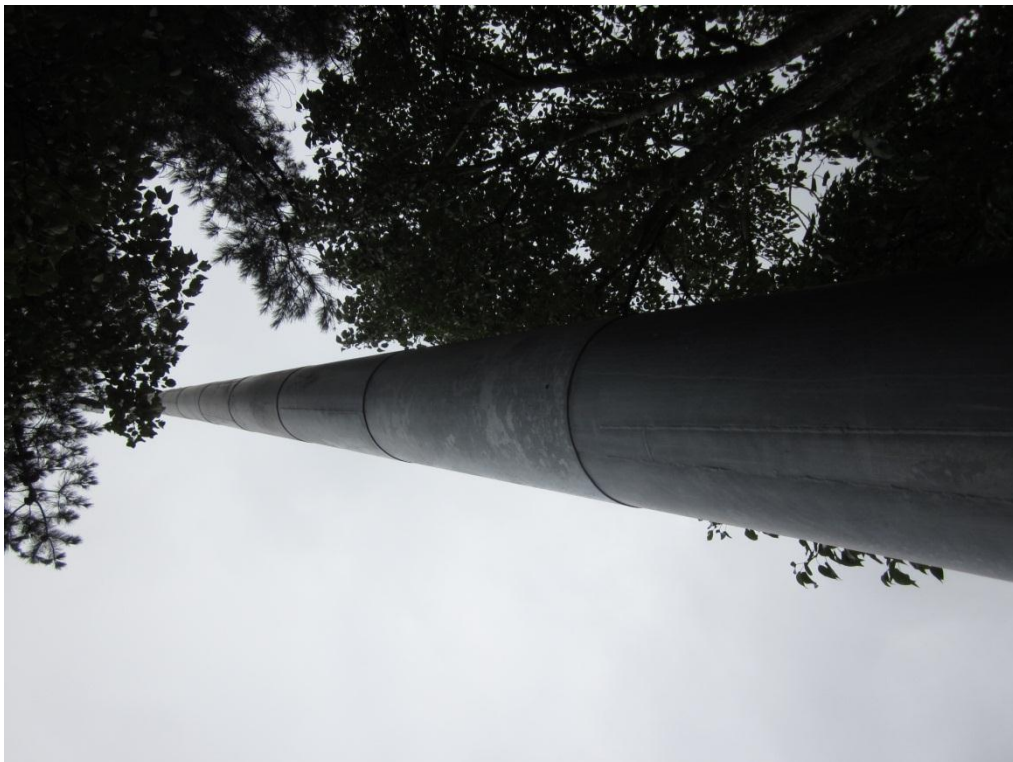
Photograph 10 Lighting tower at the North East of Denton Oval.

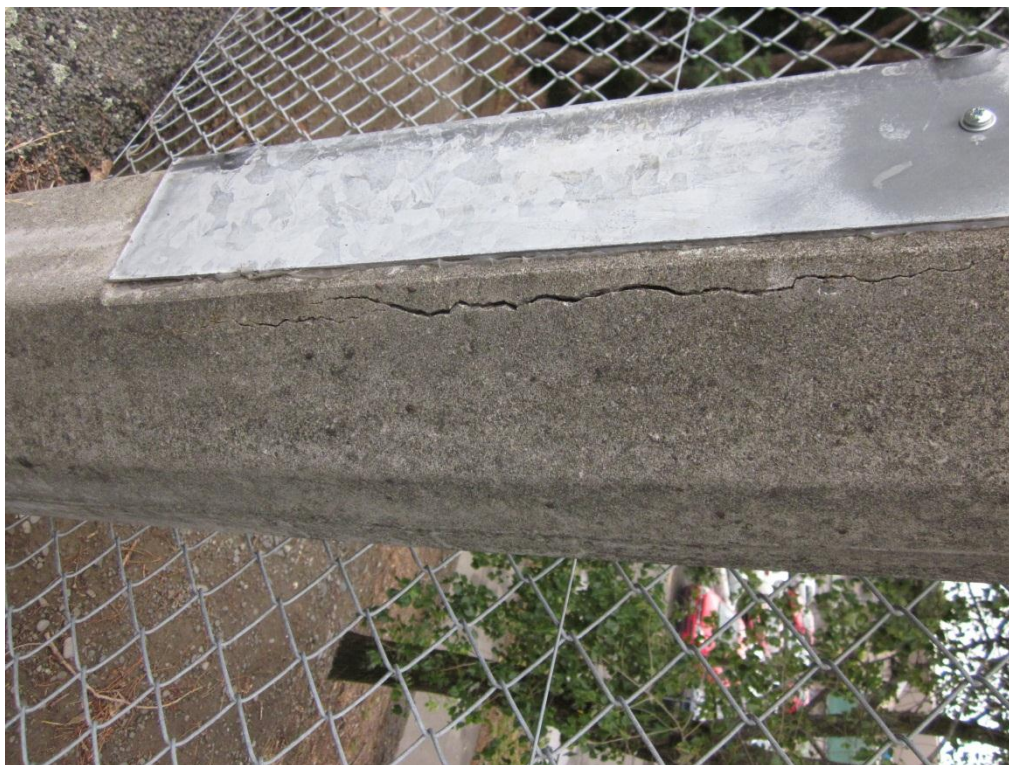
Photograph 11 Cracking to one of the smaller concrete lighting towers around Denton Oval.

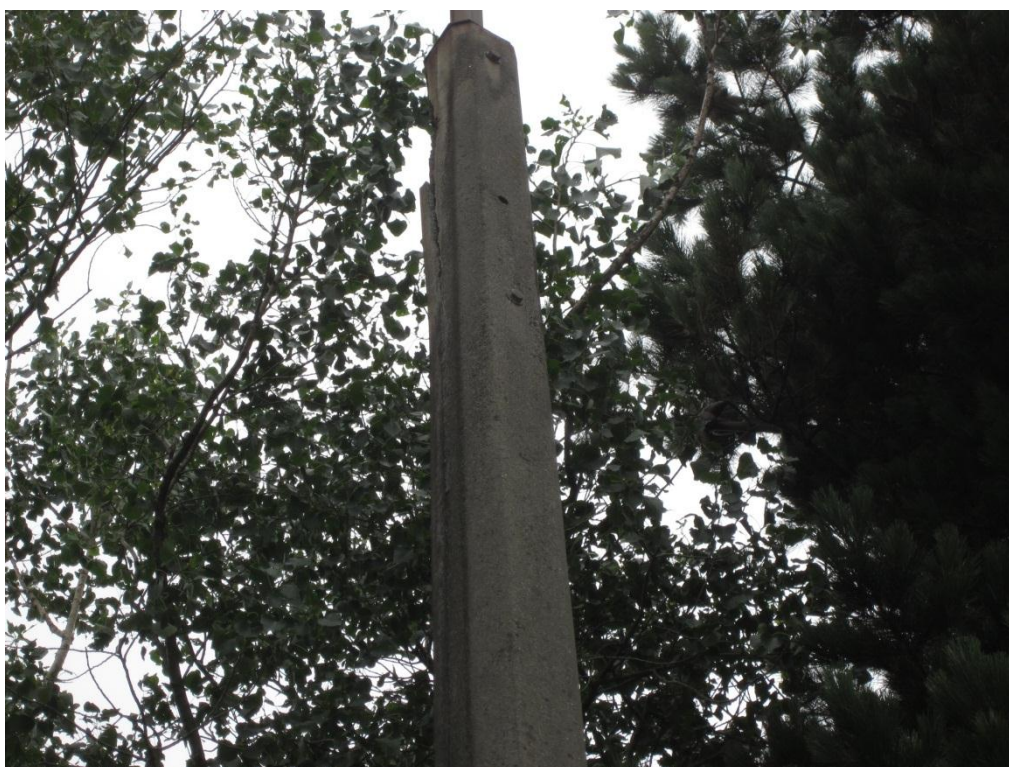
The closest buildings to the lighting towers are the spectator stand and club facility. Minor cracking was noted in the concrete masonry of the spectator stand structure and the changing room structure. Though not covered by this assessment, cracking was noted to several of the smaller concrete light poles surrounding the cycling track (See Photograph 11). Metal extensions at the top of these poles have suffered damage as a result of contact with encroaching trees (See Photograph 12).

Photograph 12 Spalling of concrete of one of the lighting towers at the Eastern end of Denton Oval.
