**Christchurch City Council**  
BU 3555-007 & BU 3555-008  
Diamond Harbour Hall/Library/Toilets  
Waipapa Avenue 1 J

QUANTITATIVE REPORT  
FINAL

- Rev B
- 05 April 2013

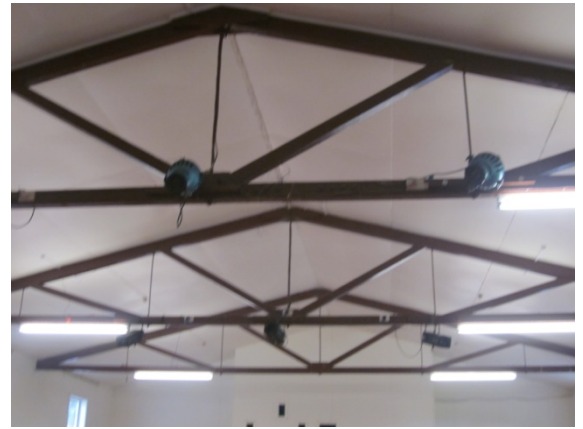
Photo 10: Timber trusses – no apparent damage

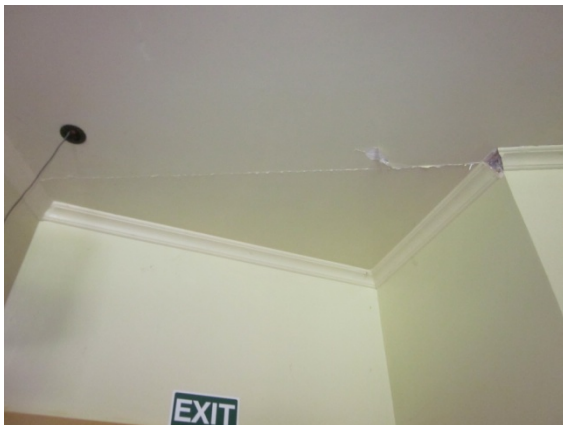
- 1) The only structural damage observed was to internal linings where minor separation has occurred between panels

Photo 13: Typical damage to the interior linings of the meeting room

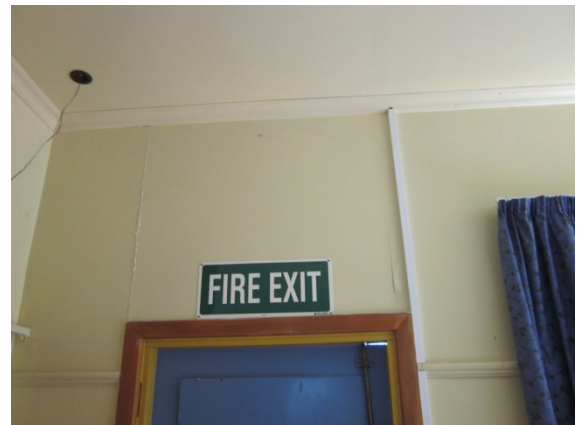
Photo 14: Typical separation between internal wall linings

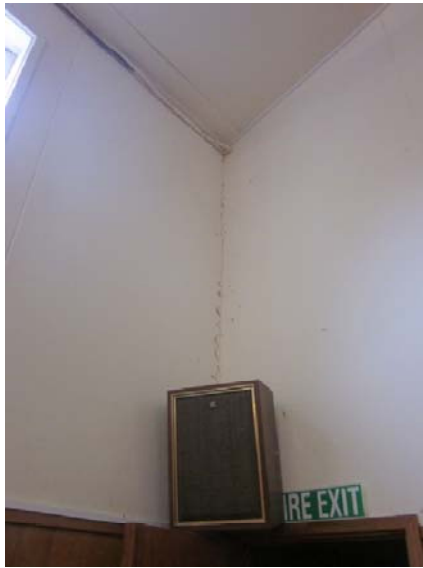
Photo 15: Typical plasterboard damage to the hall

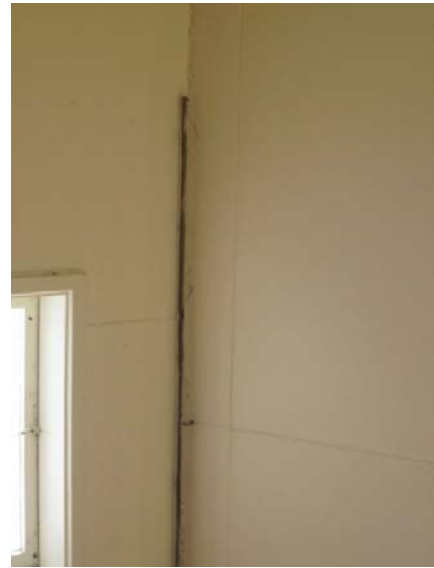
Photo 16: Typical plasterboard damage to the hall

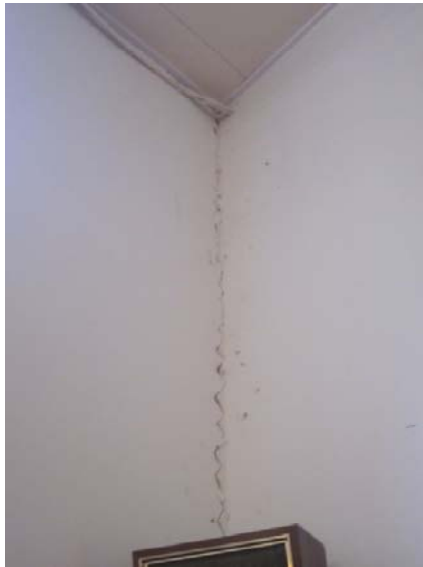
Photo 17: Typical plasterboard damage to the hall

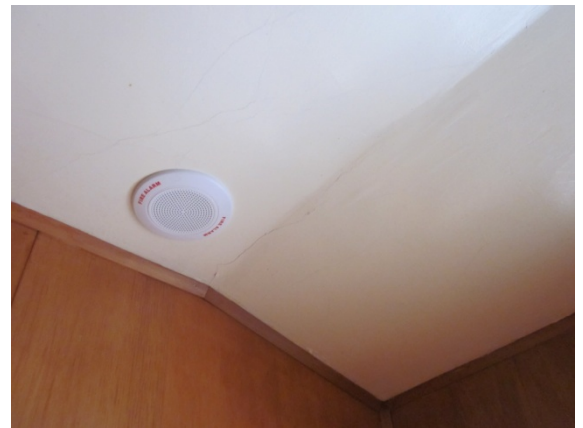
Photo 18: Typical plasterboard damage to the hall entrance

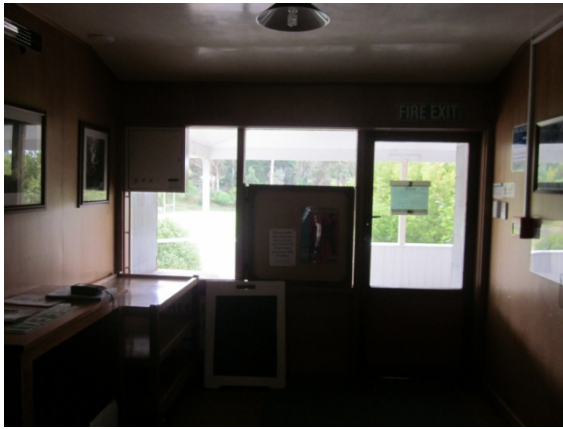
Photo 19: Typical plasterboard damage to the hall entrance

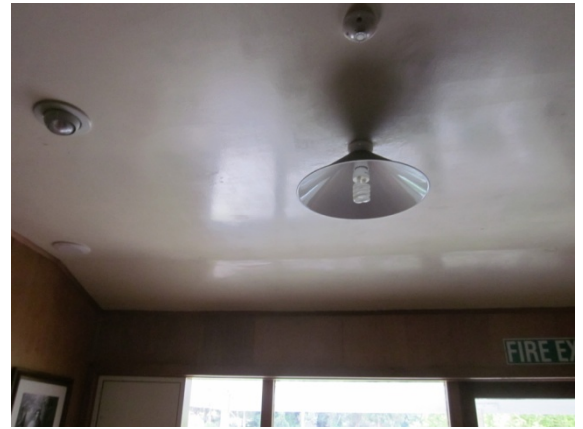
Photo 20: Typical plasterboard damage to the hall entrance

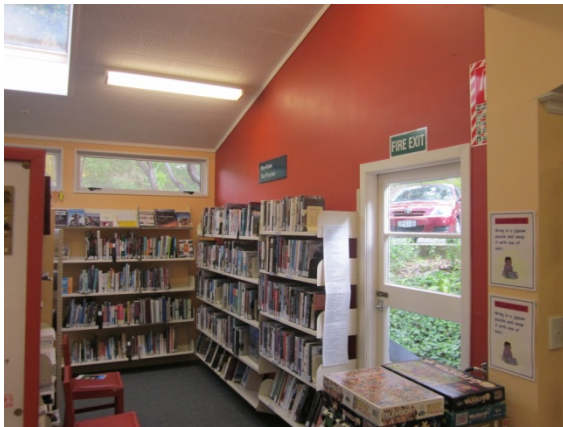
Photo 21: Plasterboard separation in the Library

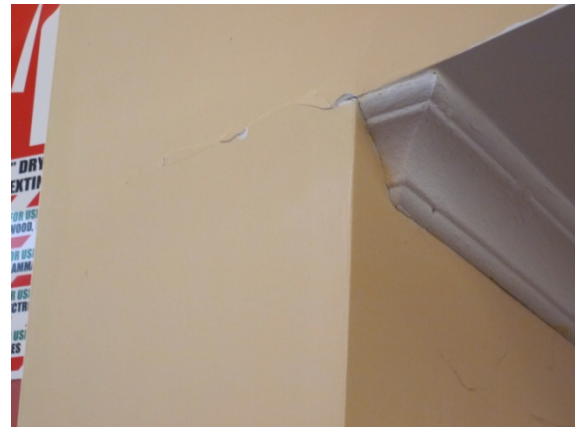
Photo 22: Plasterboard separation in the Library

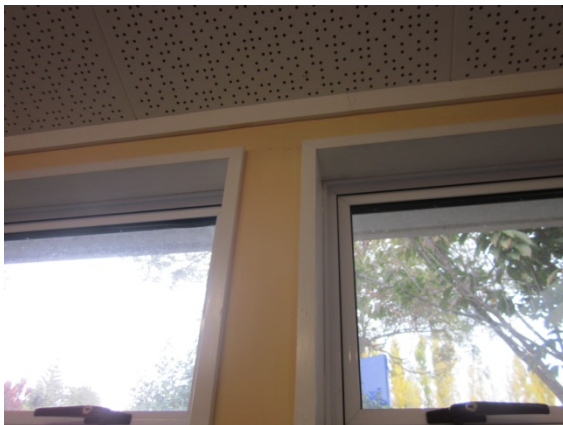
Photo 23: Plasterboard separation in the Library

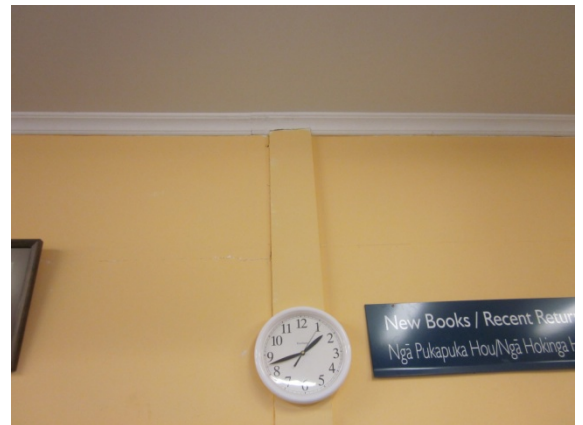
Photo 24: Plasterboard separation in the Library

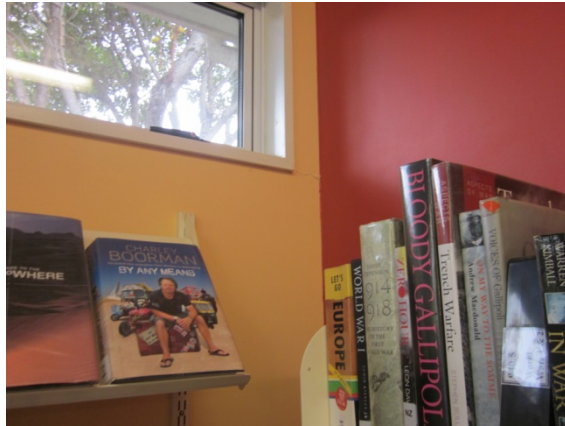
Photo 25: Plasterboard separation in the Library

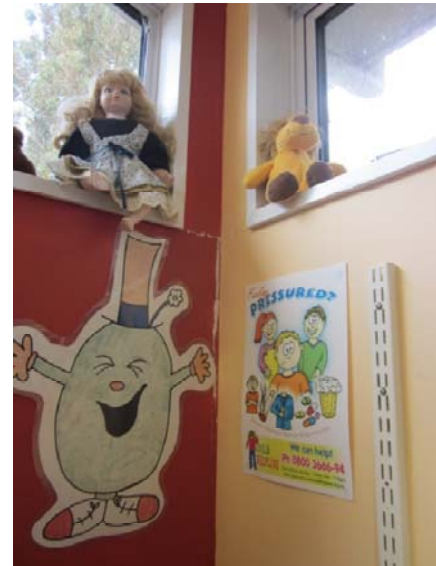
Photo 26: Plasterboard separation in the Library
