**Division Street
Housing Complex
PRO 0547**

**Detailed Engineering Evaluation
Quantitative Assessment Report**

**38 Division Street, Riccarton,
Christchurch 8041**

Date: February 2014
Reference: 6-QC336.00
Status: Final

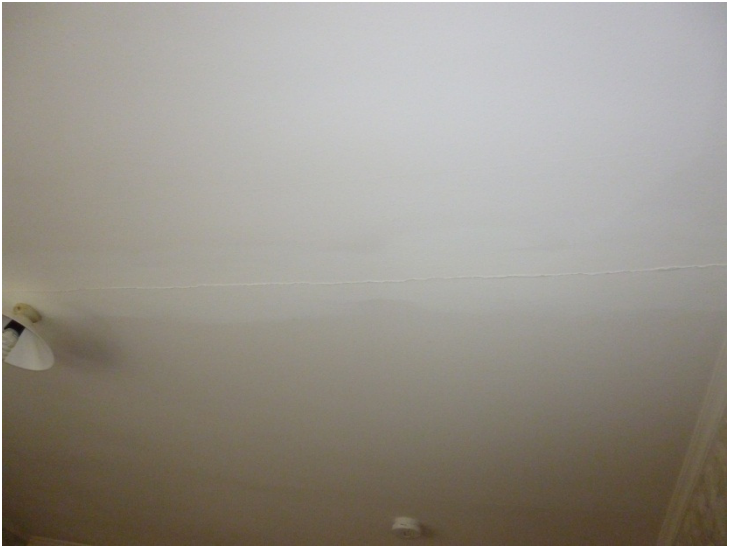
Minor to moderate plasterboard cracking was observed in all units, typically above doorways, windows and in the ceiling line (photo 12). Cracking was also observed in the ceiling diaphragms (photo 11). This damage is considered minor and does not affect the lateral resistance of the structure.

A photograph of a roof space with a prominent concrete block fire wall. The timber trusses are clearly visible, and the floor is insulated with yellow material. The lighting is somewhat dim, highlighting the structural elements.
<p>11.</p>	<p>Typical cracking of ceiling diaphragm</p>

- Veneer at height (gable ends) have the veneer ties checked.
- Cosmetic repairs be undertaken as required.
- Strengthening schemes be developed to increase seismic capacity of all blocks to 67%NBS.
- Unrestrained header tanks in the ceiling spaces be secured or removed.

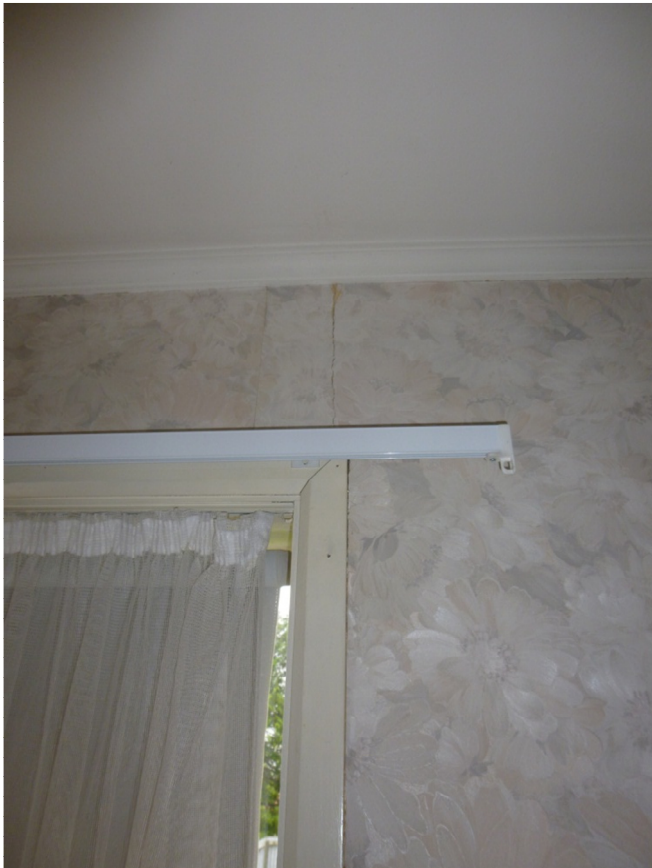
<p>12.</p>	<p>Typical gib cracking above windows</p>

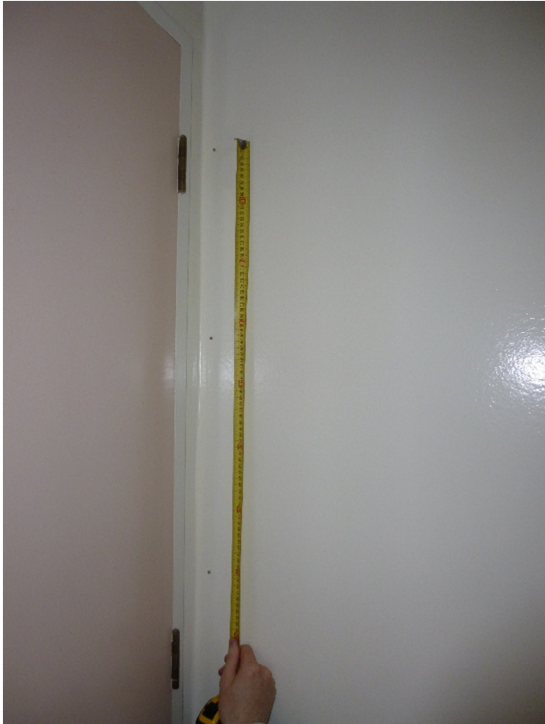
The internal lining nail spacings were measured on site averaged at 300mm for Blocks A-C and 450mm for Blocks D-F.

The %NBS has been calculated using the strength of the braces within the wall. The nail spacing does not comply with the minimum fixing requirements for plasterboard in some units. An increase in the number of fixings would enhance the performance of these structures.

A photograph showing a wall with floral wallpaper. A window with white curtains is visible. Above the window frame, there is a vertical crack in the white plaster or gypsum board, which is the 'gib' mentioned in the text.
<p>13.</p>	<p>Typical nail spacings Approx. 300mm</p>

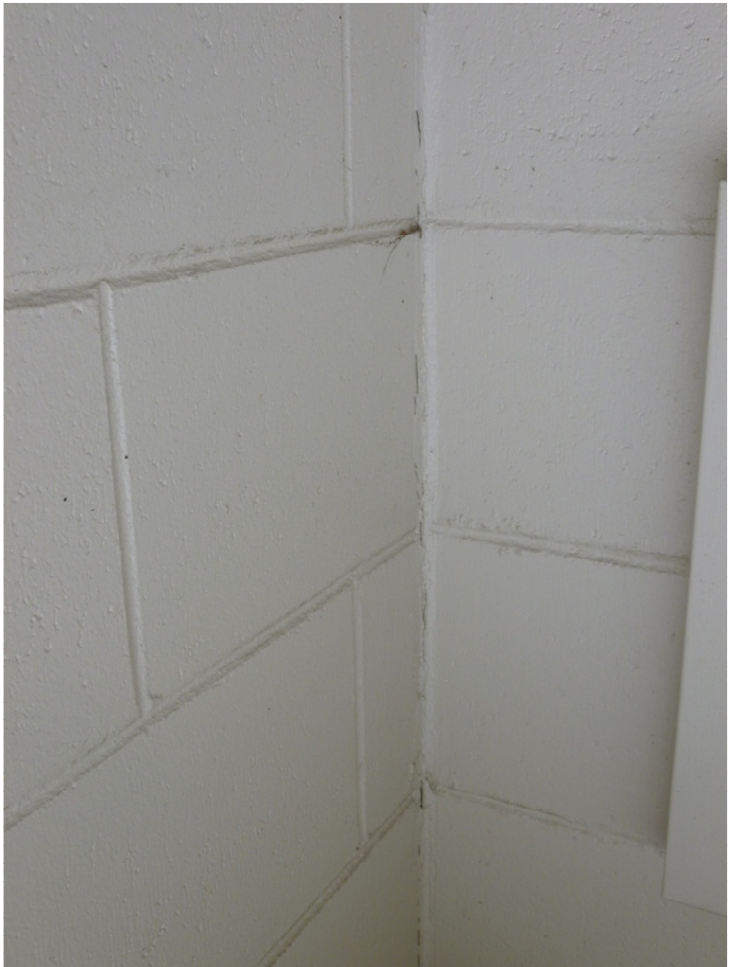
Slight splitting was observed between the veneer and the firewall in Block F (photo 14). Settlement was observed in the footpaths and foundation veneers.

<p>14.</p>	<p>Cracking between veneer and firewall</p>

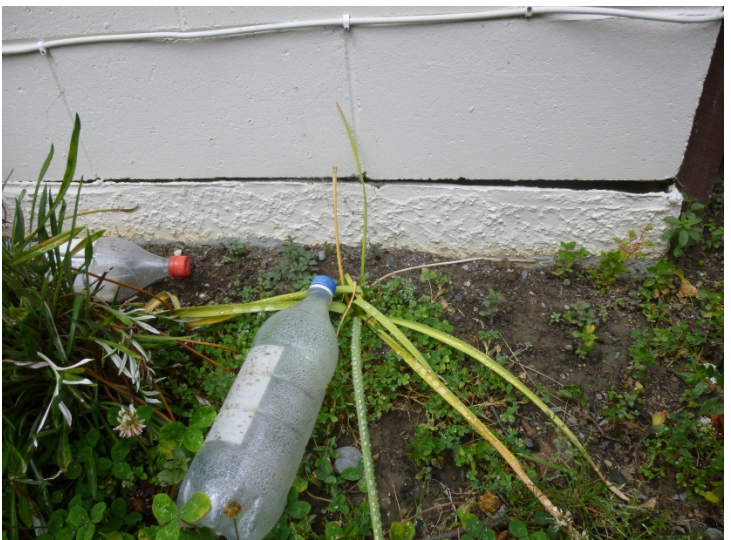
Cracking were observed in the render of the concrete foundation in Block C (photo 17) and settlement of the render on Block F (photo 15).

<p>15.</p>	<p>Displacement of foundation render</p>

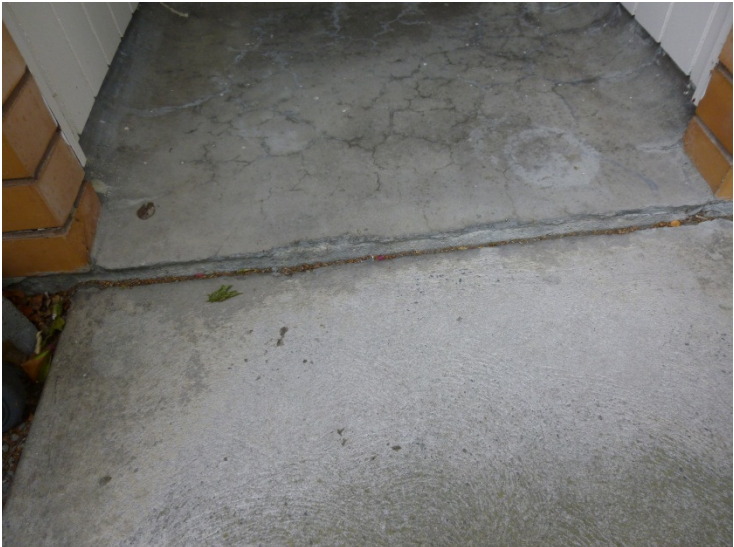
<p>16.</p>	<p>Settlement of pathways</p>

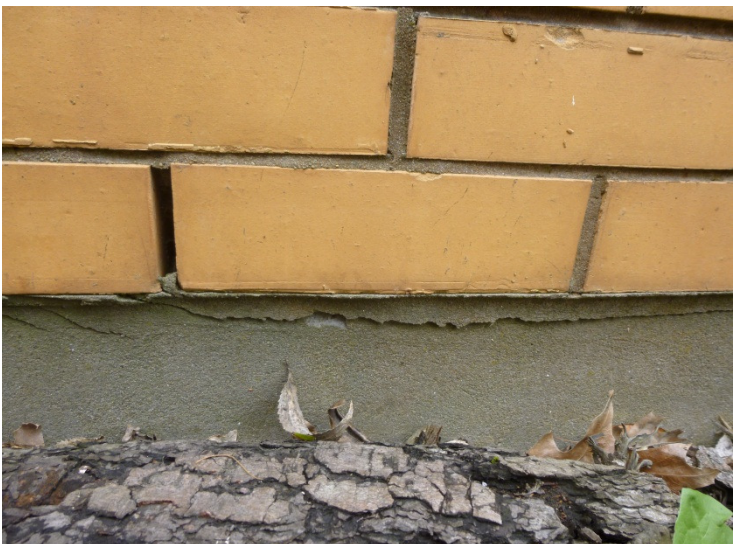
A photograph showing a concrete pathway with a distinct horizontal crack and some surface cracking. The concrete is light grey and appears to be in an outdoor setting with some debris and a white wall visible in the background.
<p>17.</p>	<p>Lateral cracking of render on foundation of Block C</p>

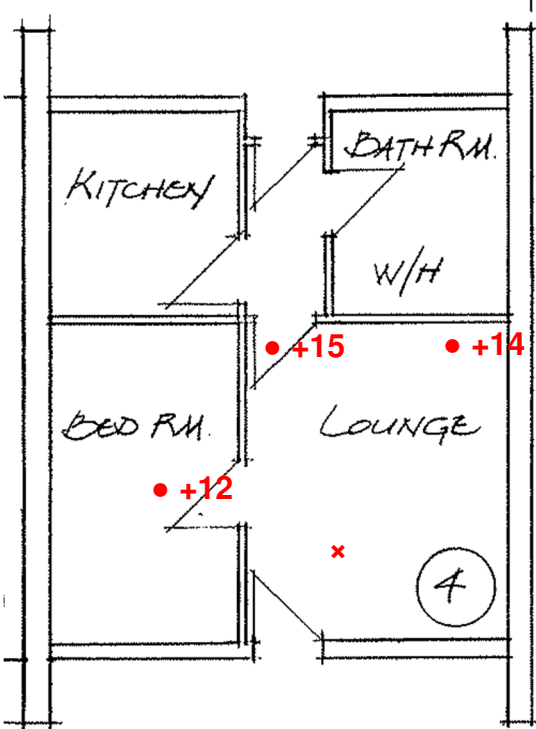
Unit 2

Residual displacement was observed in Units 2, 3, 7 and 17. Displacements in units 2 and 3 only exceeded MBIE guidelines by small amounts which could be attributed to the accuracy margin of the equipment used.

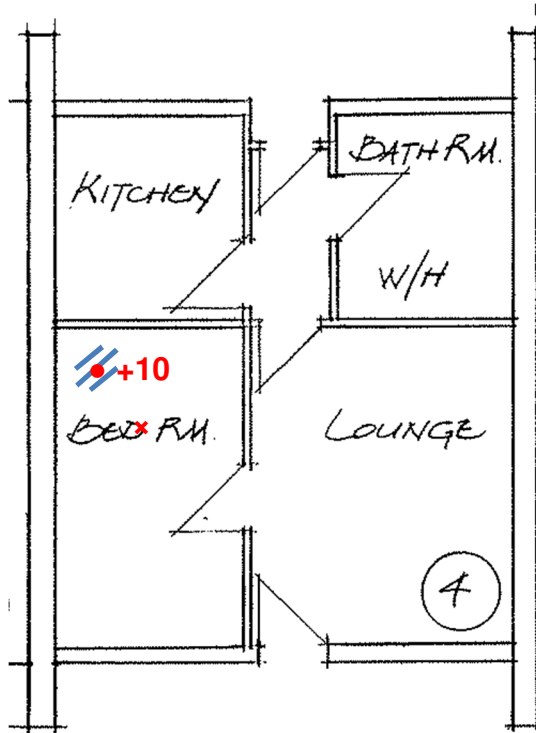
The displacements in Units 7 and 17 were more significant. A local residual displacement was observed in the bedroom corner of Unit 7 which exceeds MBIE guidelines. Unit 17 experienced settlement across the lounge.
