PRK_ 3616_BLDG_002 EQ2

Duvauchelle Reserve and Campground Garage
Seafield Rd, Duvauchelle

QUALITATIVE ASSESSMENT REPORT

FINAL

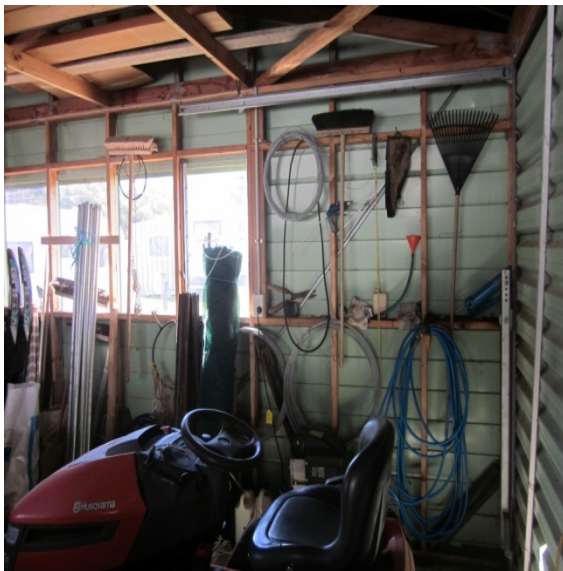
Photo 3: Elevation on an internal wall of the garage showing timber framing and steel strap bracing

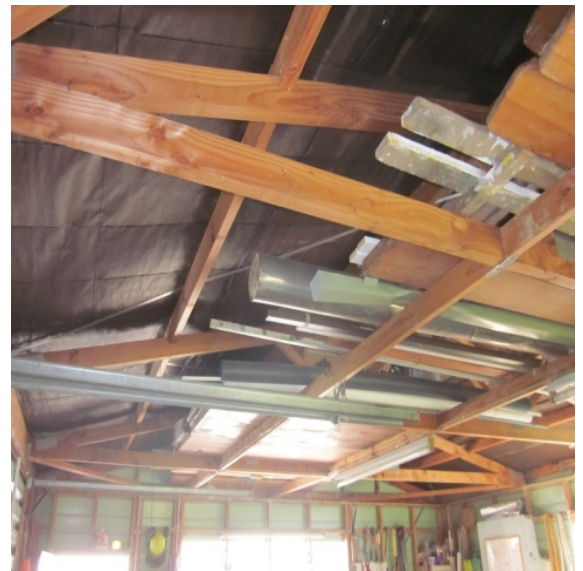
Photo 4: The roof framing of the garage showing the timber A-frame trusses, timber purlins and steel strap bracing

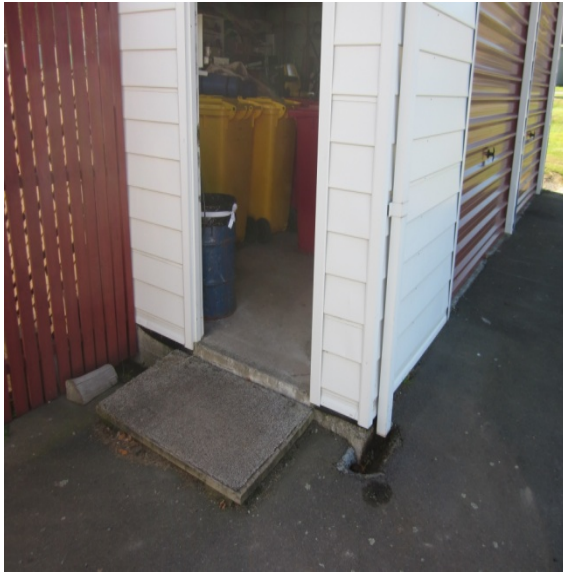
Photo 5: The door at the south end of the west wall where one of the cracks in the foundation are located

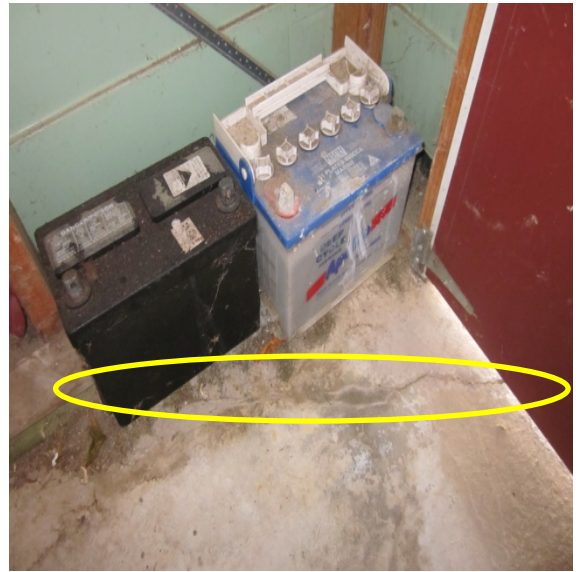
- 1) Cracking was found in the slab foundation of the building. The cracks and their respective widths are listed below:
 - a. A 1.5mm crack was found in the south west corner of the slab (see Photo 5 and Photo 6)
 - b. A 2mm crack was found running north-south through the centre of the slab (see Photo 7)
 - c. A 3mm crack was found south east corner of the slab (see Photo 8)

Photo 6: The crack in the south west corner of the foundation slab

Recommendations		Level of repair/strengthening required: minor non-structural	Building Consent required: no	Interim occupancy recommendations: full occupancy	Describe: Repairs to cracks in foundation
Along	Assessed %NBS before: 81%	Assessed %NBS after: 81%	%NBS from IEP below	if IEP not used, please detail assessment methodology:	Qualitative Assessment carried out includes NZSEE IEP (refer to SKM report)
Across	Assessed %NBS before: 81%	Assessed %NBS after: 81%	%NBS from IEP below

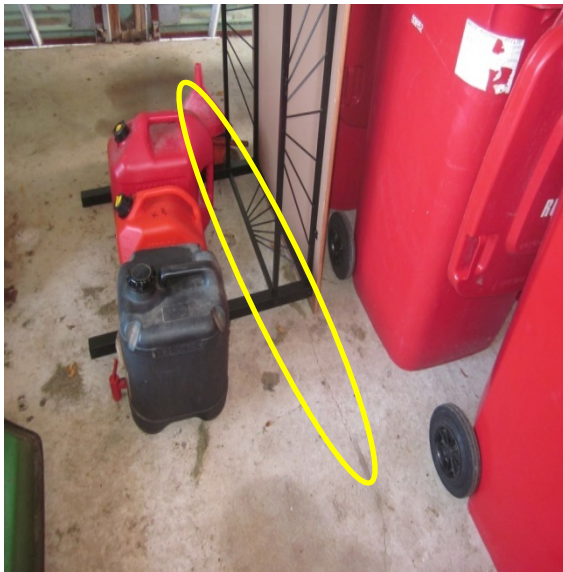
Photo 7: The crack through the centre of the foundation slab

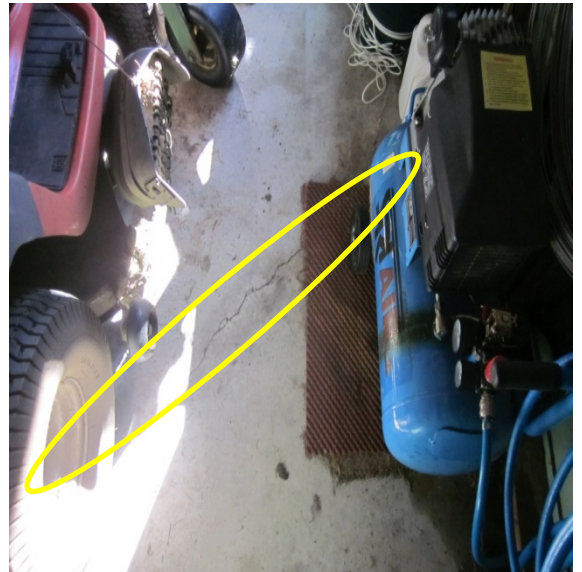
Photo 8: The crack in the south east corner of the slab
