CHRISTCHURCH CITY COUNCIL

PRK_3616_BLDG_004 EQ2

Duvauchelle Reserve and Campground – Office
Seafield Rd, Duvauchelle

QUALITATIVE ASSESSMENT REPORT

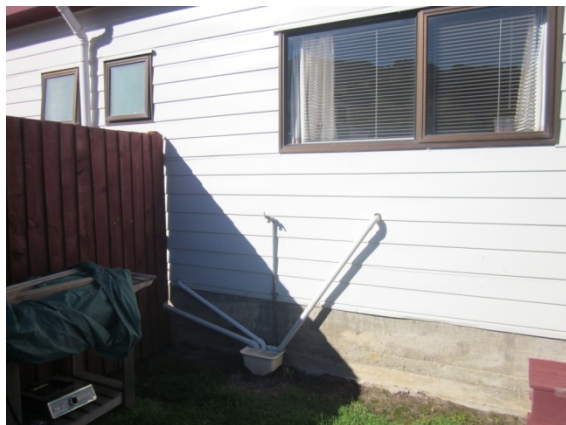
- 1) One hairline crack was found in the foundation on the north side of the building. The cracking was vertical and extended from the top to the bottom of the foundation. (see
- 2) Some minor separation was noted between internal wall lining panels at the junction between perimeter walls. The separation recorded on site is insufficient to indicate damage to the timber framing behind.

Photo 1: The north face of the building showing the external drain, adjacent to which, cracking in the foundation was observed

Recommendations	Level of repair/strengthening required: minor non-structural	Describe: Repairs to cracks in foundation and internal wall lining
	Building Consent required: no	Describe:
	Interim occupancy recommendations: full occupancy	Describe:
Along	Assessed %NBS before: 100%	%NBS from IEP below
	Assessed %NBS after: 100%	If IEP not used, please detail assessment methodology.
Across	Assessed %NBS before: 100%	%NBS from IEP below
	Assessed %NBS after: 100%

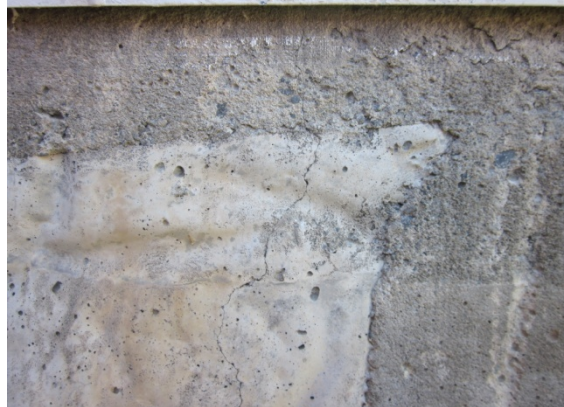
Photo 2: Details of hairline cracking in the north face of the foundation

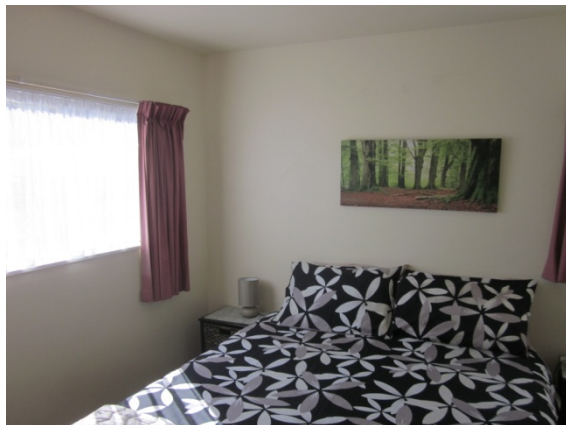
Photo 3: Internal lining at the junction between perimeter walls

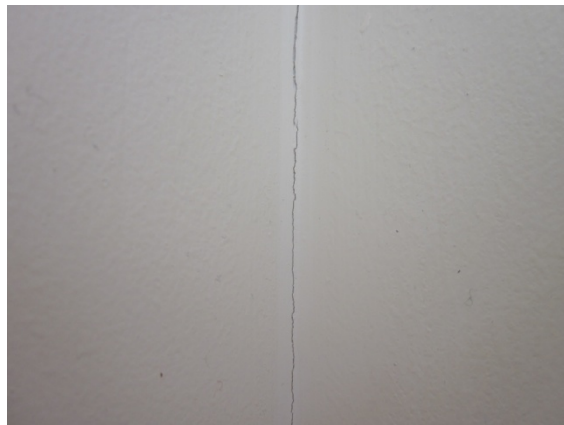
Photo 4: Typical separation found between internal wall lining at the junction between the perimeter walls

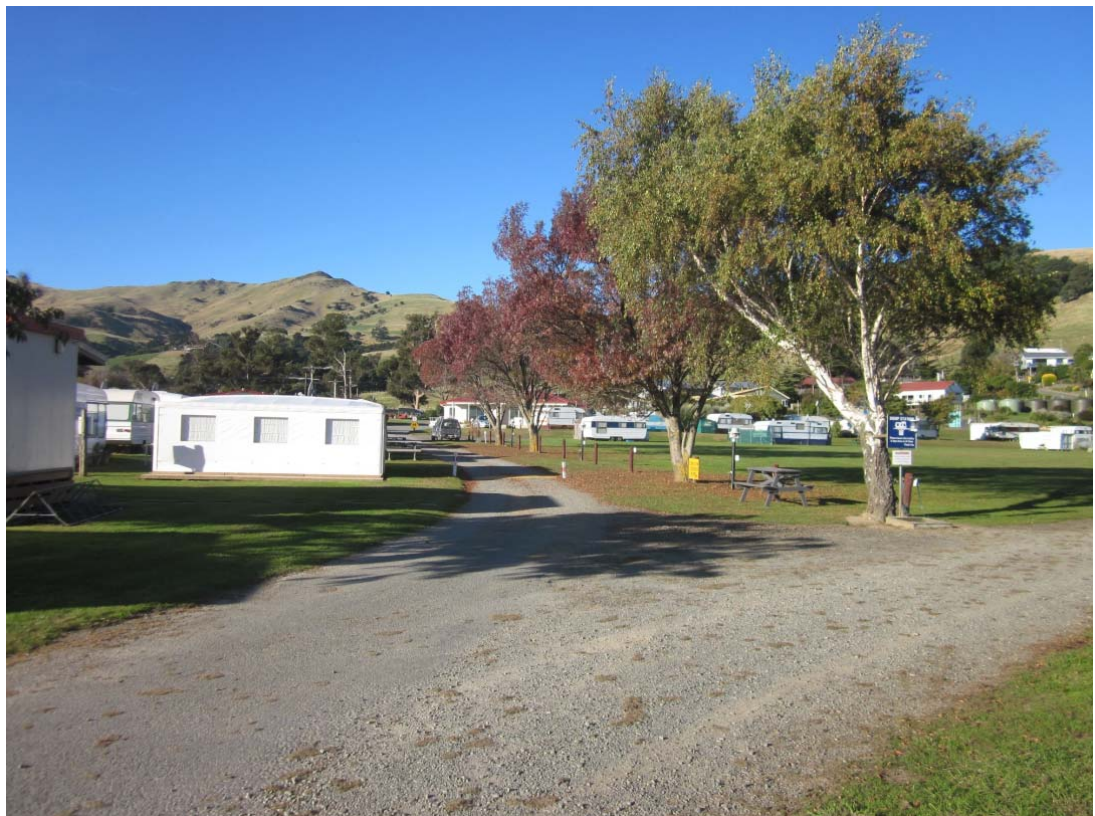
The only evidence of earthquake damage to the onsite structures was shear cracking to the masonry clad toilet. There is no evidence of any land damage.

■ **Figure 4 Overview of the site looking north east.**
