CHRISTCHURCH CITY COUNCIL
PRK_3616_BLDG_007 EQ2
Duvauchelle Reserve – BLDG 007
Seafield Rd, Duvauchelle

QUALITATIVE ASSESSMENT REPORT

FINAL

- Rev B
- 21 November 2012

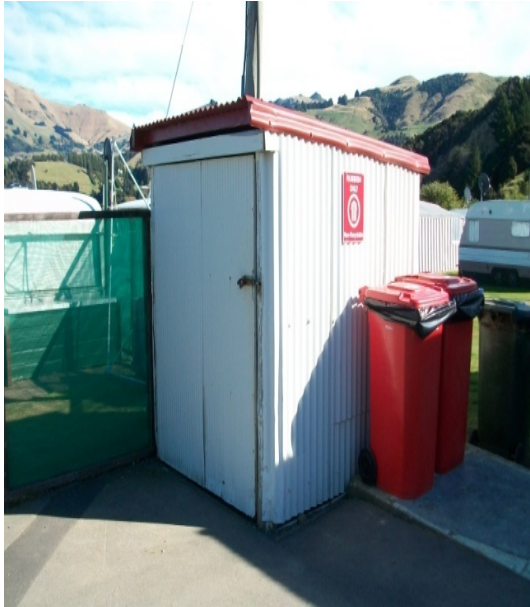
Photo 1: The south and east elevations of the mower shed

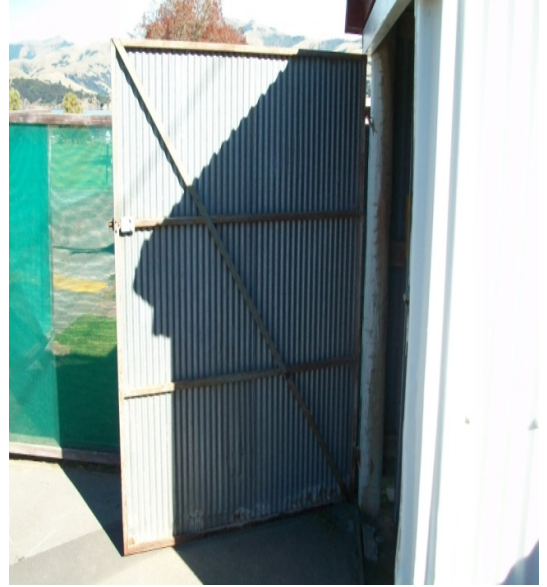
Photo 2: The steel framed door in the south side of the shed

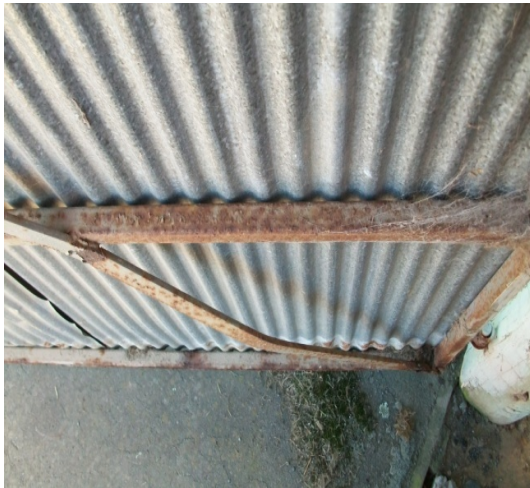
The diagonal steel flat brace on the door of the shed has buckled, presumably due to mechanical damage. Corrosion was also present on the steel door framing.

Photo 3: Detail of the shed door bracing showing the buckled flat bar

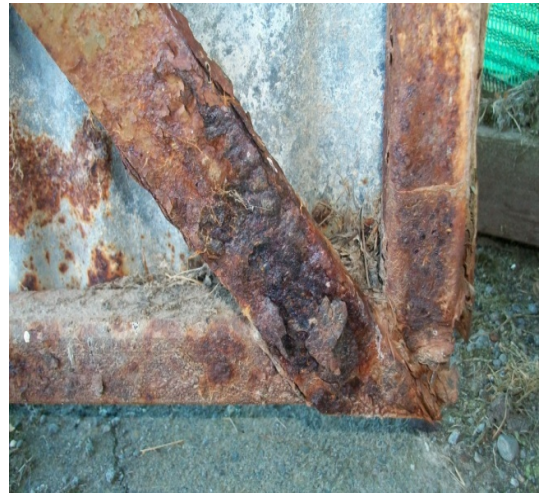
Photo 4: Example of corrosion present on the steel framing of the shed door
