CHRISTCHURCH CITY COUNCIL
PRK_3616_BLDG_001 EQ2
Duvauchelle Reserve – Toilet Block 2 &
Kitchen
Seafield Rd, Duvauchelle

QUALITATIVE ASSESSMENT REPORT

- Rev C
- 23 May 2013

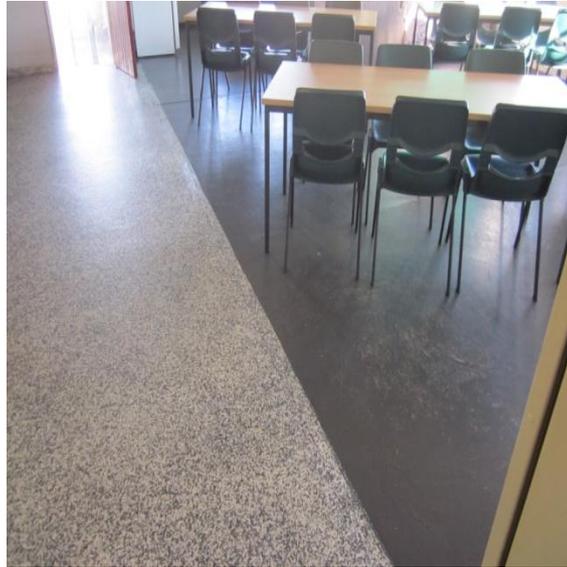
- 1) Separation between sections of floor slab were noted in the kitchen/living room. Approximately 3mm of differential settlement of the slab sections was also observed. Separation and settlement of the slab sections is expected to have occurred prior to the earthquakes. (see Photo 1 and Photo 2)

Photo 1: The internal floor slab in kitchen/living room

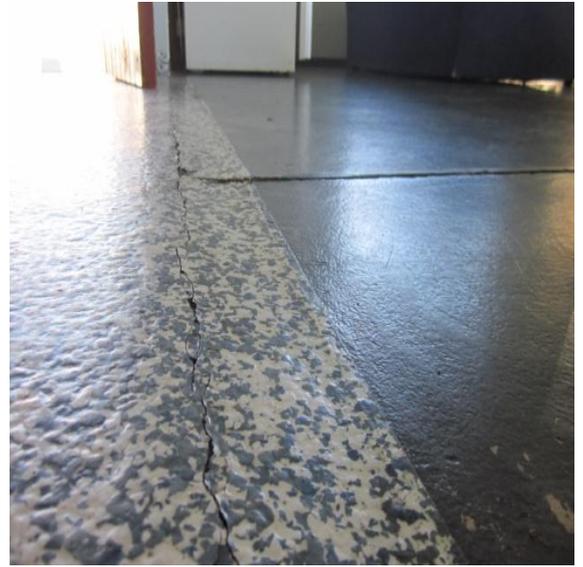
Photo 2: Separation and differential settlement between slab sections in the kitchen/living

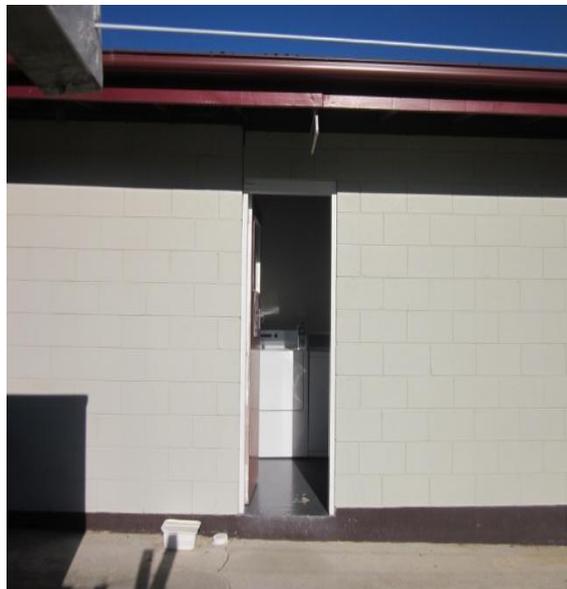
- 2) Separation was noted at the junction between the eastern structure and the extension to the west. Two junctions were present, one on the north side of the structure and one on the south. Both junctions occurred at the location of a doorway. Some pre-existing separation is expected to have occurred at this interface and therefore it is difficult to determine the extent of movement that has occurred in the recent earthquakes. Some minor damage to the timber framing for the door has occurred at the northern junction. (see Photo 3, Photo 4, Photo 5 and Photo 6)

Photo 3: The northern junction between the eastern and western structures

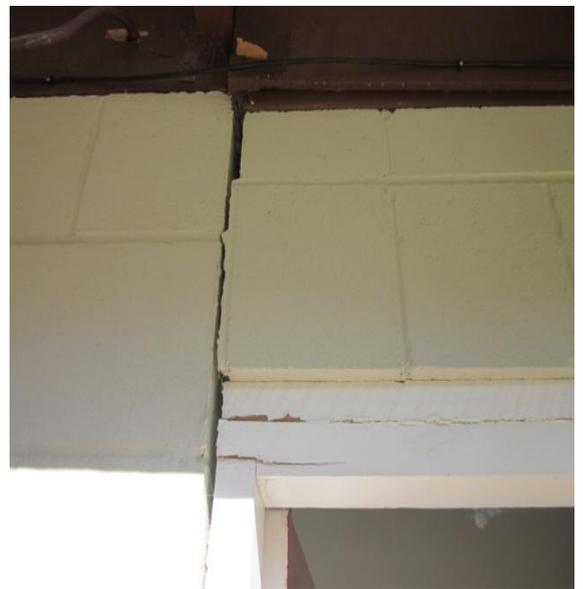
Photo 4: Detail of the separation and damage to the door framing at the northern junction

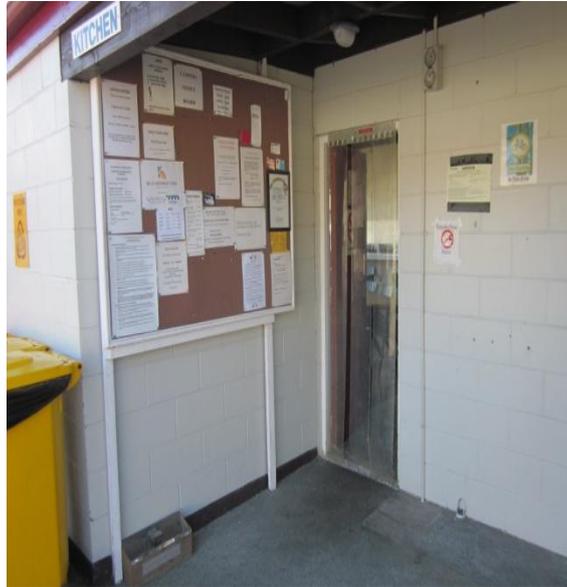
Photo 5: The southern junction between the eastern and western structures

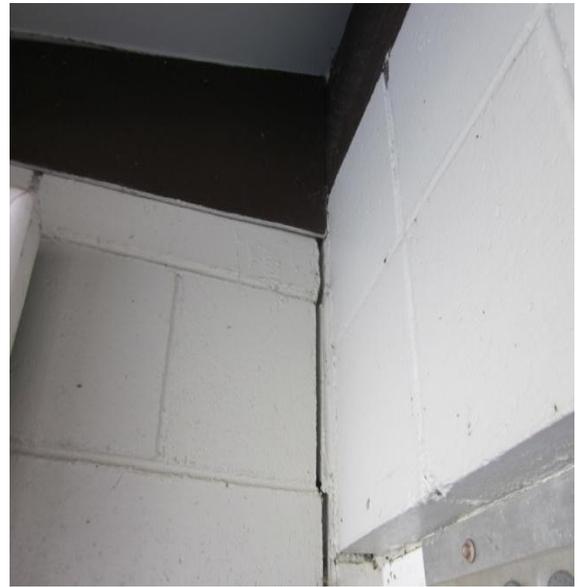
Photo 6: Detail of the separation at the southern junction

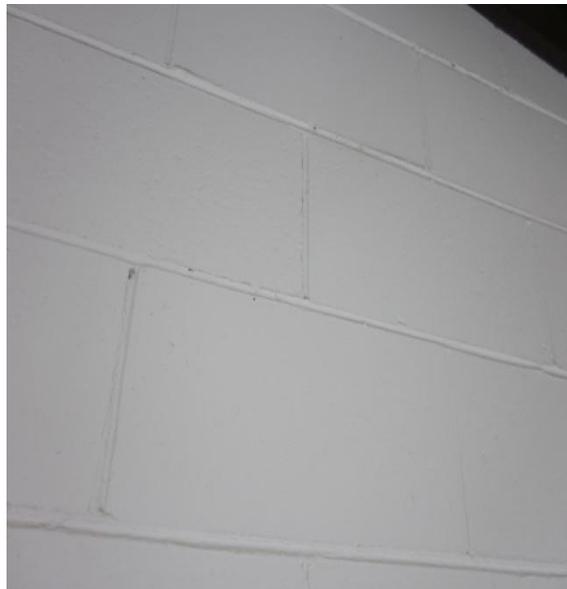
- 3) Hairline shear cracking was found throughout the masonry wall running through the centre of the building, in a north-south direction. 1.5mm separation was found between this wall and the masonry wall to the south. 0.2mm separation was noted where this wall meets the masonry wall to the north. (see Photo 7, Photo 8 and Photo 9)

Photo 7: Typical hairline cracking in the north-south masonry wall at the centre of the building

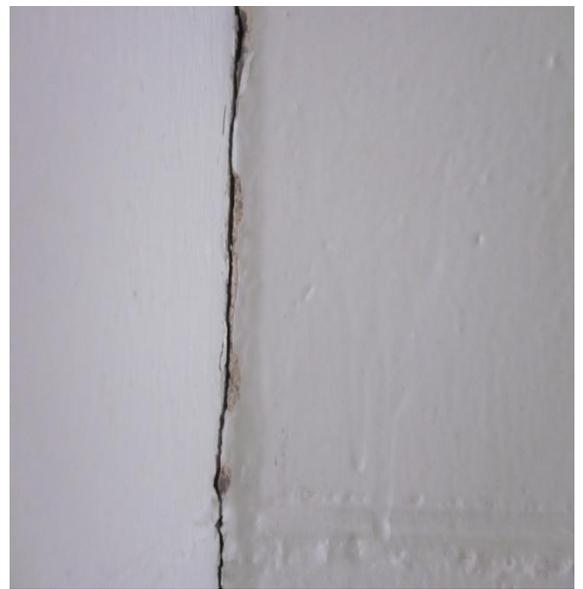
Photo 8: 1.5mm separation at the south end of the north-south wall

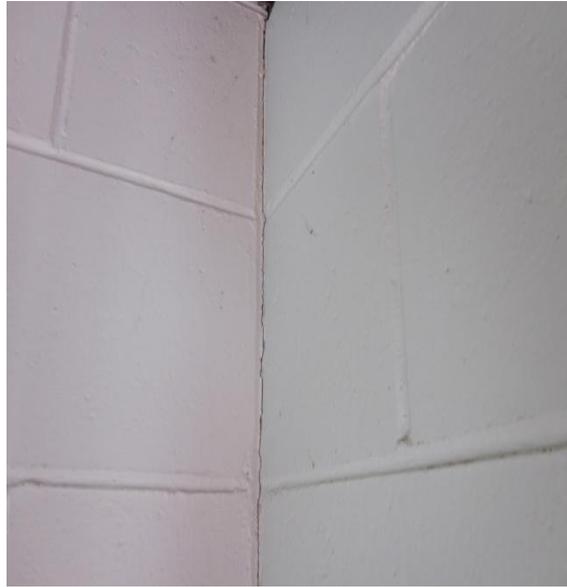
Photo 9: 0.2mm separation at the north end of the north-south wall

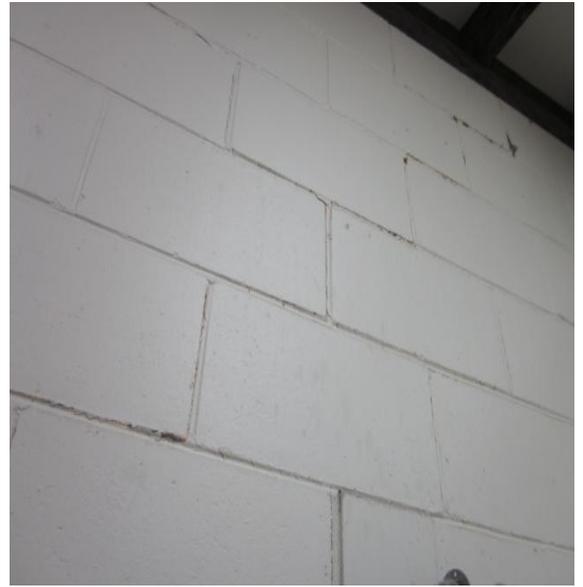
- 4) Hairline shear cracking was found in the masonry wall dividing the men's and women's toilets. The cracking spanned from floor to ceiling and is located mid way along the wall. Damage to the paint was noted along this crack. 0.1-0.2mm separation was noted at the either end of this wall, where it meets the perpendicular walls. (see Photo 10, Photo 11 and Photo 12)

Photo 10: Typical hairline cracking in the wall dividing the men's and women's toilet

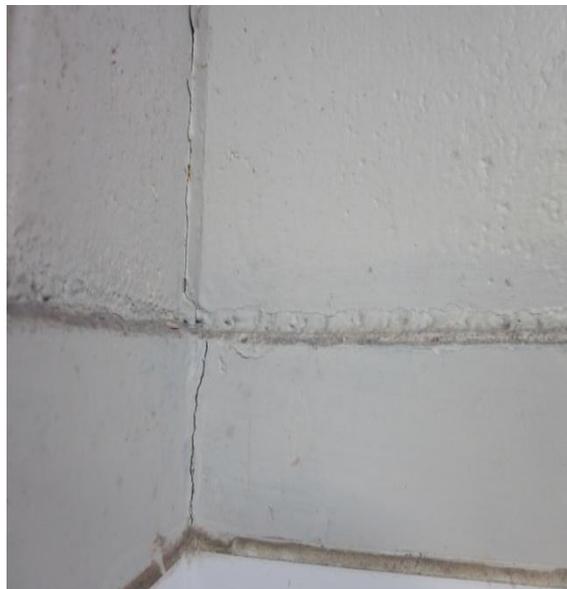
Photo 11: Separation at the east end of the dividing wall

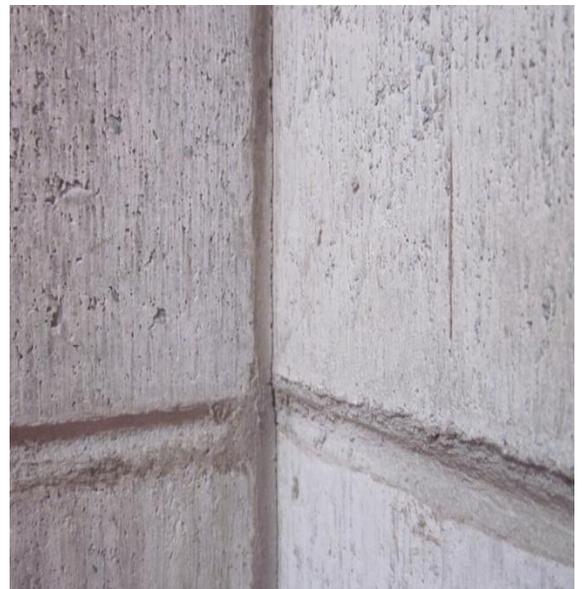
Photo 12: Separation at the west end of the dividing wall

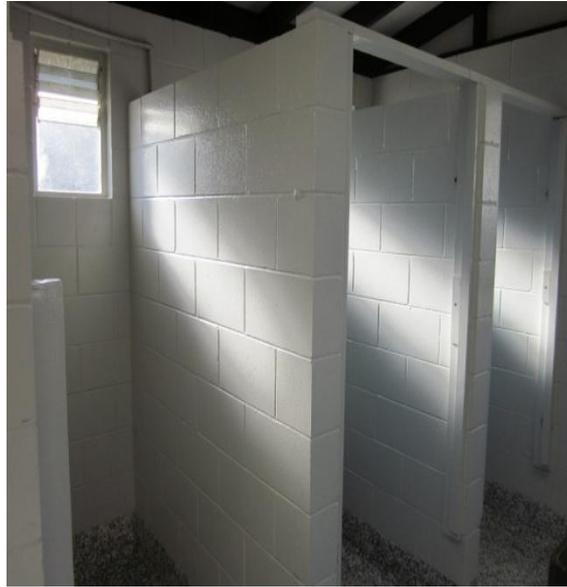
- 5) Hairline separation was observed between the short, 2m high, internal walls and the perpendicular walls in the men's and women's toilets. In the men's toilets 1mm separation was found between these walls and the northern wall of the of the toilet block. (see Photo 13, Photo 14 and Photo 15)

Photo 13: Typical 2m high masonry walls in the men's and women's toilets

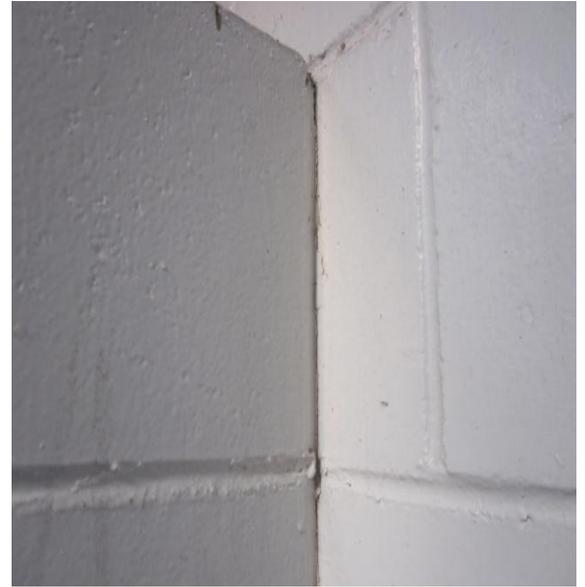
Photo 14: Typical hairline separation between the 2m high internal walls and the perpendicular walls

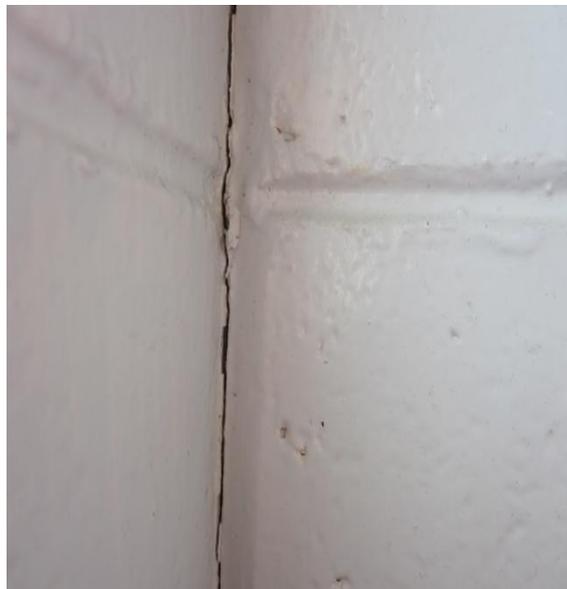
Photo 15: 1mm separation between the 2m high internal walls and the northern walls of the toilet block

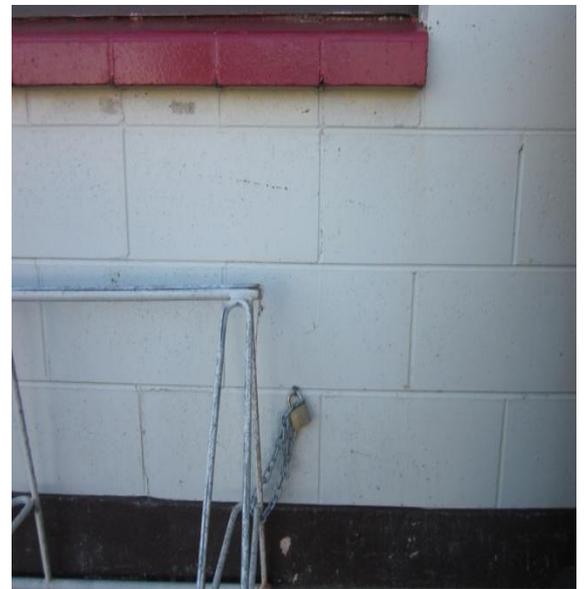
- 6) Hairline cracking was observed on the exterior of the perimeter masonry walls, adjacent to the windows and doors, and at the corners of the building. This cracking is expected to have been present prior to the recent earthquakes. (see Photo 16)

Photo 16: Existing stepped cracking on the exterior of the perimeter walls

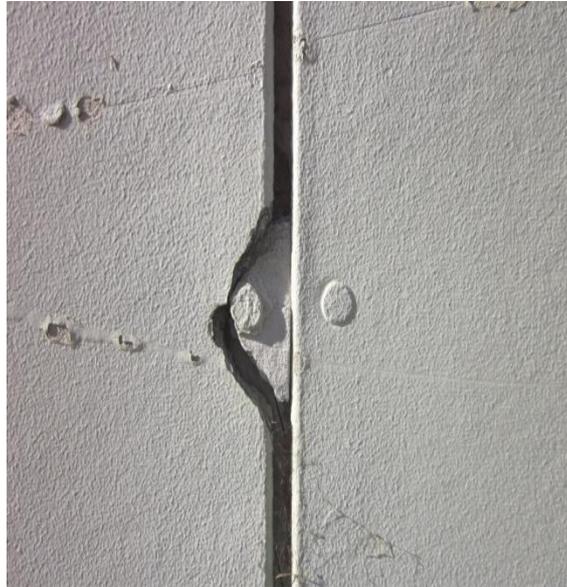
- 7) External wall panels on the west side of the building have broken and cracked at the nail points. Some separation was noted between external wall panels at the south end of the west wall. (see Photo 17 and Photo 18)

Photo 17: Typical damage to the external wall lining on the western wall of the building

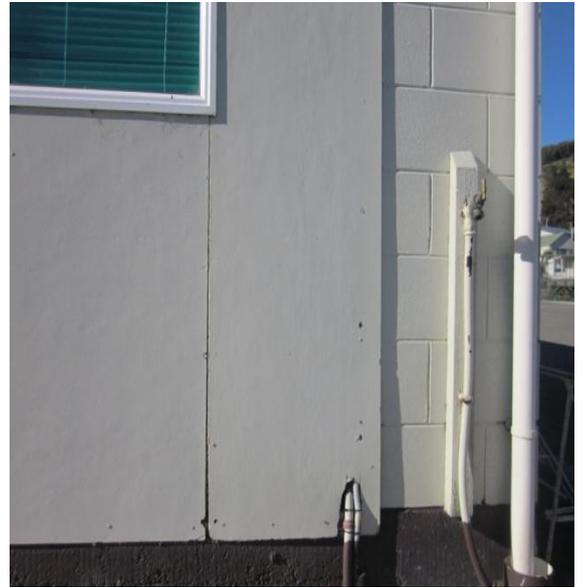
Photo 18: Separation between the external wall lining panels in the south west corner of the building

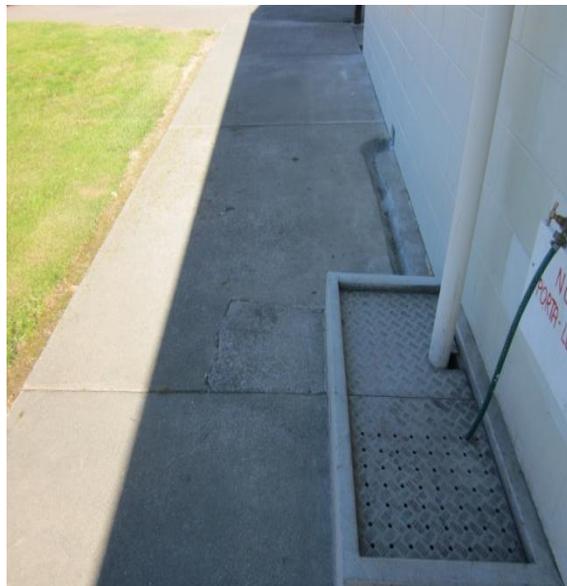
- 8) The external concrete path on the perimeter of the building has undergone differential settlement and cracking was found in the path sections. The cracks varied in width around the building with the greatest being 4mm on the west side of the building. Separation was

observed between the base of the masonry walls and external path. Sections of the path were out of level. This damage appears to be pre-existing and is likely to have been exacerbated by the recent earthquakes. (see Photo 19 and Photo 20)

Photo 19: The external concrete path on the east side of the building showing typical differential settlement

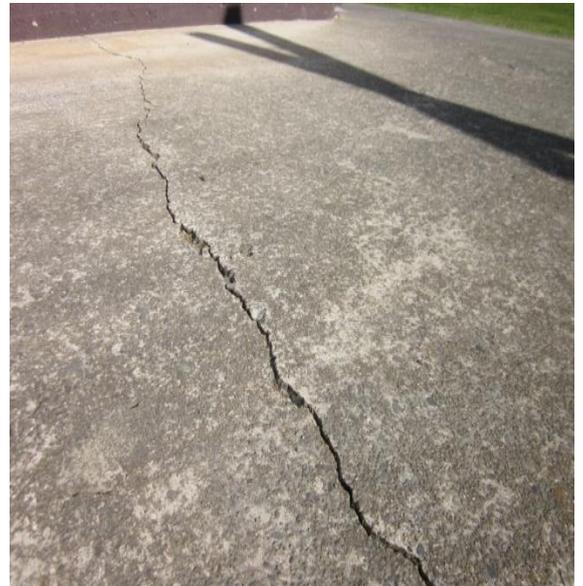
Photo 20: Typical cracking in the external concrete path
