Duvauchelle Works Yard Shelter
PRO 3612-001
Detailed Engineering Evaluation
Qualitative Report
Version Final

Pawsons Valley Road, Duvauchelle

Christchurch City Council

Detailed Engineering Evaluation

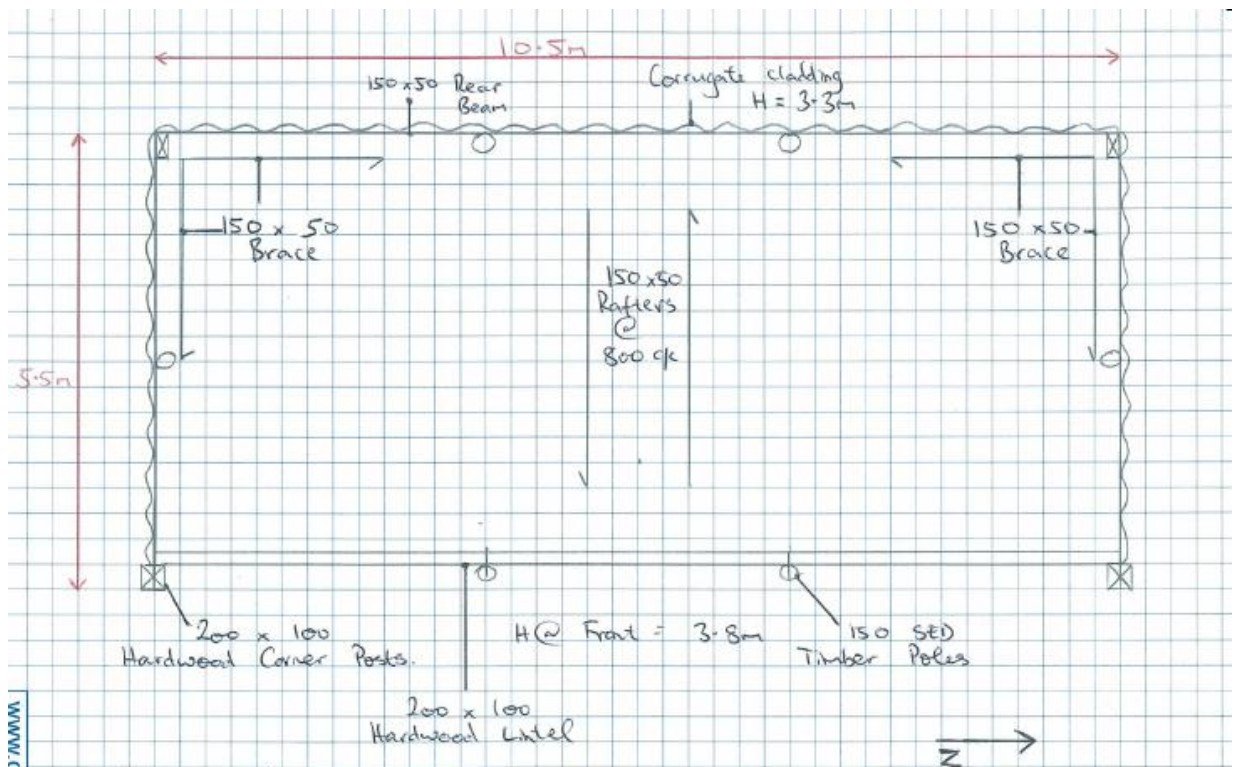
Figure 2 Plan Sketch Showing Key Structural Elements

The building has a timber framed gravity support system consisting of front and rear timber bearers supported by rectangular and circular timber posts embedded into the ground. The lintels support the timber rafters which in turn are overlaid by timber purlins for roof cladding support. This structure is most likely wind load dominated.

The seismic bracing system observed for both longitudinal and transverse directions is the diagonal 150x50 tension/compression timber braces present in each of the three corrugate clad walls, as shown in Photograph 3 in Appendix A. As these are present in only three sides of the structure, diagonal roof bracing would be required to transfer seismic and wind loads from the front of the building to the rear where the wall braces are; these roof braces however were absent.

The structure's timber poles may also be cantilever embedded to the ground, though this would require further physical investigation on site to prove. If there is no cantilevering capacity in the poles, the diagonal braces remain the sole bracing system, making the absence of roof bracing a critical structural weakness.

The addition of strap bracing to the roof in order to reduce the plan irregularity is recommended.

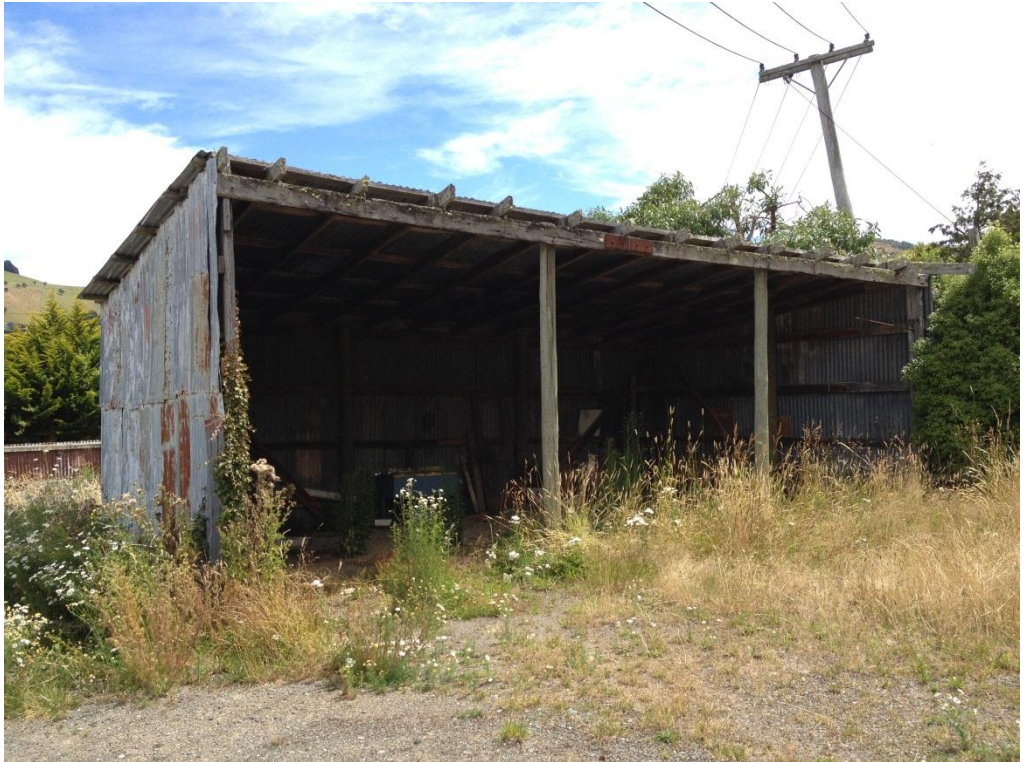
By nature of the function of the structure, the front side has less bracing than the other three sides, resulting in plan irregularity. For the purposes of % NBS determination in the IEP, for this building 'significant' was selected in accordance with NZSEE guidelines.

Photograph 1: East (front) Elevation

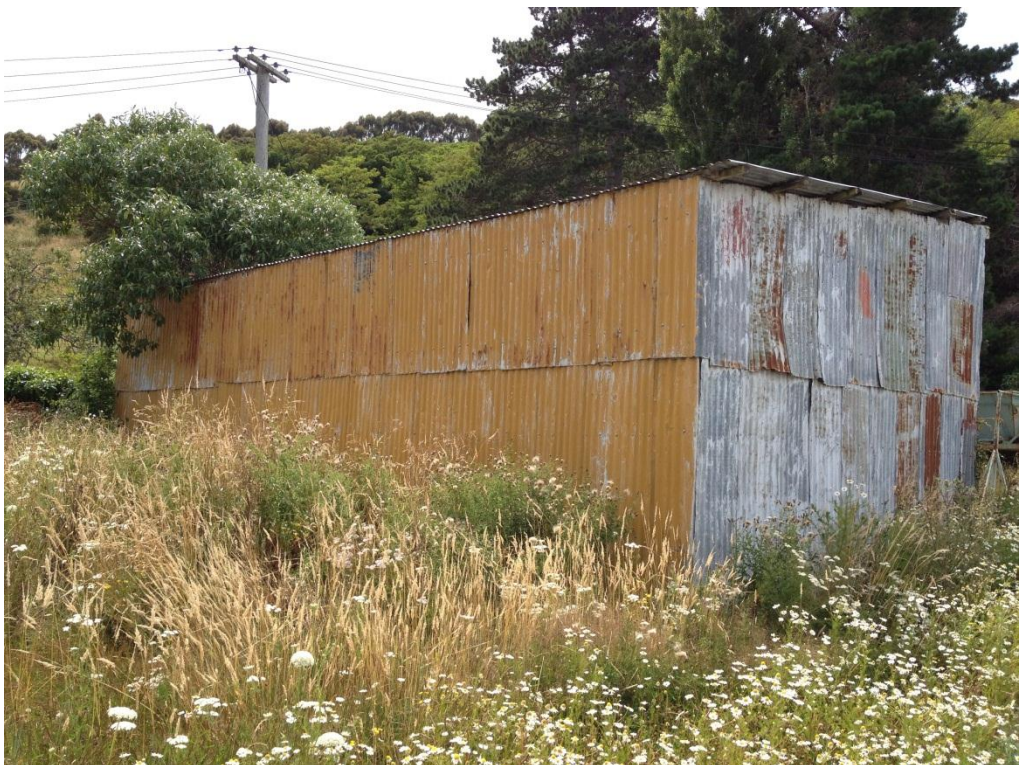
Photograph 2: South and West Elevations

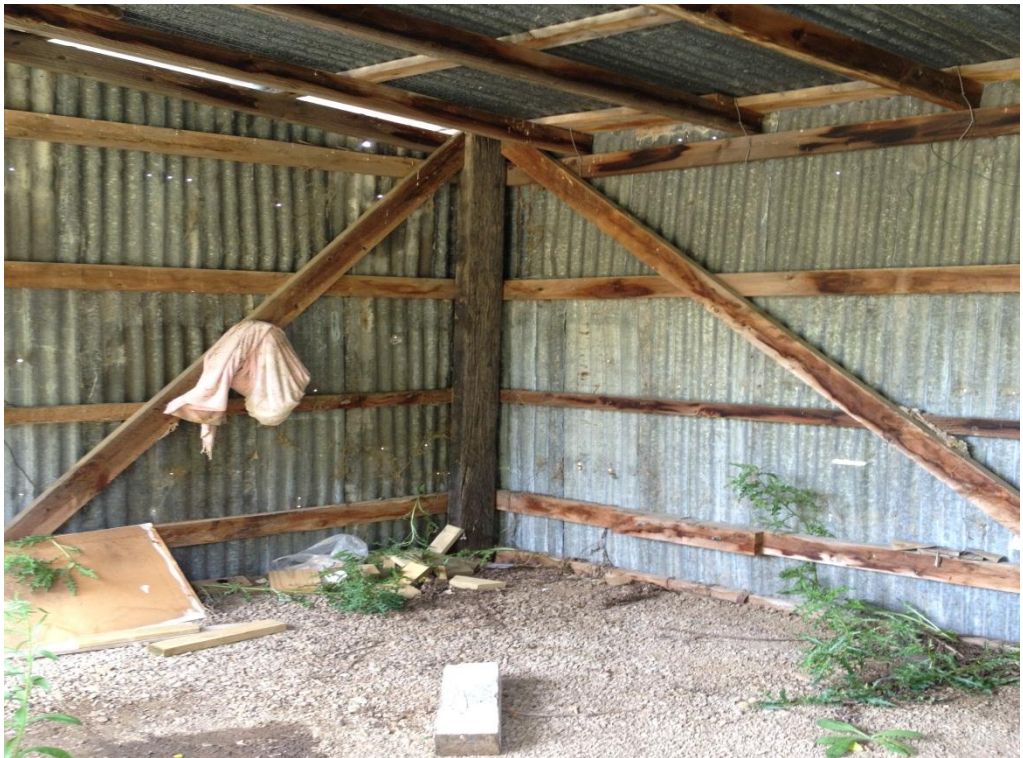
Photograph 3: Tension/Compression bracing

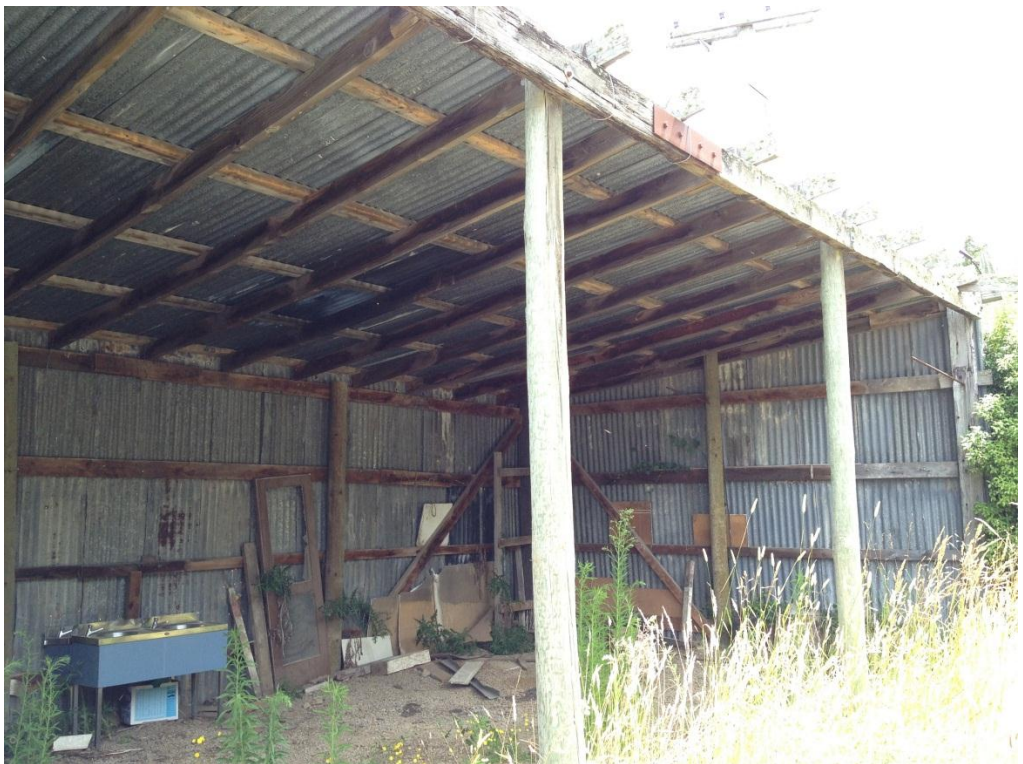
The roof had no diagonal in-line bracing which contributes significantly to resist seismic load over its open-fronted plan irregularity.

Photograph 4: Pitched timber framed roof structure

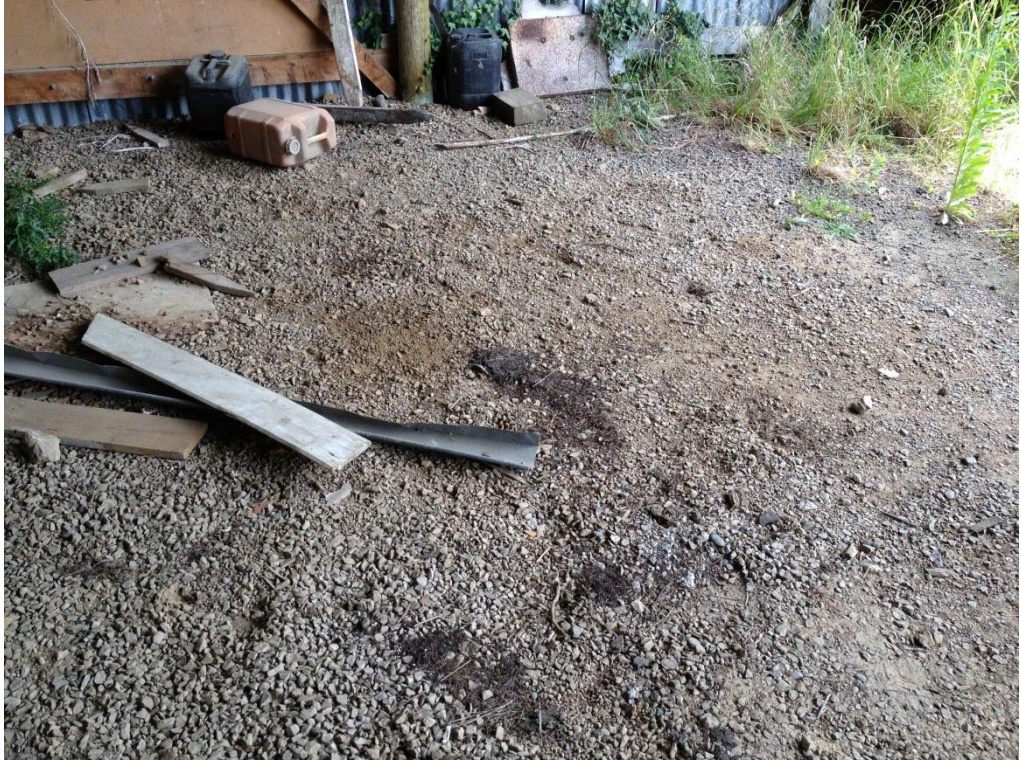
Photograph 5: Loose gravel ground material

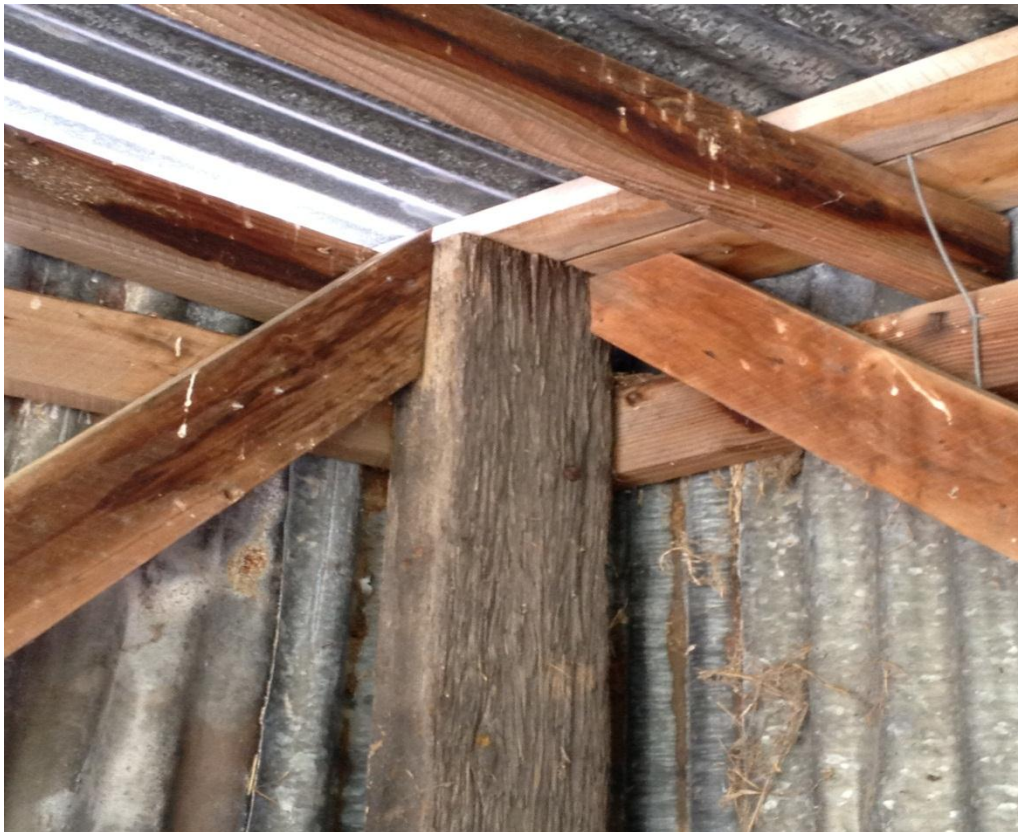
Photograph 6: Diagonal bracing to column connection
