Christchurch City Council
PRK_0572_BLDG_002 EQ2
Edgar McIntosh Park - Toilets
177 Condell Ave

QUALITATIVE ASSESSMENT REPORT

FINAL

- Rev B
- 12 March 2013

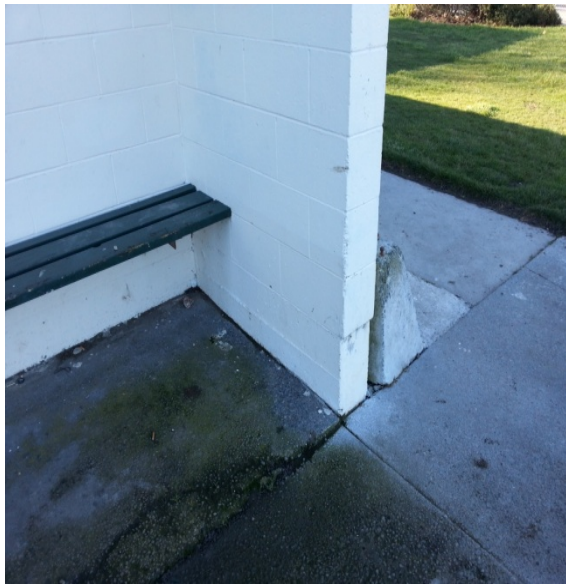
Photo 17: View of concrete foundation beneath masonry

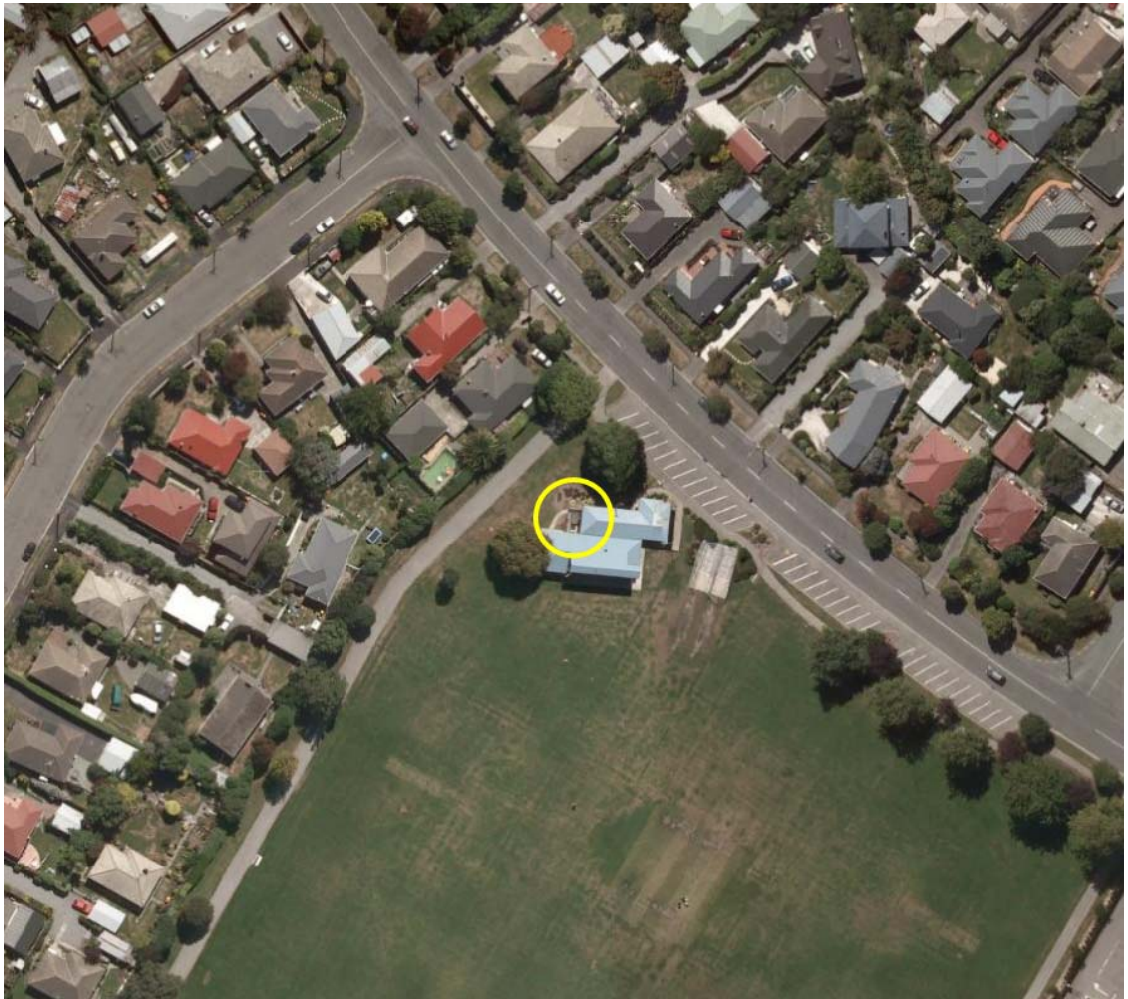
- **Figure 4 – Aerial photography from 24 Feb 2011 (<http://viewers.geospatial.govt.nz/>)**

There appears to be no evidence of any liquefied ejecta at surface or land damage that may be caused by cyclic ground motions induced by an earthquake event. Therefore, it is unlikely that any significant liquefaction of the underlying soil strata occurred on site.

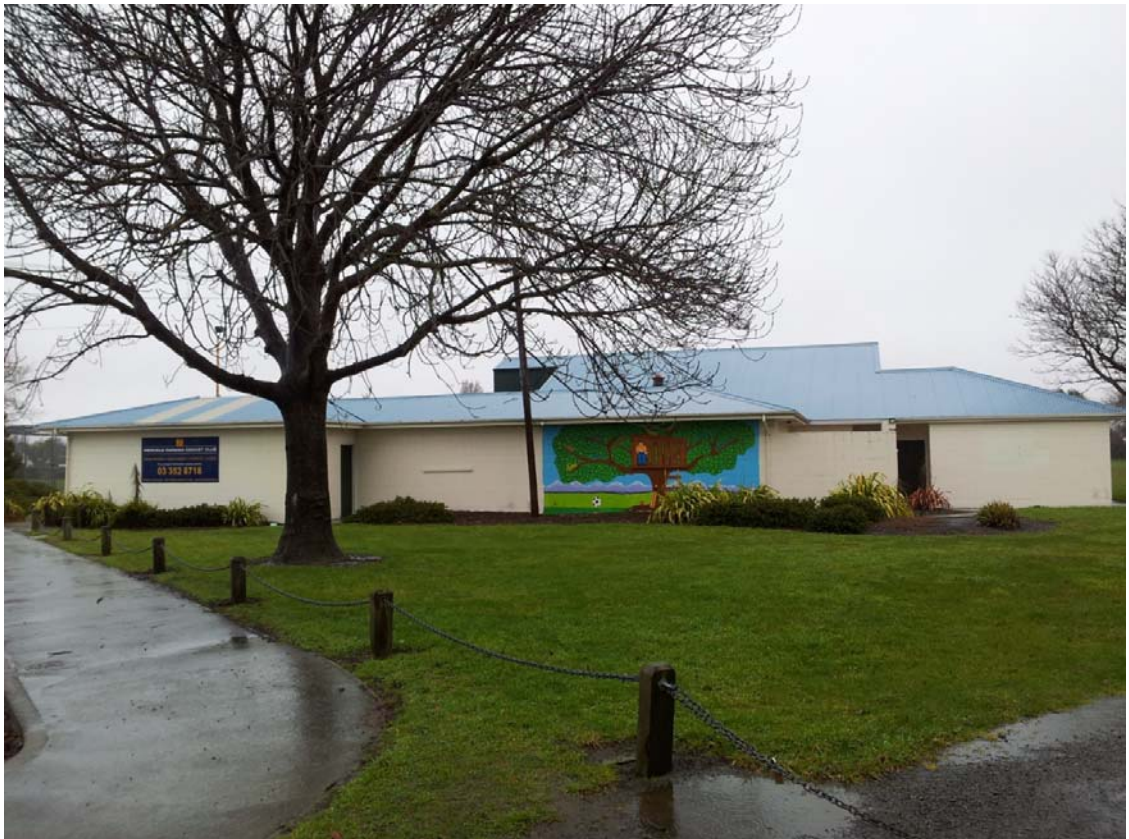
The toilet block was noted to be constructed using masonry walls with a concrete roof and slab on grade foundation. The toilet block is attached to the Merivale Papanui Cricket Club Pavilion. There was no apparent evidence of liquefaction or land damage around the toilet block and Pavilion structures. There was slight differential settlement of some concrete paving around the building. The nearby Condell Avenue appeared undamaged.

- **Figure 5 Overview of the pavilion with the toilet attached to the Pavilion structure**

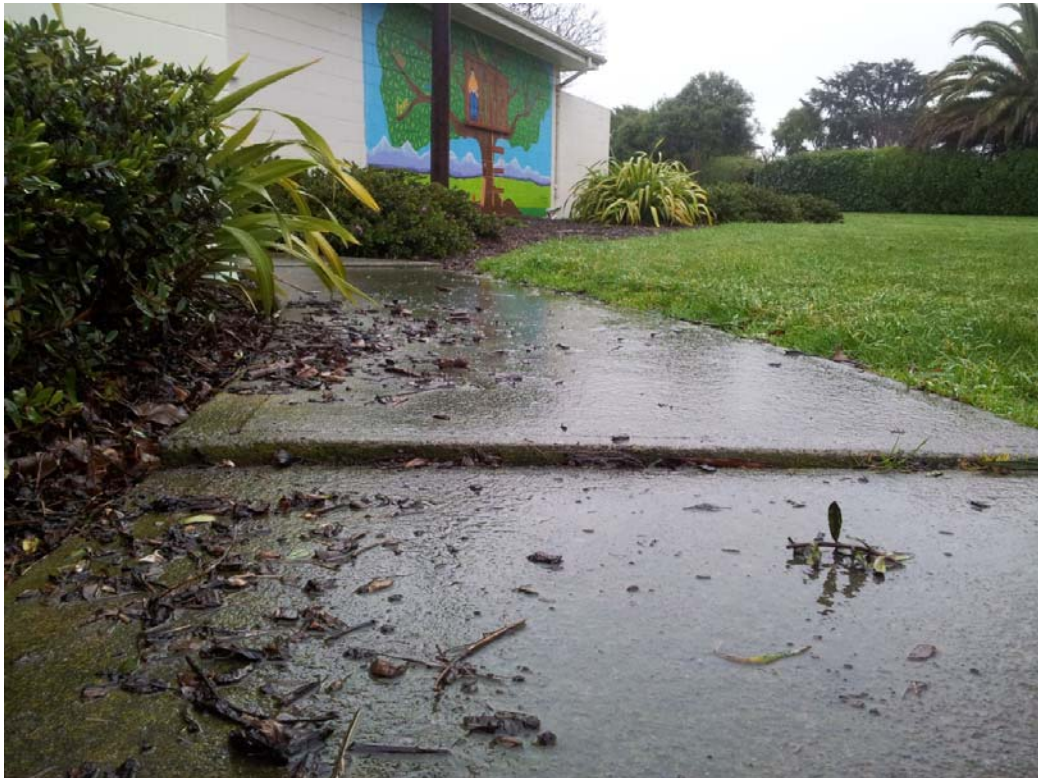
■ **Figure 6 Observed settlement of pavement slabs**

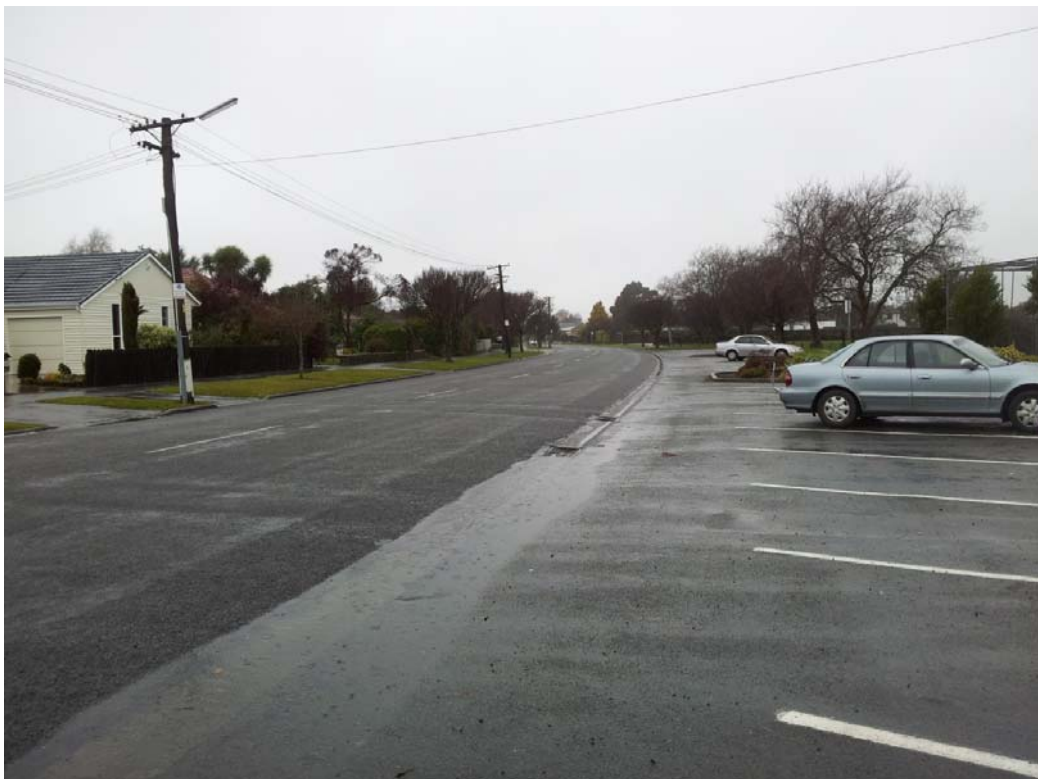
■ **Figure 7 No apparent damage to the section of Condell Avenue near the site**
