Christchurch City Council
PRK_1338_BLDG_002 EQ2
Edmonds Factory Gardens Toilets
365 Ferry Road, Phillipstown

QUANTITATIVE ASSESSMENT REPORT

FINAL

- Rev B
- 15 July 2013

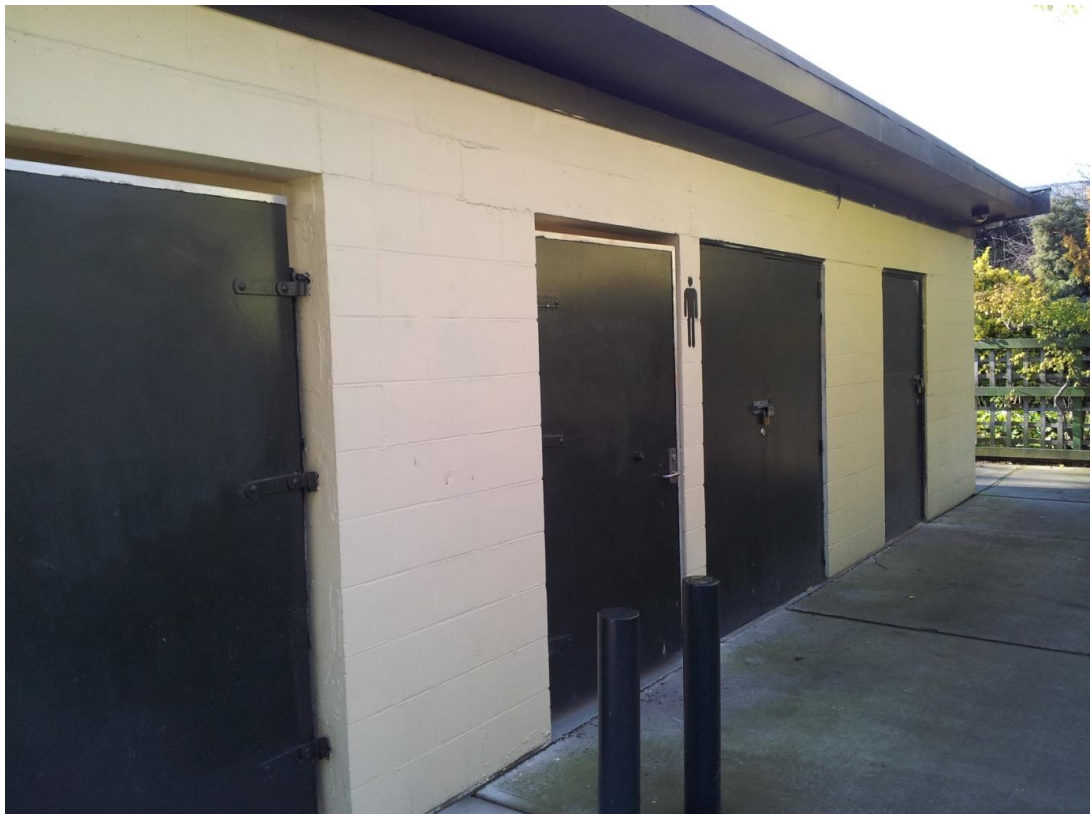
The building was noted to be a masonry block construction with a sheet metal roof and slab on grade foundation. Some hairline cracks in the masonry walls and minor spalling of the block to the north west corner of the building were observed. There was a minor separation between the building and external ground slab on the southern elevation.

■ **Figure 7 Front view of the building (southern elevation)**

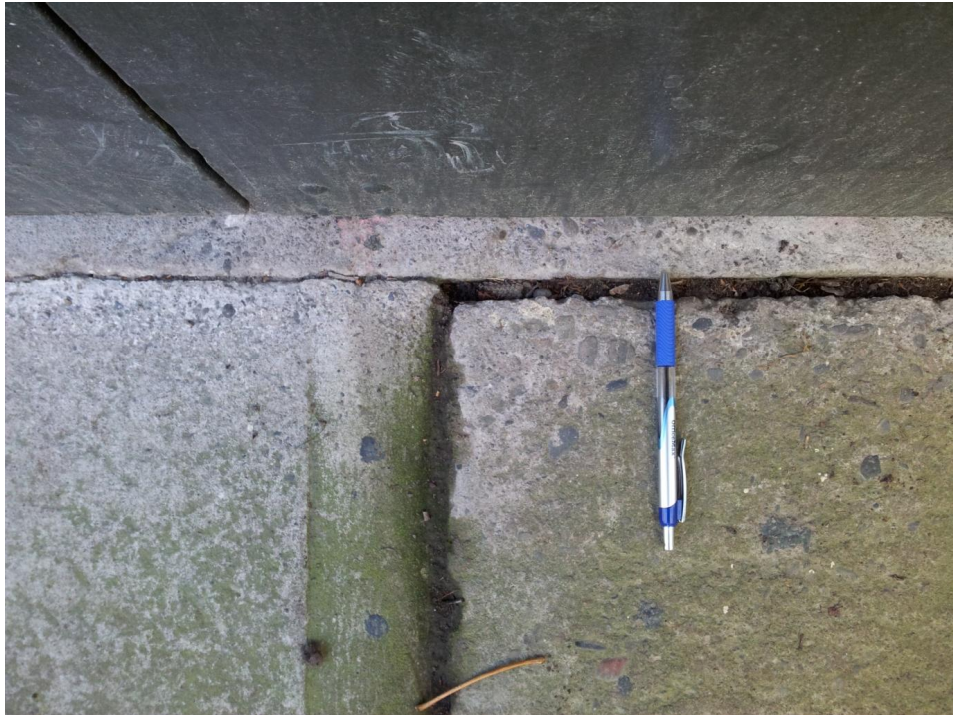
■ **Figure 8 Minor gap between the building and external ground slab**

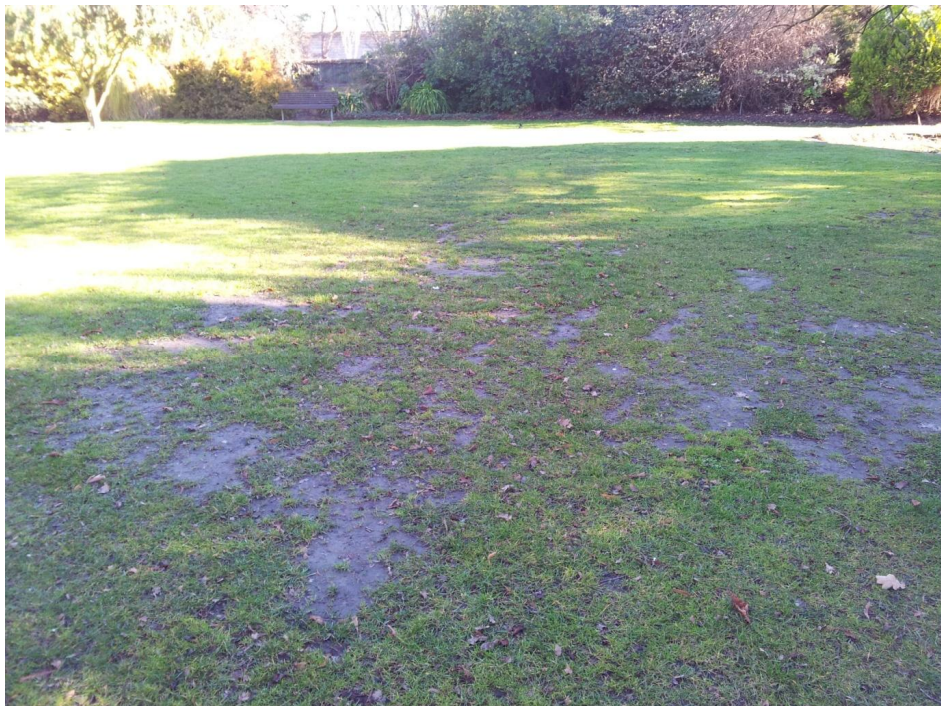
There was evidence of liquefaction having occurred at the site with significant amounts of sand ejecta still present 18 months after the 22 February 2011 event. The nearby car park appeared to have been resurfaced most likely due to the earthquake damage. No visual evidence of lateral spreading or settlement of the structure was observed during the site walkover.

■ **Figure 8 Sand and silt ejecta close to the toilet block**
