Elmwood Park Tool Shed PRK 0590 BLDG 003 EQ2

Detailed Engineering Evaluation

Quantitative Assessment Report

Date: 7 February 2013
Reference: 6-QUCC1.52
Status: Final

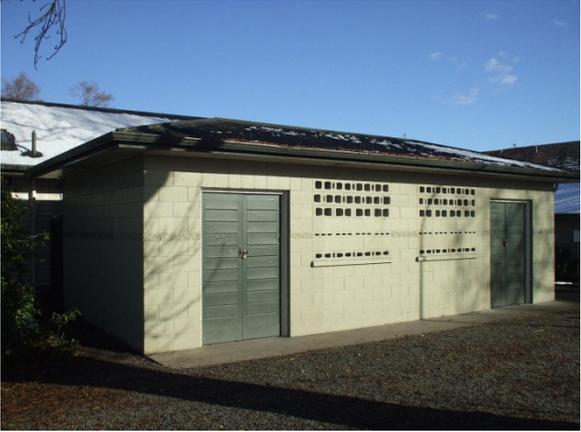
Elmwood Park Tool Shed		
No.	Item description	Photo
General		
1.	Front view of the Tool Shed

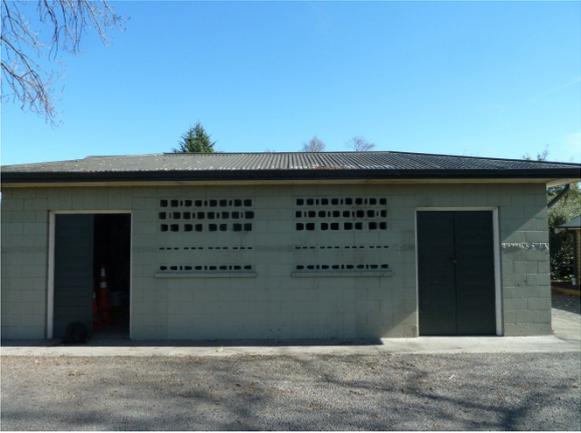
2.	Decorative blocks in front wall

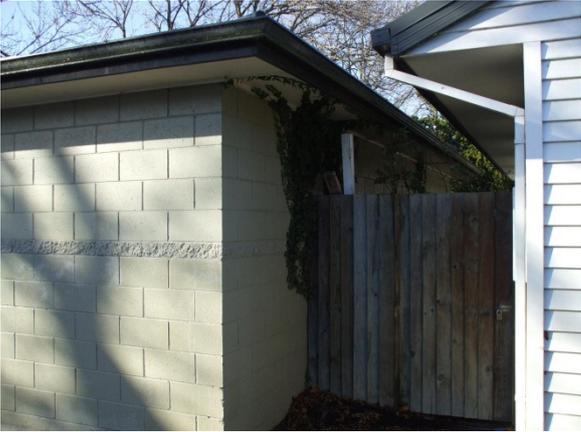
All walls are 2.5m high running bond 20 series (190mm wide) concrete masonry. All block walls have one row (100mm high) of Summerhill stone running mid-height.

3.	Summerhill stone mid-height

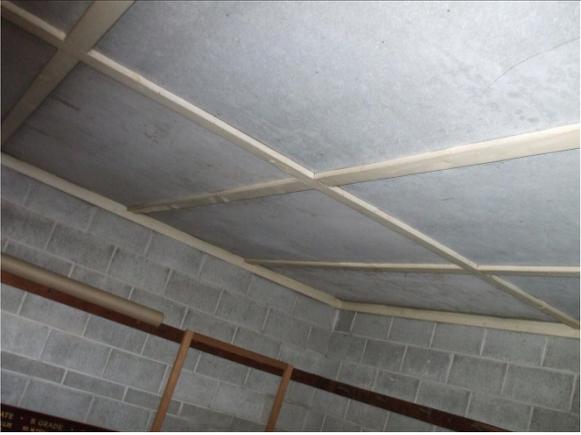
Due to the non-intrusive nature of the original survey, not all structural details could be ascertained, such as the connection of the diaphragm ceiling to block walls.

4.	Ceiling diaphragm

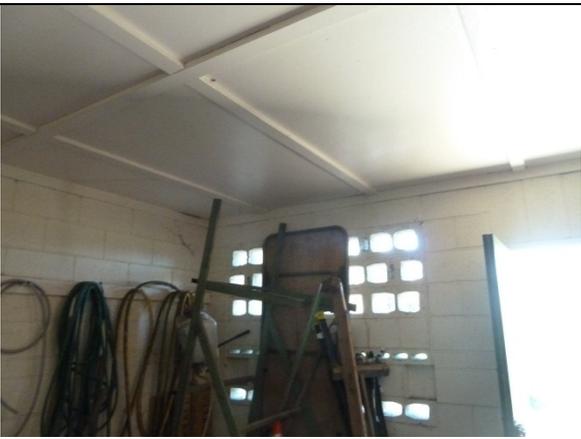
5.	Used area of tool shed

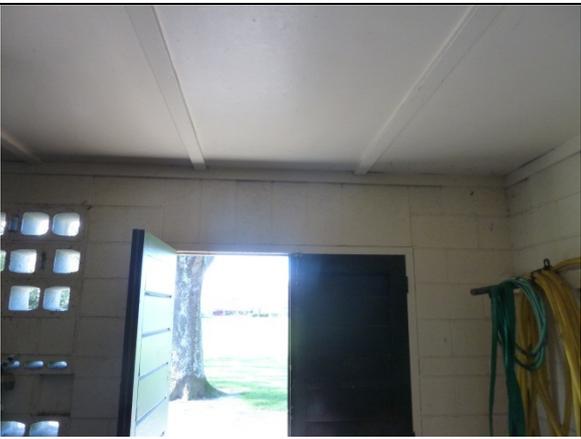
6.	Lintels spanning over doors

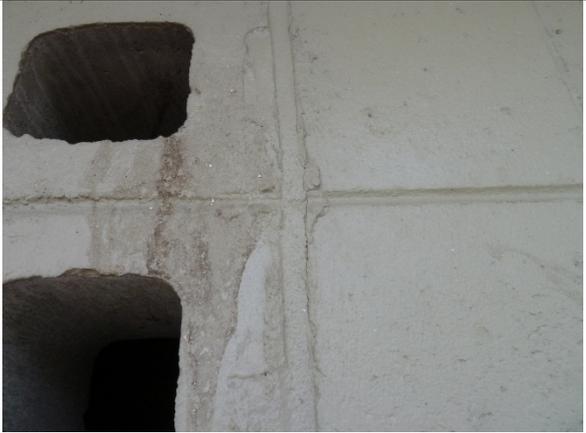
The structure shows some minor cracking by the decorative blocks. We also observed three of the four corner locations have hairline zigzag cracks near the edge. It is deemed that these cracks are a result of age, usage and long term movement and not from recent earthquake damage.

7.	Hairline cracks around decorative blocks

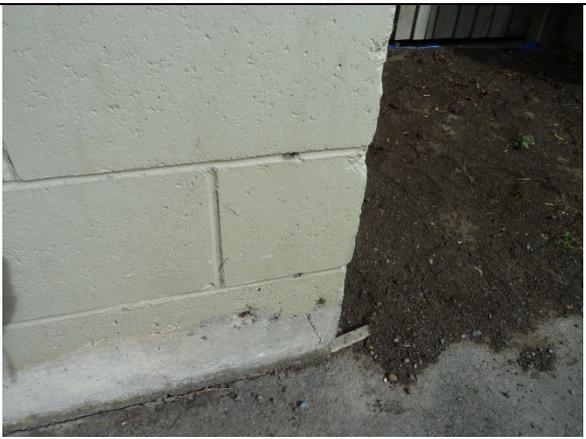
8.	Slab on ground
